Property Location
Former American Linen Supply
700 Dexter Avenue North
Seattle, Washington

Historical Property Features
Former American Linen Supply
700 Dexter Avenue North
Seattle, Washington

Property Exploration Location Map
Former American Linen Supply
700 Dexter Avenue North
Seattle, Washington

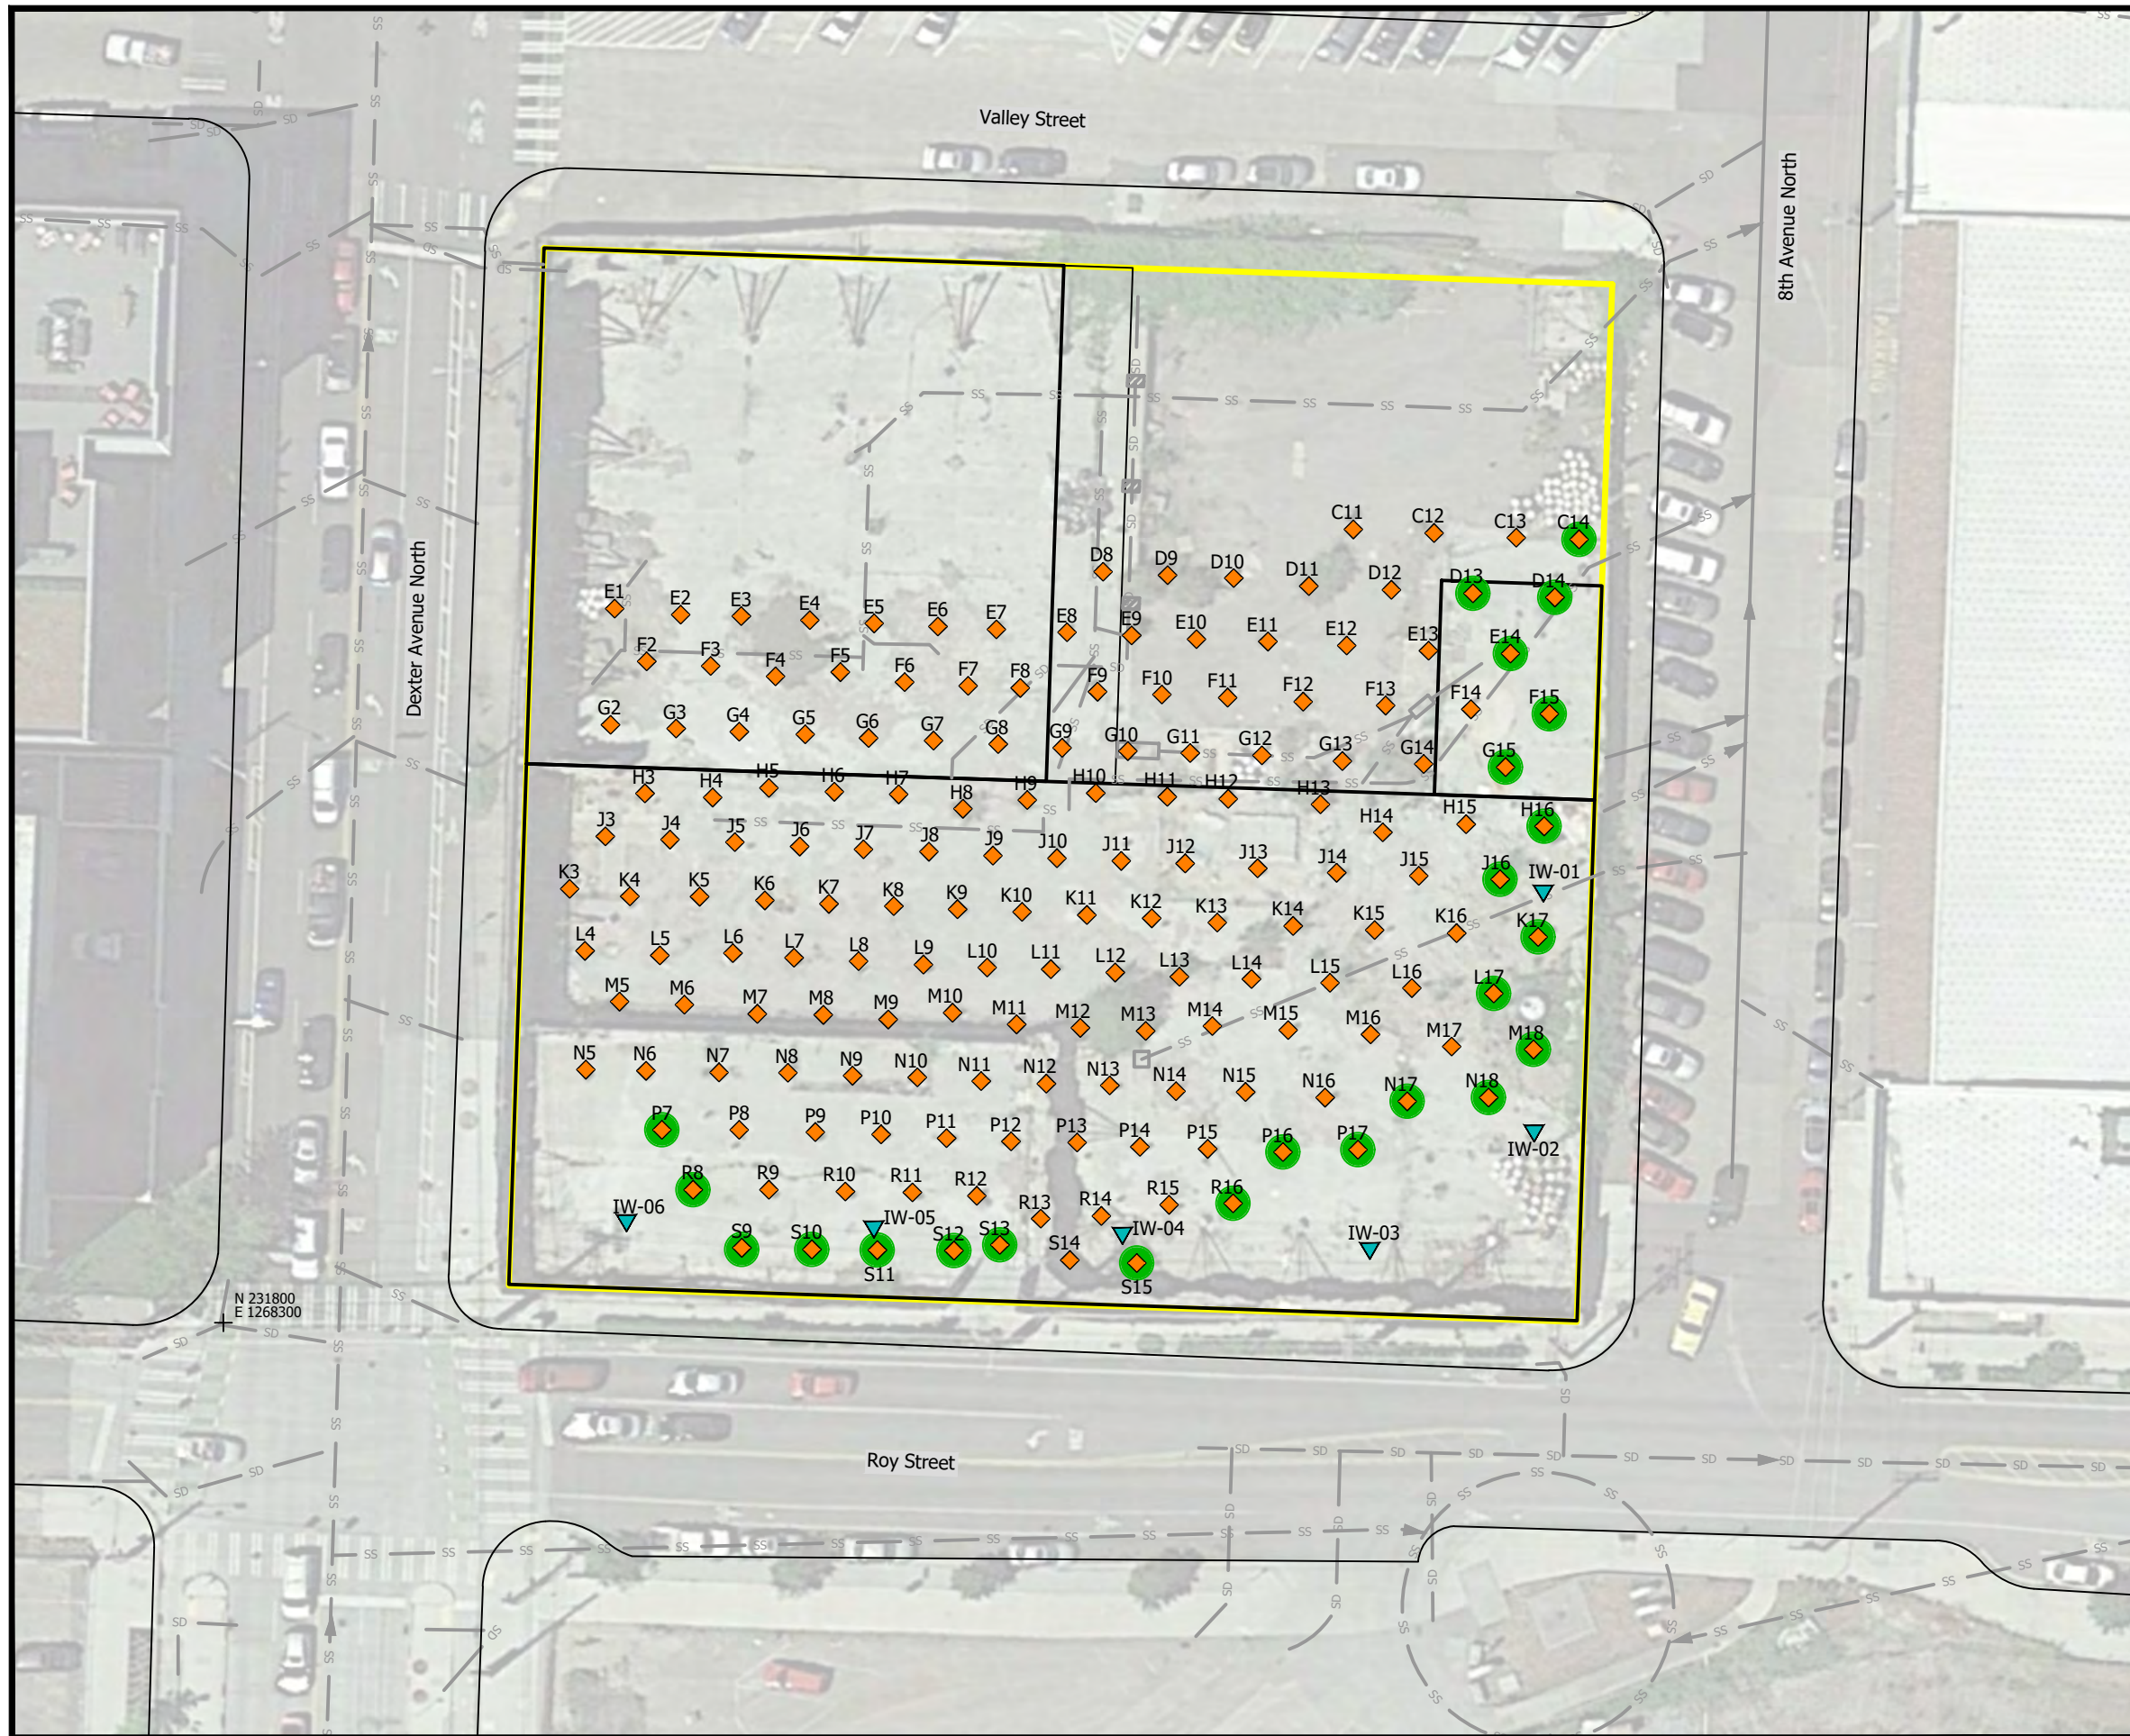
FIGURE
8

ERH/SVE System Layout and Pilot Study Wells
 Former American Linen Supply
 700 Dexter Avenue North
 Seattle, Washington

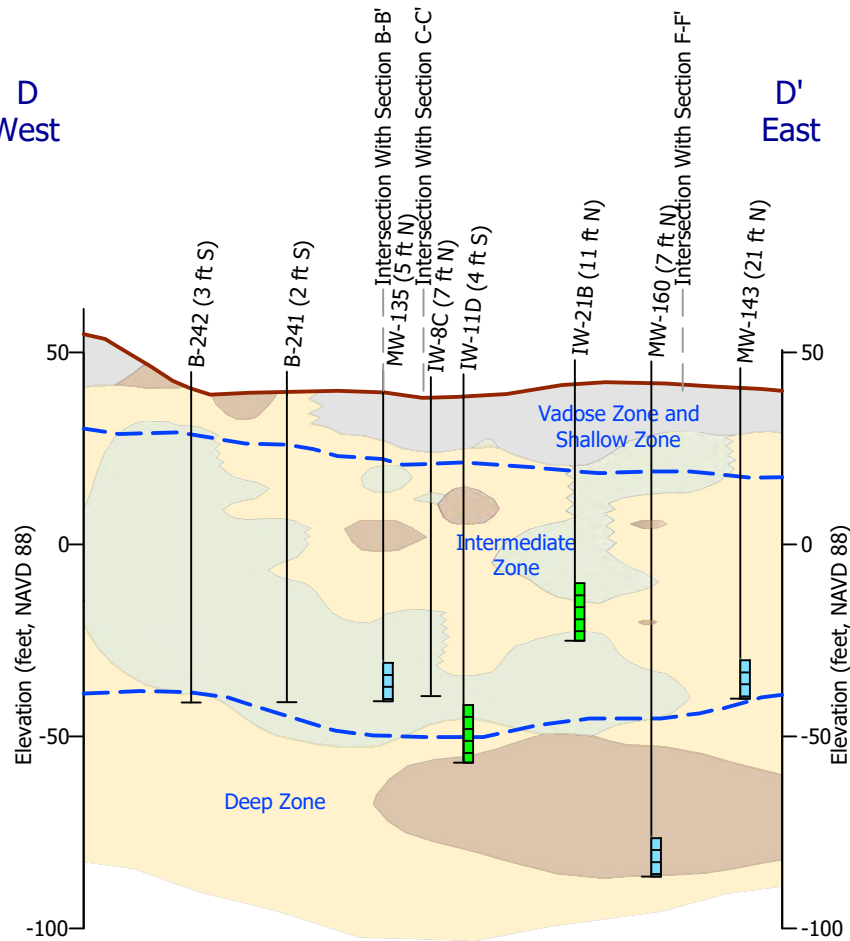
12

Geologic Cross Section D-D'
Former American Linen Supply
700 Dexter Avenue North
Seattle, Washington

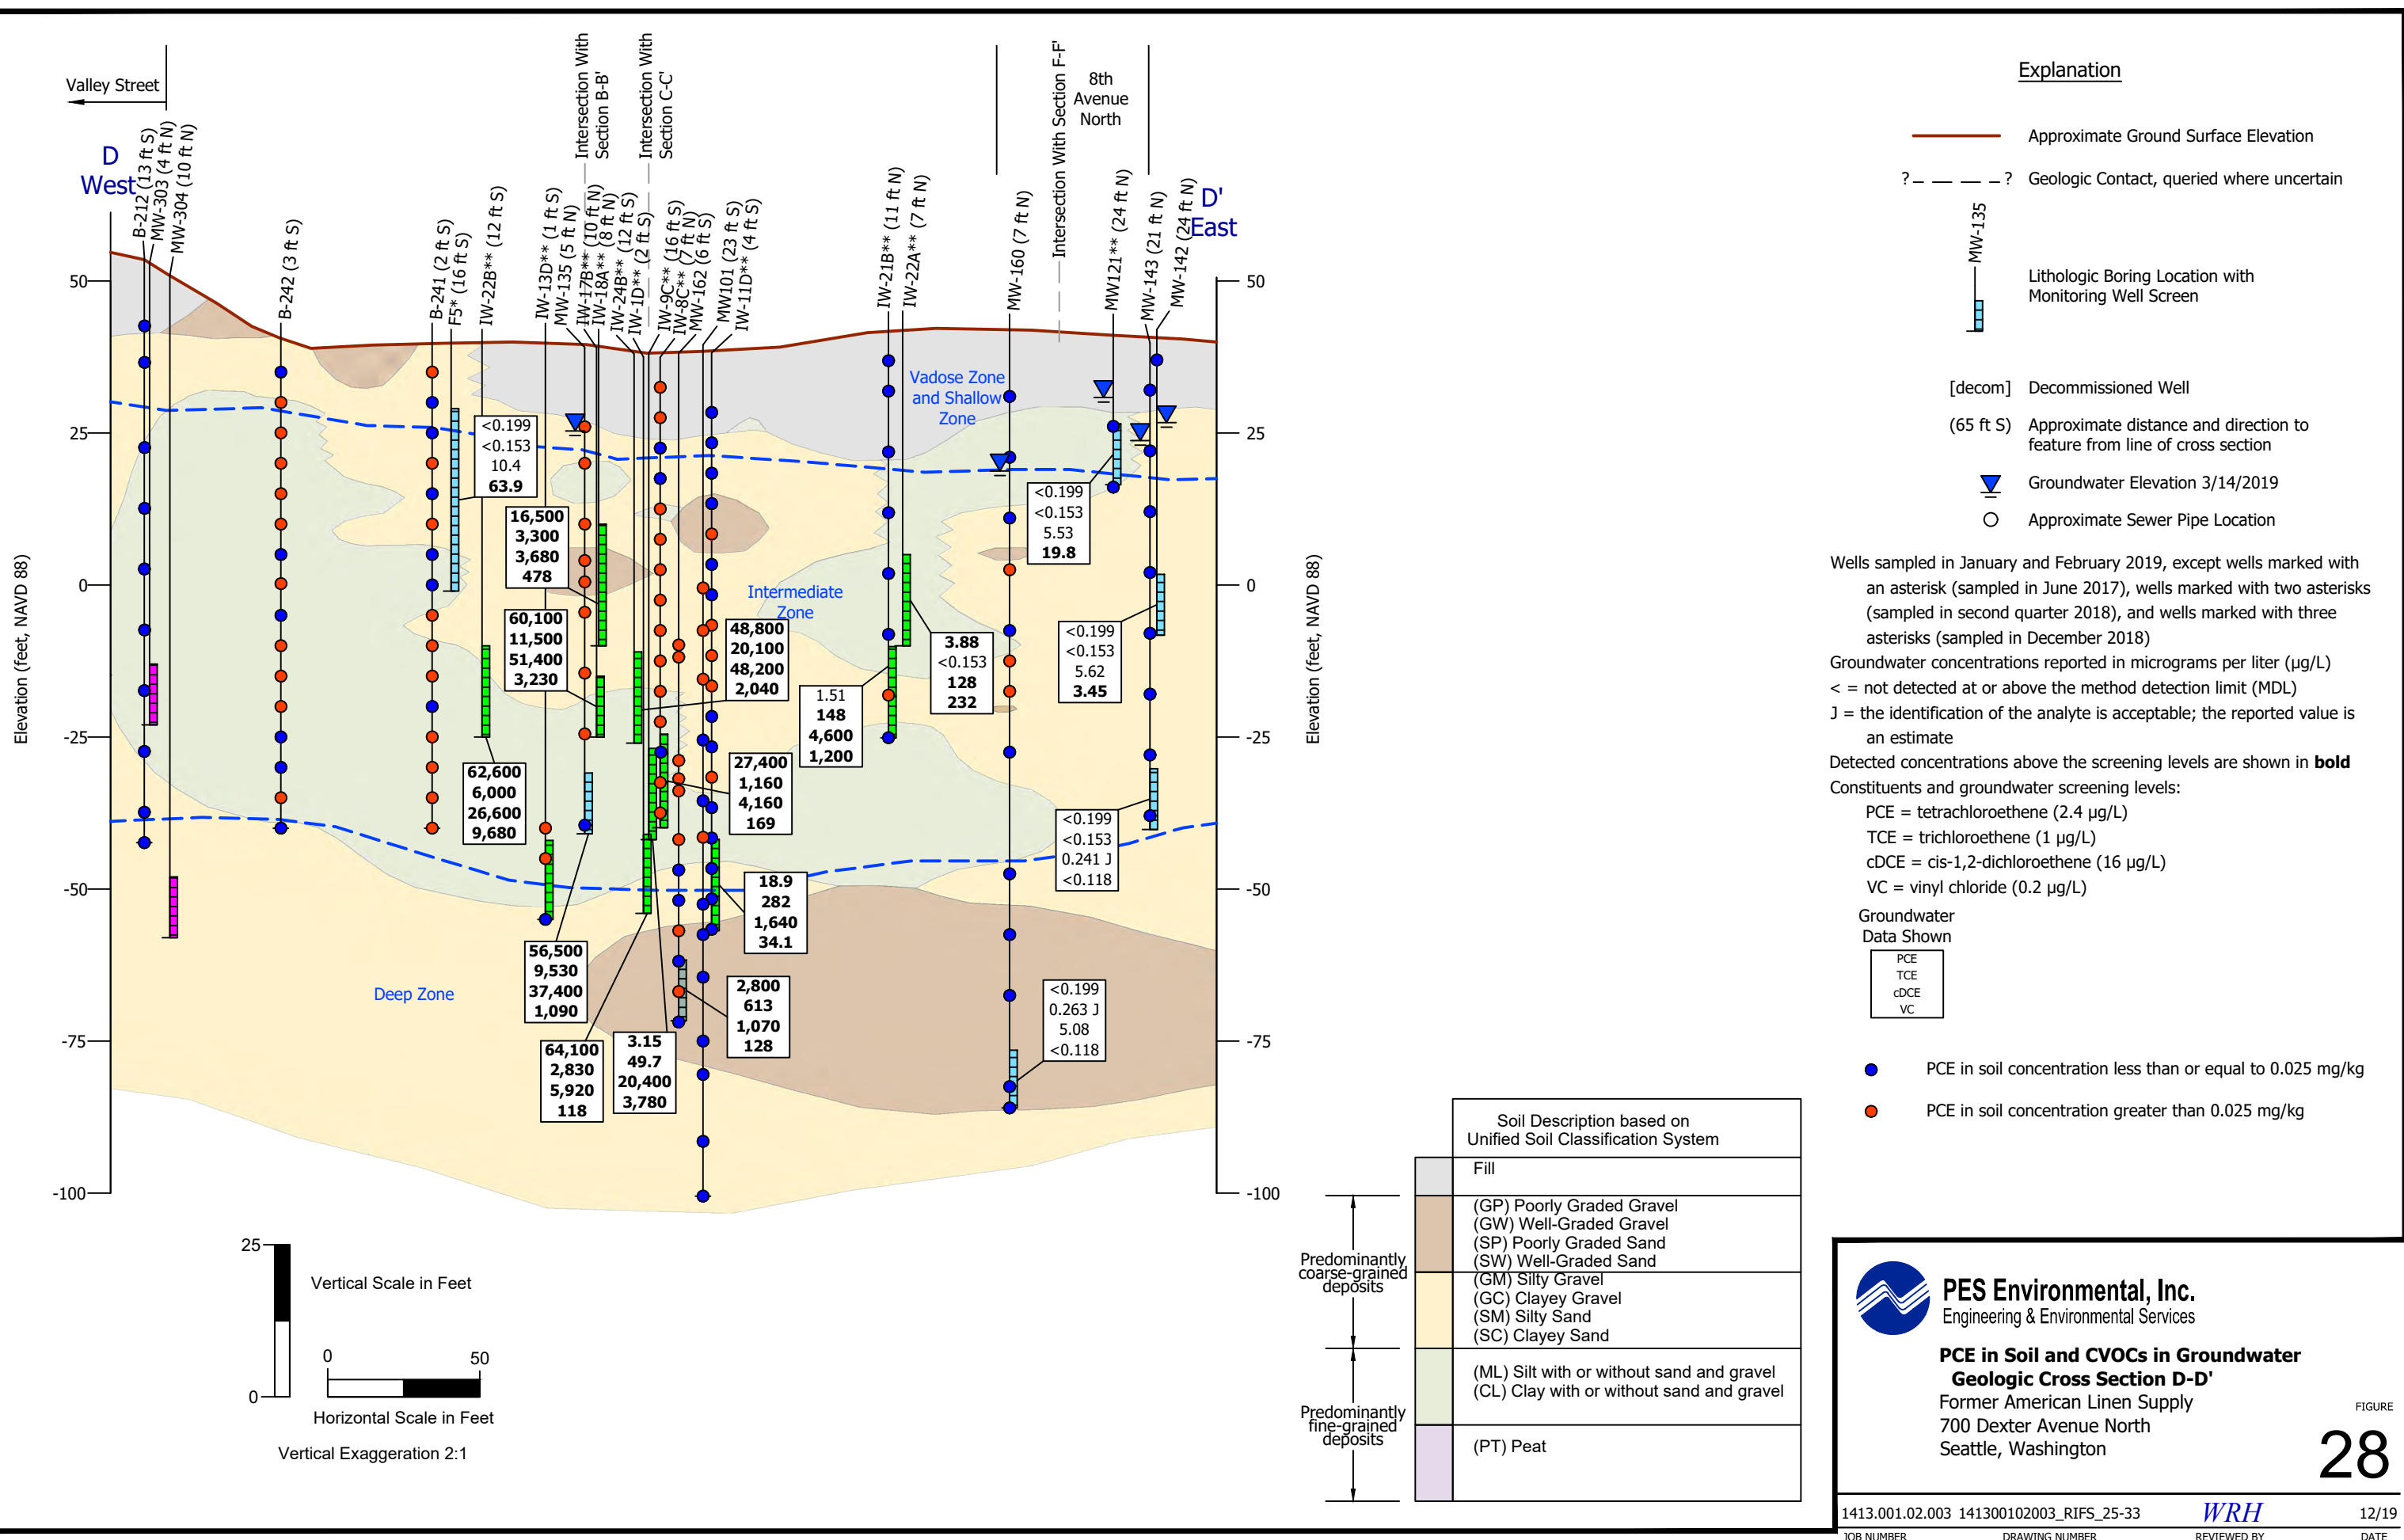
FIGURE
28

PCE in Soil and CVOCs in Groundwater
Geologic Cross Section D-D'
Former American Linen Supply
700 Dexter Avenue North
Seattle, Washington
