# Hydrogeologic Assessment for Compliance of 1,4-Dioxane Midway Landfill

**Seattle Public Utilities**  
700 5th Avenue  
Seattle, WA 98124-4018

Parametrix and EHS-International, Inc. 2019.  
Hydrogeologic Assessment for Compliance of  
1,4-Dioxane  
Midway Landfill  
Prepared by Parametrix and  
EHS-International, Inc.  
Seattle, WA. October 2019.

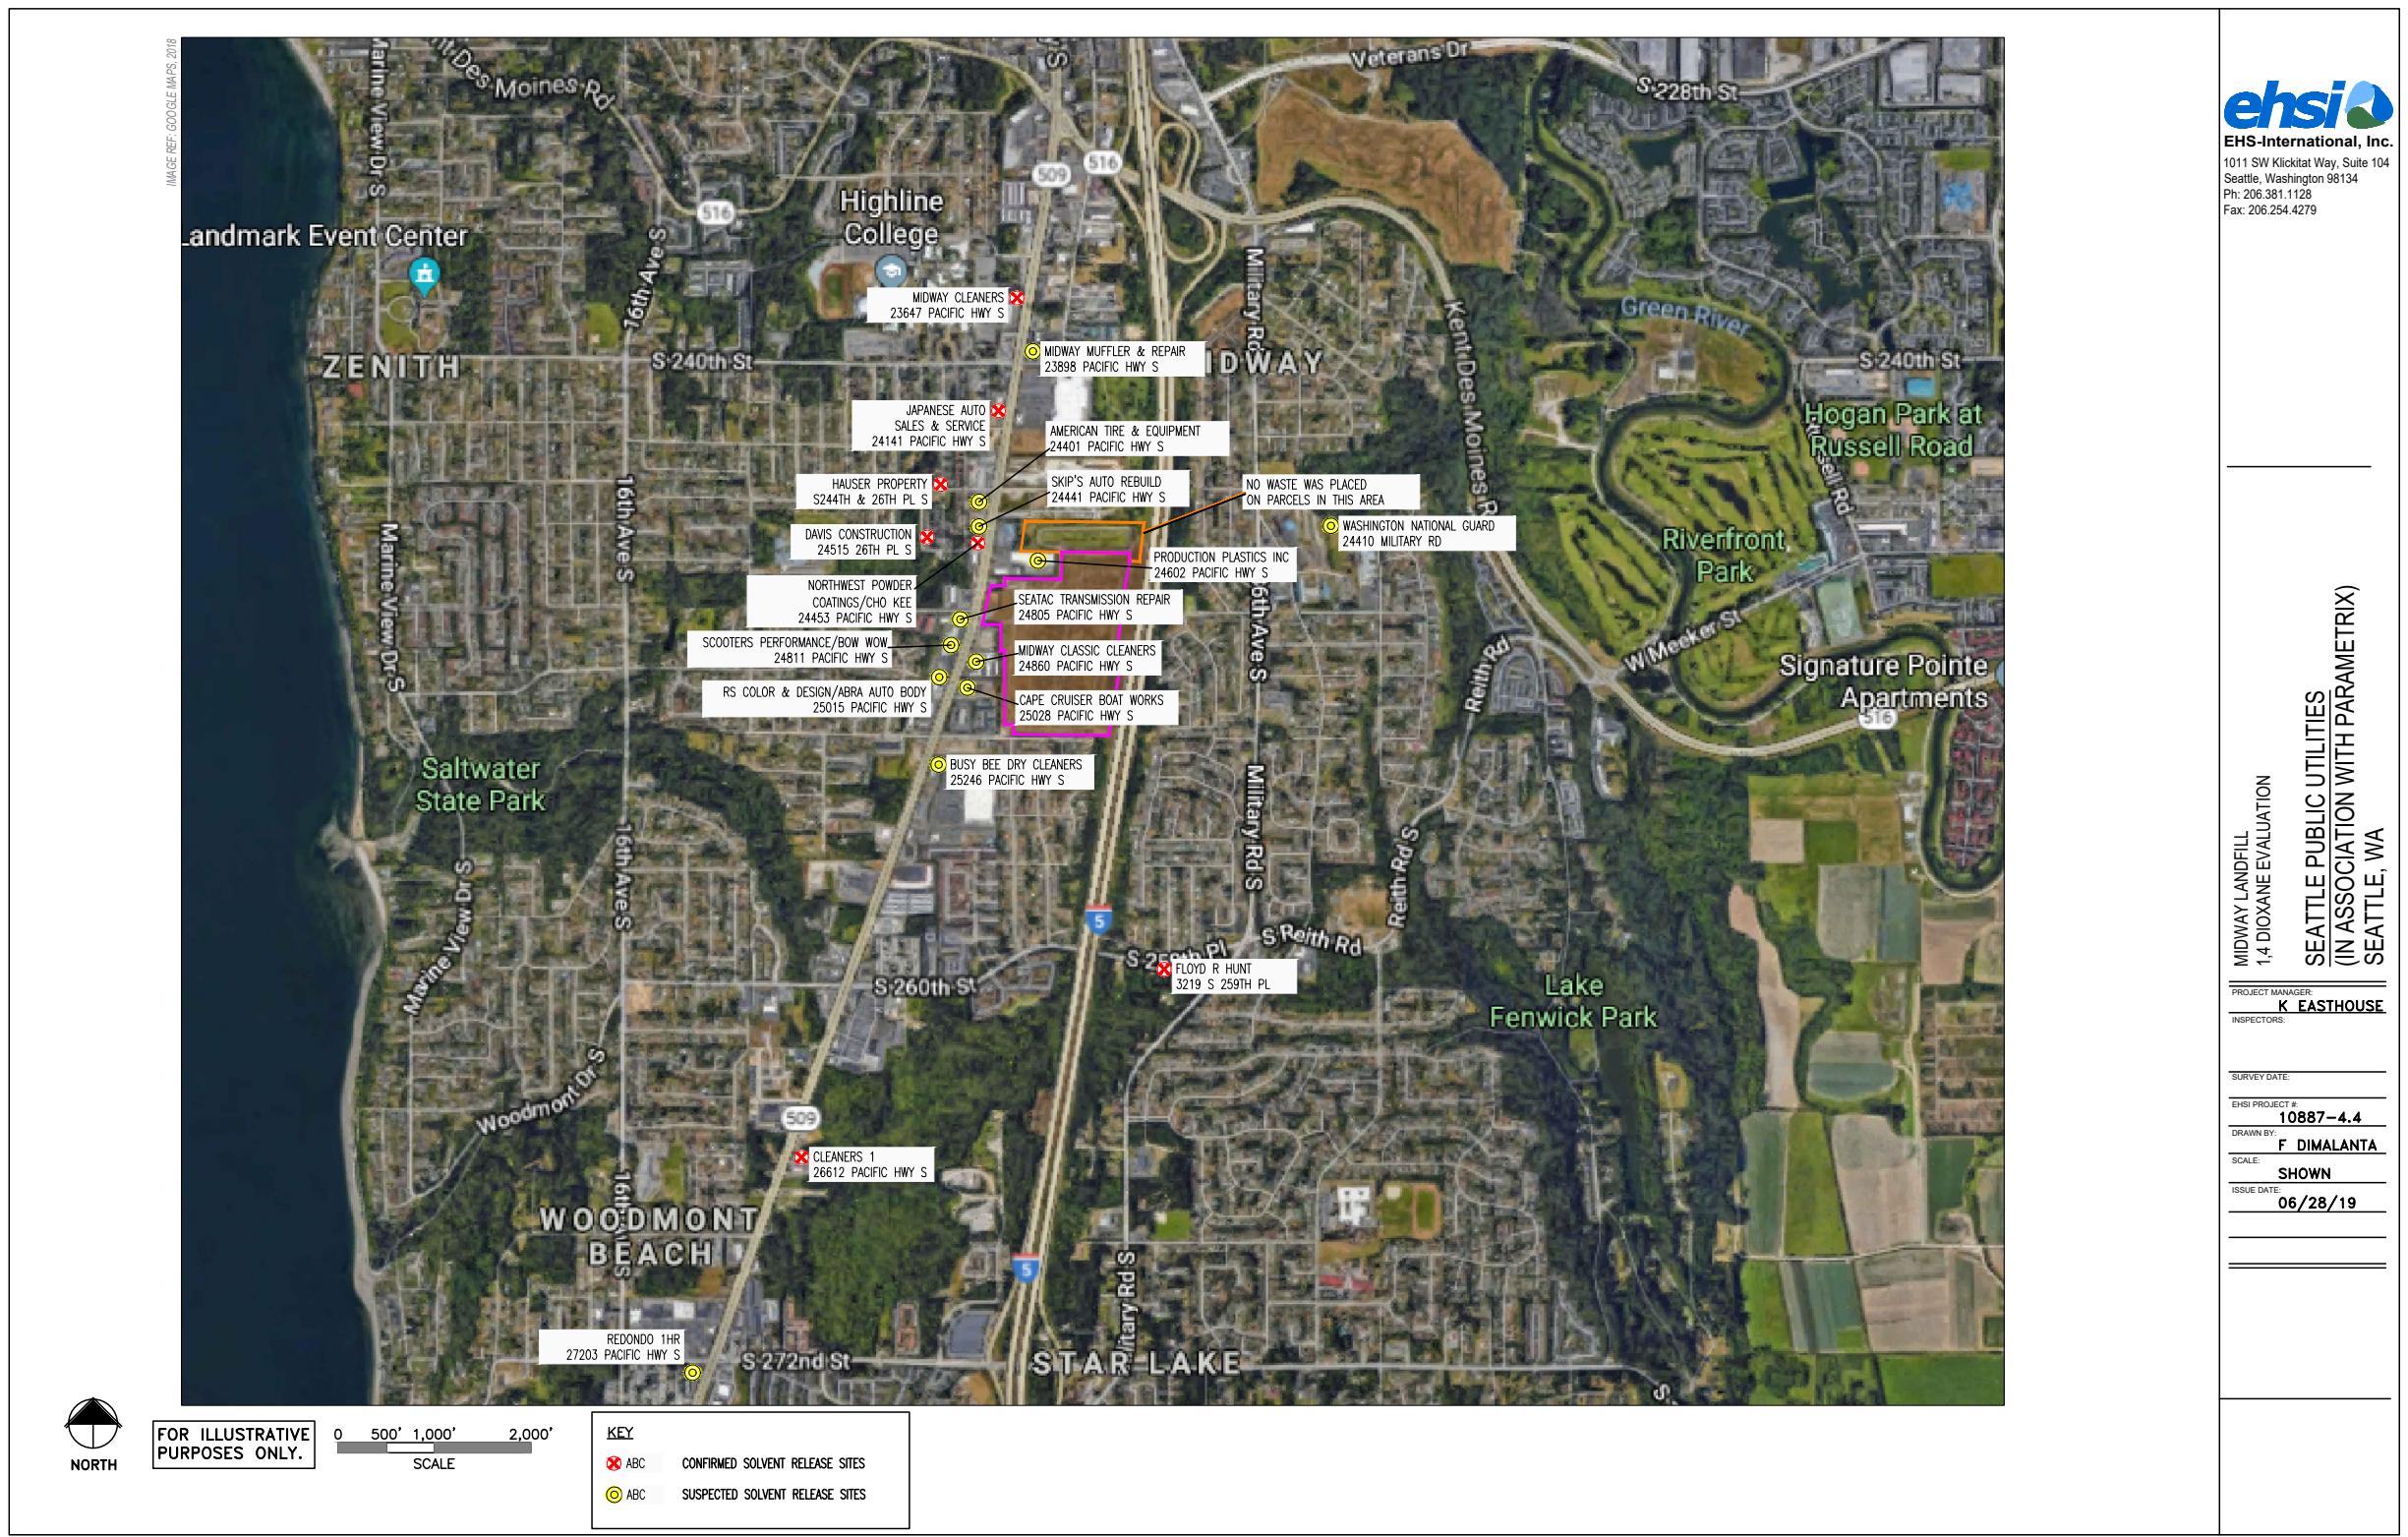
**Figure 7**  
**Group A Water Supply Wells Surrounding the Midway Landfill**  
**and 1,4-Dioxane Testing**  
Midway Landfill  
Kent, Washington

Figure 7 displays the location of the nearest Group A water wells surrounding the Midway Landfill. As shown on the figure, all Group A systems in the area surrounding the landfill that were tested had no detections of 1,4-dioxane (less than 0.07 µg/L). Based on the results of the EPA's UCMR 3 testing, it does
