REMEDIAL INVESTIGATION REPORT

**THE FORMER BOULEVARD NURSERY SITE
CLEANUP SITE ID: 223 FACILITY/SITE ID: 3749
2021 BOULEVARD ROAD SOUTHEAST
OLYMPIA, WASHINGTON 98501**

**September 6, 2020
0820-03**

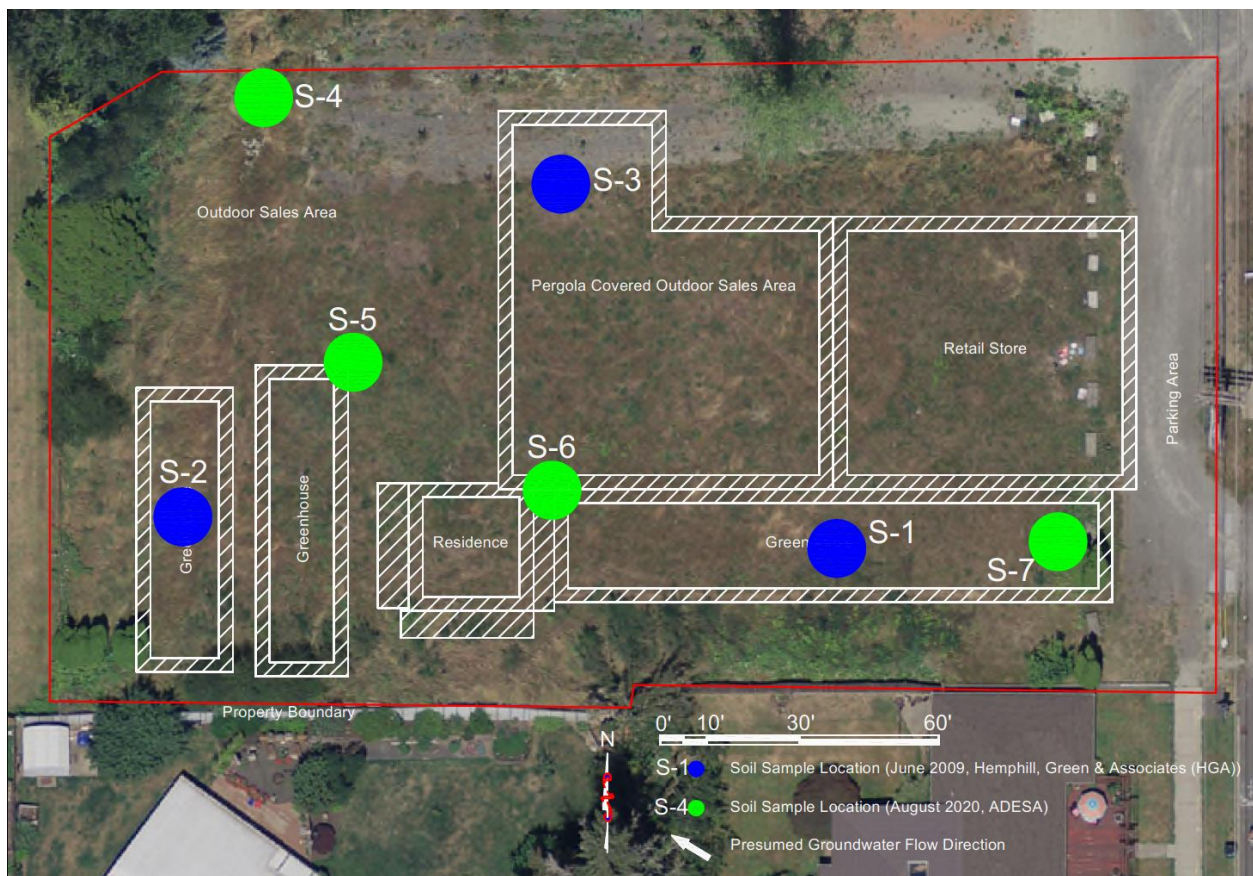
Figure 2.0: Sample Location Map

On August 24, 2020 ADESA personnel collected four shallow soil samples (S-4 to S-7; at depths of 12 inches) using dedicated stainless-steel hand tools and laboratory supplied 4oz jars. The sample locations were selected based on the historical layout of the greenhouse structures formerly located on the property and the locations of the soil samples collected by Hemphill, Green & Associates (HGA) in 2009 (S-1 to S-3). The results of the current investigation are discussed below:

- ✦ Sample S-4 contained detectable concentrations of the following analytes above the laboratory reporting limit but below the Washington State MTCA cleanup levels: dieldrin at 0.0344 mg/kg (MTCA Method B Cleanup Level 0.063 mg/kg); DDE at 0.0296 mg/kg (MTCA Method B Cleanup Level 2.9 mg/kg); DDD at 0.0116 mg/kg (MTCA Method B Cleanup Level 4.2 mg/kg); and DDT at 0.0337 mg/kg (MTCA Method B Cleanup Level 2.9 mg/kg). None of the remaining analytes were detected at concentrations in excess of the laboratory reporting limits.

- ✦ Sample S-5 contained detectable concentrations of the following analyte above the laboratory reporting limit but below the Washington State MTCA cleanup level: dieldrin at 0.0536 mg/kg (MTCA Method B Cleanup Level 0.063 mg/kg). None of the remaining analytes were detected at concentrations in excess of the laboratory reporting limits.

- ✦ Sample S-6 contained detectable concentrations of the following analytes above the laboratory reporting limit but below the Washington State MTCA cleanup levels: gamma-chlordane at 0.0101 mg/kg and alpha-chlordane at 0.0176 mg/kg (MTCA Method B Cleanup Level 2.9 mg/kg for total chlordane). None of the remaining analytes were detected at concentrations in excess of the laboratory reporting limits.

- ✦ Sample S-7 did not contain any of the analytes at concentrations exceeding their respective laboratory reporting limits.

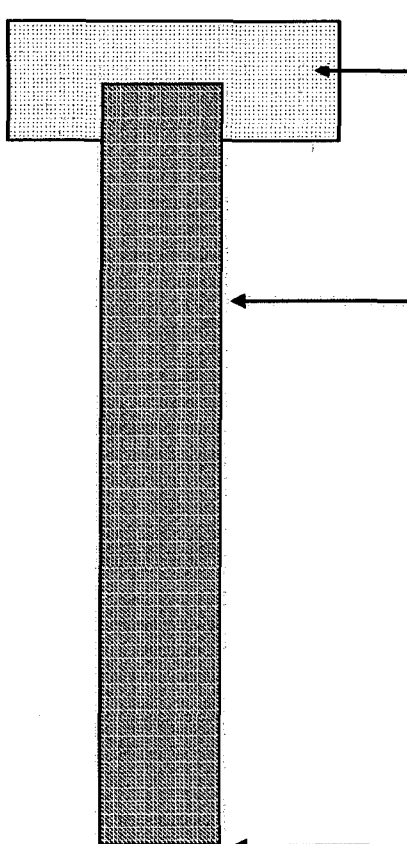
Construction/Design	Well Data W12-108	Formation Description

CONCRETE SURFACE SEAL <u>4</u> FT	<u>0 - 31</u> FT Brown silty sands
	BACKFILL <u>27</u> FT Best. Chips	<u>0 -</u> FT
	DEPTH OF BORING <u>31</u> FT	<u>0 -</u> FT

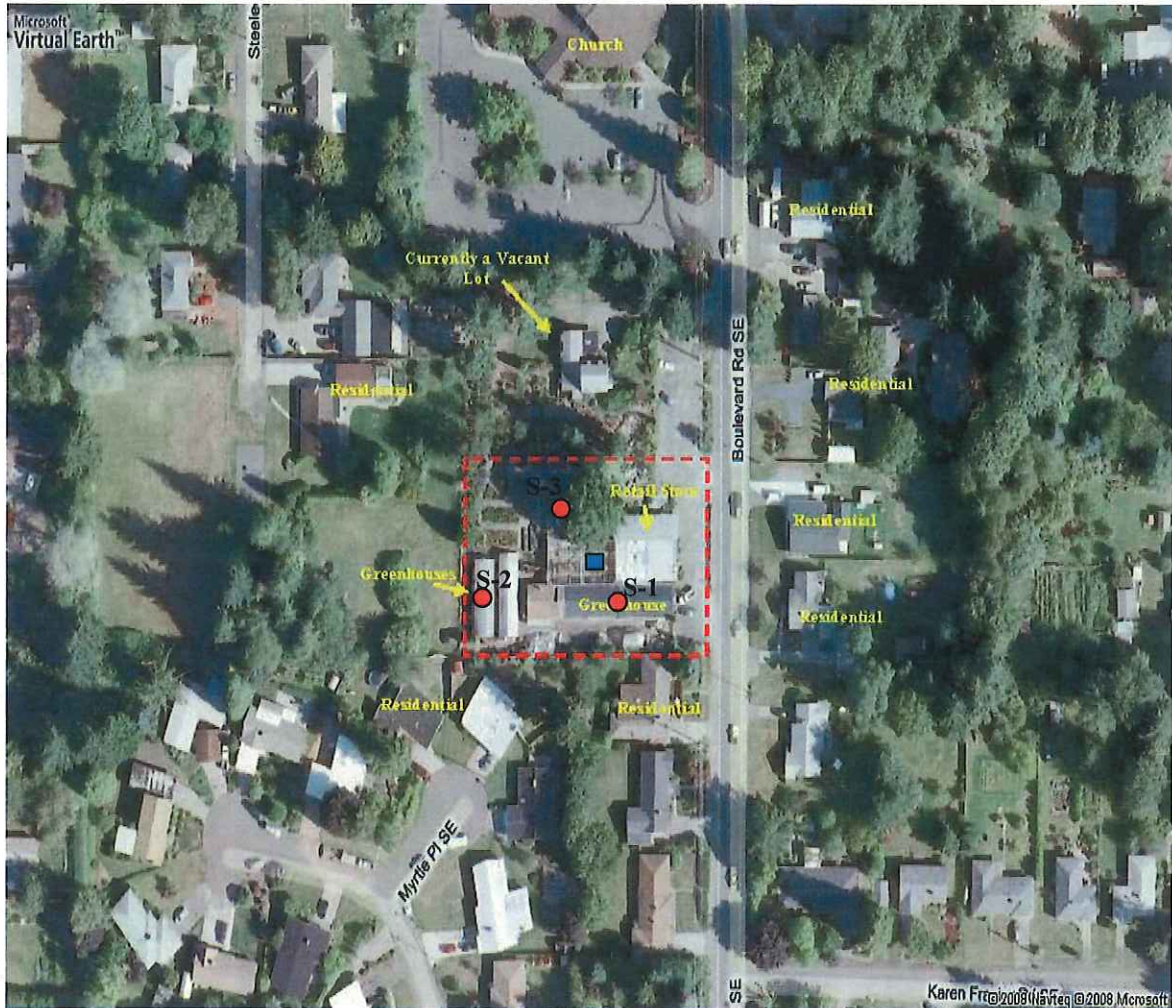
As shown on Figure 2, soil samples S-1 and S-2 were collected within the former greenhouse areas. Sample S-3 was collected in a yard area outside the greenhouses. Obvious staining or chemical odors were not observed in any of the soil samples.

--- Approximate Subject Property Boundary

- Soil Sample
- Septic Tank

A total of three soil samples, designated S-1 through S-3, were collected on April 23, 2009 by HGA. The discrete samples were collected at a depth of about 1 foot below ground surface, using a stainless steel spade that was washed between sampling locations.
