## Technical Memorandum

**Project Name:** Mill E Site

**Subject:** Mill E 2008 Ground Water Monitoring Summary

# FIELD REPORT

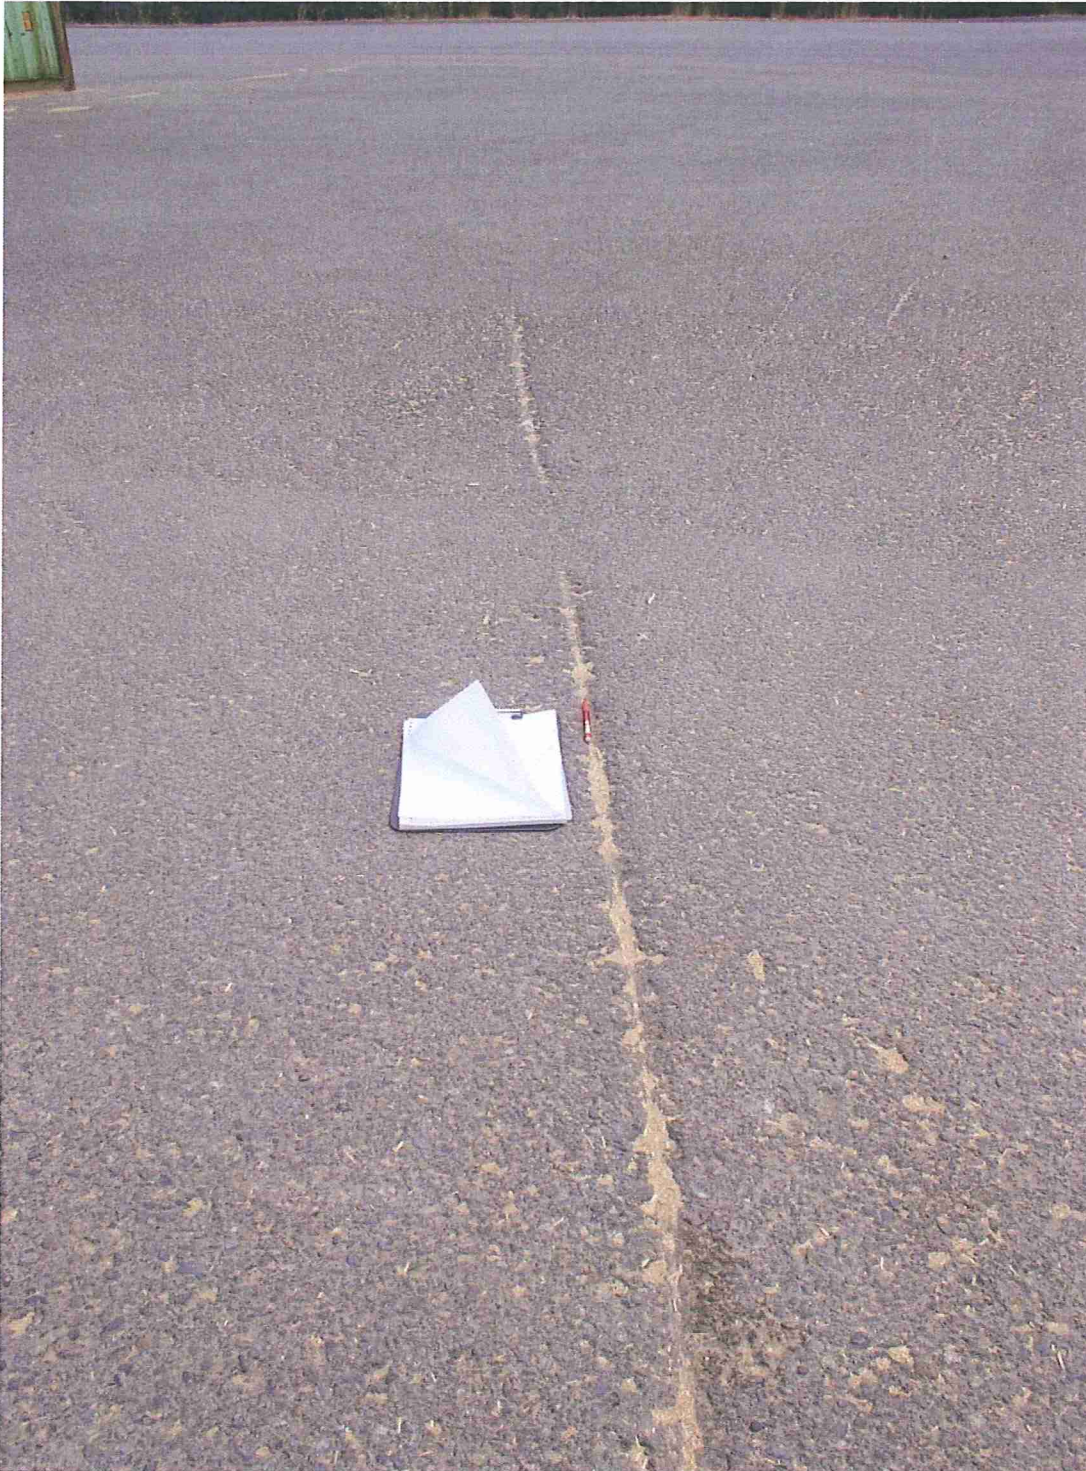
We observed numerous scratches in the pavement near the east side of the stockpile. The scratches appear to be where the front-end loader scrapes the pavement when scooping material up. The scratches appear to be less than 1/2 inch in width and less than 3/8 inch in depth. The scratches may be from the ends of bolts extending away on the bottom of the front-end loader bucket. Although the scratches are minor, we recommend that these areas be observed periodically for cracking. We also recommend that the bottom of the bucket be fitted with a smooth steel plate, if bolts or other extensions are causing these scratches or the bucket tilted/operated in such a way to minimize scratching. Photo 1 below shows of one of the larger scratches.

Photo 1: Scratch near the stockpile area with a pencil in the scratch and 8.5" x 11" clipboard for scale.

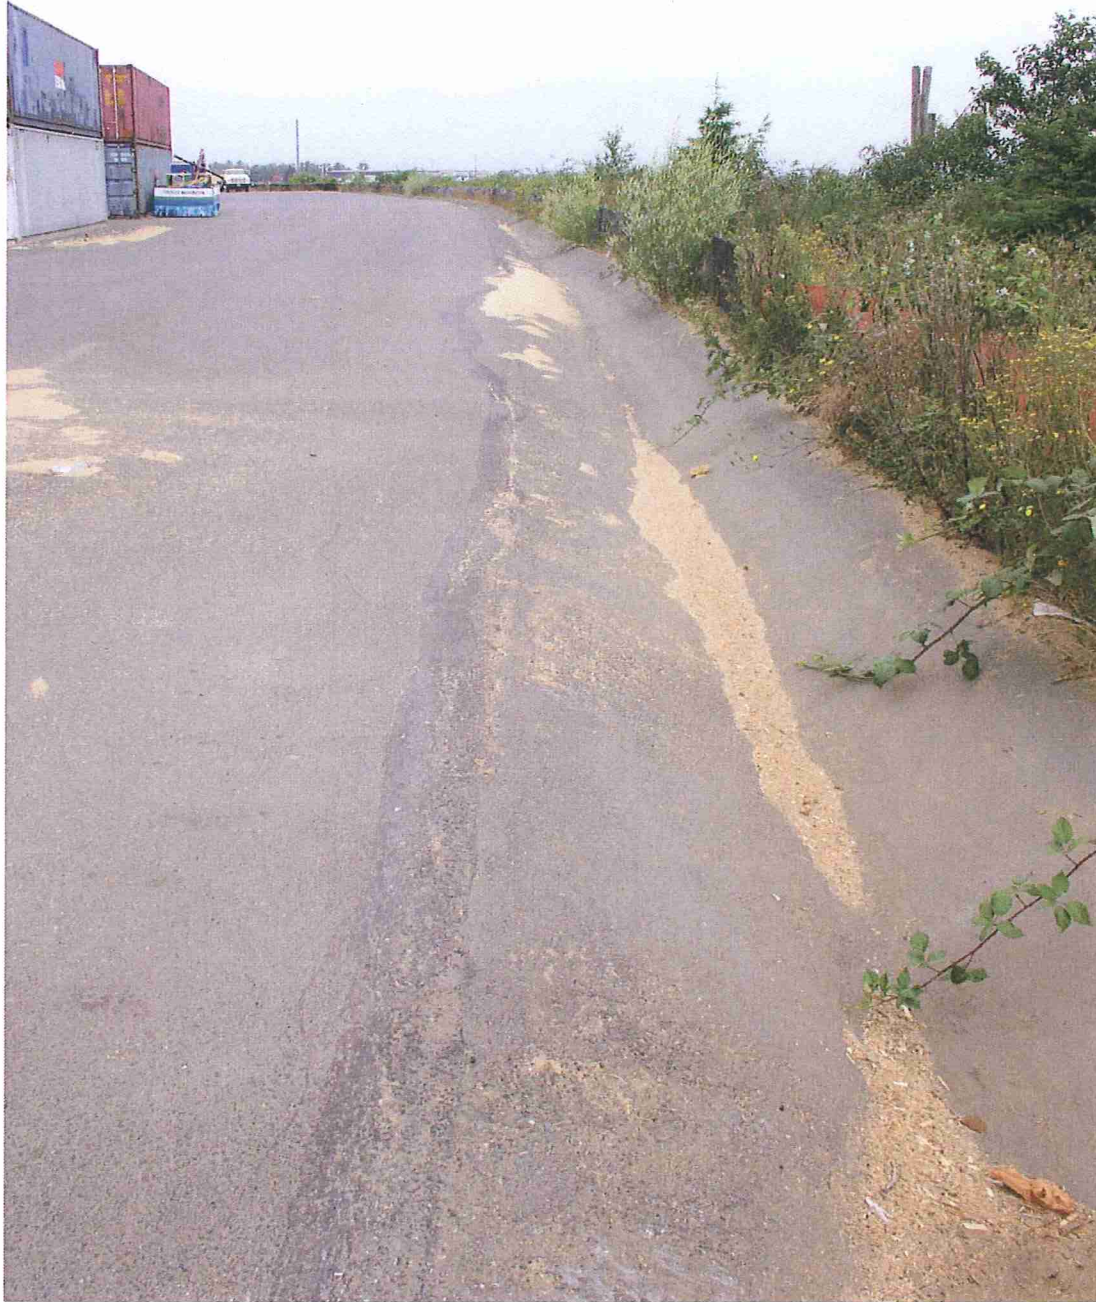
We did not observe cracks in the pavement, except for along the very eastern edge of the asphalt cap. The cracks here appeared to be at the lap between the asphalt-paved drainage ditch and the flat interior portion of the asphalt cap. The cracks appeared to be minor and were covered with asphalt crack sealer. These cracks do not appear to be from traffic-related stress, but from overlap joints when paving the drainage ditch. We recommend that these cracks be observed periodically for integrity. Photo 2 below shows a typical sealed crack area.

Photo 2: Sealed crack at ditch pavement overlap at east edge of cap.
