Phase 1 – Vashon Island Closed Landfill  
CONTRACT NO. E00102E08  
Task No. 310.3 - D310.3.1.3

## Remedial Investigation Report

## Vashon Island Closed Landfill

Project No. 090057 Task 310.3 • November 6, 2020 Final

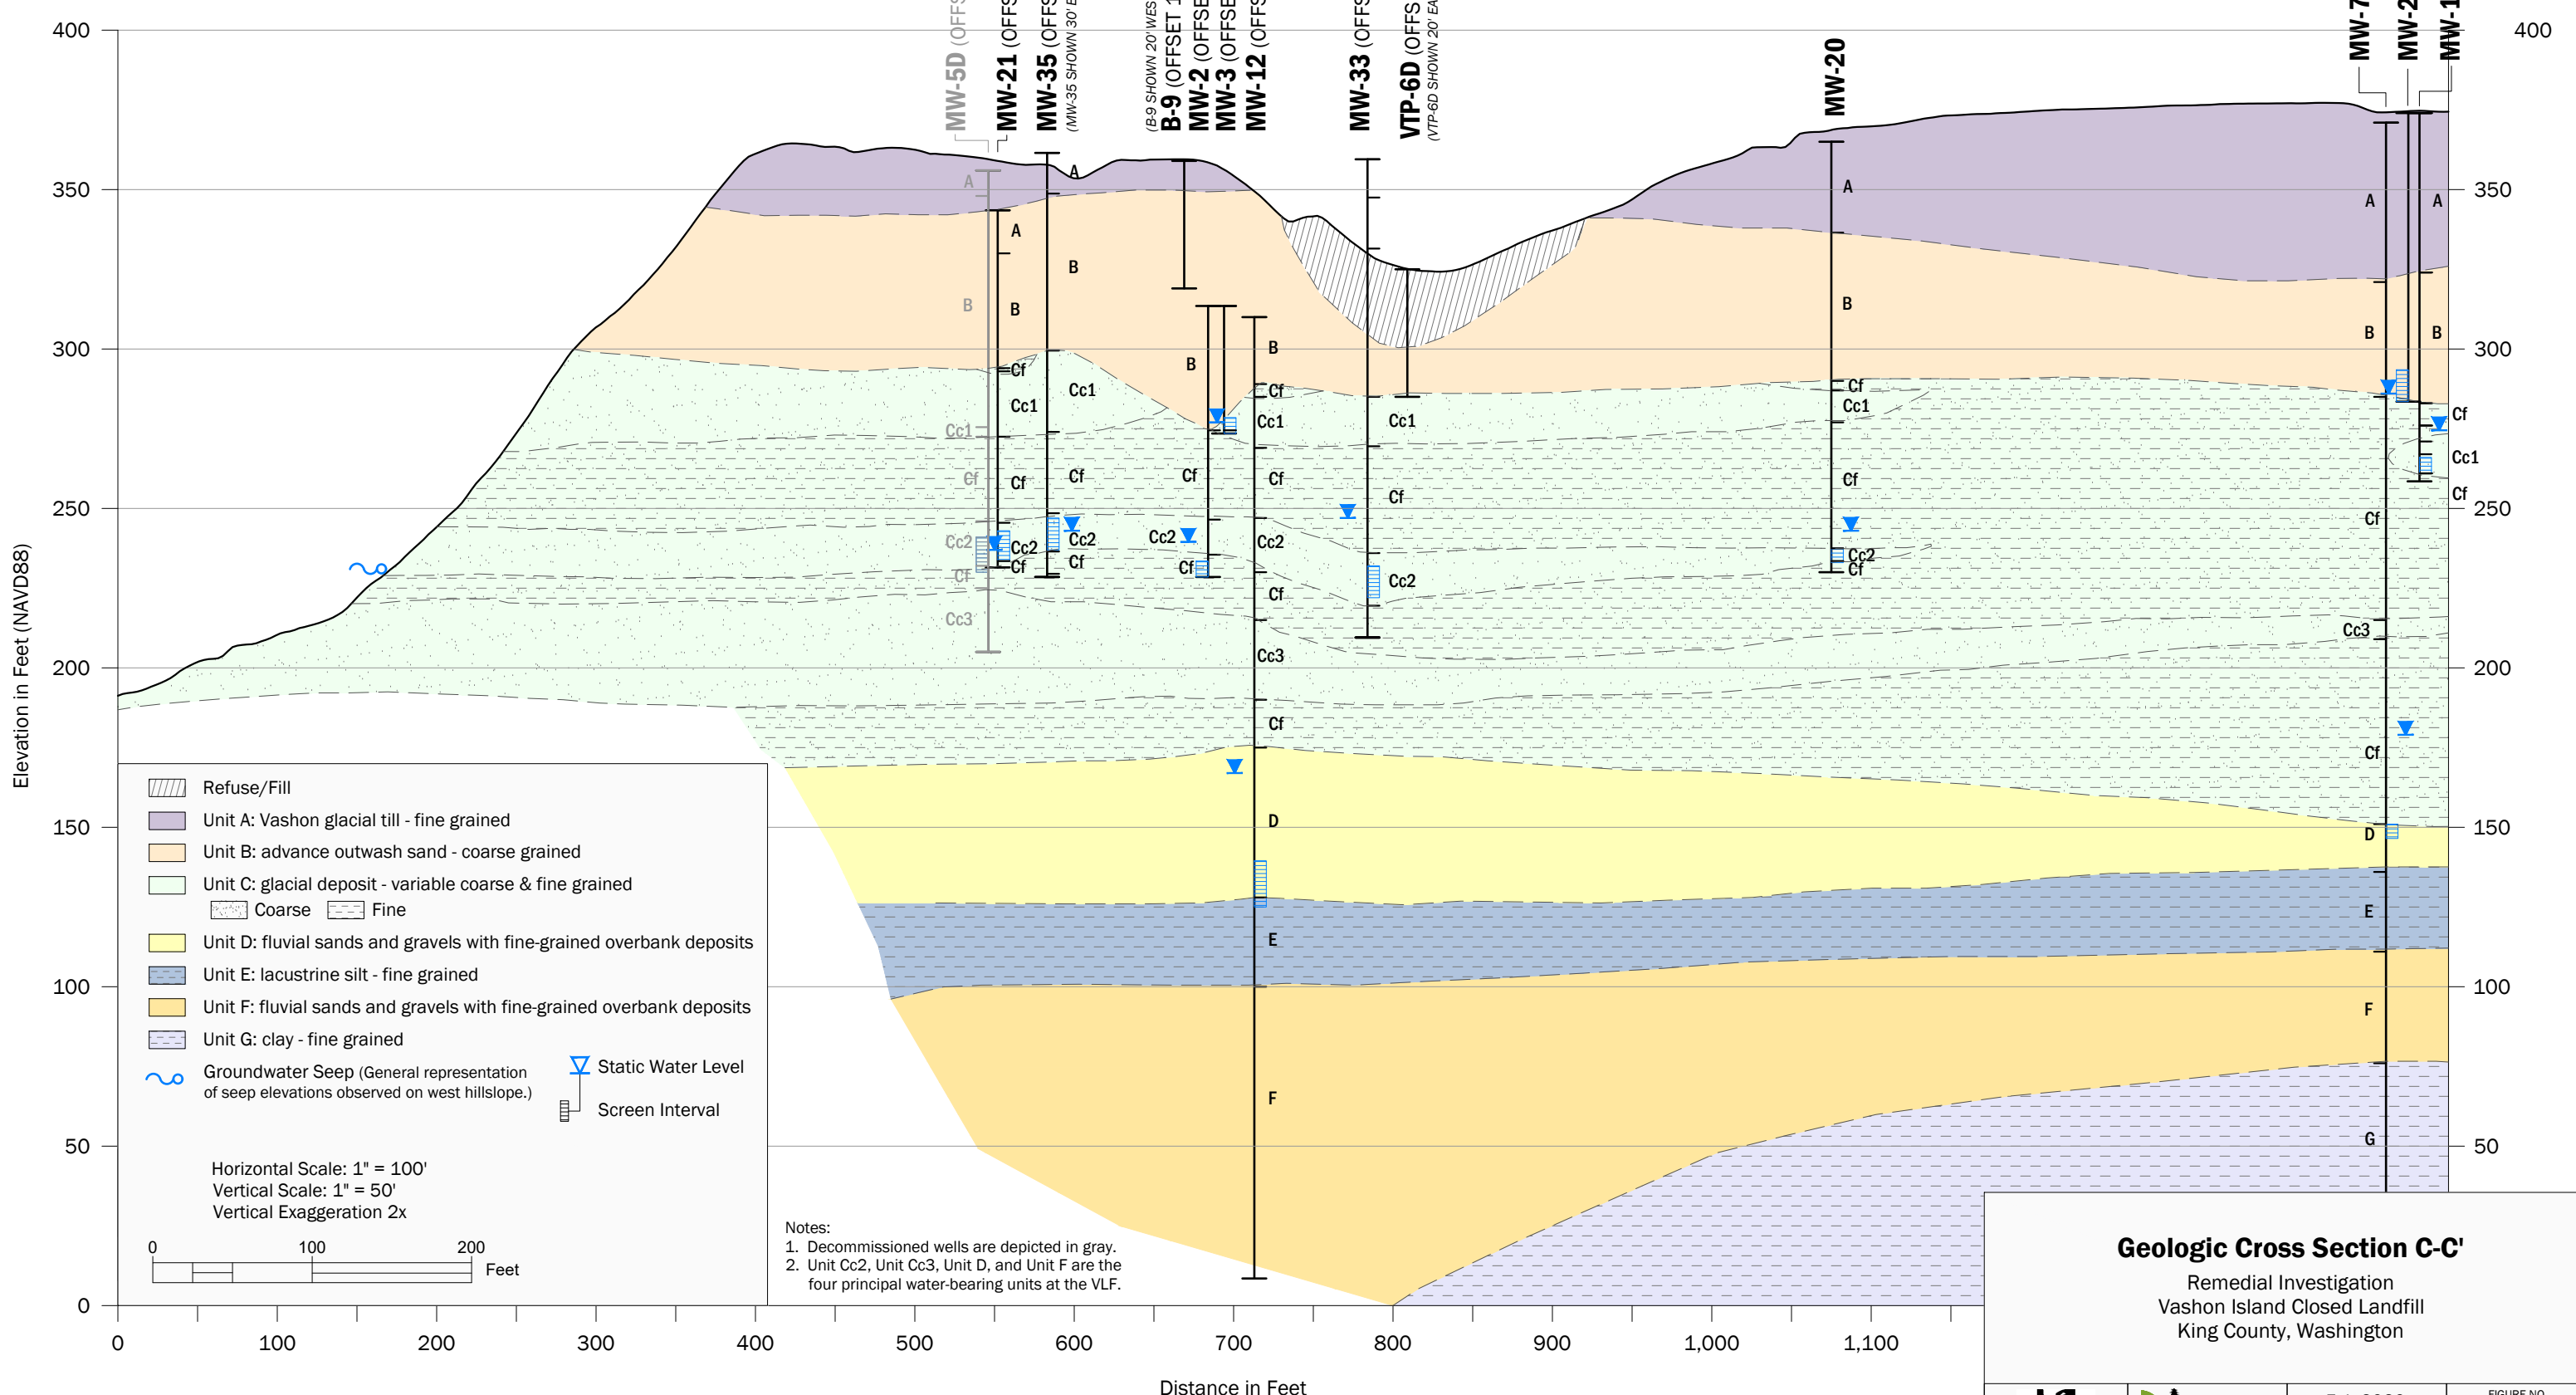
Feb-2020	FIGURE NO.
		BY: DLC/SCC	<b>3.5</b>

- Refuse/Fill
- Unit A: Vashon glacial till - fine grained
- Unit B: advance outwash sand - coarse grained
- Unit C: glacial deposit - variable coarse & fine grained
  - Coarse
  - Fine
- Unit D: fluvial sands and gravels with fine-grained overbank deposits
- Unit E: lacustrine silt - fine grained
- Unit F: fluvial sands and gravels with fine-grained overbank deposits
- Unit G: clay - fine grained
- Groundwater Seep (General representation of seep elevations observed on west hillslope.)
- Static Water Level
- Screen Interval

As depicted in the cross sections, the Cc units are not continuous across the VLF property. For example, Unit Cc3 was not observed in borings completed north of the VLF

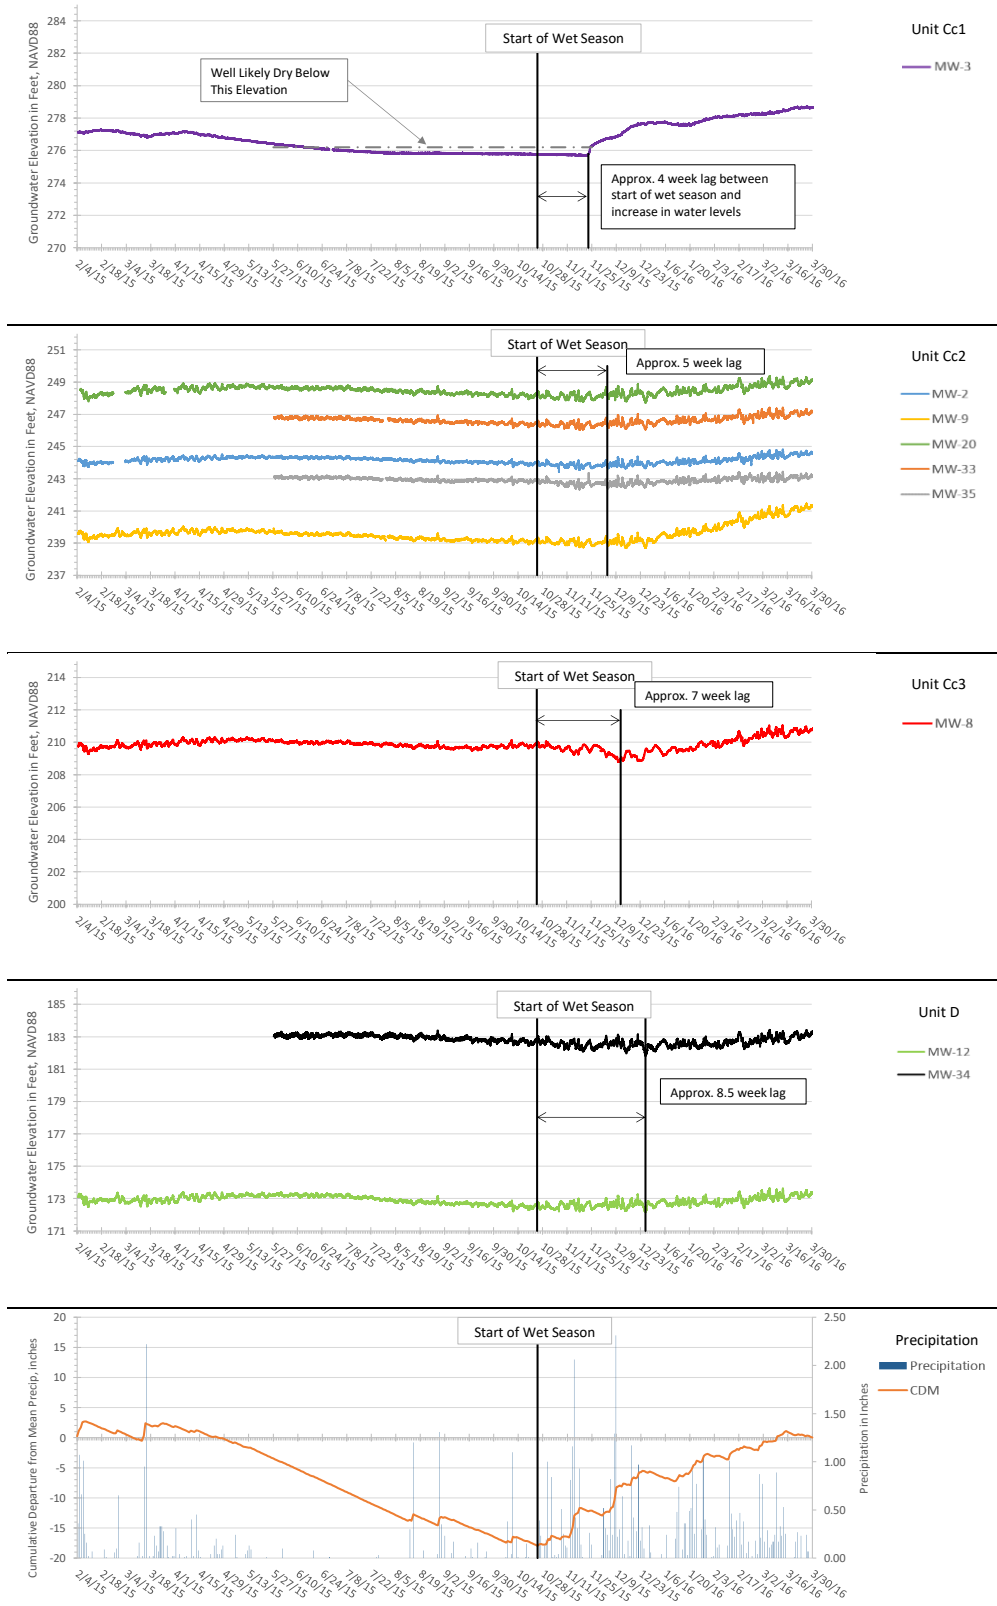
**Figure 3.12**  
**Groundwater Hydrographs (with Precipitation)**  
 Remedial Investigation

Note: Groundwater elevation values based on pre-2019 survey

It is further hypothesized, based on seasonally dry conditions in most of the Unit Cc1 wells and the hydrograph presented on Figure 3.12, that the residence time of groundwater in this unit is short and that the presence of groundwater in Unit Cc1 wells is likely a transient reflection of downward migration of recharge.
