**FINAL
INDEPENDENT REMEDIAL ACTION REPORT
SEATAC PARKING GARAGE DEVELOPMENT SITE
SEATAC, WASHINGTON
(MASTER PARK LOT C)**

SeaTac Investments LLC

Golder Associates Inc.
Redmond, Washington

January 24, 2002

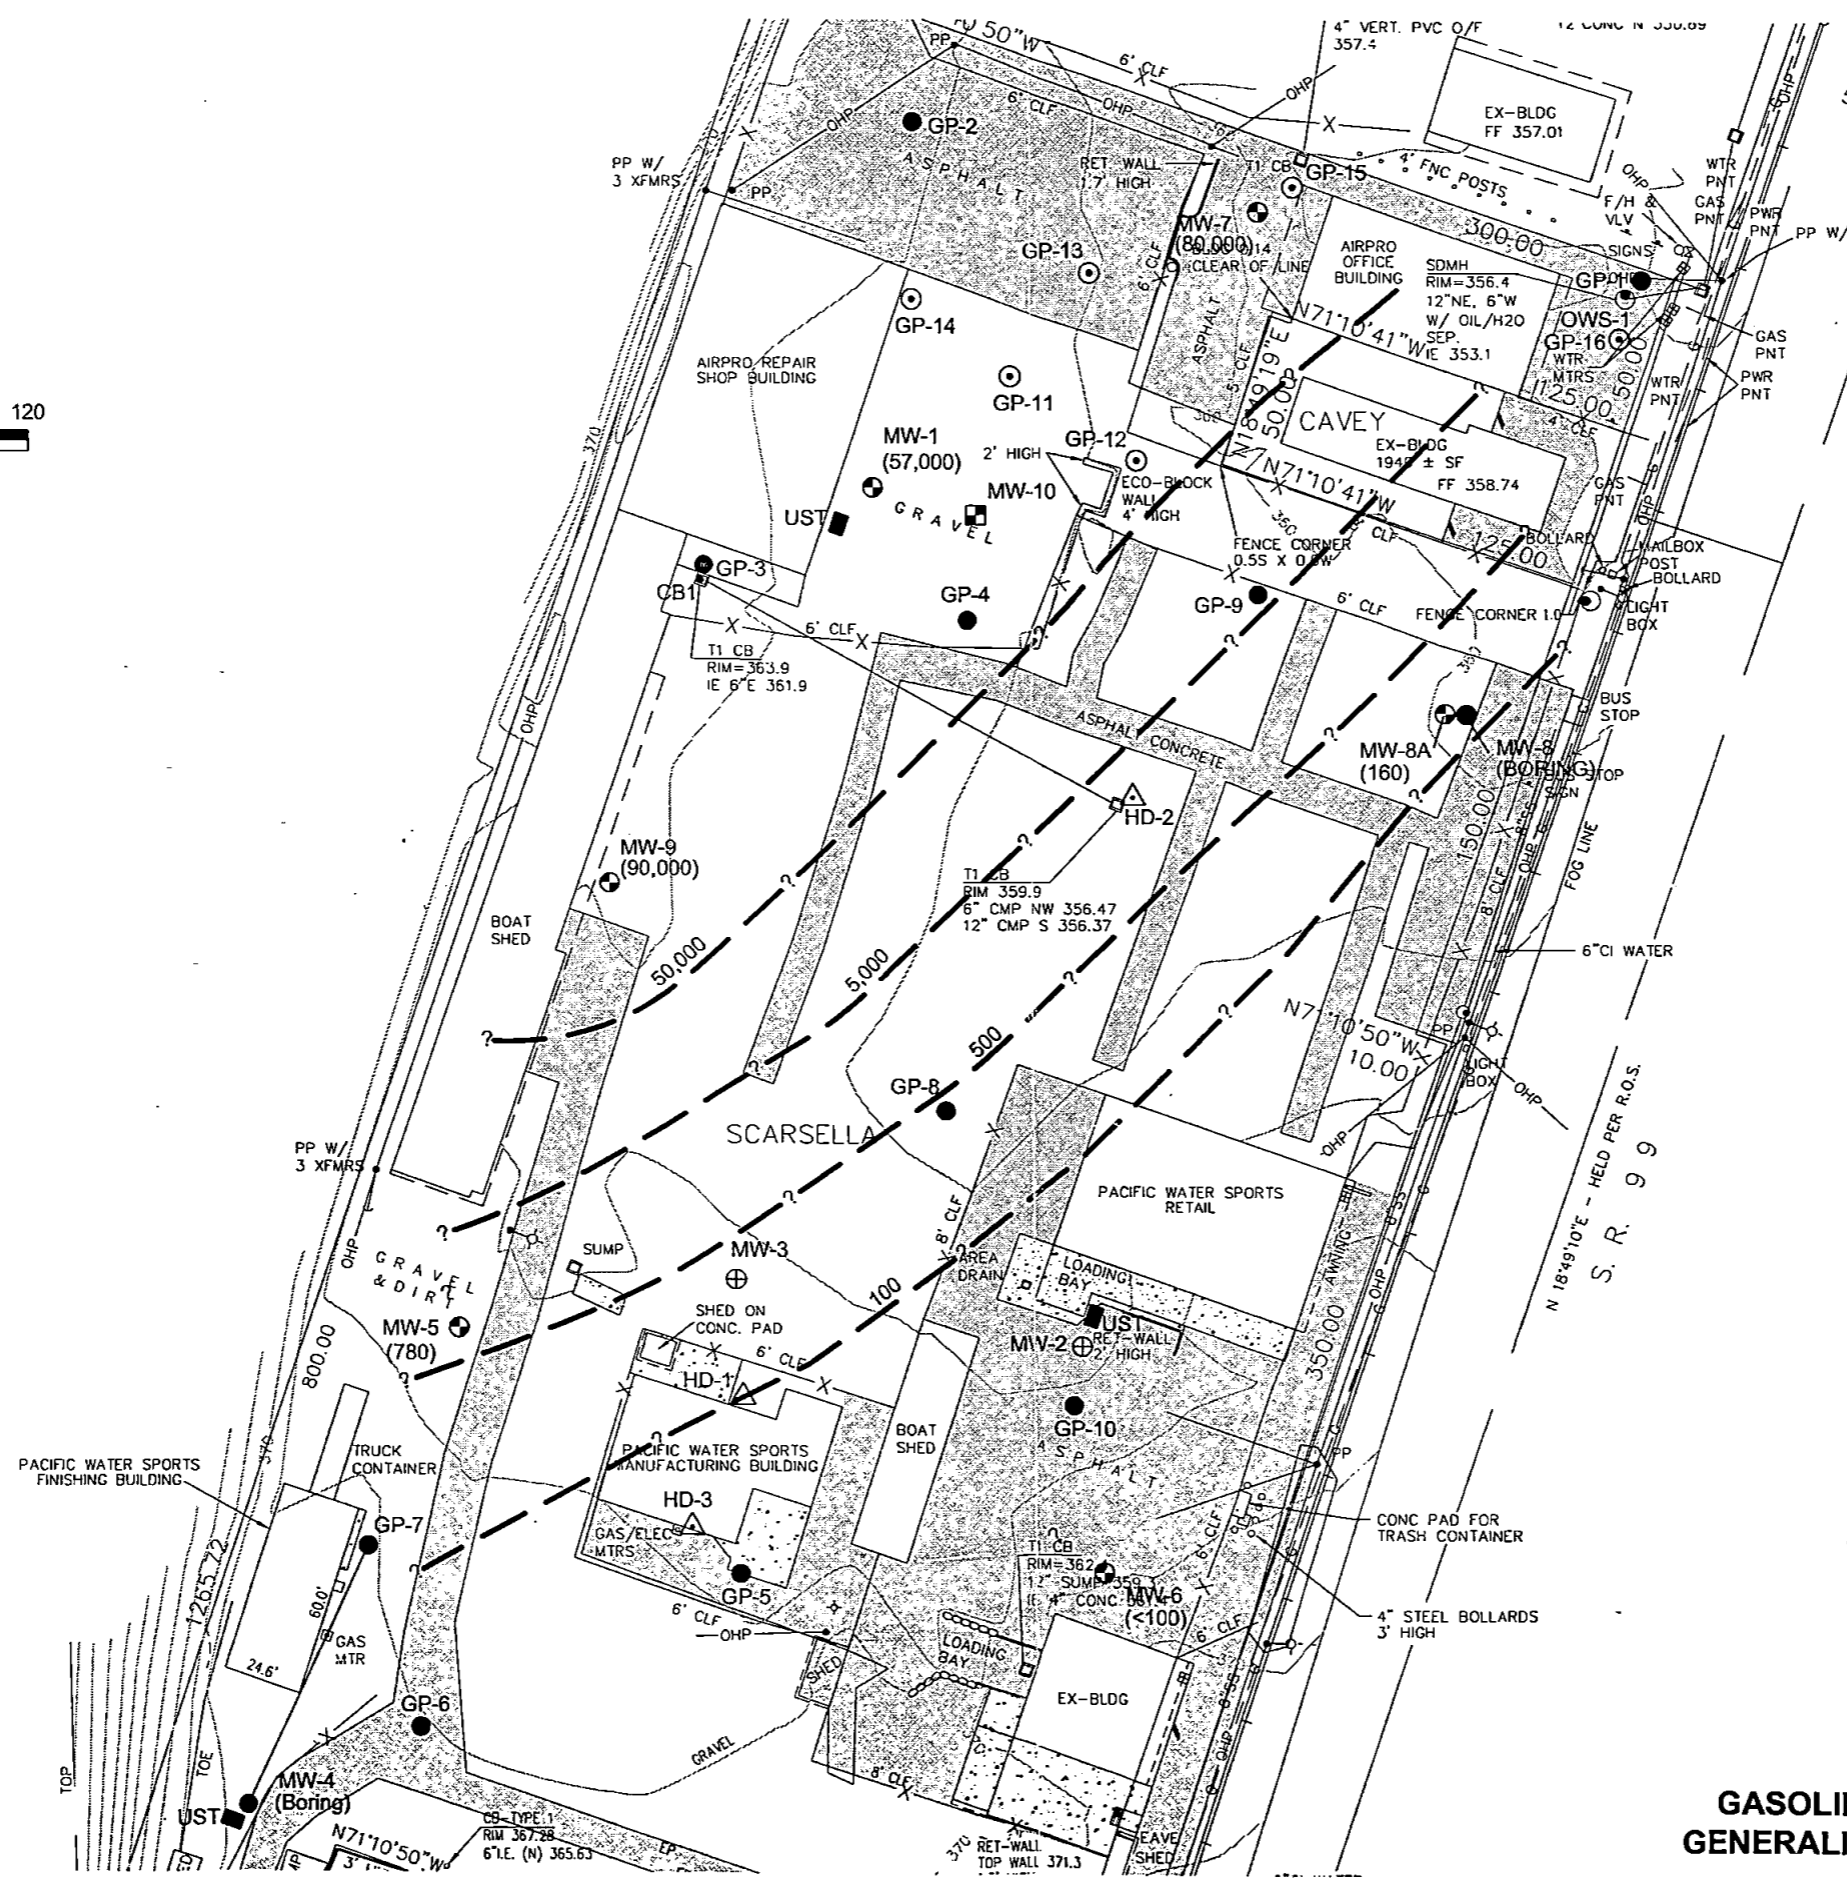
FIGURE 5
MASTER PARK LOT C DEVELOPMENT
REGIONAL AQUIFER
GASOLINE RANGE PETROLEUM HYDROCARBON
GENERALIZED ISO CONCENTRATION MAP (1/08/01)
 SUNREAL/SEATAC GARAGE ESA/WA

The regional groundwater aquifer beneath the subject property (~50 ft. depth) was determined to be flowing toward the southwest through the subject property. The groundwater was found to be contaminated with elevated levels of gasoline hydrocarbons and BTEX. The groundwater contamination was found only in the northwestern portion of the subject property. Concentrations of gasoline and BTEX were comparable in the northeast property boundary to the highest levels found in the plume at other downgradient locations within the plume.

Concentrations of gasoline and BTEX were comparable in the northeast property boundary to the highest levels found in the plume at other impacted locations. Based on Site investigations, the data indicates that the observed groundwater impacts are a result of an off-site source(s), of which several potential current and historical sources were identified in earlier reports.
