# MEMORANDUM

Project No. 160315

**Re: Underground Storage Tank Site Assessment**  
Reserve Silica Plant Site  
28131 Ravensdale-Black Diamond Road  
Ravensdale, Washington 98051

**Facility Map**  
 Underground Storage Tank Site Assessment  
 Reserve Silica  
 Ravensdale, Washington

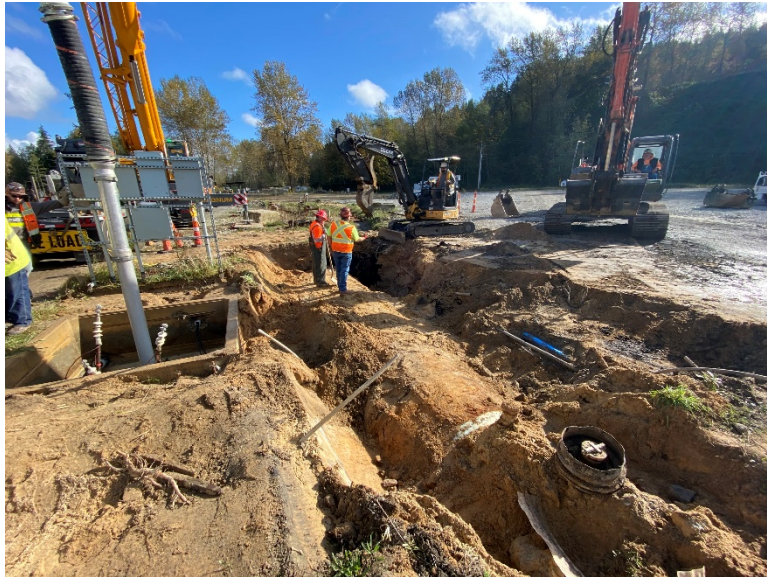
Photograph 1. Standing at east corner of excavation and oriented facing west. At the southwest end of the tank (closest), the fill port and fuel dispenser ports are visible. The two vent ports are at the far end of the tank by the two workers. In the photo, the transformer vault is being cleaned using a vacuum truck and will be eventually supported by the crane present in the left side of the photo during UST removal.

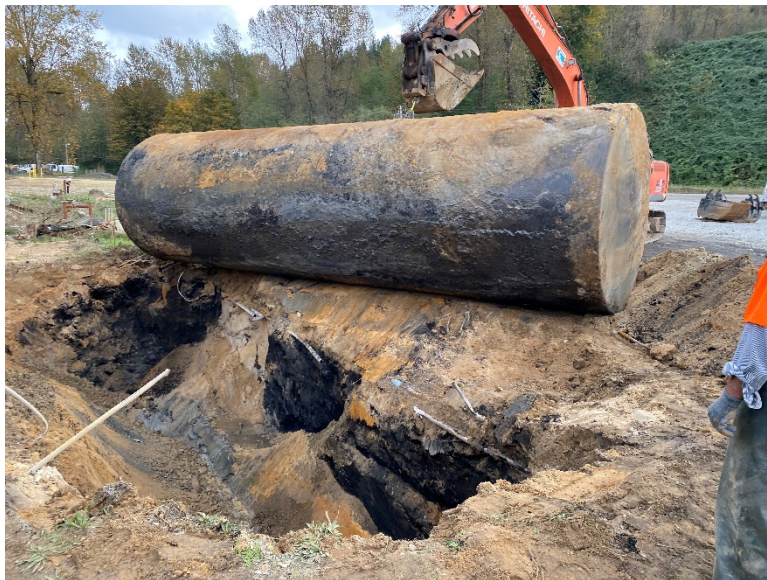
Photograph 2. The UST as it was removed from the tank pit. Photograph taken from the eastern corner of the excavation facing southeast.

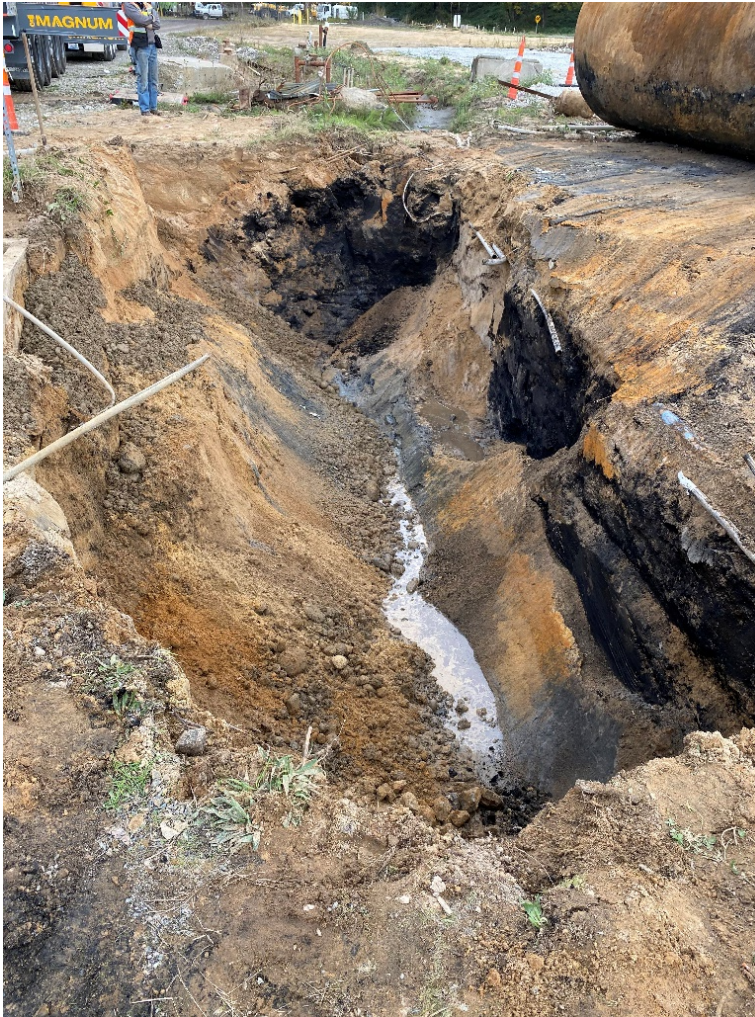
Photograph 3. The tank excavation after removal. Groundwater has begun infiltrating at a depth of approximately 6 to 7 feet below ground surface. The sloughing soil from the northwest sidewall (left hand side of photo) was removed prior to collecting the bottom sample.

5. **Groundwater Observations:** During excavation, groundwater was observed seeping from the excavation sidewalls at approximately 6 feet bgs (Attachment 6).

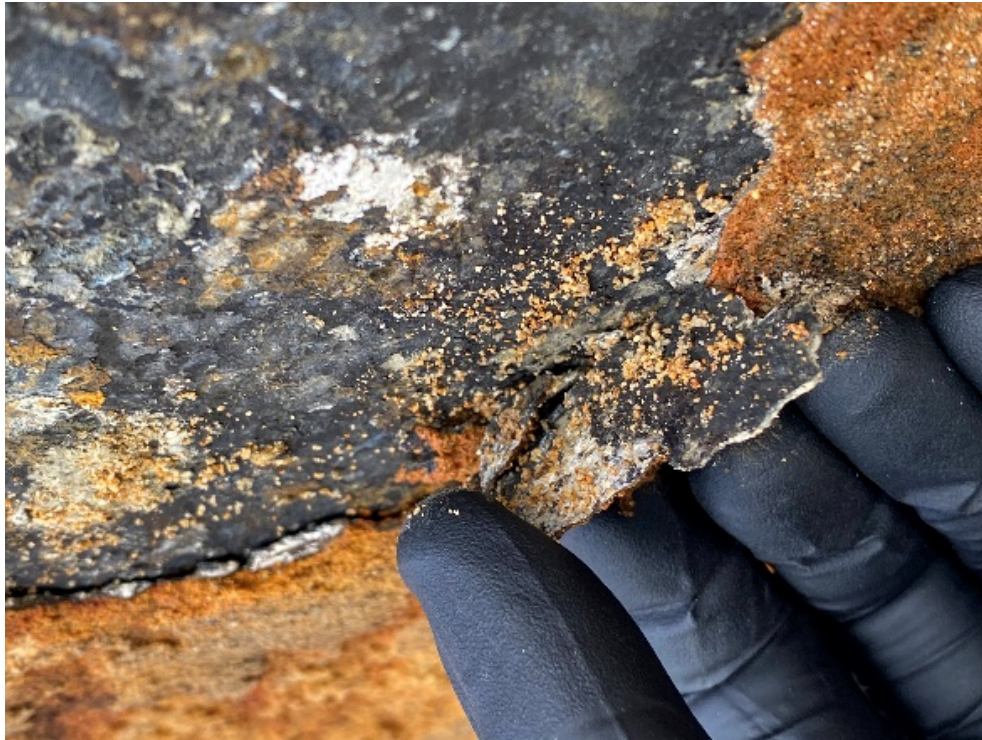
Photograph 4. UST condition on removal. Some scale buildup and small pitting in the steel surface. No visible cracks or holes were noted.

1. **UST Location:** A map depicting the Reserve Silica Plant Site and the location of the UST is attached (Attachment 2).
2. **Site Inspection Results:** Inspection of the UST at the time of removal indicates that the dispenser resided directly over the UST, and the vent pipe rose directly from the UST. Therefore, no conveyance piping runs associated with the UST were assessed. Soil samples were collected from each of the four sidewalls and the from the bottom of the UST excavation in accordance with the site assessment requirements in the UST regulations, Washington Administrative Code (WAC) 173-360A-0730.
