APPENDIX C

Select Site Investigation Reports (Provided on CD)

Seepage Sampler & Weir Installation Photos

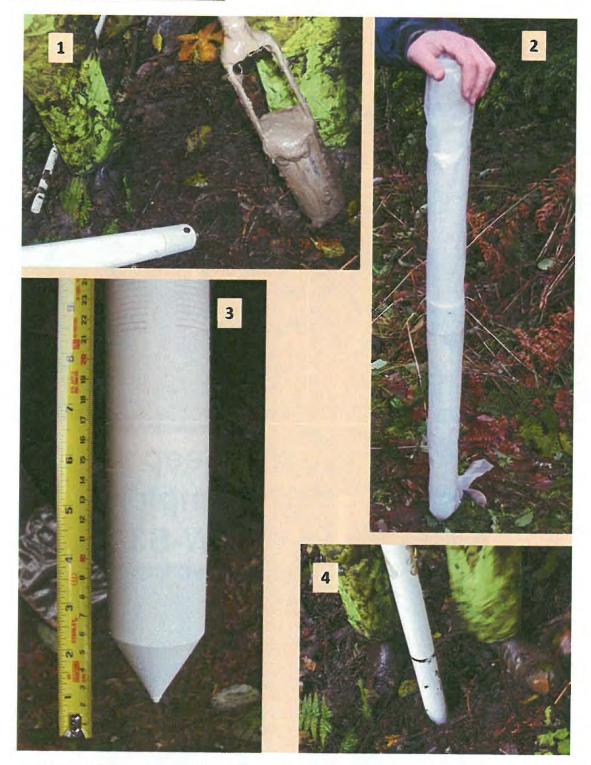
Seepage Samplers Installations

(1) Borehole was hand augered through soil and into underlying sediments (2) Sampler was constructed of clean 2-inch Sch. 40 PVC with 0.010-slot screen (3)Bottom PVC Monopoint; 0.010-inch slots visible at top of picture (4) Inserting seepage sampler into borehole.

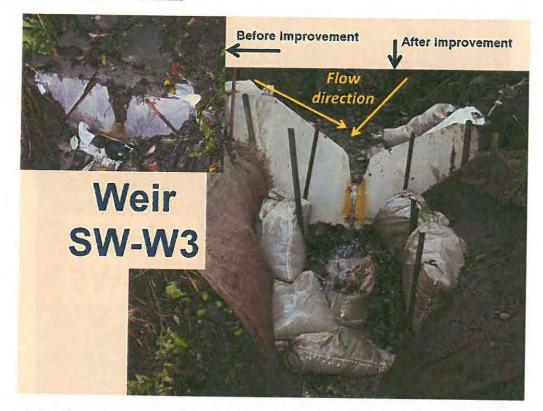
Weir Installations (continued)

In the above photo, the inset shows how the weir used to fill up with debris and sediment during a high rainfall event. The newer weir has not had the problem.
