Landfill Gas System Evaluation Summary Report

Phase 1 – Vashon Island Closed Landfill

August 29, 2019
FINAL

Vashon Island Closed Landfill

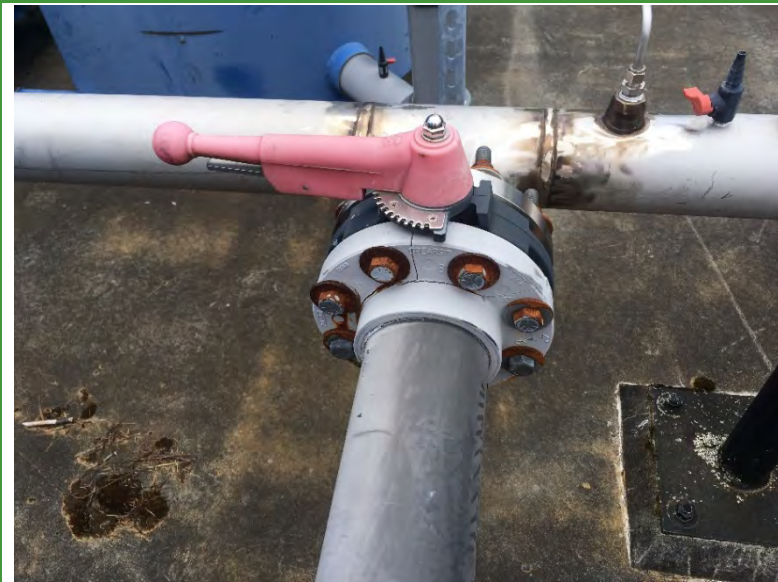
6. Broken valve flange at GAC manifold

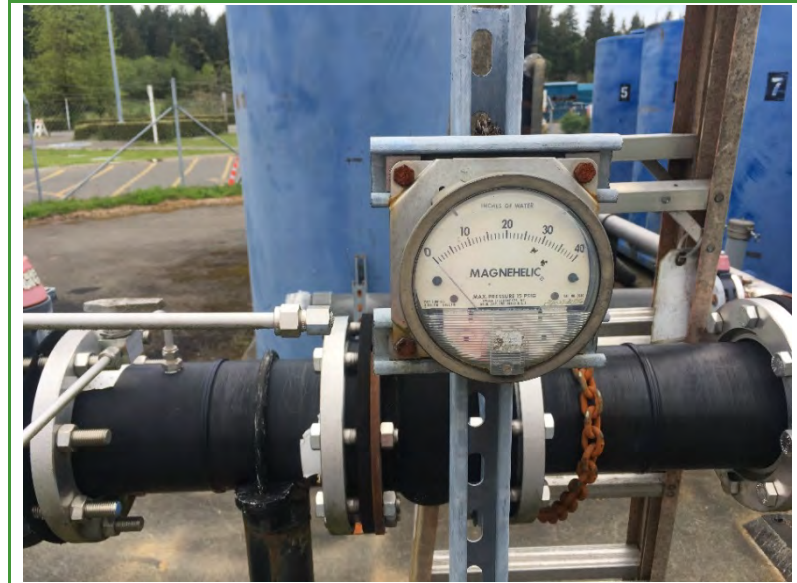
10. Inlet pressure gauge; broken tubing
