FINAL REMEDIAL INVESTIGATION REPORT

Troy Laundry Seattle Site 300 Boren Avenue North and 399 Fairview Avenue North Seattle, Washington Ecology Facility ID: 19135499

August 20, 2020

Project No.: 0731-004-07

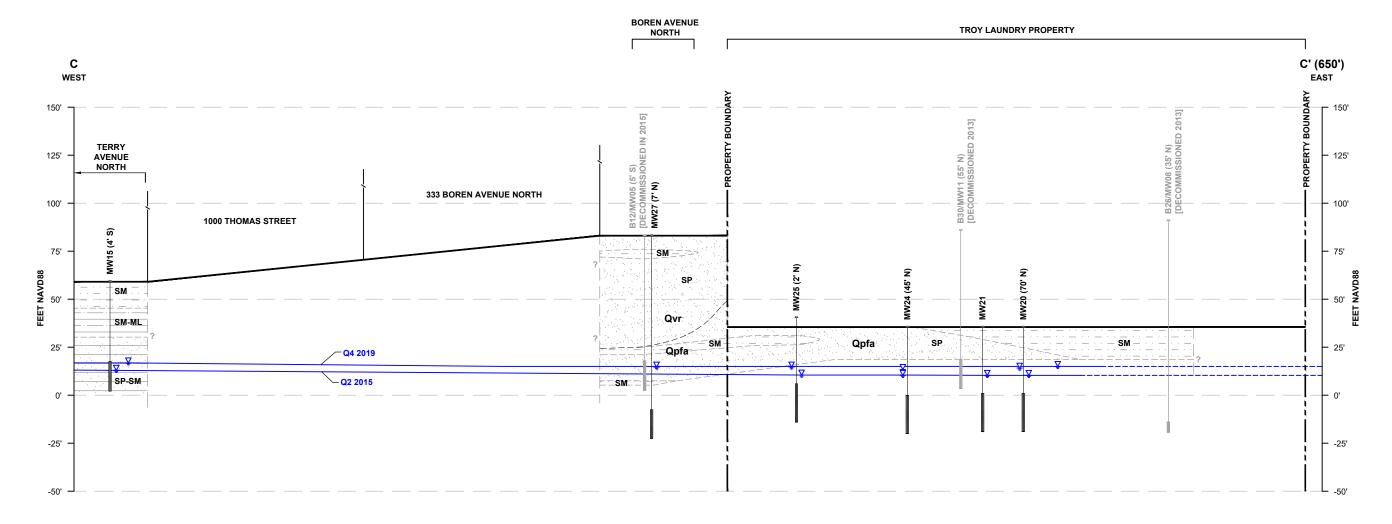
FIGURE 6

SOIL TYPES BASED ON UNIFIED SOIL CLASSIFICATION

SYSTEM VISUAL ASSESSMENT

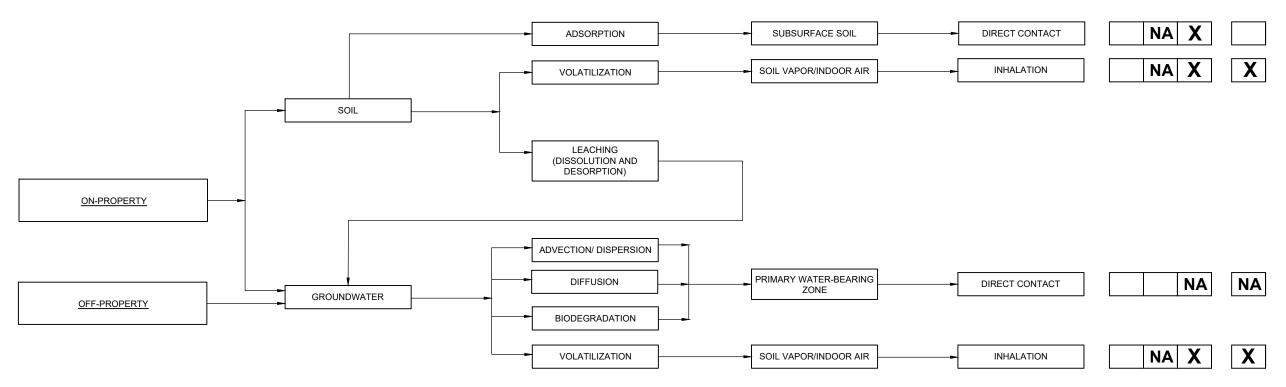
EXPOSURE PATHWAY

POTENTIAL RECEPTORS

EXPOSURE PATHWAY COMPLETE FOR POTENTIAL RECEPTOR

A CSM identifies confirmed and suspected source areas of hazardous substances, affected environmental media, fate and transport mechanisms, environmental media of potential concern, and exposure pathways for potential receptors.

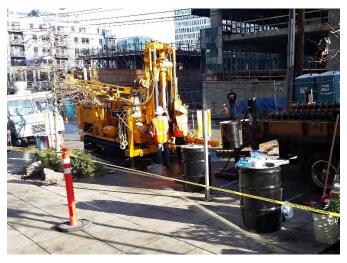
Photograph 1. Installing supplemental monitoring well MW27 in Boren Avenue North ROW; December 1, 2015.

In September 2015, Ecology requested that two of the three wells damaged during excavation and shoring activities be replaced. In November and December 2015, monitoring wells MW26 and MW27 were installed adjacent to the previously broken and decommissioned monitoring wells MW02, located in the Harrison Street ROW, and MW05, located in the Boren Avenue North ROW, respectively (Figure 5).

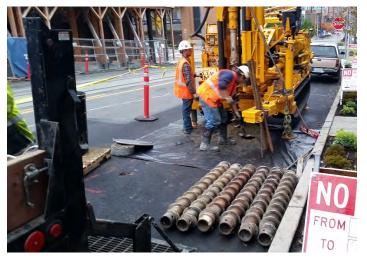
Photograph 2. Installing supplemental monitoring well MW26 in Harrison Street ROW; December 2, 2015.

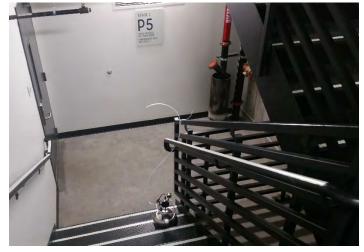
Photograph 6. 2019 supplemental vapor intrusion evaluation; indoor air sampling in stairwell; February 17, 2019.

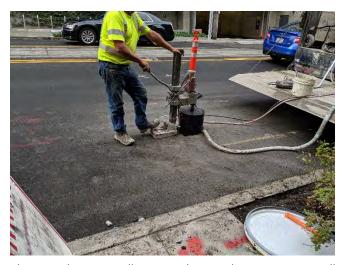
Photograph 7. Installing supplemental monitoring well MW32 in Harrison Street ROW; September 9, 2019.

- CVOCs were not detected above laboratory reporting limits in groundwater samples
 collected from MW32 and MW33, located in the Harrison Street ROW. These results
 indicate that the groundwater contamination observed in the Harrison Street ROW
 does not extend to the east beyond well MW32 or to the west beyond well MW33.

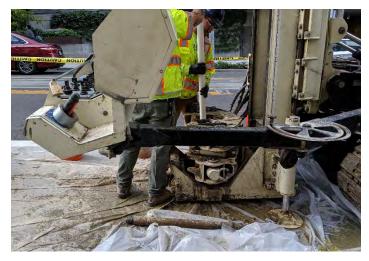
Photograph 8. Installing supplemental monitoring well MW31 in Boren Avenue North ROW; September 11, 2019.

- The sample collected from MW31 did not contain concentrations of COCs above the applicable laboratory reporting limits and/or applicable MTCA cleanup level. These results indicate that the groundwater contamination observed in the Boren Avenue North and Harrison Street ROWs does not extend to the north beyond well MW31.

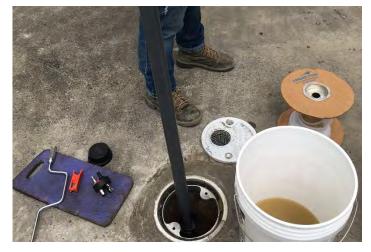
Photograph 12. Installing dedicated bladder pumps in supplemental monitoring wells; September 20, 2019.
