Figure ES-1
Carbon Tetrachloride in Groundwater Samples from Wells
 Remedial Investigation/Feasibility Study Report
 Grain Handling Facility at Freeman,
 Freeman, Washington

Figure 1-1
Site Location
 Remedial Investigation/Feasibility Study Report
 Grain Handling Facility at Freeman,
 Freeman, Washington

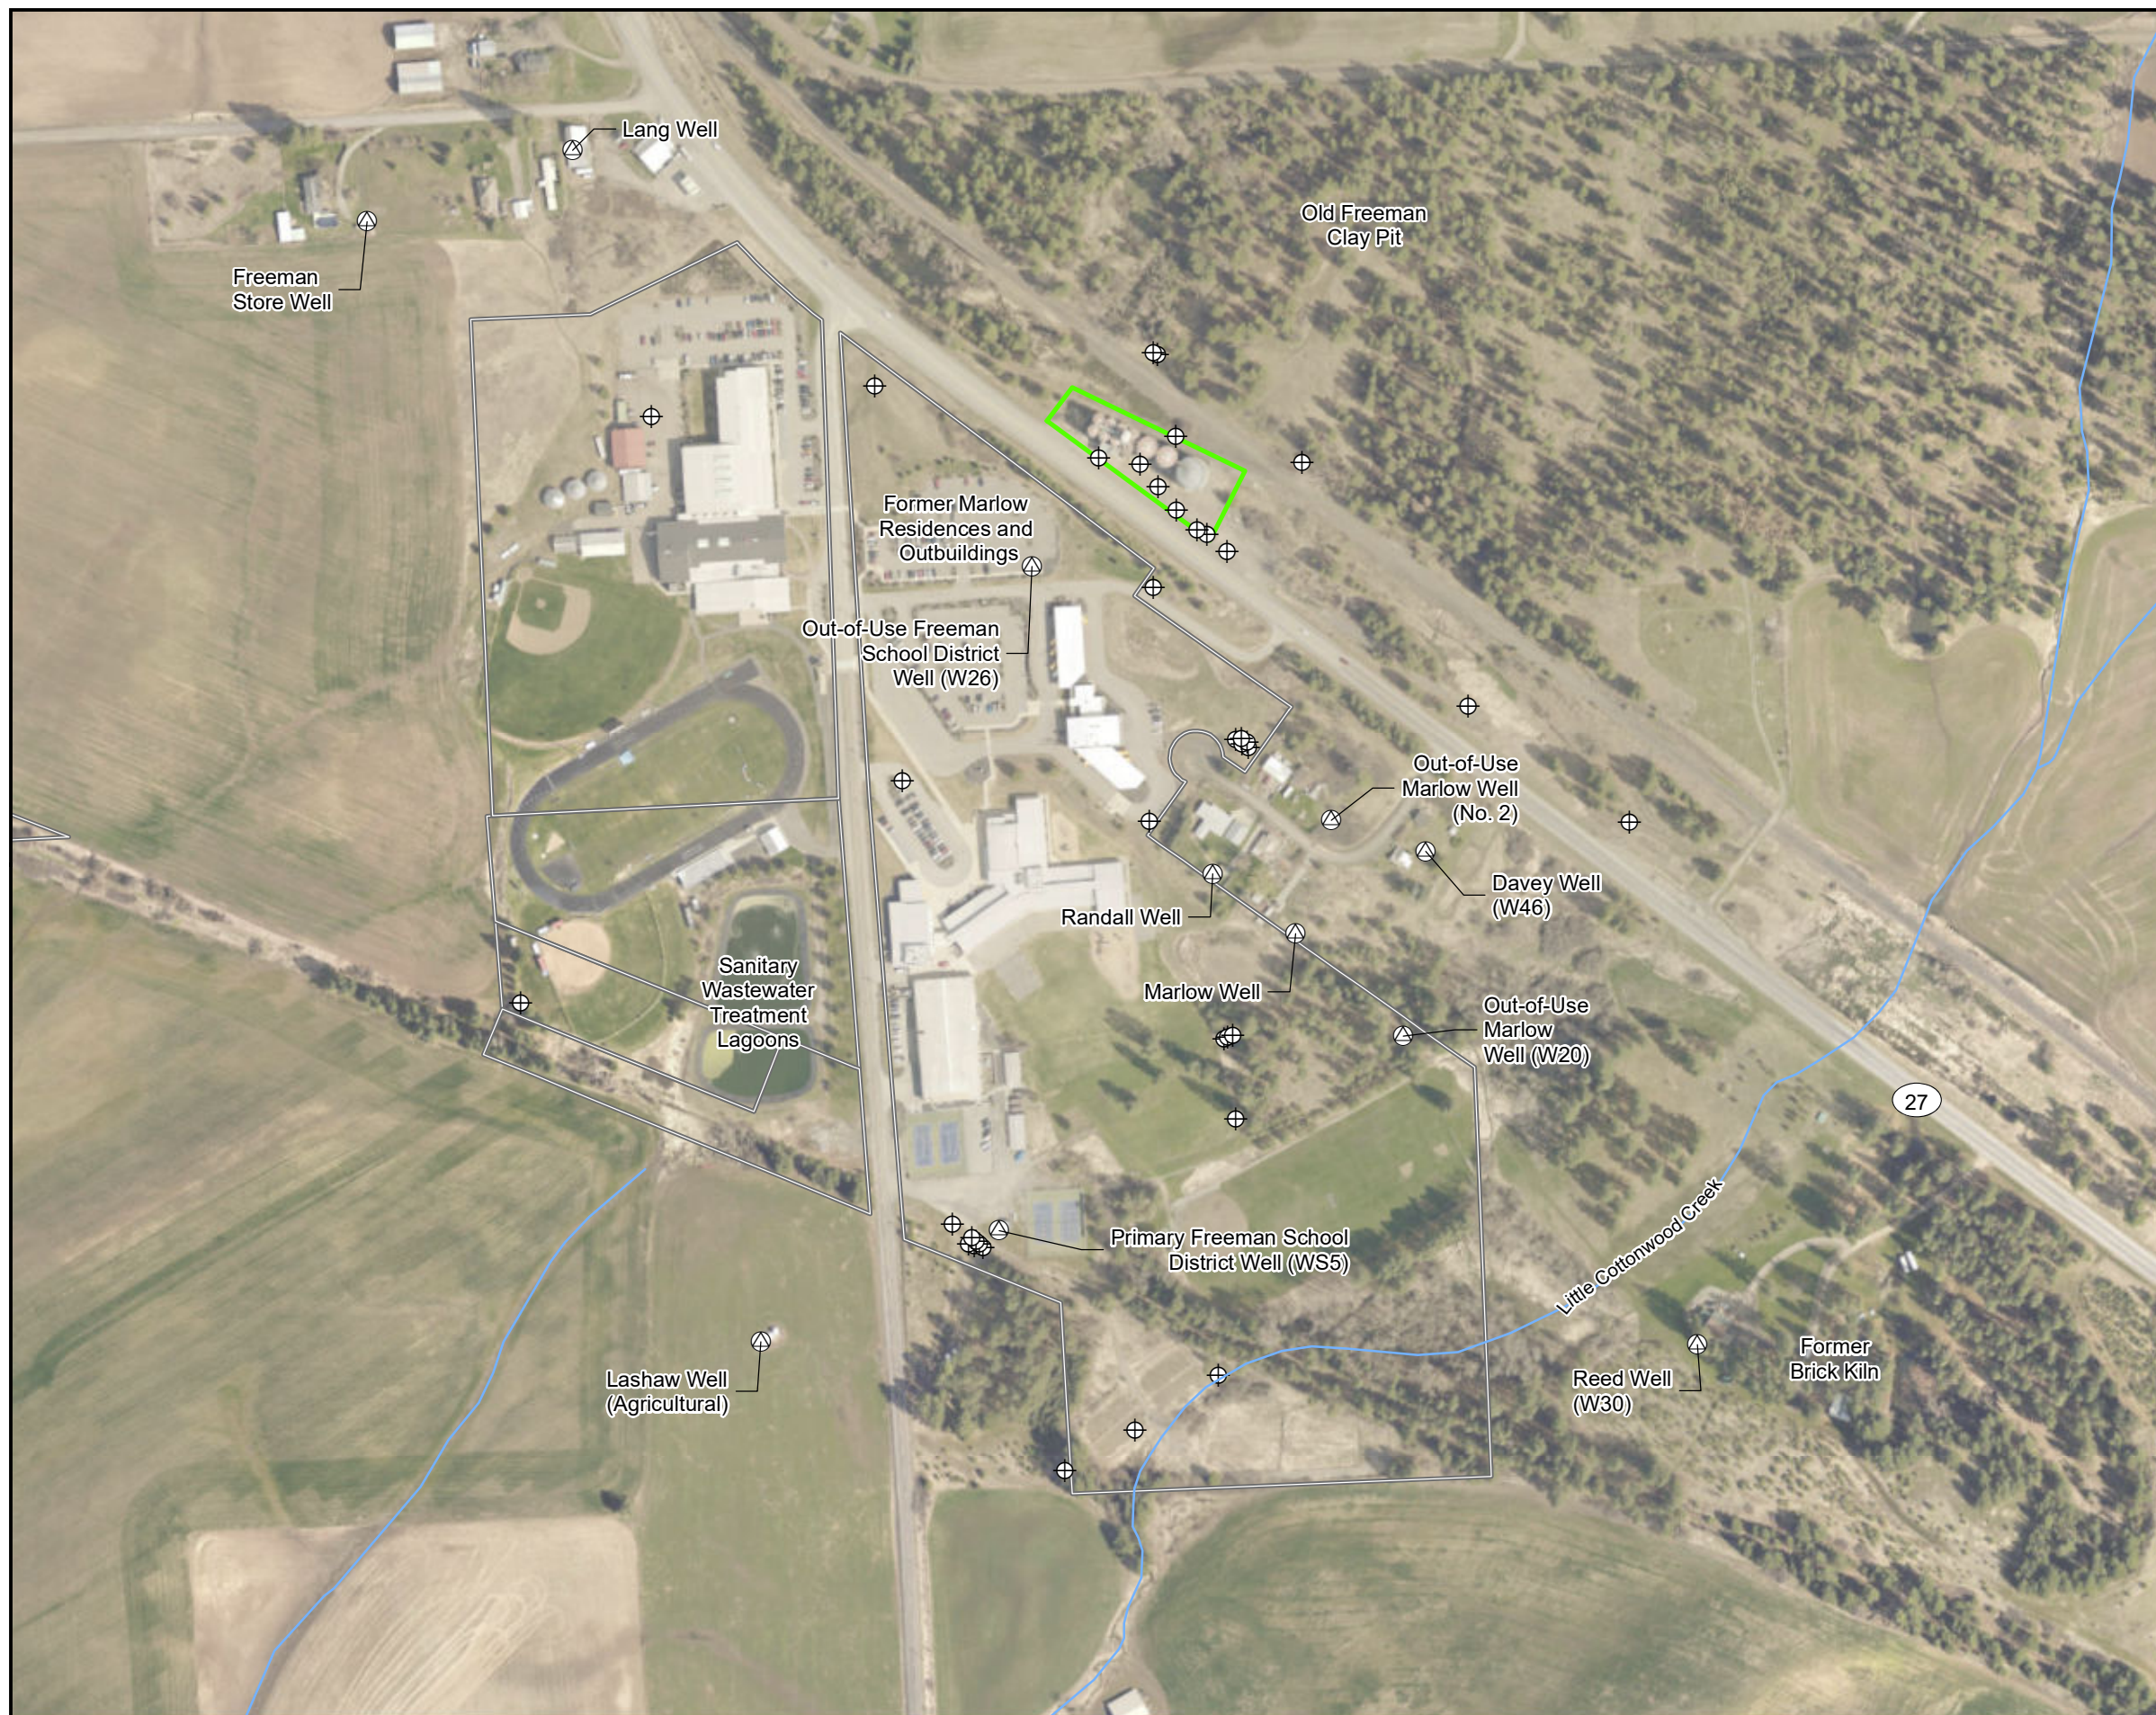
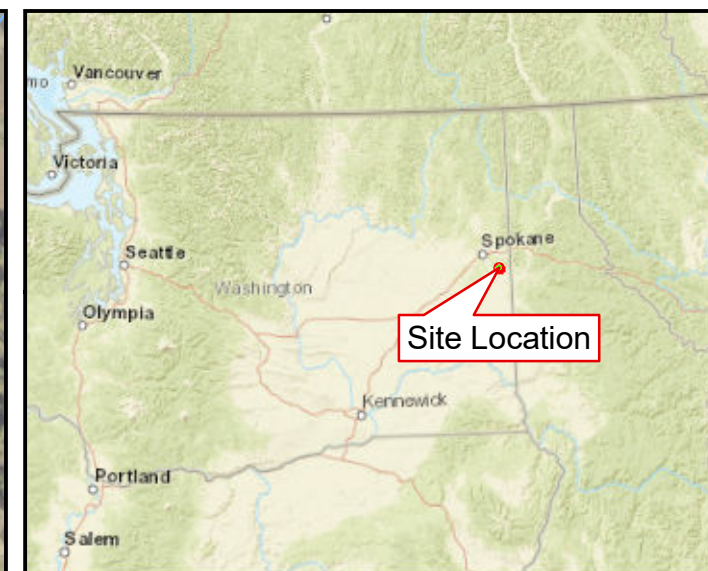
Figure 2-2
Site and Surrounding Features
 Remedial Investigation/Feasibility Study Report
 Grain Handling Facility at Freeman,
 Freeman, Washington

- ⊕ Monitoring Well
- ⊗ Domestic Well
- ▭ Grain Handling Facility at Freeman
- ▭ Freeman School District
- Stream

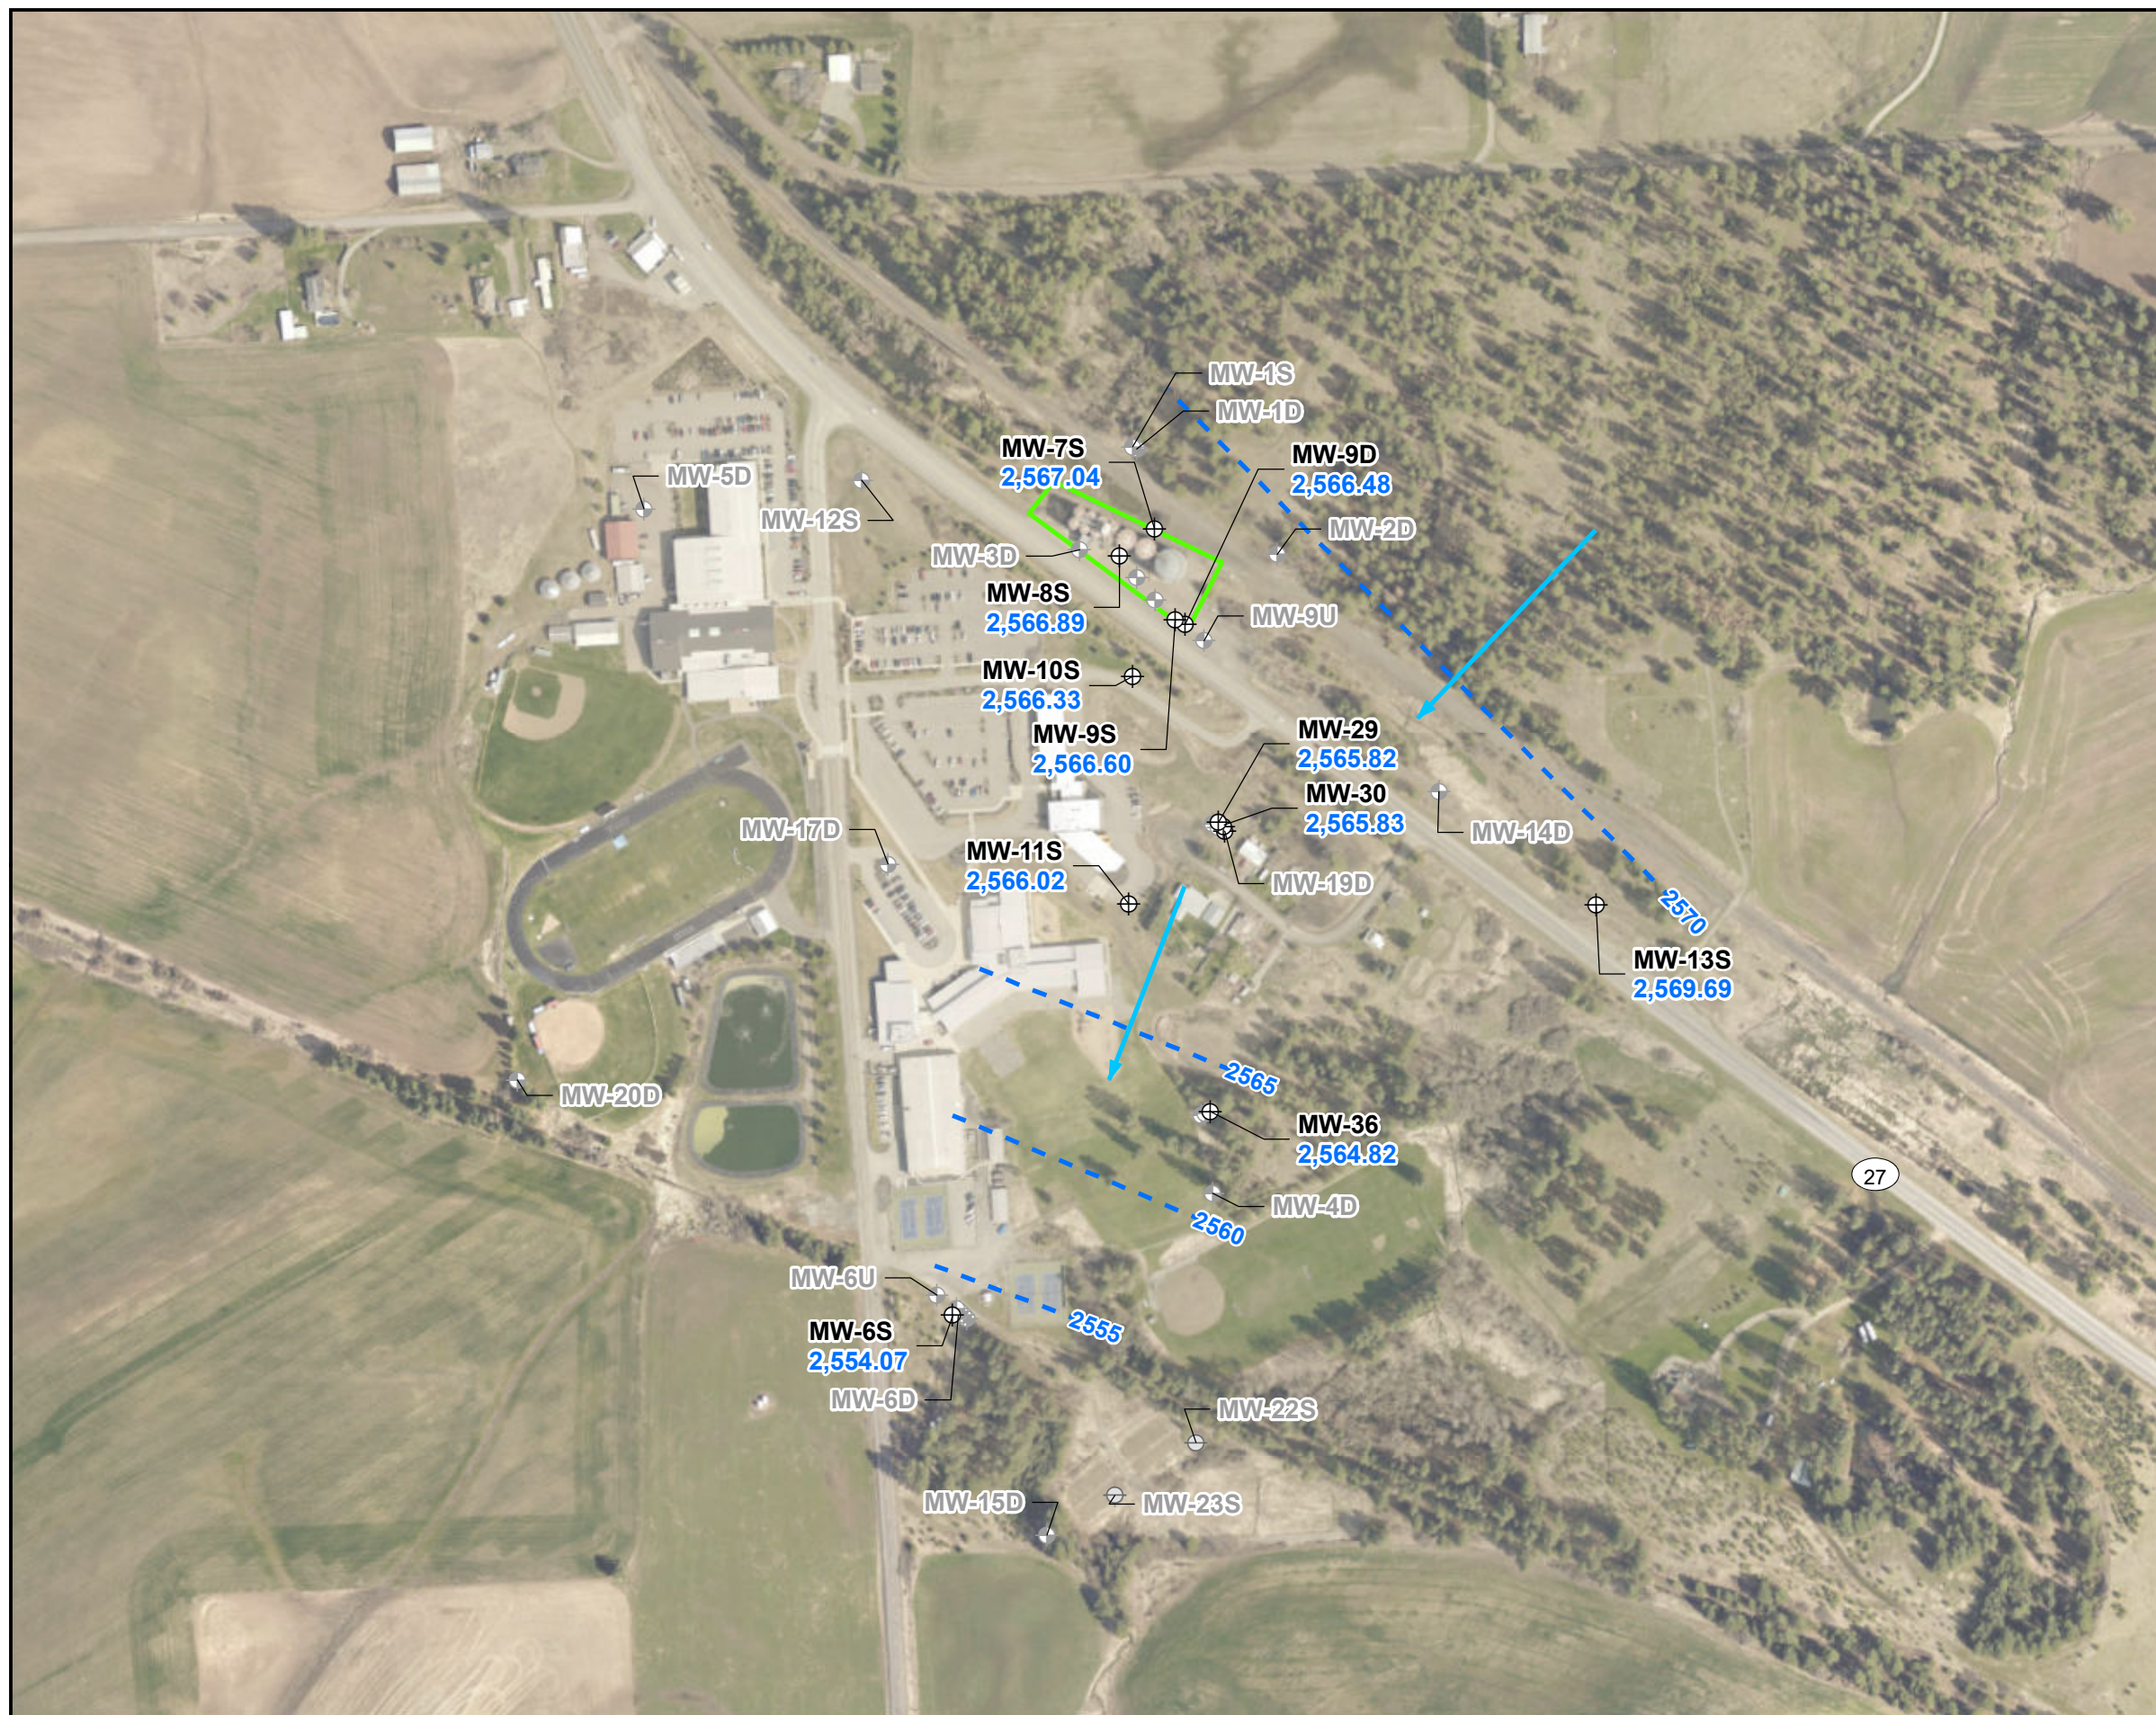
1. Groundwater elevations near each well represent measurements from September 2019.
2. Wells grouped in this category include upper unconsolidated and basalt units inferred to be in hydraulic connection near GHFF.
3. See separate map for wells south of 6s/6dwell pair.
4. Wells in grey text not used for contouring.
5. MW-22s and MW-23s were decommissioned due to artesian conditions.

Figure 3-12
Inferred Groundwater Elevation Contours and Flow Map for
Upper Unconsolidated Sediment and Basalt Unit
 Remedial Investigation/Feasibility Study Report
 Grain Handling Facility at Freeman,
 Freeman, Washington

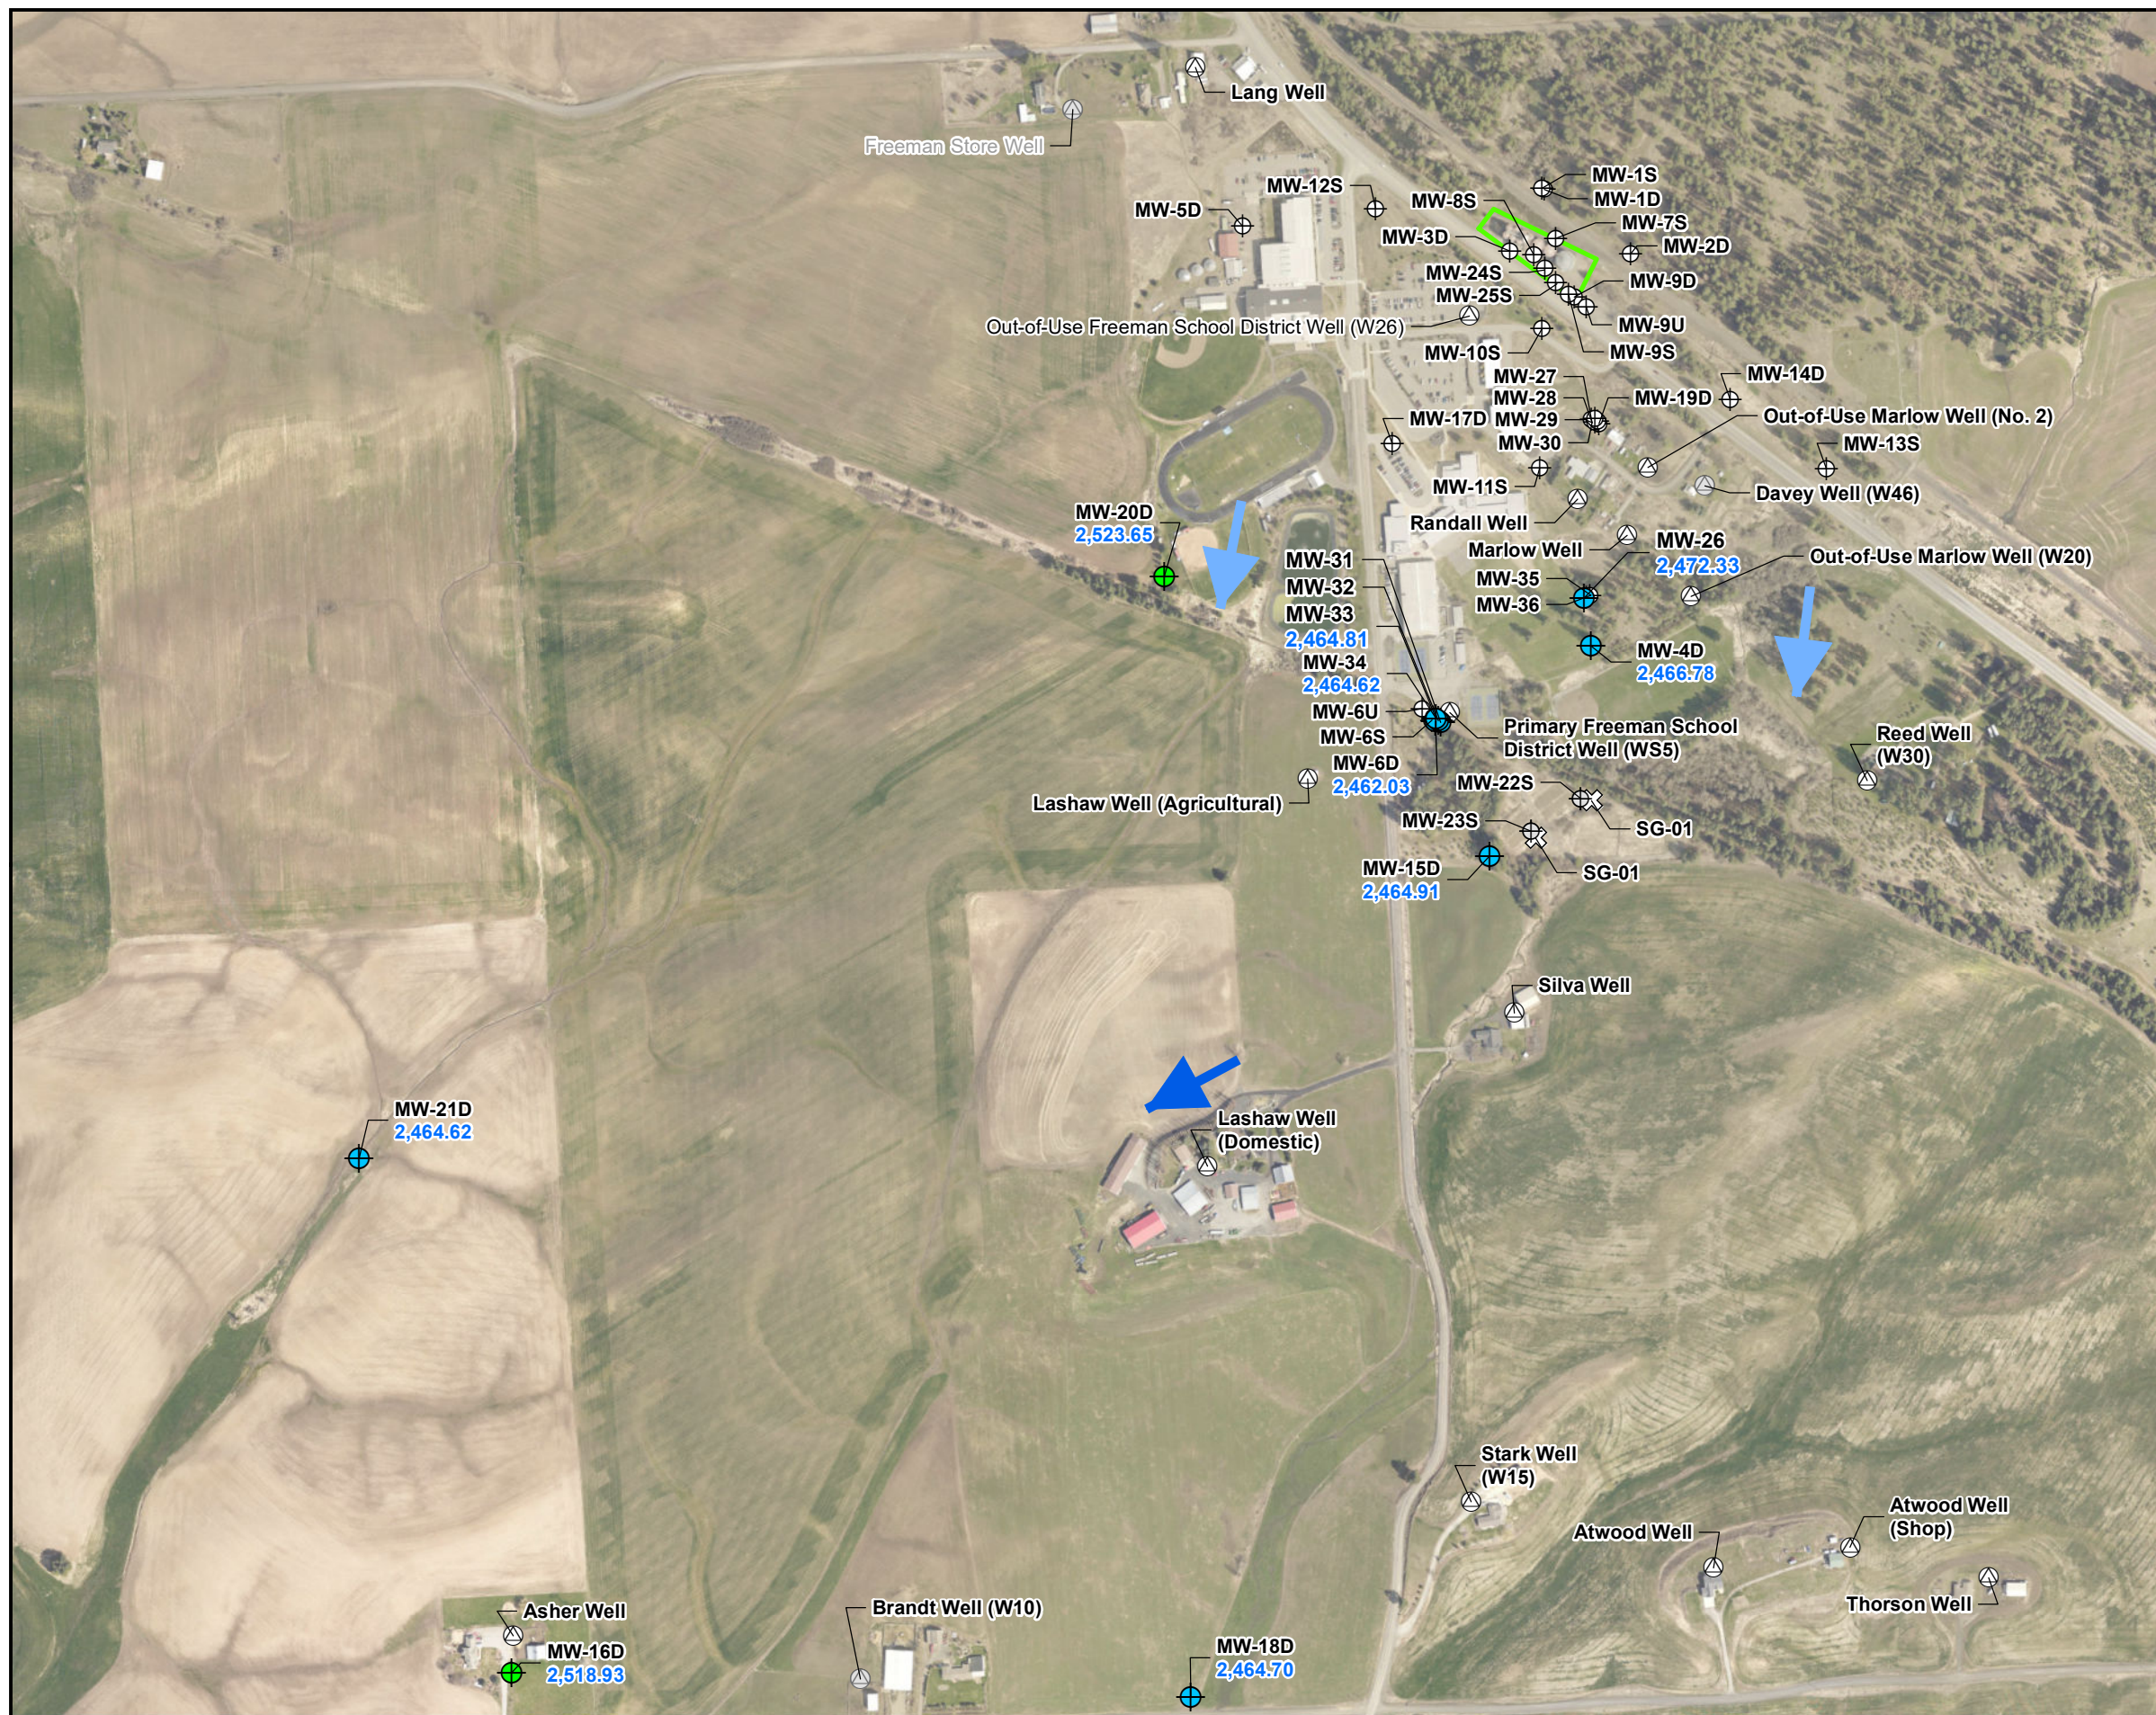
3. Groundwater elevations near each well represent measurements from September 2019.
4. Wells shown in blue are within the lower fractured basalt unit south of transition zone where an unfractured basalt separates the upper and lower fractured basalt units. The lower fractured basalt unit becomes more confined.

5. Wells MW-20D and MW-16D exhibit uncharacteristically high elevations to be grouped or included in the "lower fractured basalt unit" –well screen depth below top of basalt is relatively shallow and suggests they should be categorized as "upper fractured basalt".

6. Groundwater elevations from MW-4D, MW-6D, MW-15D, MW-18D, and MW-21D suggest general GW flow direction in lower fractured basalt unit shifting to more west-southwest direction in this area, which would be consistent with the regional setting/watershed characteristics. Need more data in southern locations to prove this hypothesis.

Figure 3-13
Groundwater Elevations and Conceptualized Flow for Area South/Southwest of Site
 Remedial Investigation/Feasibility Study Report
 Grain Handling Facility at Freeman,
 Freeman, Washington

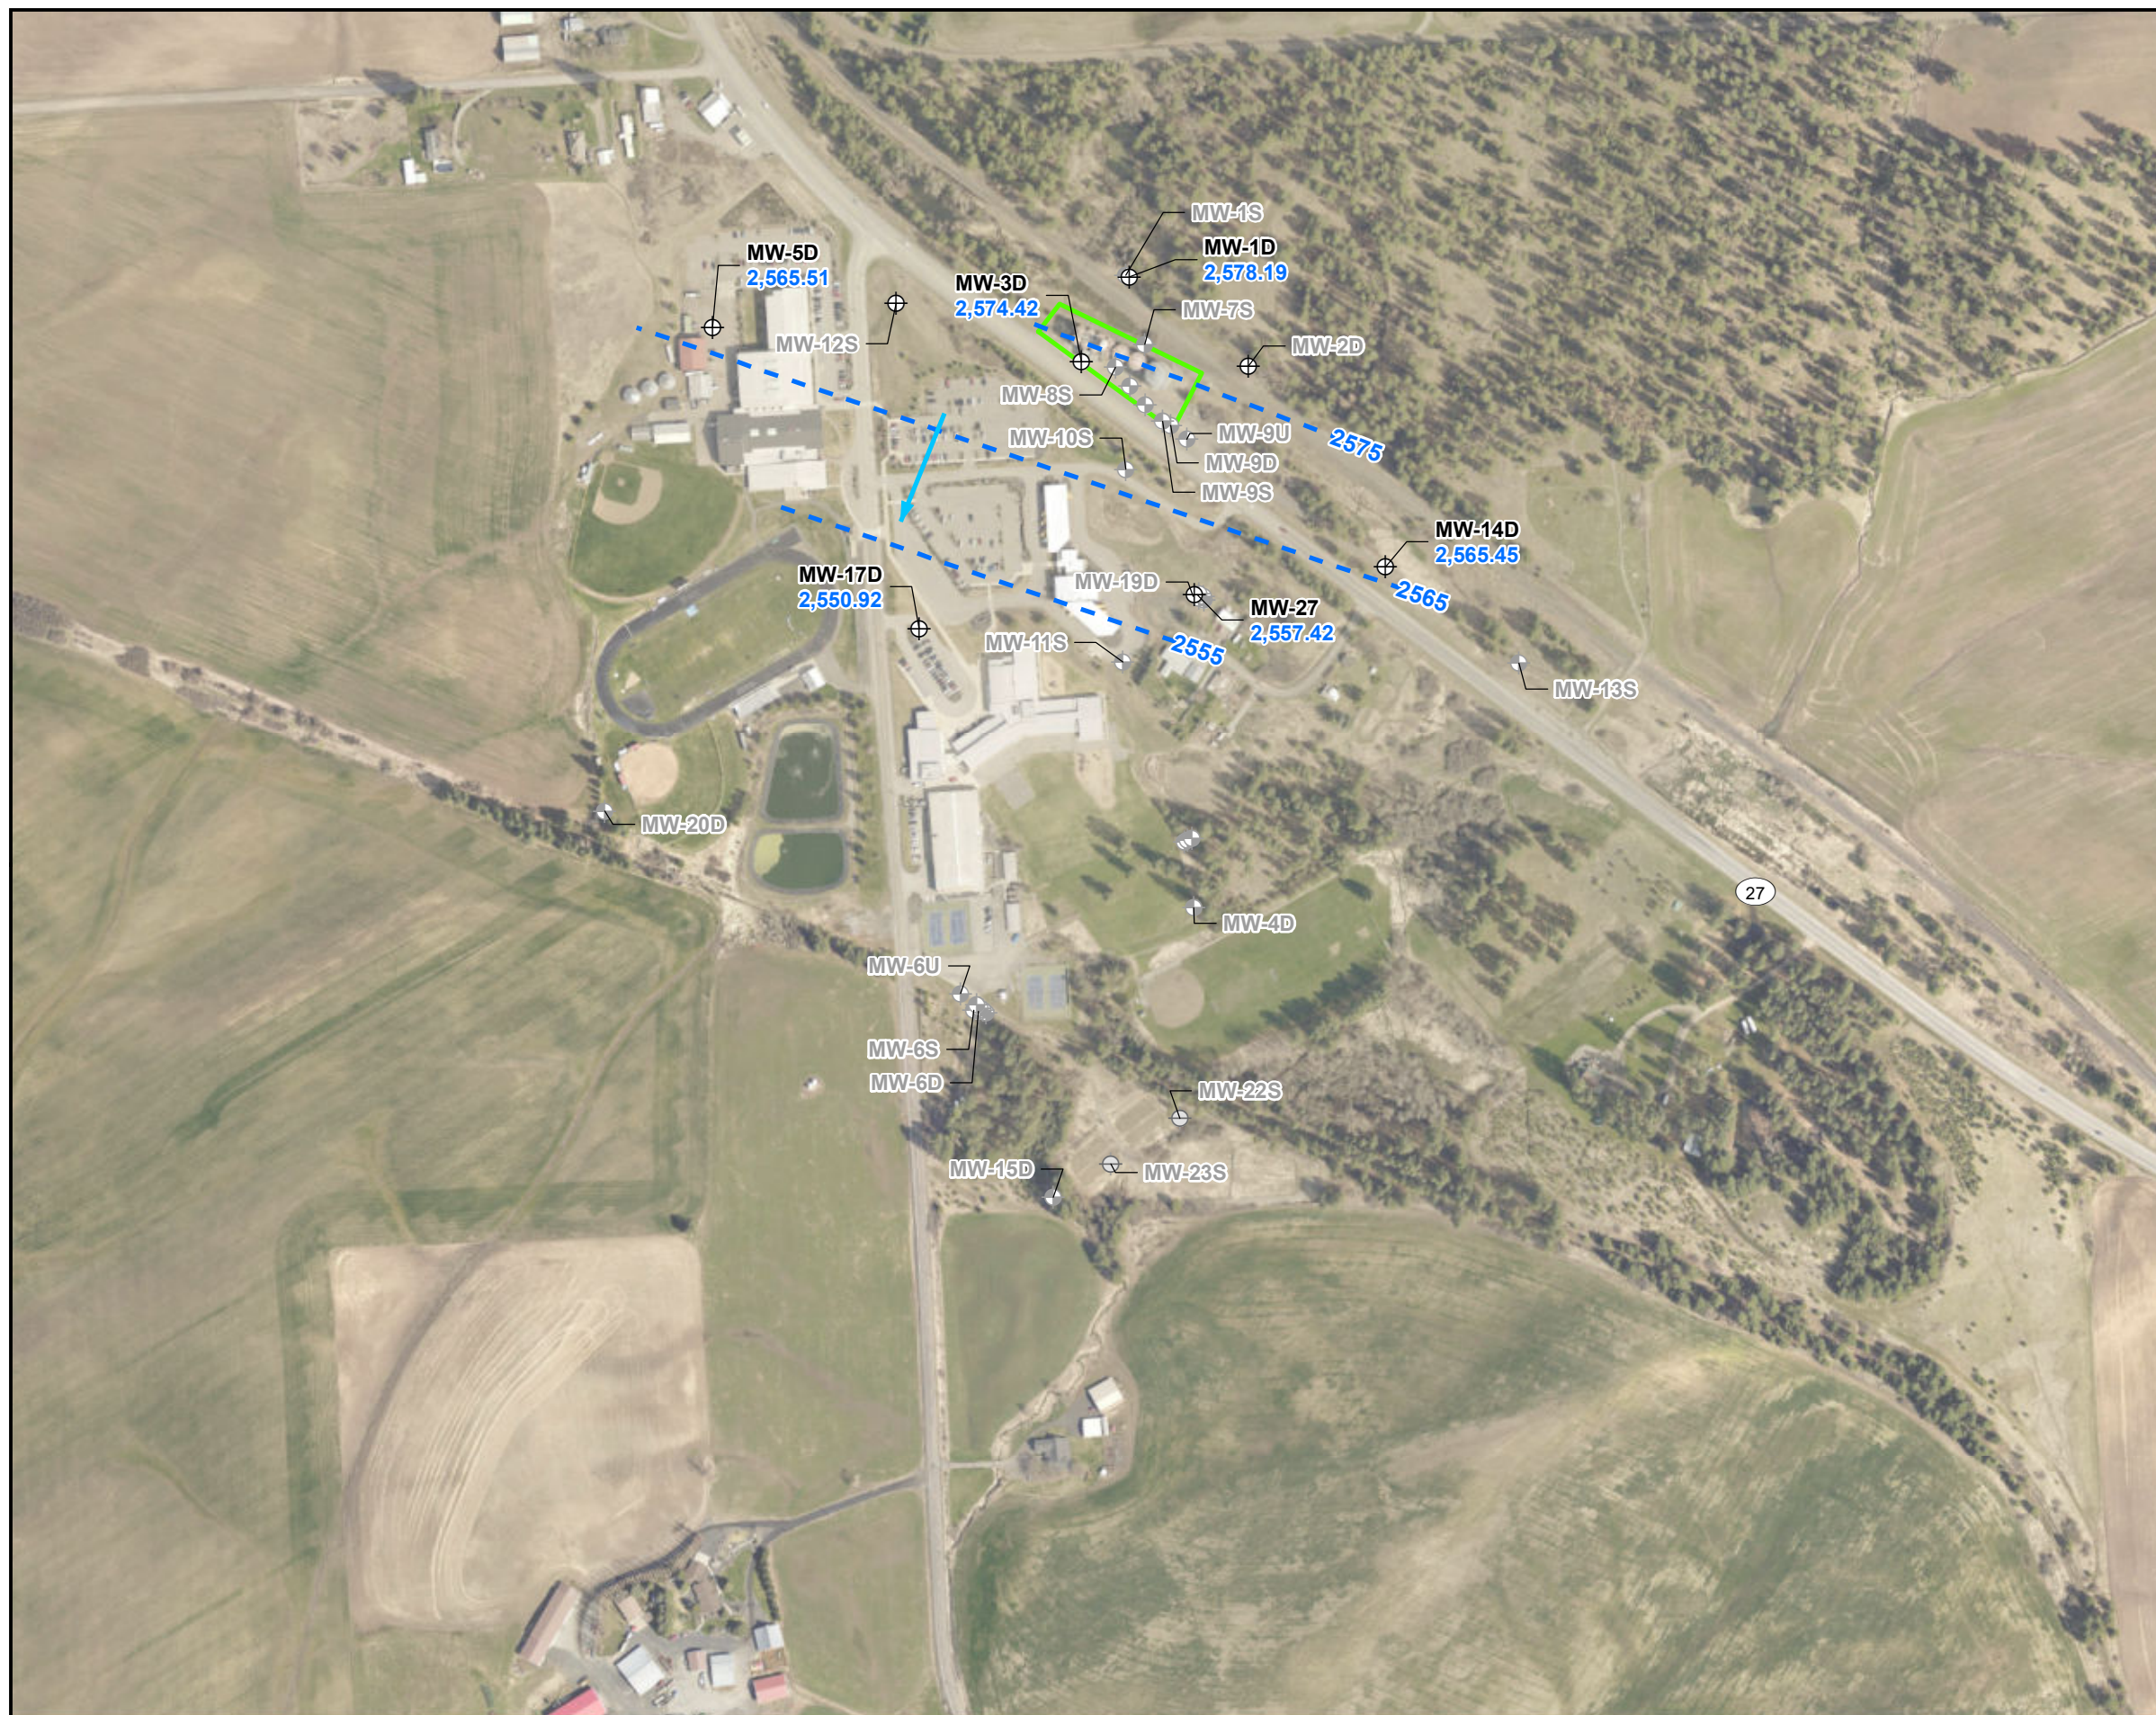
1. Groundwater elevations near each well represent measurements from September 2019
2. Wells grouped in this category include lower decomposed/weathered granite near GHFF assumed to be in hydraulic connection.
3. Wells in grey text not used for contouring.
4. MW-22S and MW-23S were decommissioned due to artesian conditions.

Figure 3-14
Inferred Groundwater Elevation Contours and Flow Map for Lower Decomposed/Weathered Granite Unit
 Remedial Investigation/Feasibility Study Report
 Grain Handling Facility at Freeman,
 Freeman, Washington

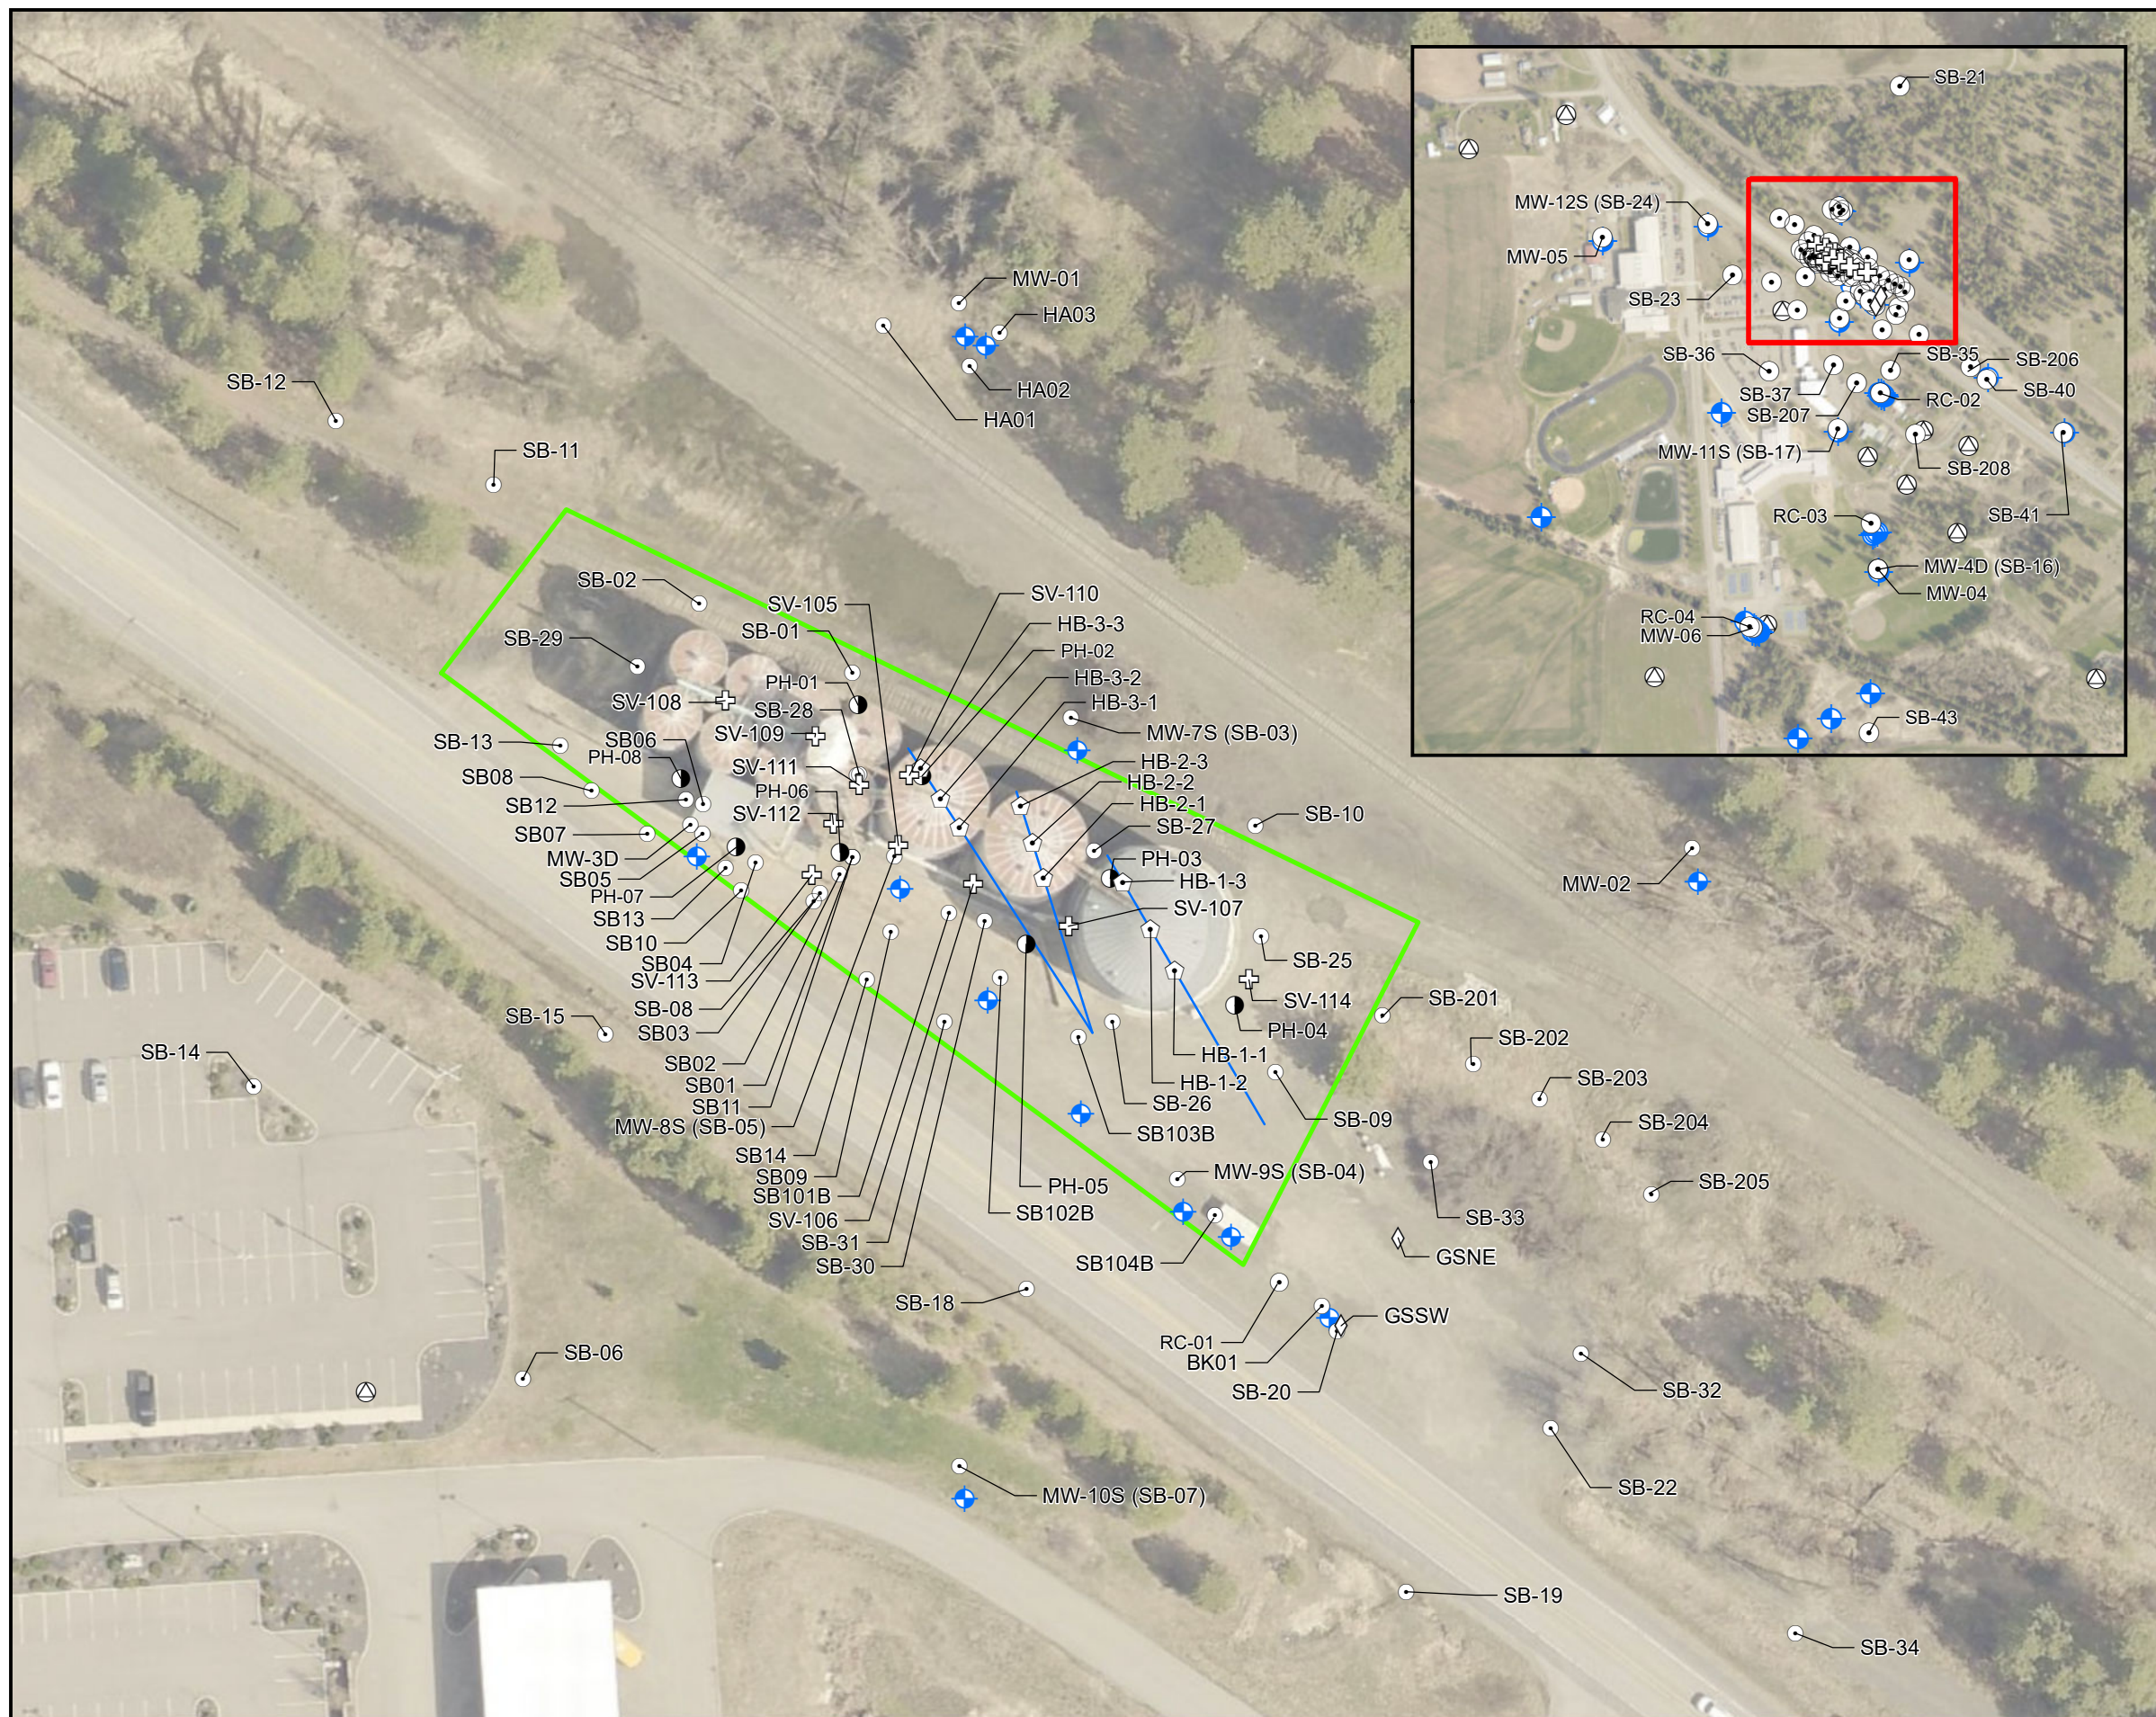
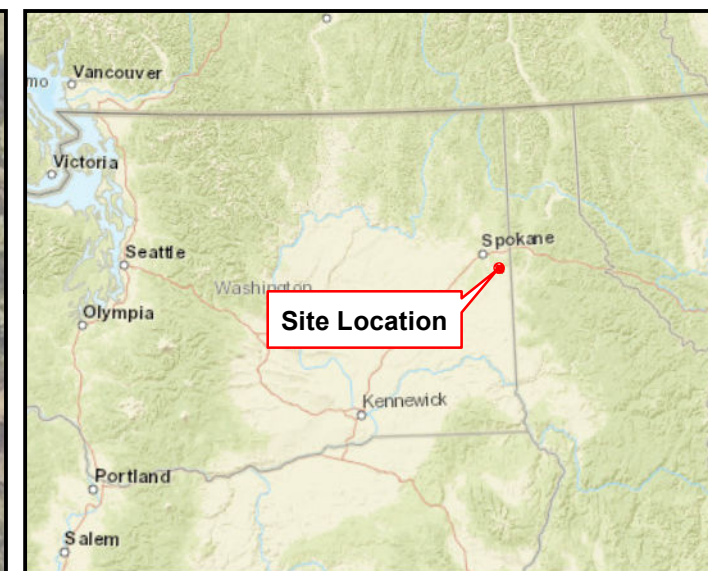
Figure 4-1
Soil Sample Locations
 Remedial Investigation/Feasibility Study Report
 Grain Handling Facility at Freeman,
 Freeman, Washington

- Soil Boring
- ⊕ Monitoring Well
- ⊗ Domestic Well
- ⊕ Horizontal Boring Location
- Pothole Location
- ⊕ Sub Slab Locations
- ◇ Excavation Location
- Horizontal Boring (HB)
- ▭ Grain Handling Facility at Freeman
