Figure ES-1
Carbon Tetrachloride in Groundwater Samples from Wells
 Remedial Investigation/Feasibility Study Report
 Grain Handling Facility at Freeman,
 Freeman, Washington

Figure 1-1
Site Location
 Remedial Investigation/Feasibility Study Report
 Grain Handling Facility at Freeman,
 Freeman, Washington

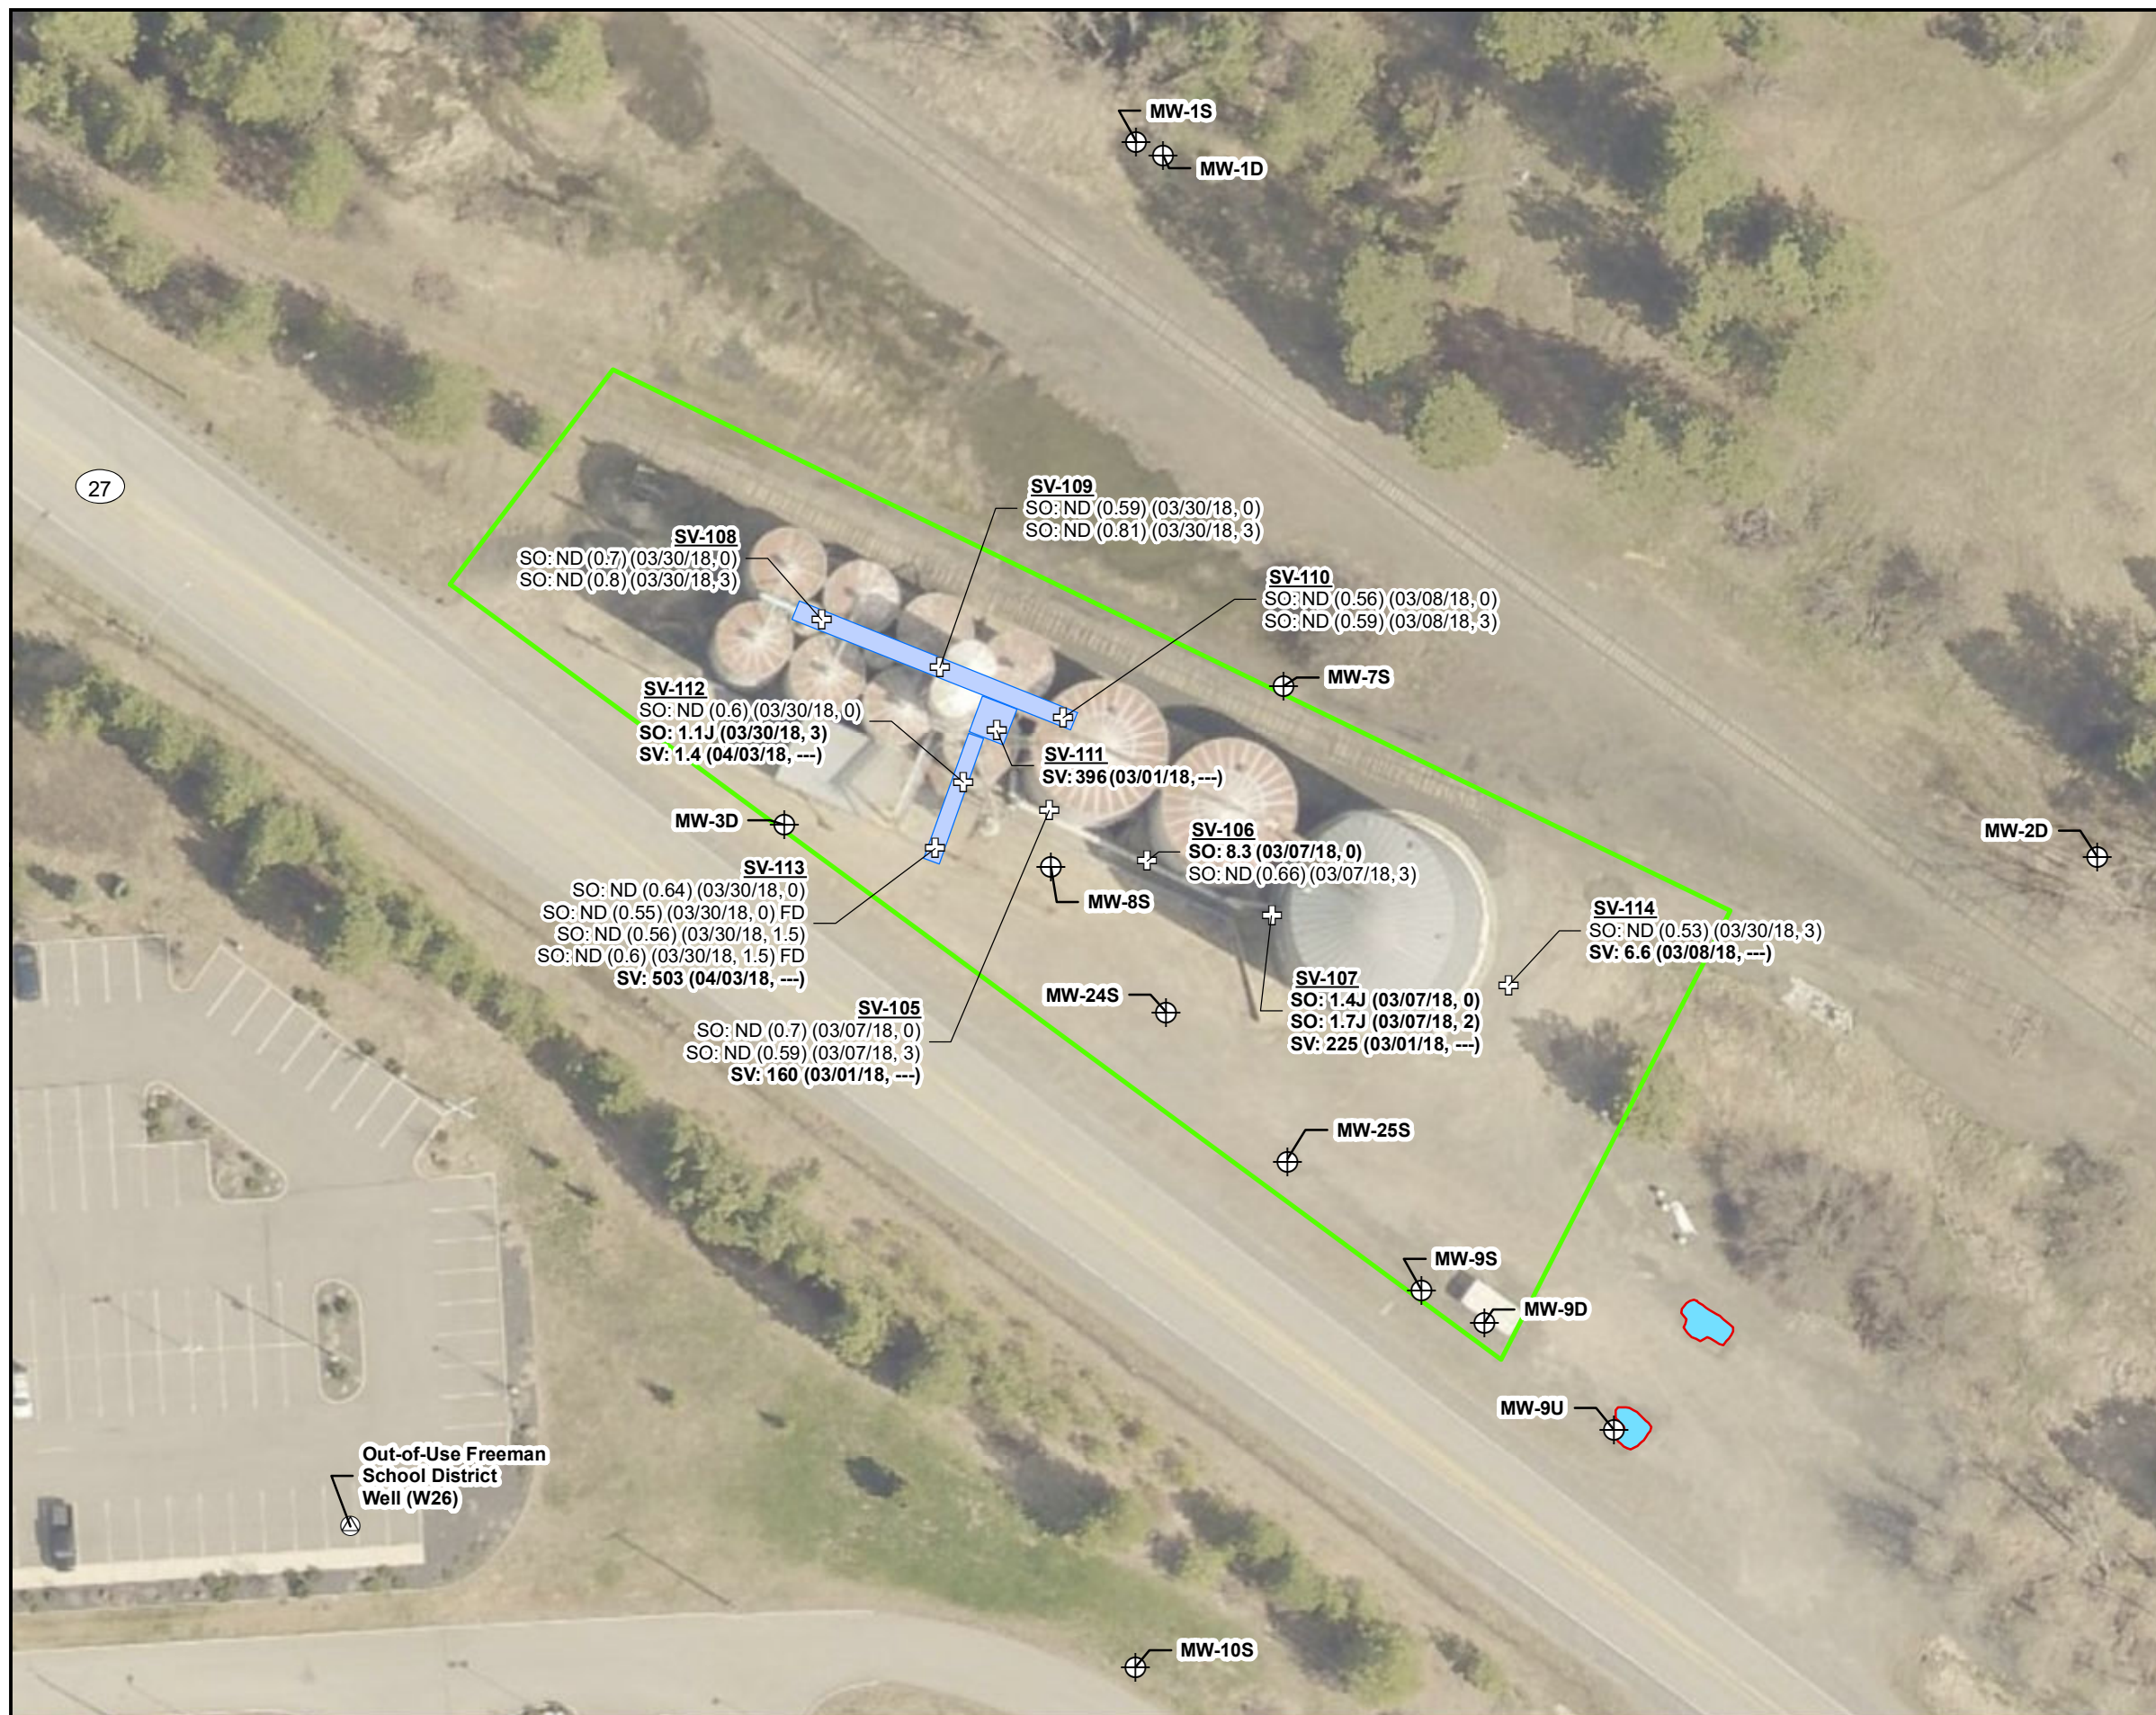
Sub-slab vapor sampling was attempted but unsuccessful from vapor probes installed at locations SV-106, SV-108, SV-109, and SV-110 due to either water entry to the Summa canister or to field conditions preventing vapor entry to the Summa canister (i.e., tight formation).

Figure 4-2
Carbon Tetrachloride in Sub-slab Soil and Soil Vapor Samples
 Remedial Investigation/Feasibility Study Report
 Grain Handling Facility at Freeman,
 Freeman, Washington

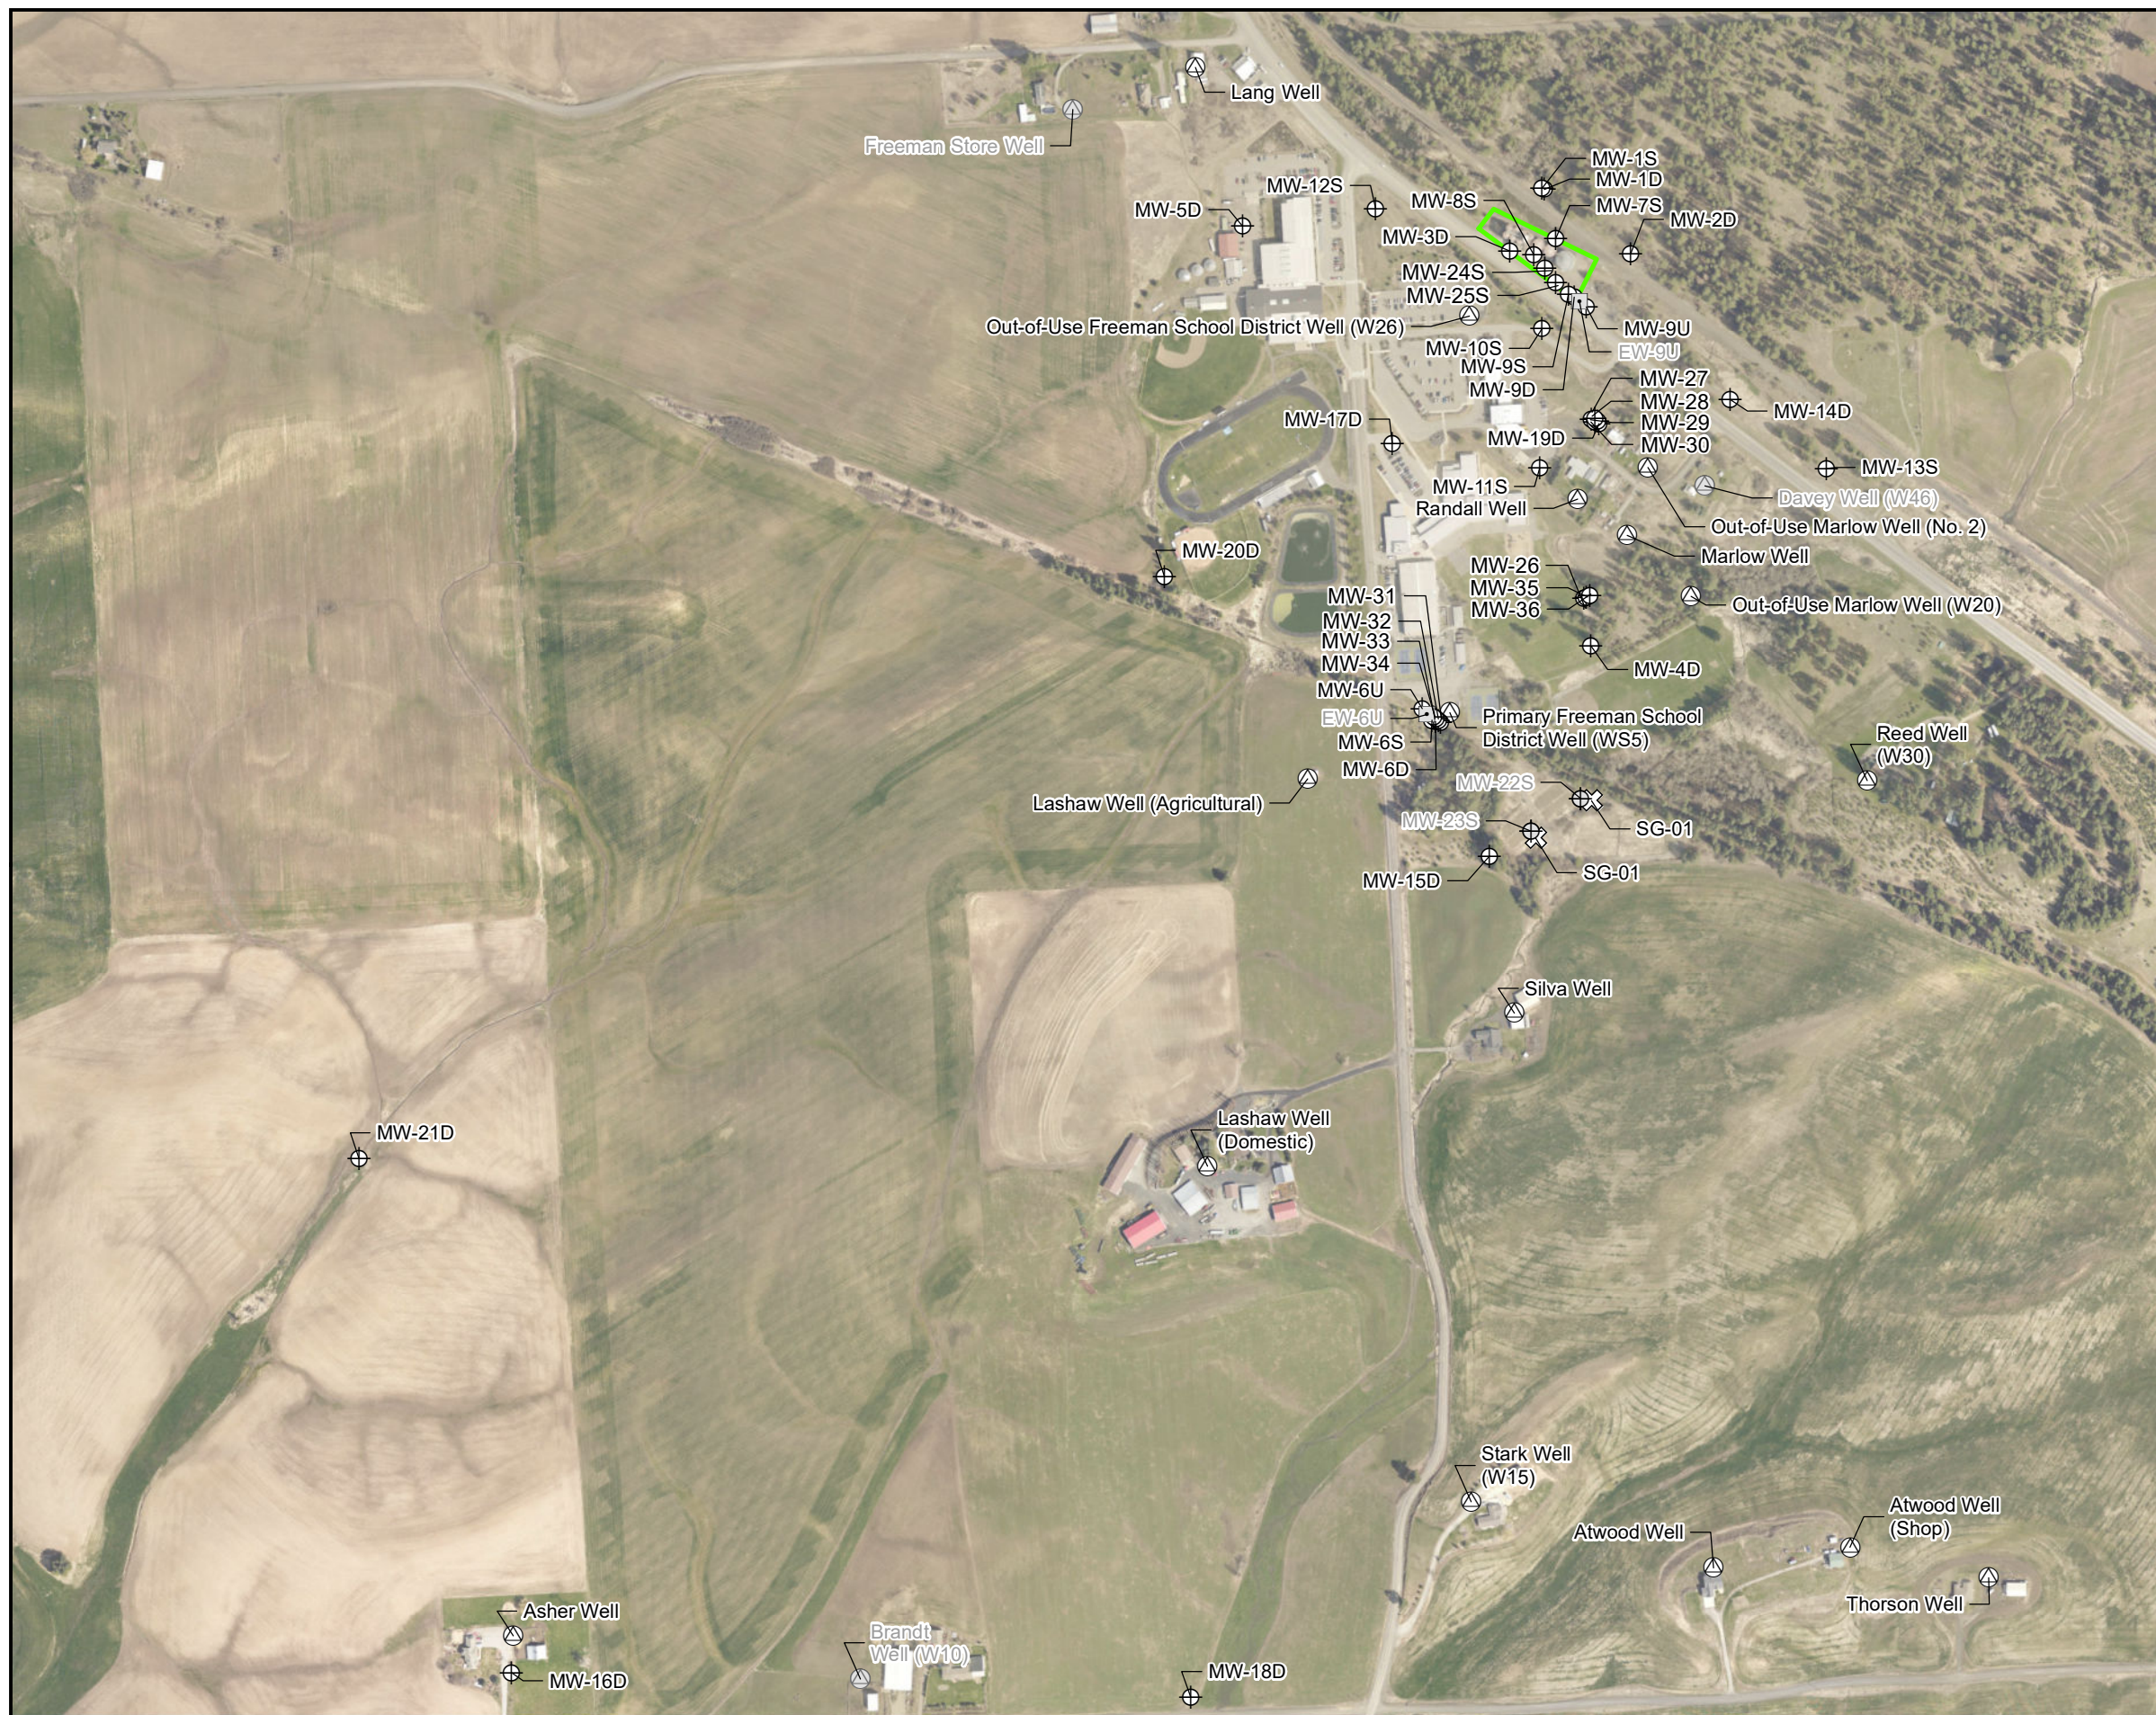
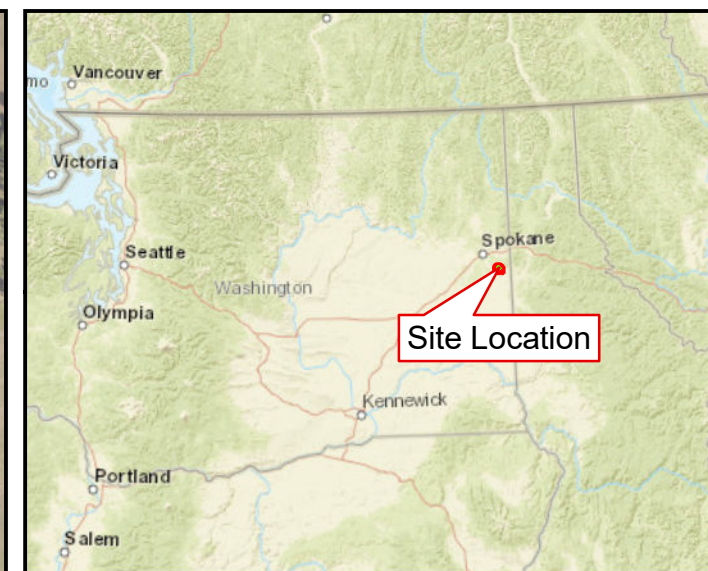
- Extraction Well
- ⊕ Monitoring Well
- ⊖ Domestic Well
- ⊗ Stream Gauge
- ▭ Grain Handling Facility at Freeman

1. EW-6U, EW-9U, MW-22s and MW-23s were decommissioned due to artesian conditions.
2. Davey, Brandt and Freeman Store wells are not included in the GW monitoring program.

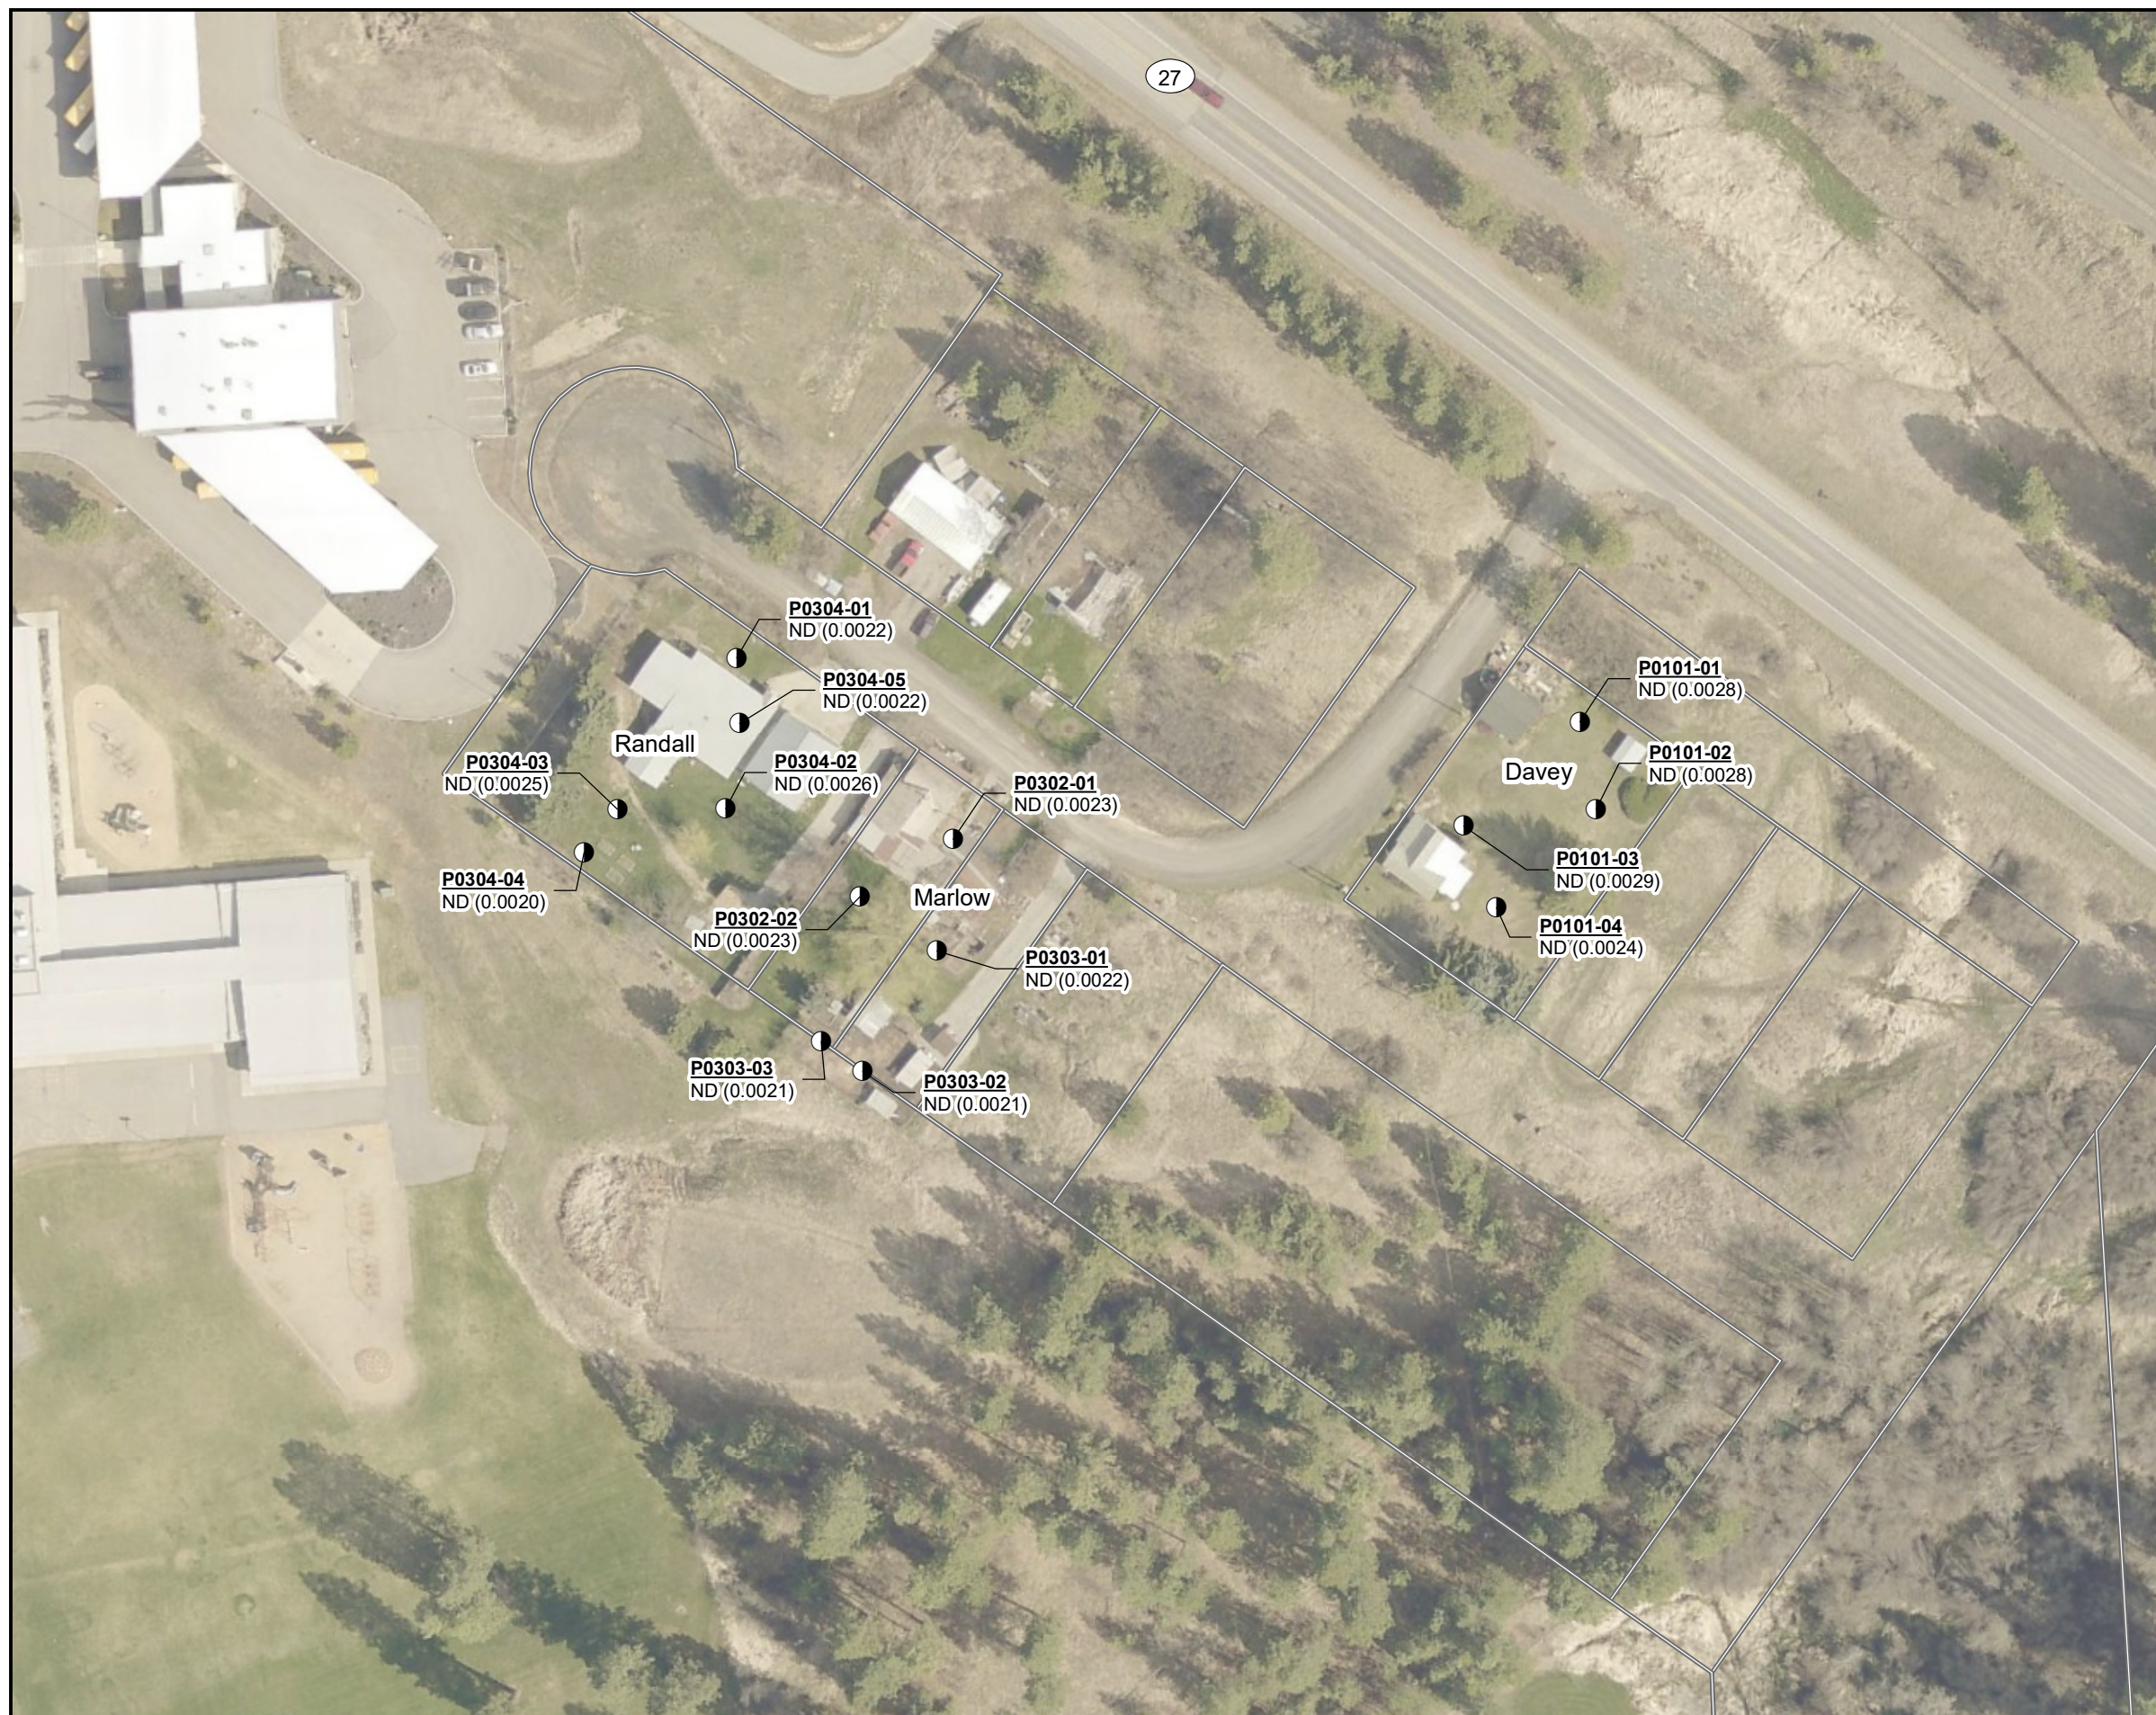
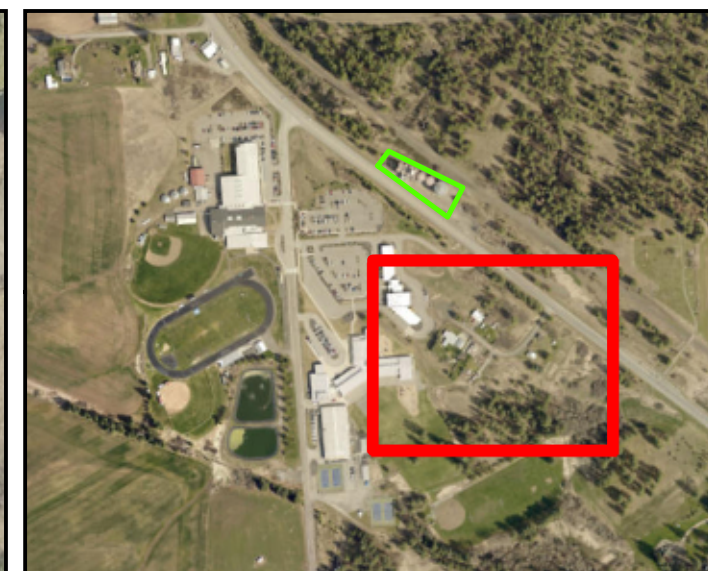
Figure 4-10
Residential Soil Sample Locations
 Remedial Investigation/Feasibility Study Report
 Grain Handling Facility at Freeman,
 Freeman, Washington

- Surface Soil Sample
- ▭ Parcel Boundary
- ▭ Grain Handling Facility at Freeman
