Appendix G
ECA Geophysics – Geophysical
Investigation Report, UPRR GHFF and the
Freeman School District Complex

Geophysical Investigation Report

UPRR GHF and the FSD Complex

Freeman, Washington

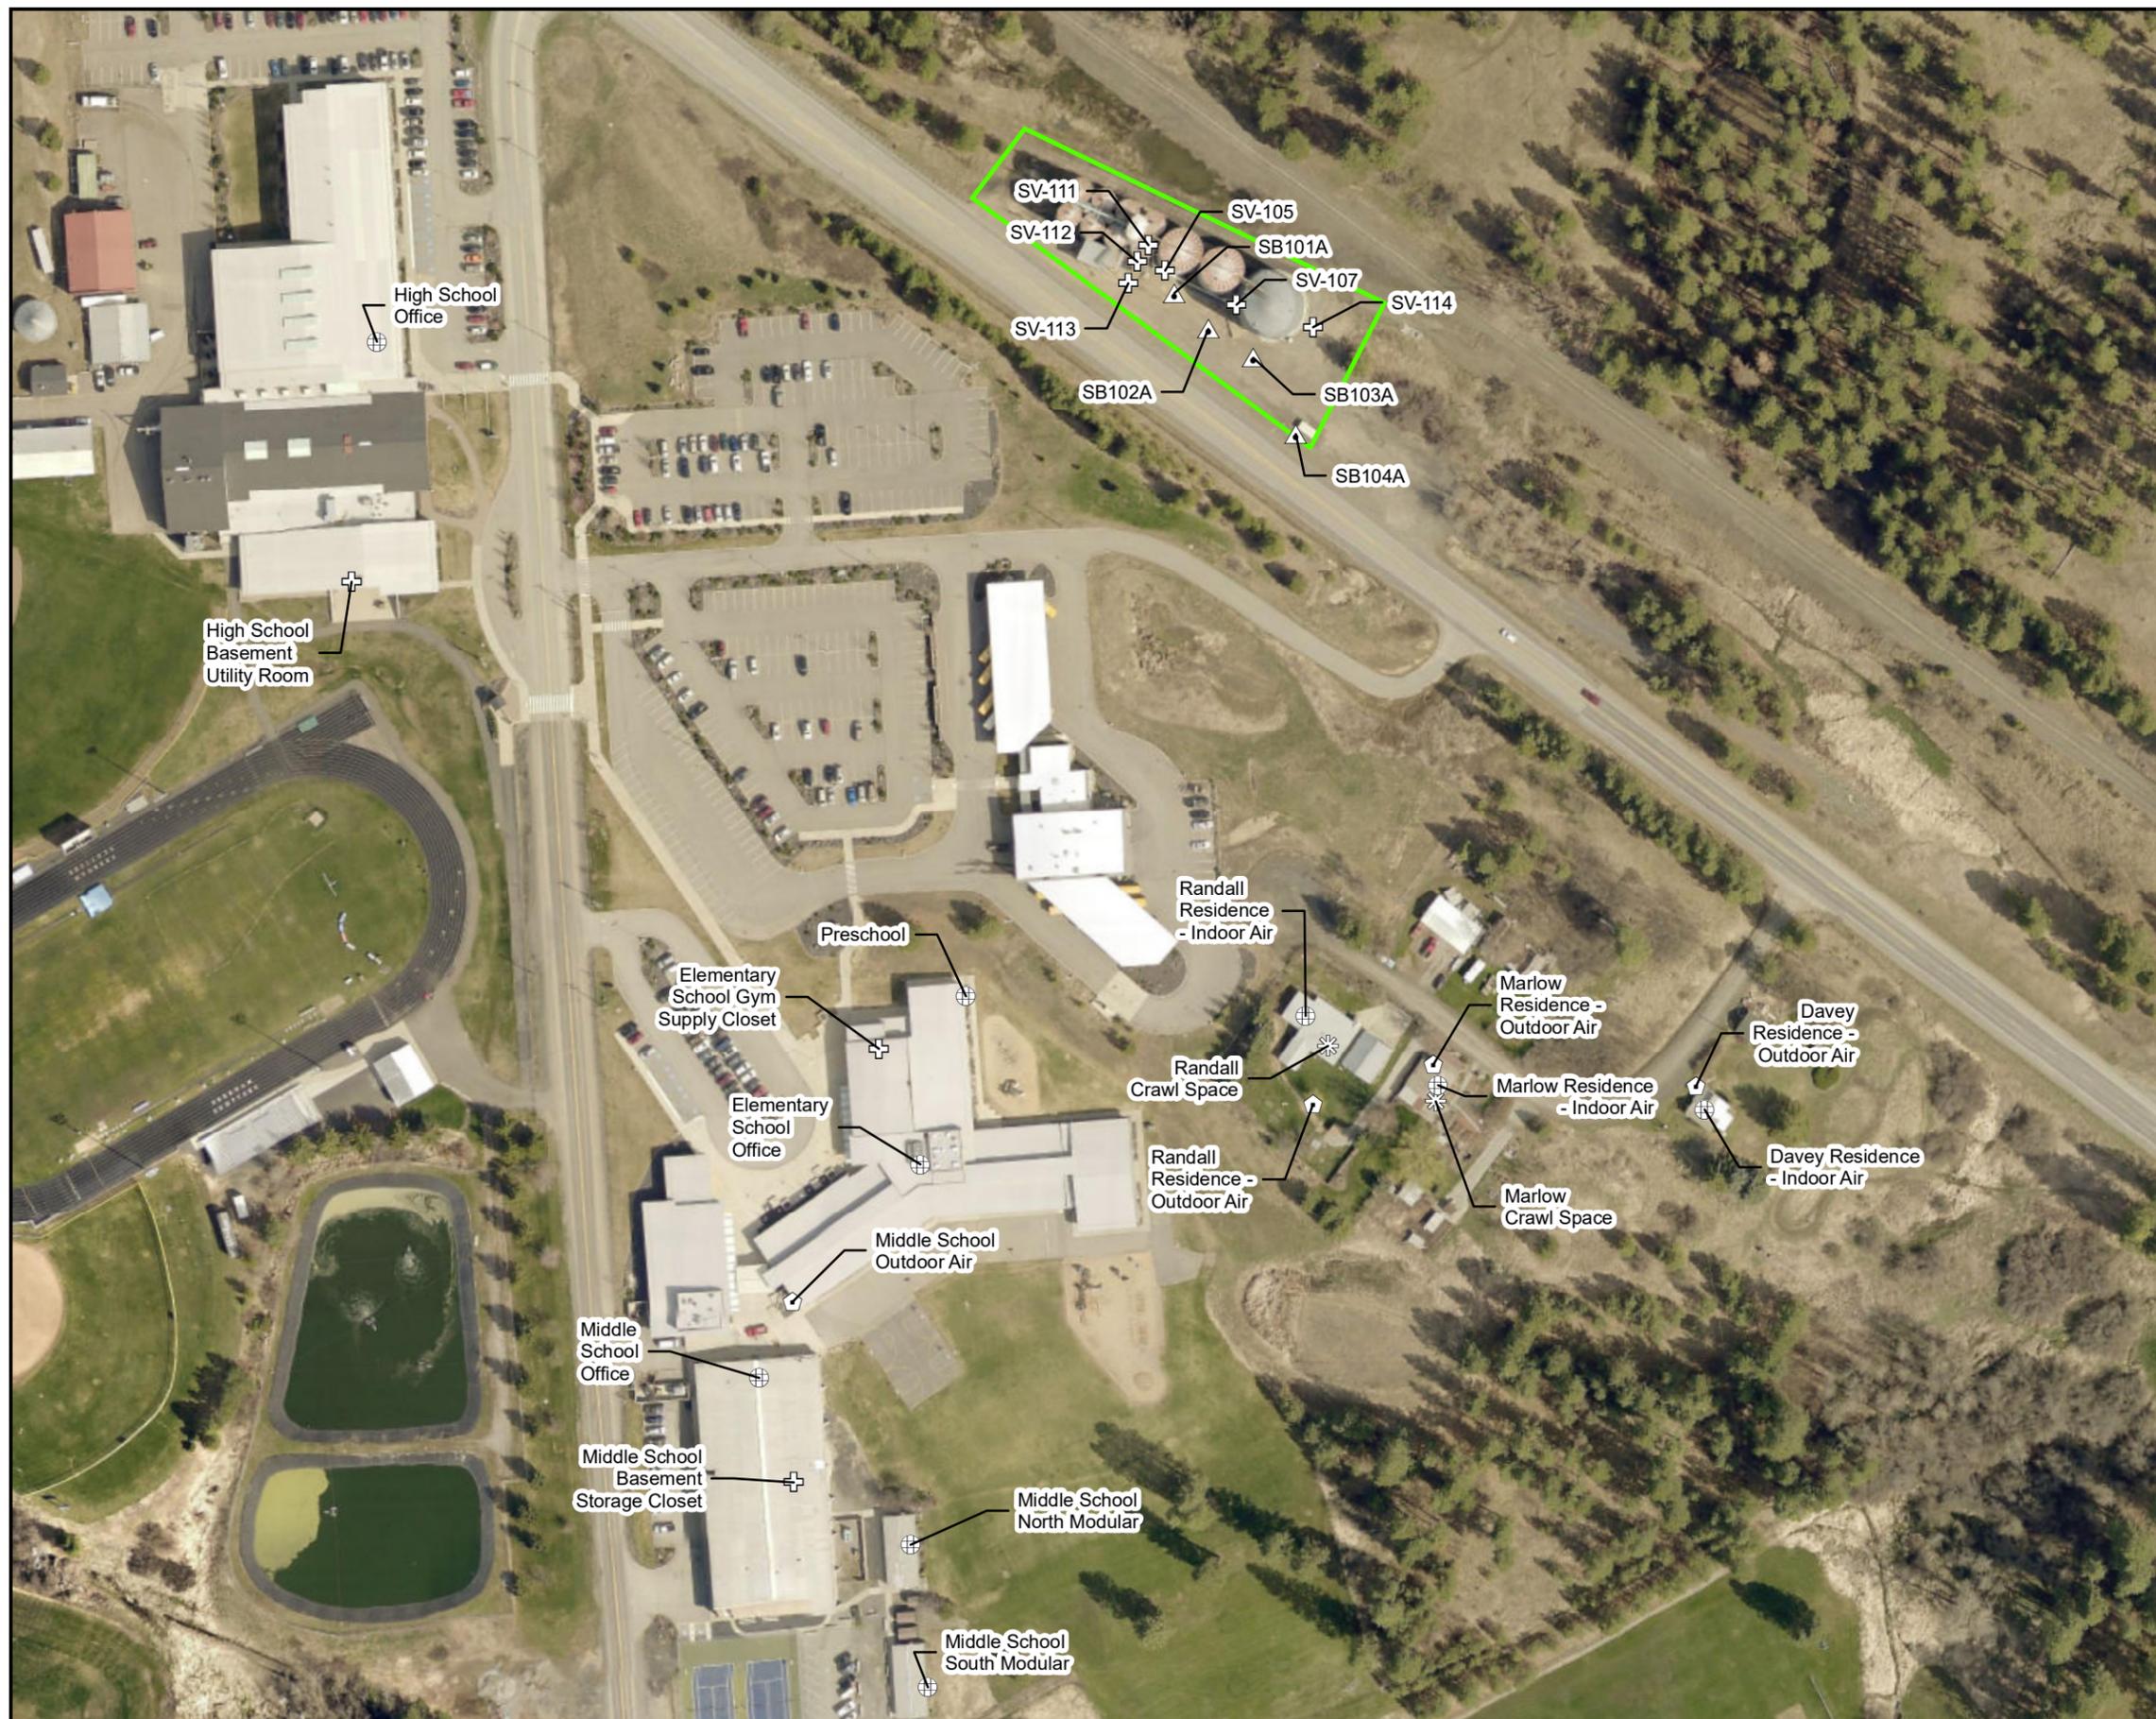
Figure H-1
Outdoor Air, Indoor Air, Indoor Crawl Space, Background Air, Sub-Slab Soil Vapor, and Soil Vapor Sampling Locations
 Remedial Investigation/Feasibility Study Report
 Grain Handling Facility at Freeman, Freeman, Washington

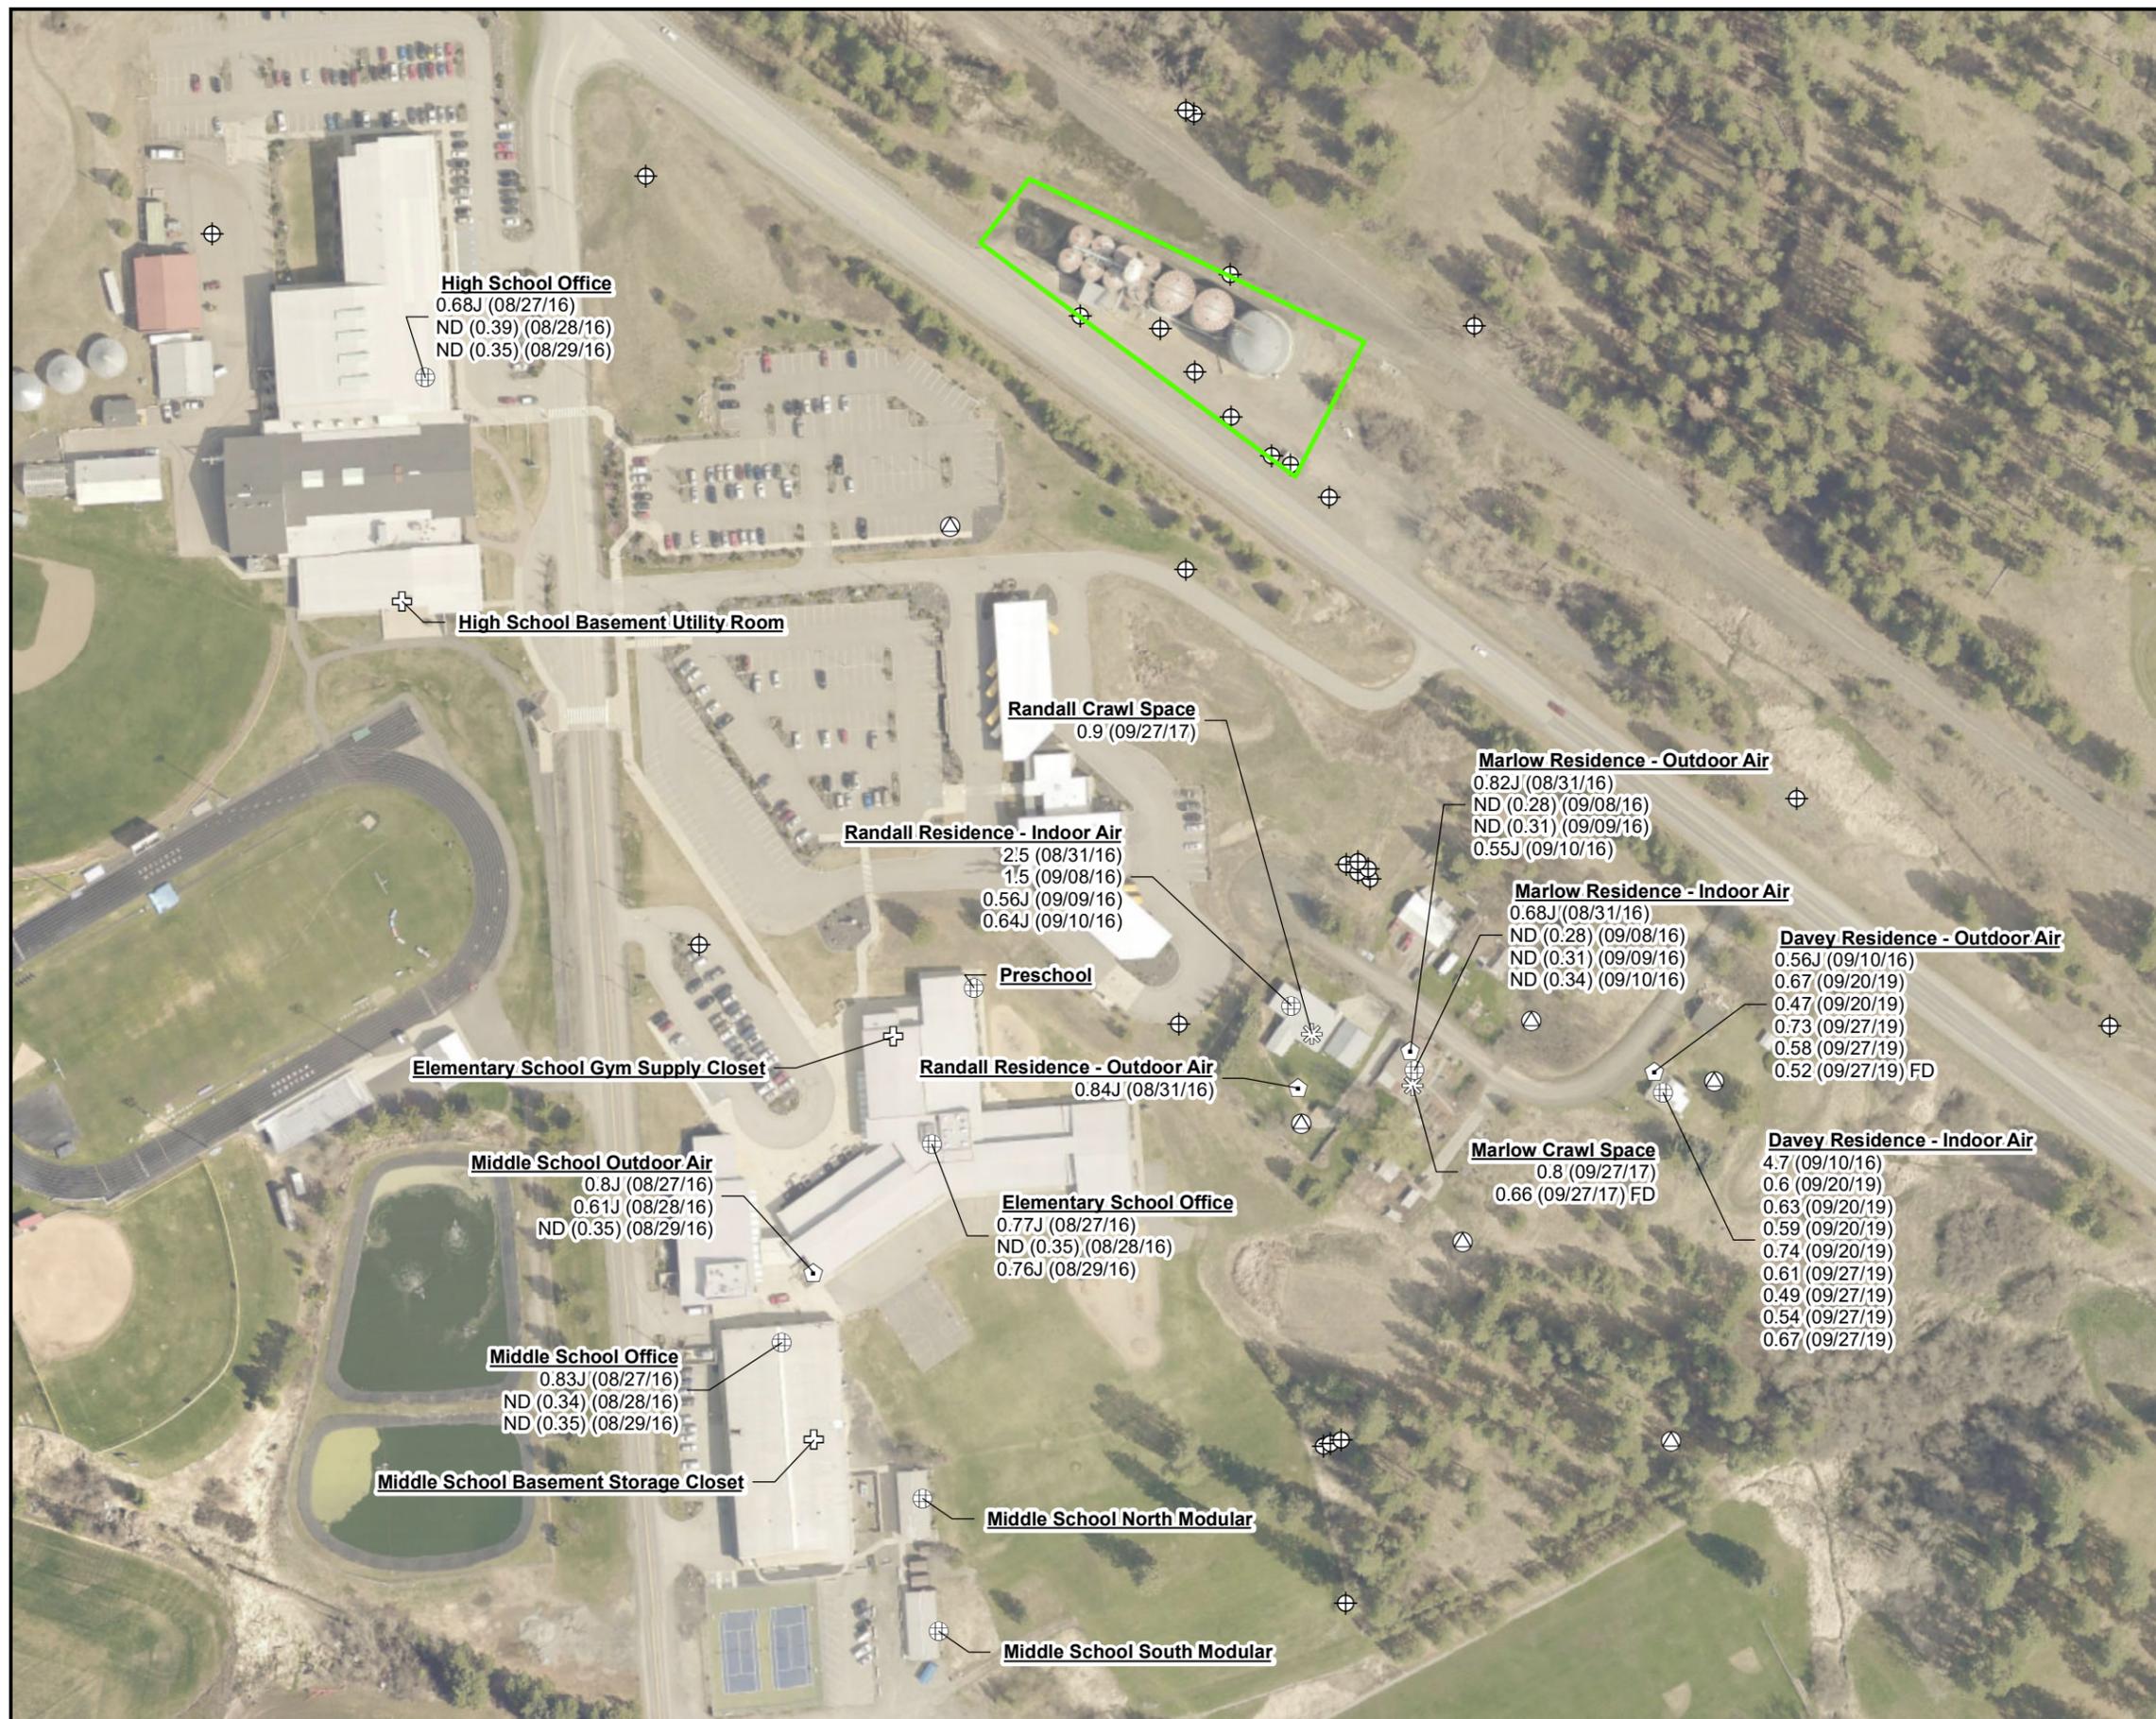
Figure H-3
Carbon Tetrachloride (CT) Concentrations in Indoor and Outdoor Air - August 2016, September 2016 and September 2019
Remedial Investigation/Feasibility Study Report
Grain Handling Facility at Freeman, Freeman, Washington

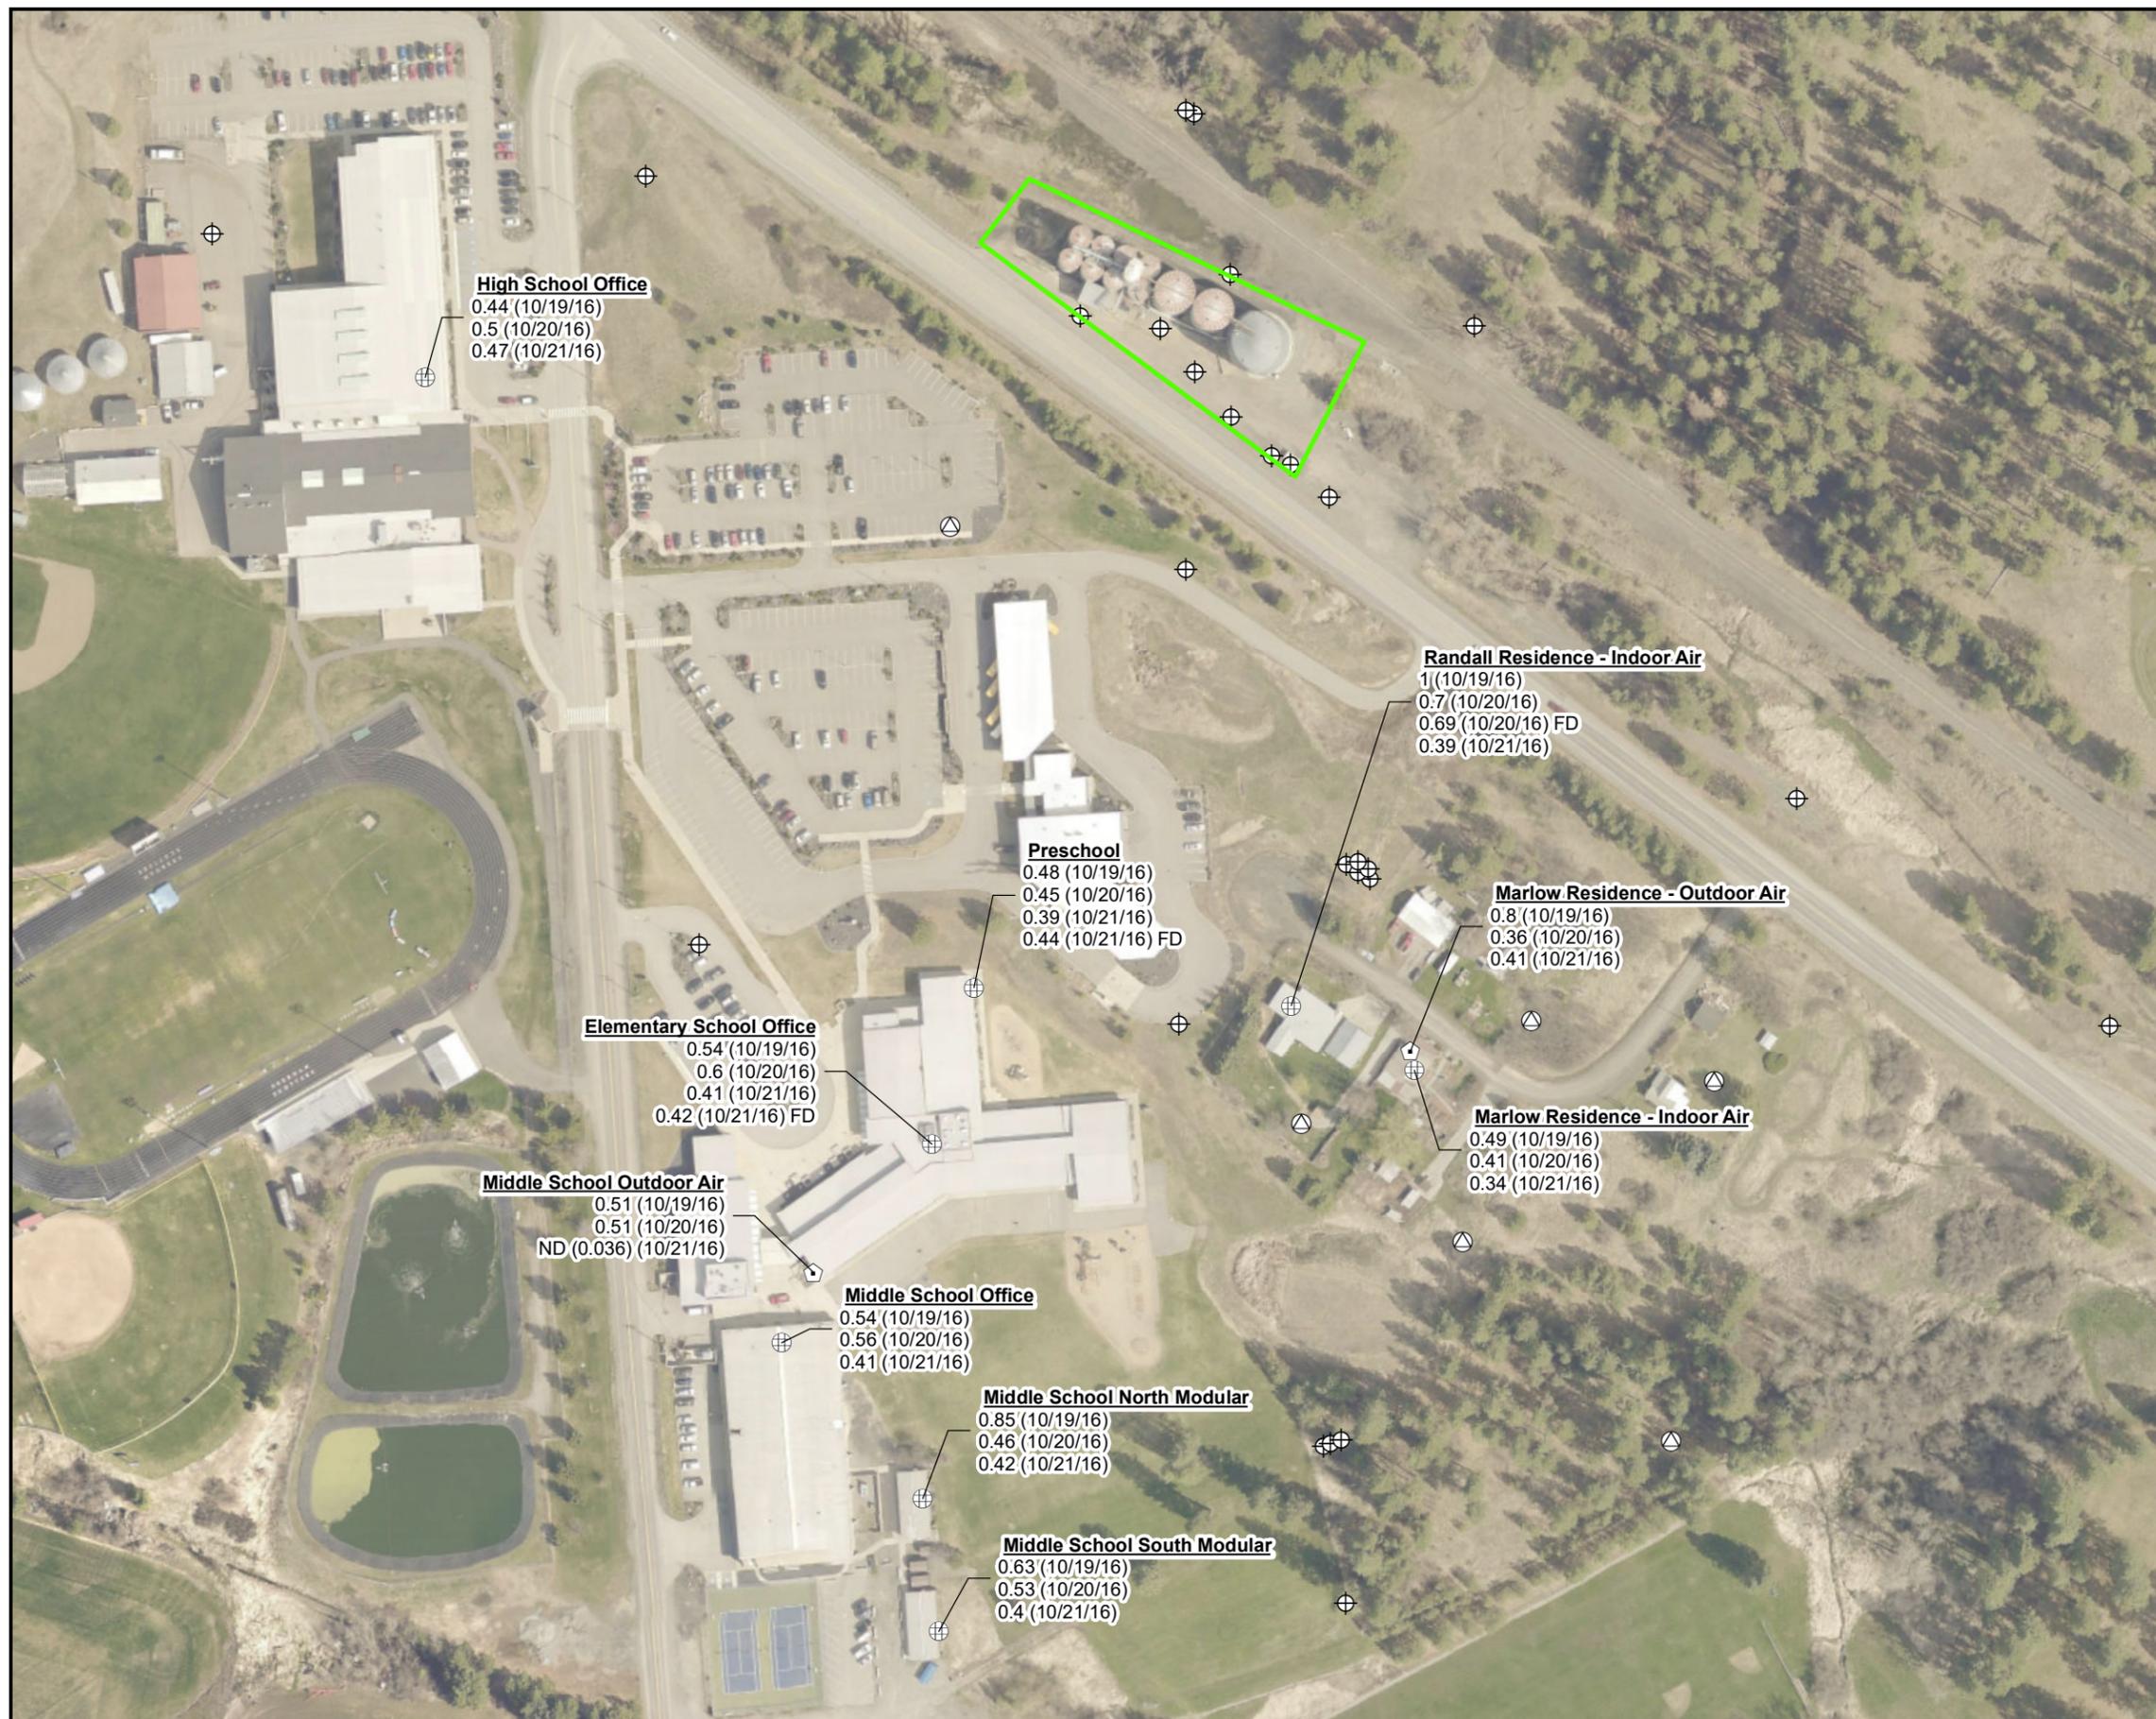
Figure H-4
Carbon Tetrachloride (CT) Concentrations in Indoor and Outdoor Air - October 2016
 Remedial Investigation/Feasibility Study Report
 Grain Handling Facility at Freeman,
 Freeman, Washington

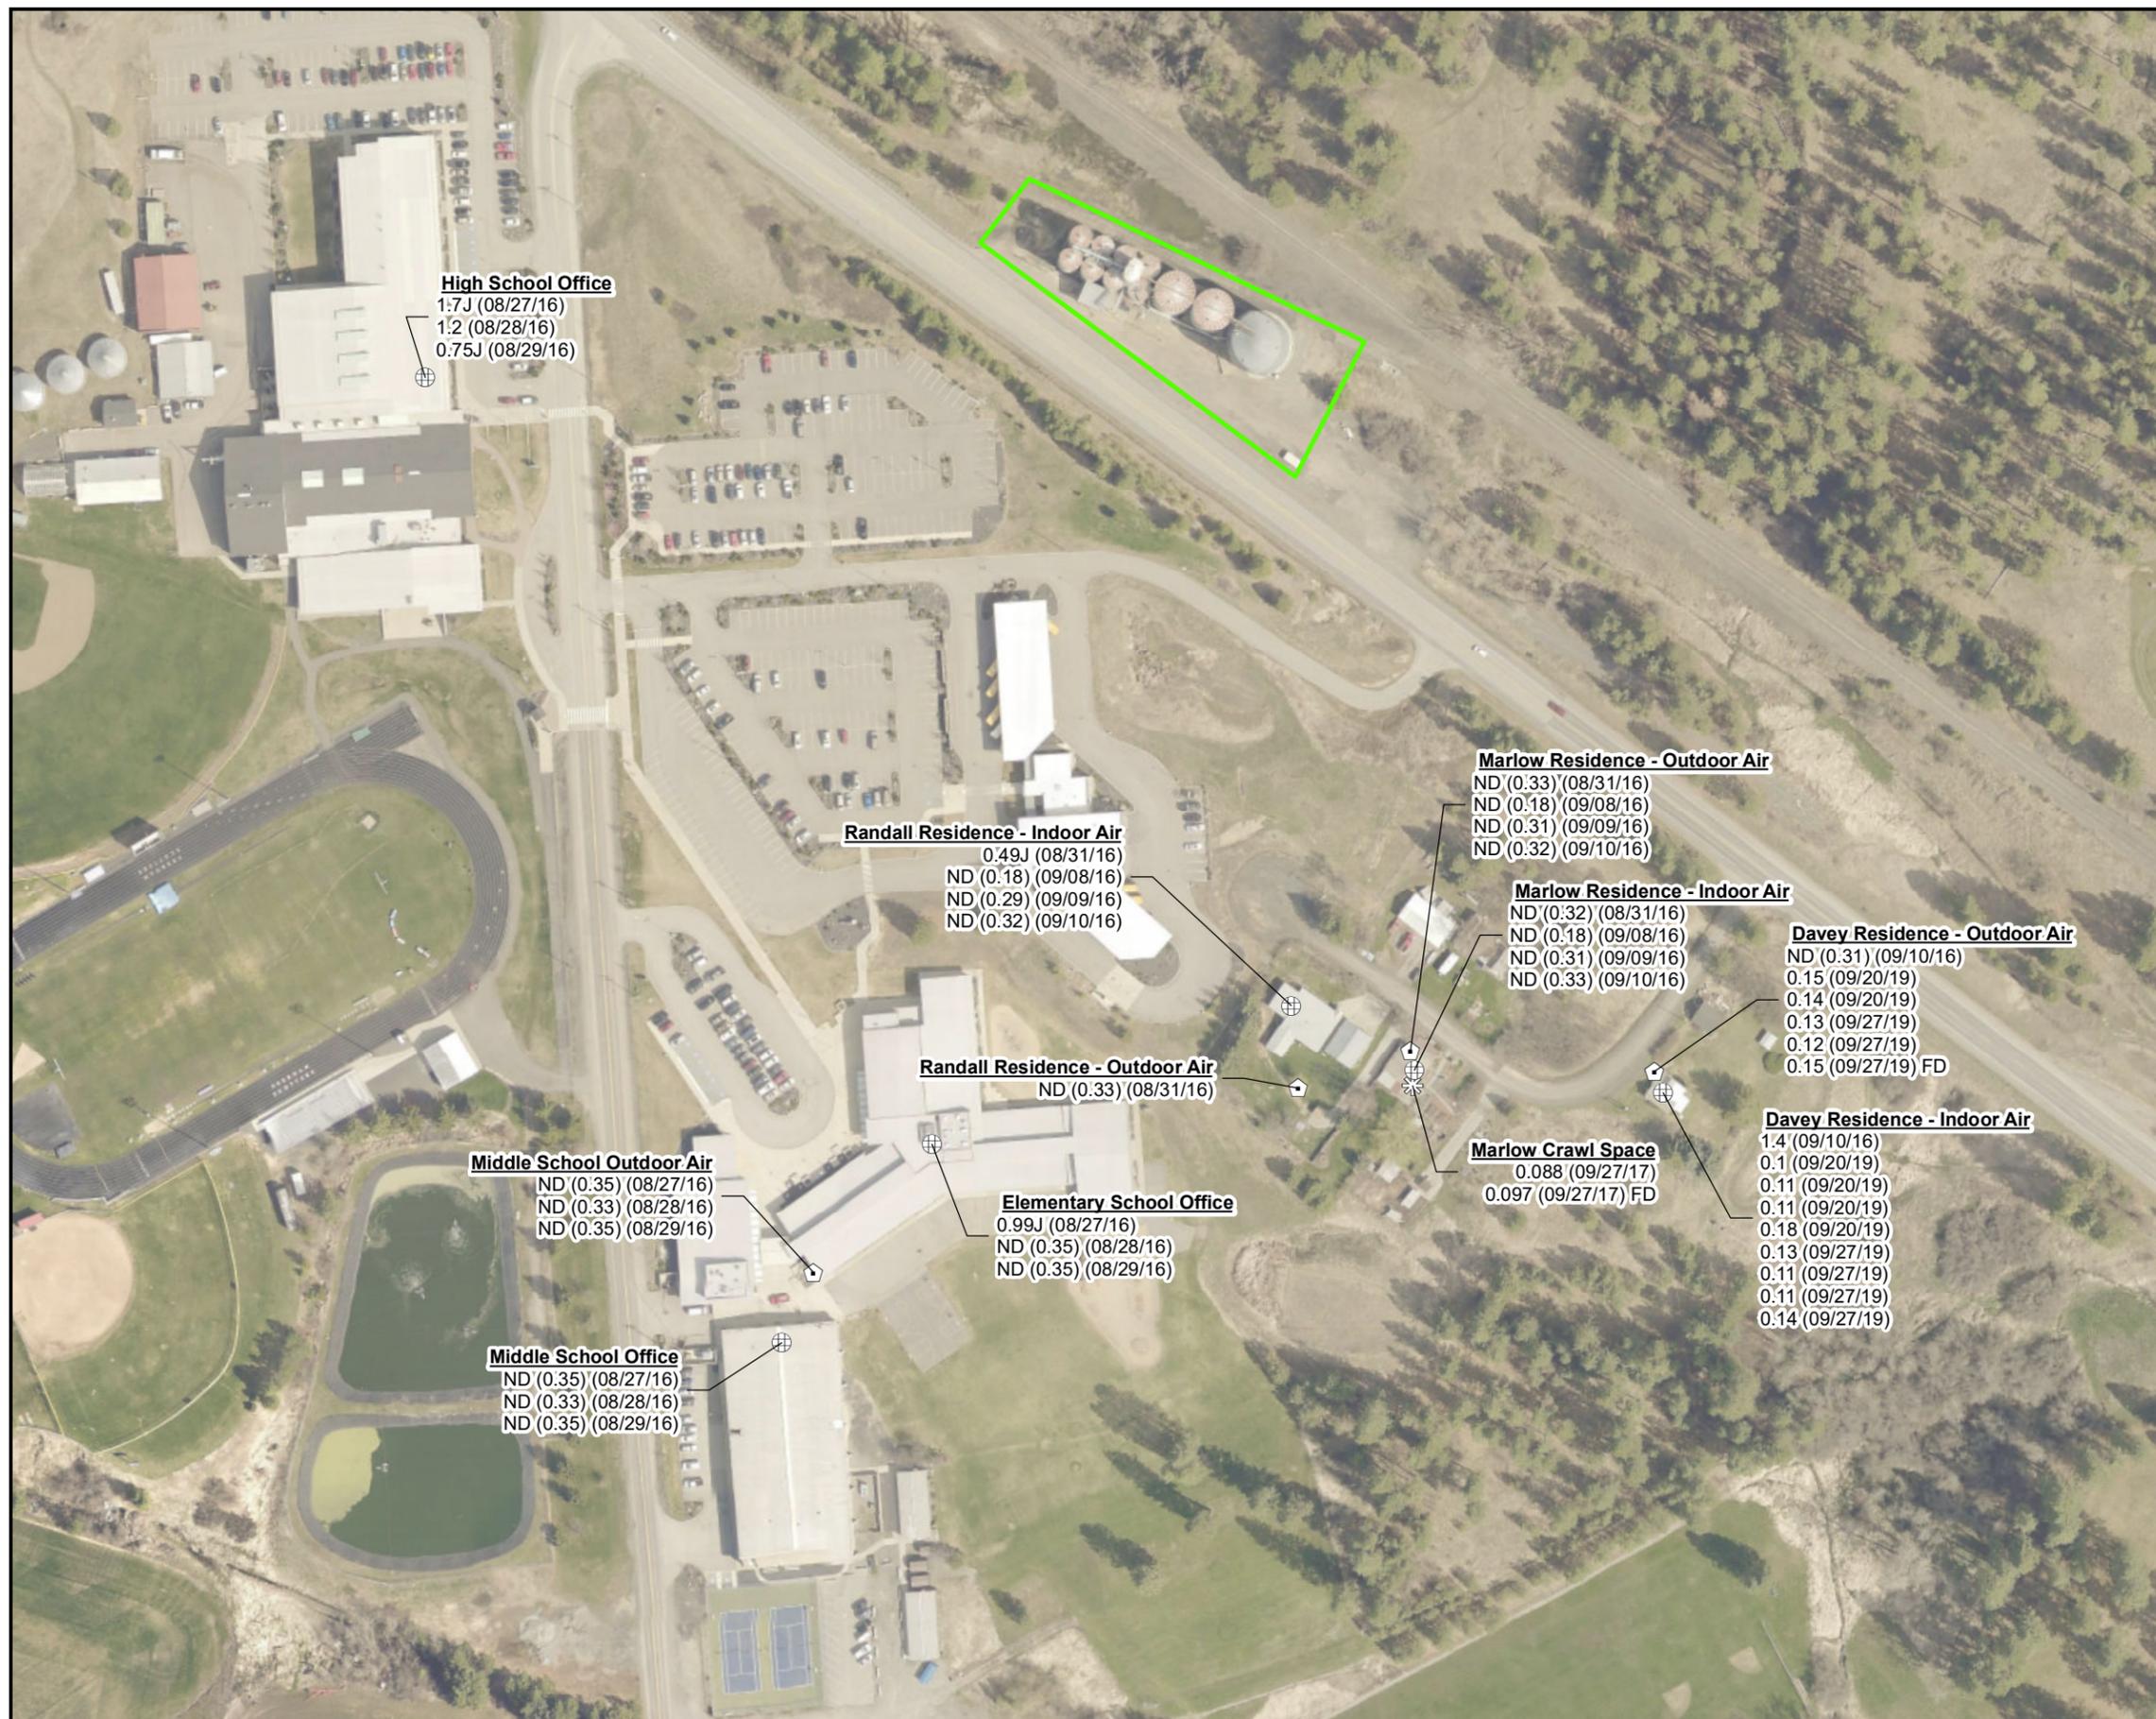
Figure H-5
Chloroform (CF) Concentrations in
Indoor and Outdoor Air - August 2016, September 2016
and September 2019
 Remedial Investigation/Feasibility Study Report
 Grain Handling Facility at Freeman,
 Freeman, Washington

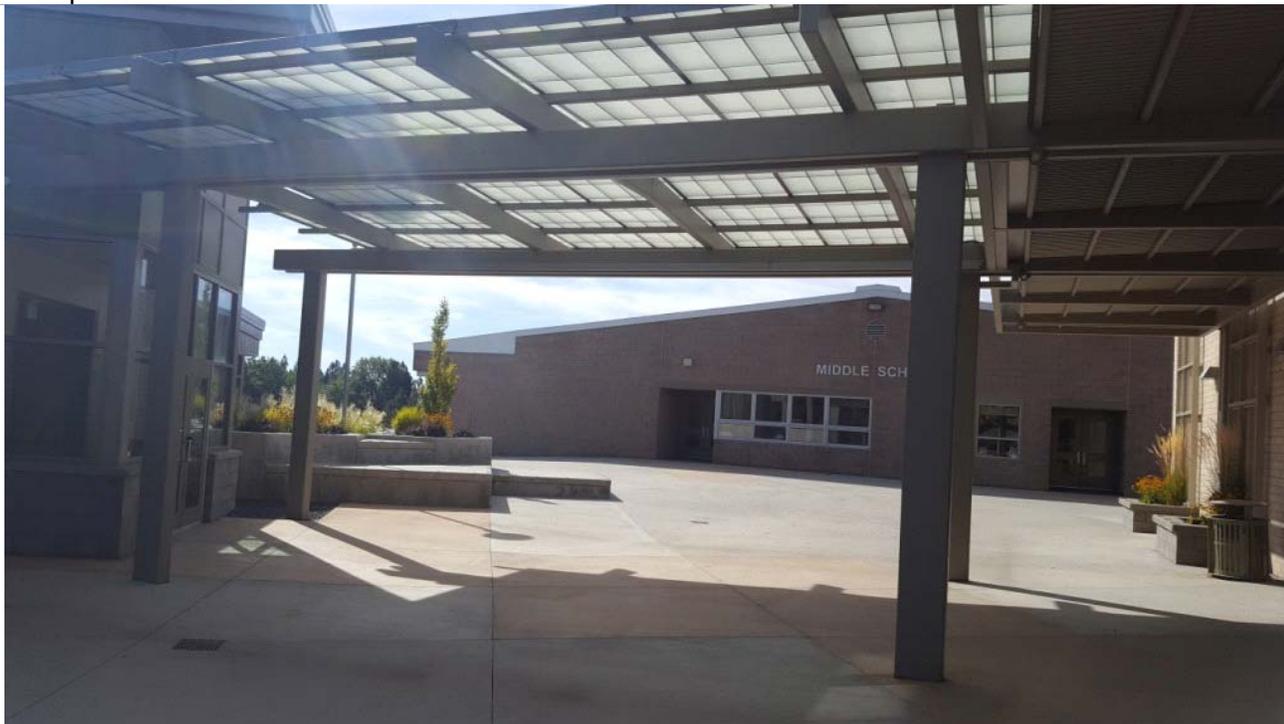
File Name:	20160828_095613	Date Taken:	8/28/2016	View Direction:	southwest
Sample Location:	Between Elementary and Middle Shools				
Comments	Summa canister sample location MS-OA1-S

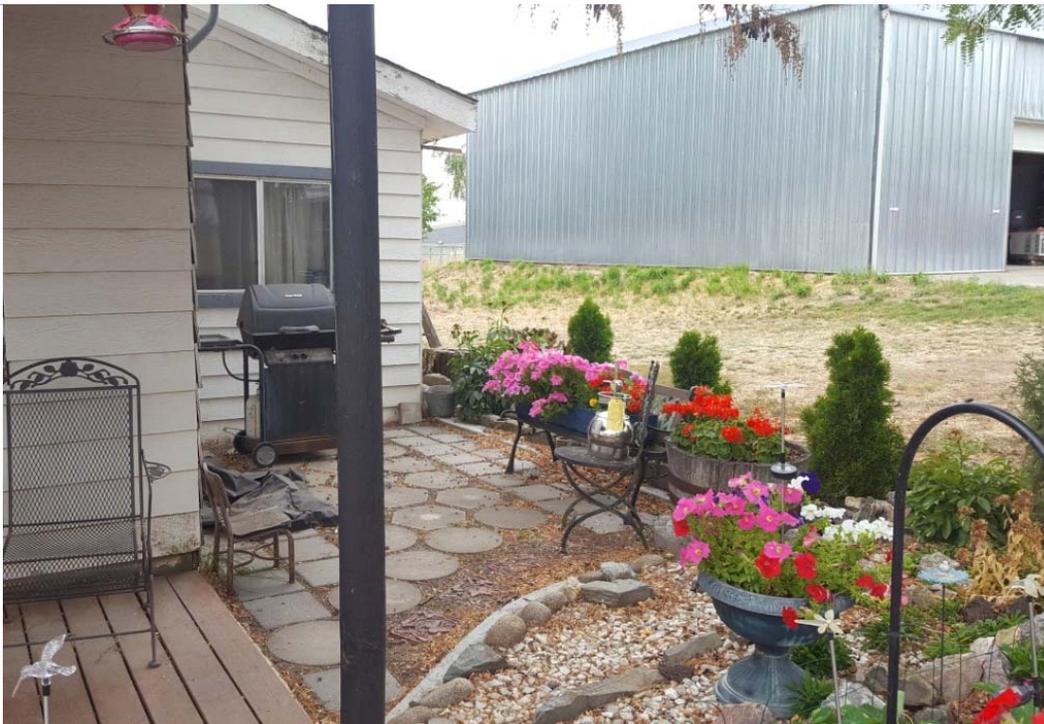
File Name:	20160830_123203	Date Taken:	8/30/2016	View Direction:	west
Sample Location:	15710 Prospect, Yard				
Comments	Summa canister sample location OA1-15710P

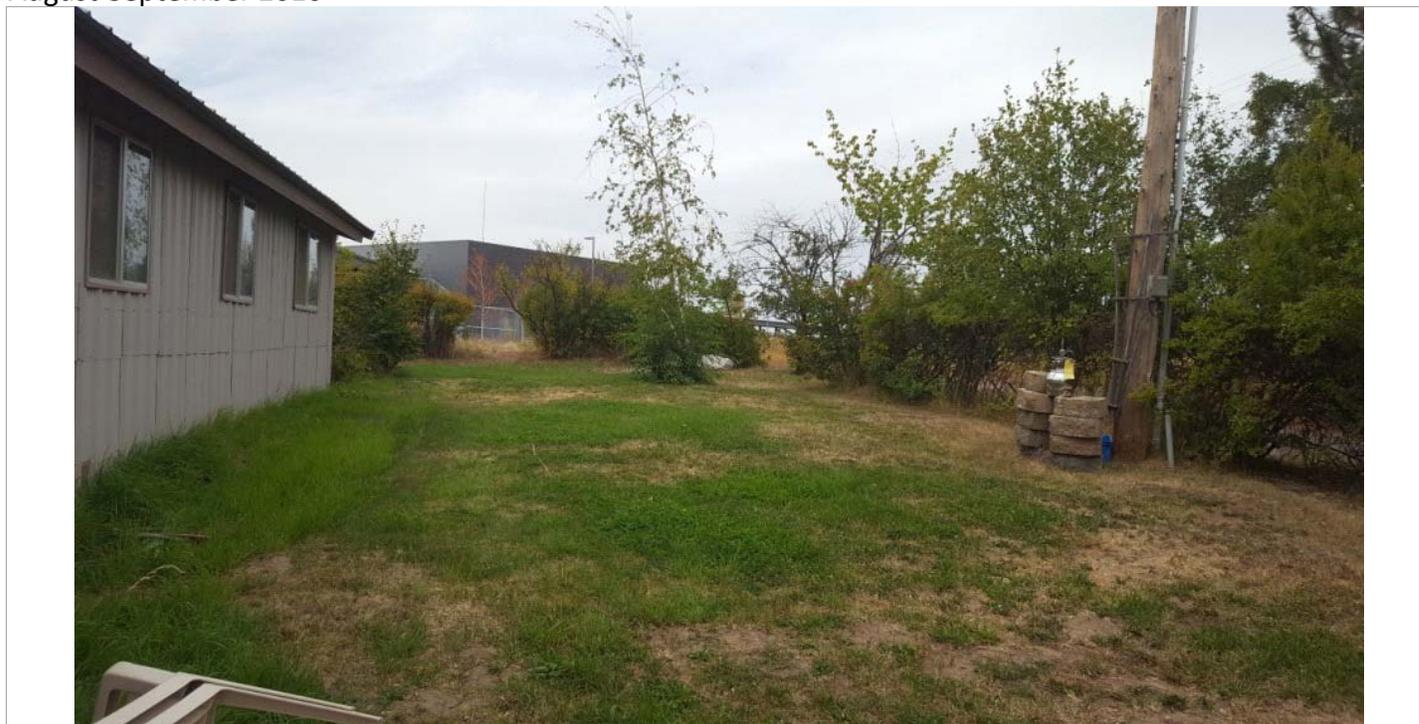
File Name:	20160830_124435	Date Taken:	8/30/2016	View Direction:	northwest
Sample Location:	15608 Prospect, Yard				
Comments	Summa canister sample location OA1-15608P

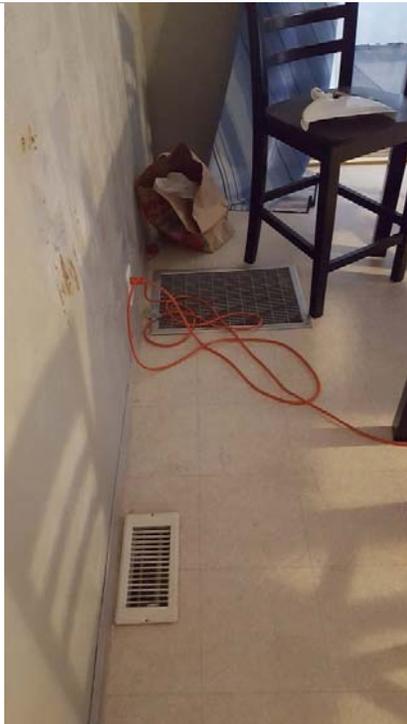
File Name:	20160907_144128	Date Taken:	9/7/2016	View Direction:	
Sample Location:	15608 Prospect, Kitchen				
Comments	Floor Vent and Return Air

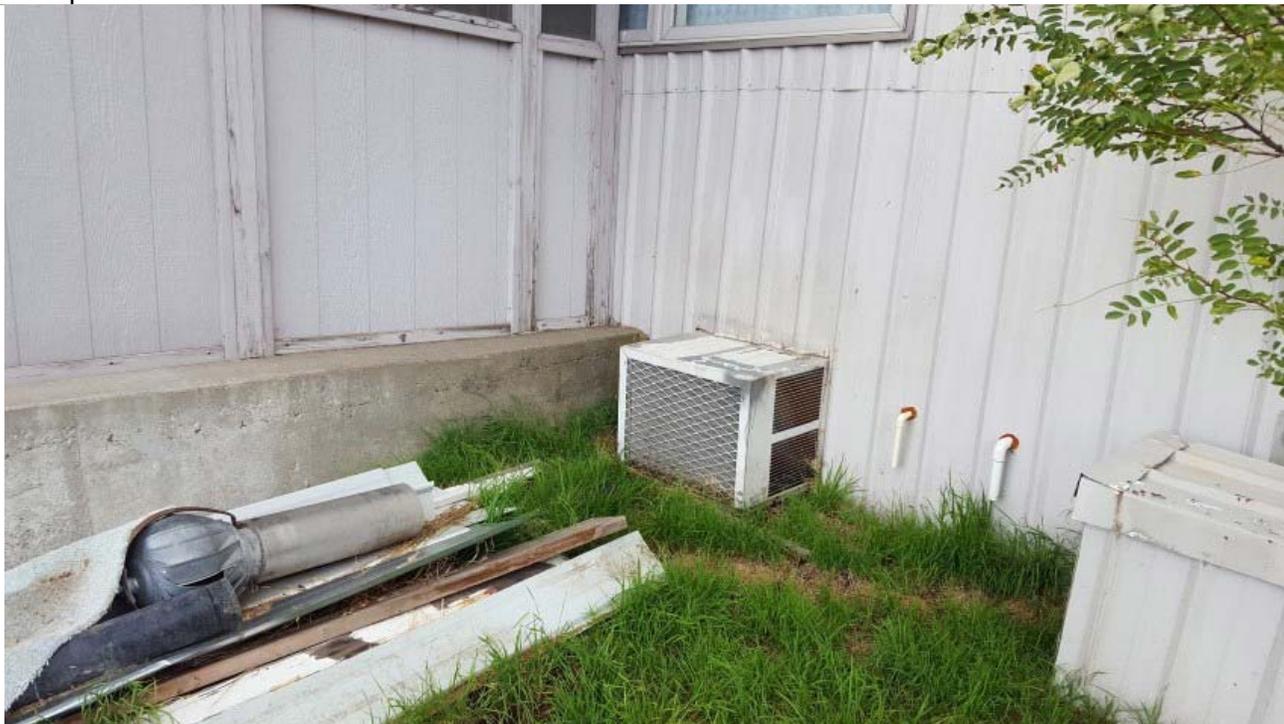
File Name:	20160907_151939	Date Taken:	9/7/2016	View Direction:	
Sample Location:	15608 Prospect, Outside Breezeway				
Comments	Crawlspace Air Mover (Not in Use)

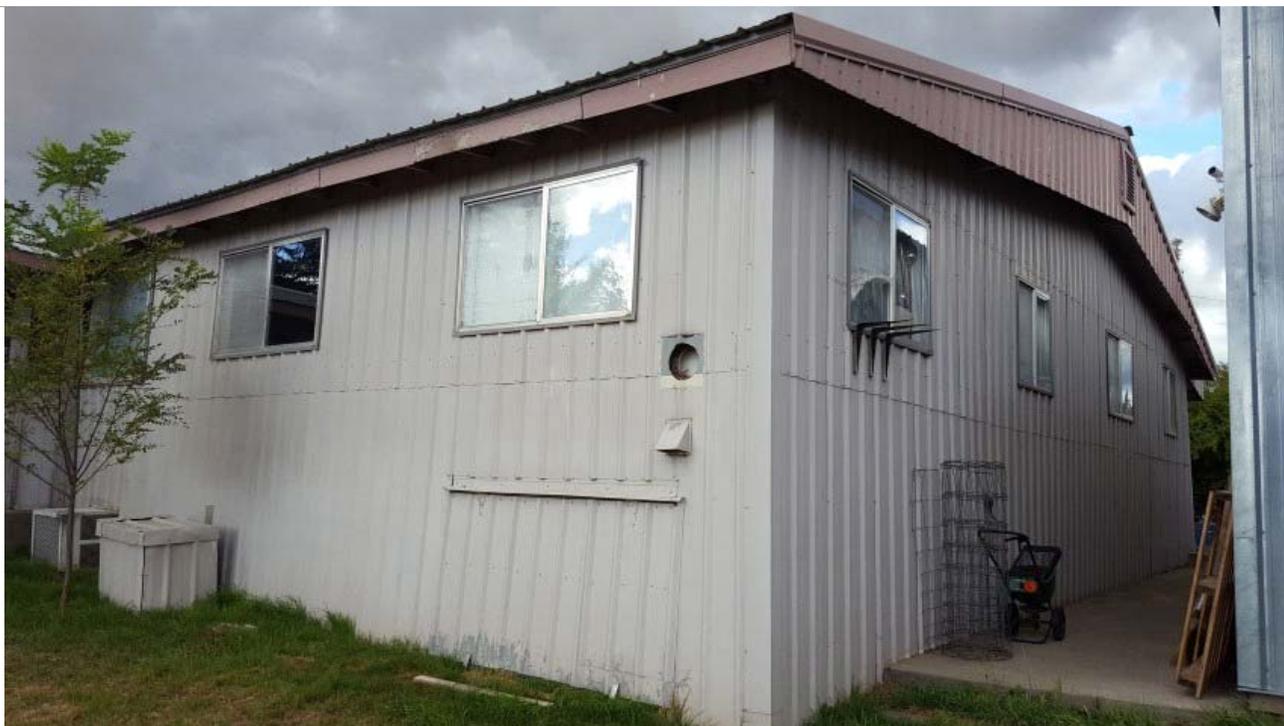
File Name:	20160907_152016	Date Taken:	9/7/2016	View Direction:	
Sample Location:	15608 Prospect, Outside Breezeway				
Comments	Crawlspace Access Door (Closed)

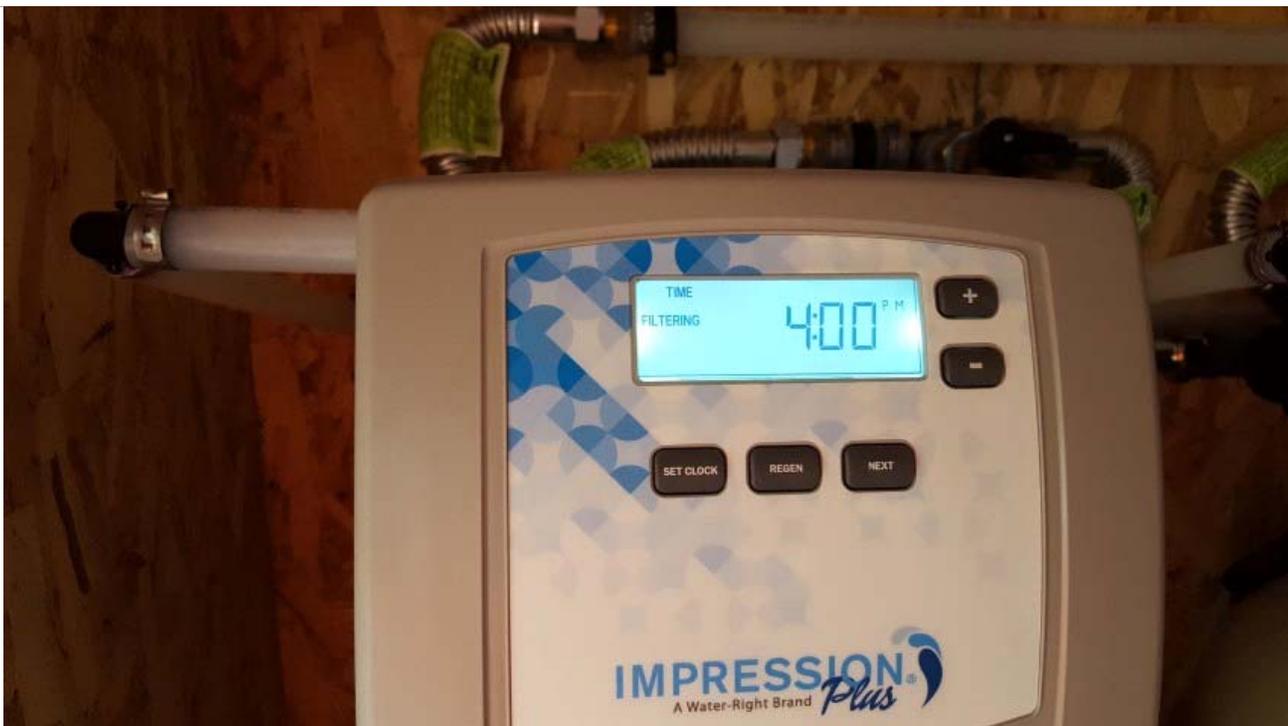
File Name:	20160907_155959	Date Taken:	9/7/2016	View Direction:	
Sample Location:	15608 Prospect, Water Treatment Shed				
Comments	Digital Panel

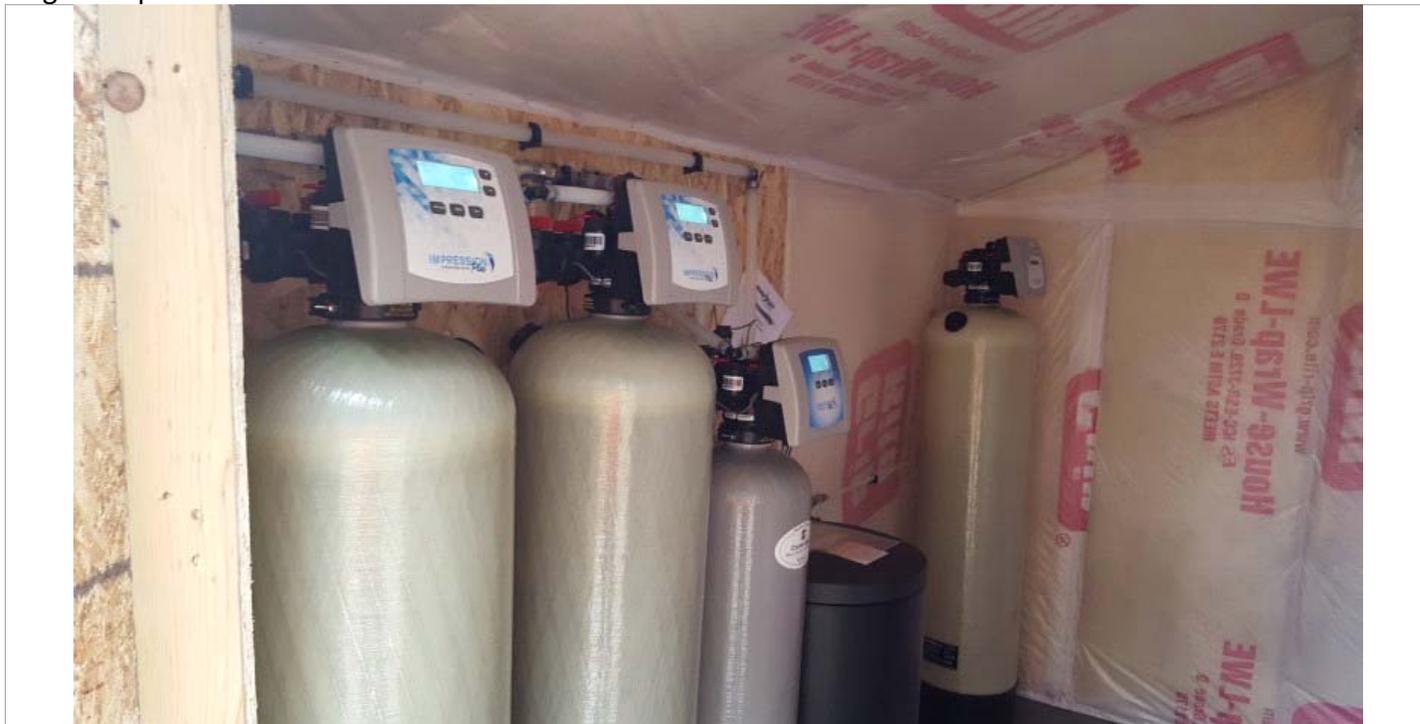
File Name:	20160907_160013	Date Taken:	9/7/2016	View Direction:	
Sample Location:	15608 Prospect, Water Treatment Shed				
Comments	Water Treatment System

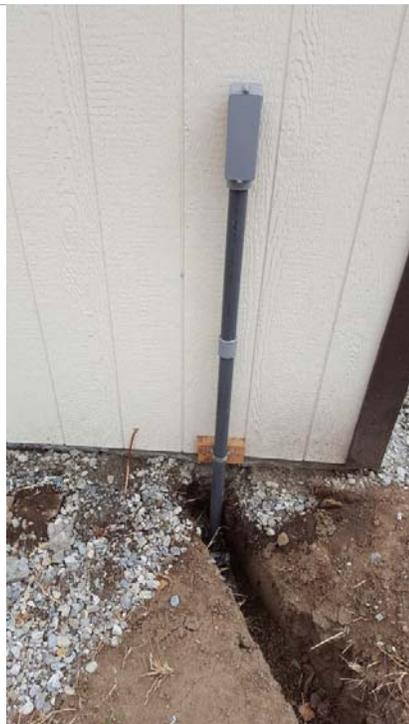
File Name:	20160907_160048	Date Taken:	9/7/2016	View Direction:	
Sample Location:	15608 Prospect, Outdoors				
Comments	Water Treatment Shed; Electrical

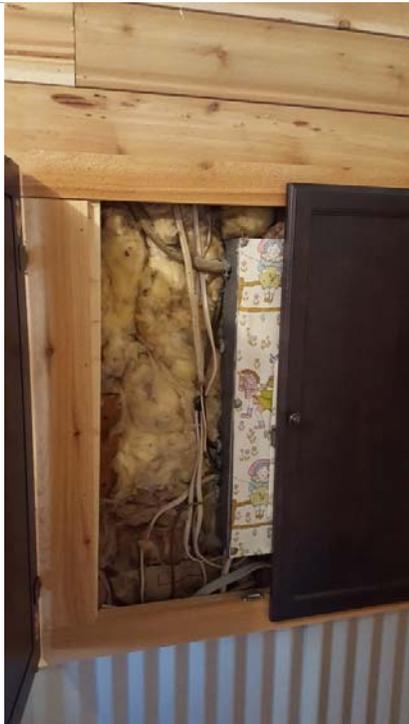
File Name:	20160907_170452	Date Taken:	9/7/2016	View Direction:	
Sample Location:	15710 Prospect, Office				
Comments	Electrical Panel Cabinet
