Appendix G
ECA Geophysics – Geophysical
Investigation Report, UPRR GHFF and the
Freeman School District Complex

Geophysical Investigation Report

UPRR GHF and the FSD Complex

Freeman, Washington

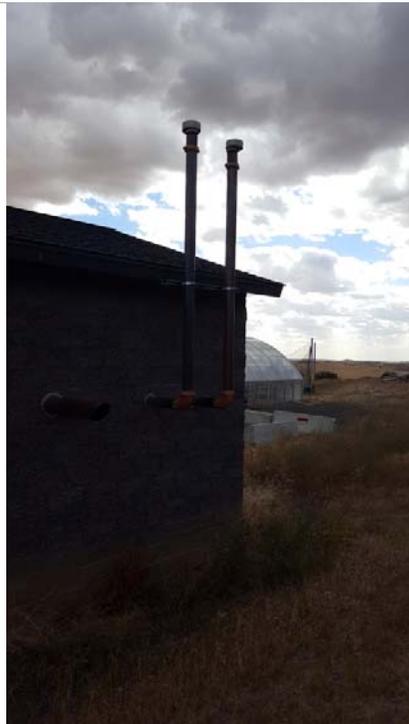
File Name:	20160907_154555	Date Taken:	9/8/2016	View Direction:	
Sample Location:	School				
Comments	Air Sparge System Building

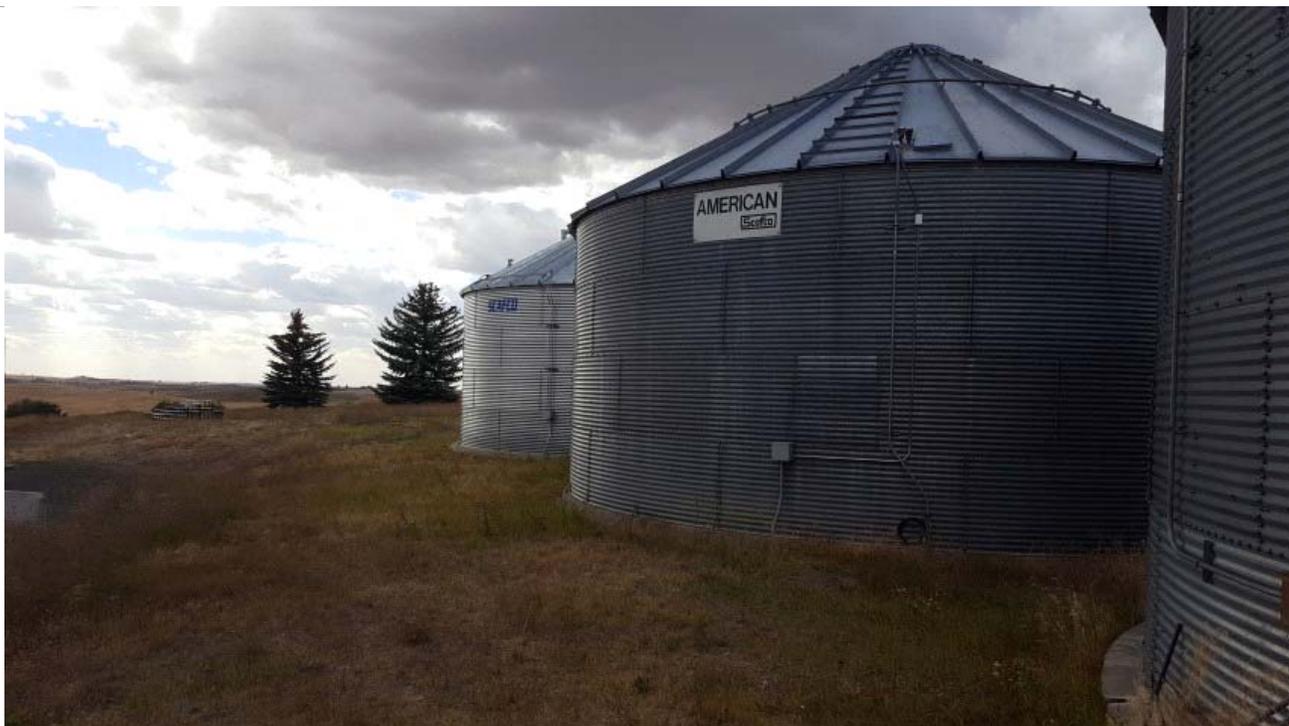
File Name:	20160907_154559	Date Taken:	9/8/2016	View Direction:	
Sample Location:	School				
Comments	Water Holding Tanks

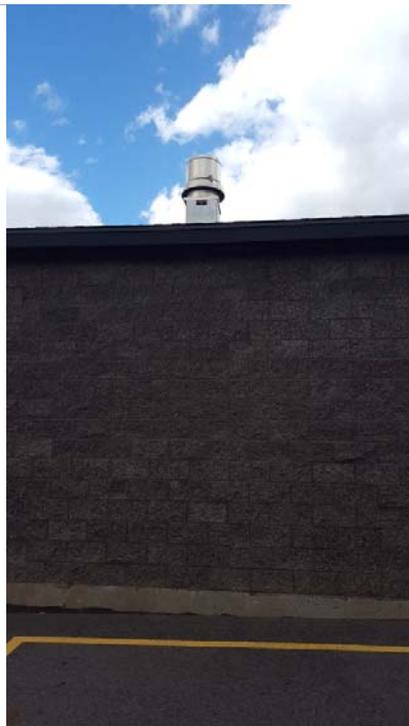
File Name:	20160907_154700	Date Taken:	9/8/2016	View Direction:	
Sample Location:	School				
Comments	Air Sparge System Building Effluent Stack

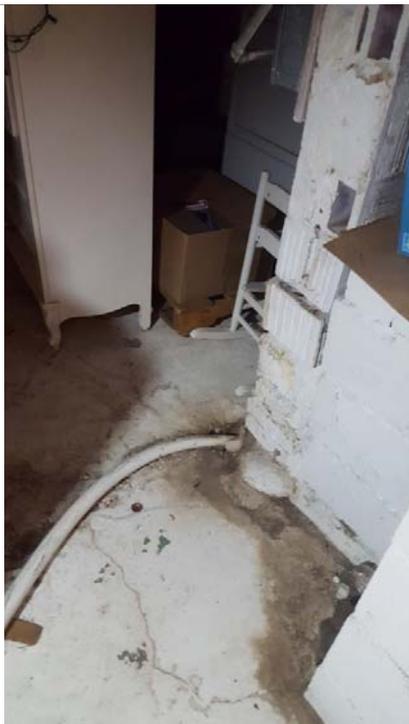
File Name:	20160907_161756	Date Taken:	9/9/2016	View Direction:	
Sample Location:	15809 Prospect, Partial Basement				
Comments	Sink Drain Pipe Run

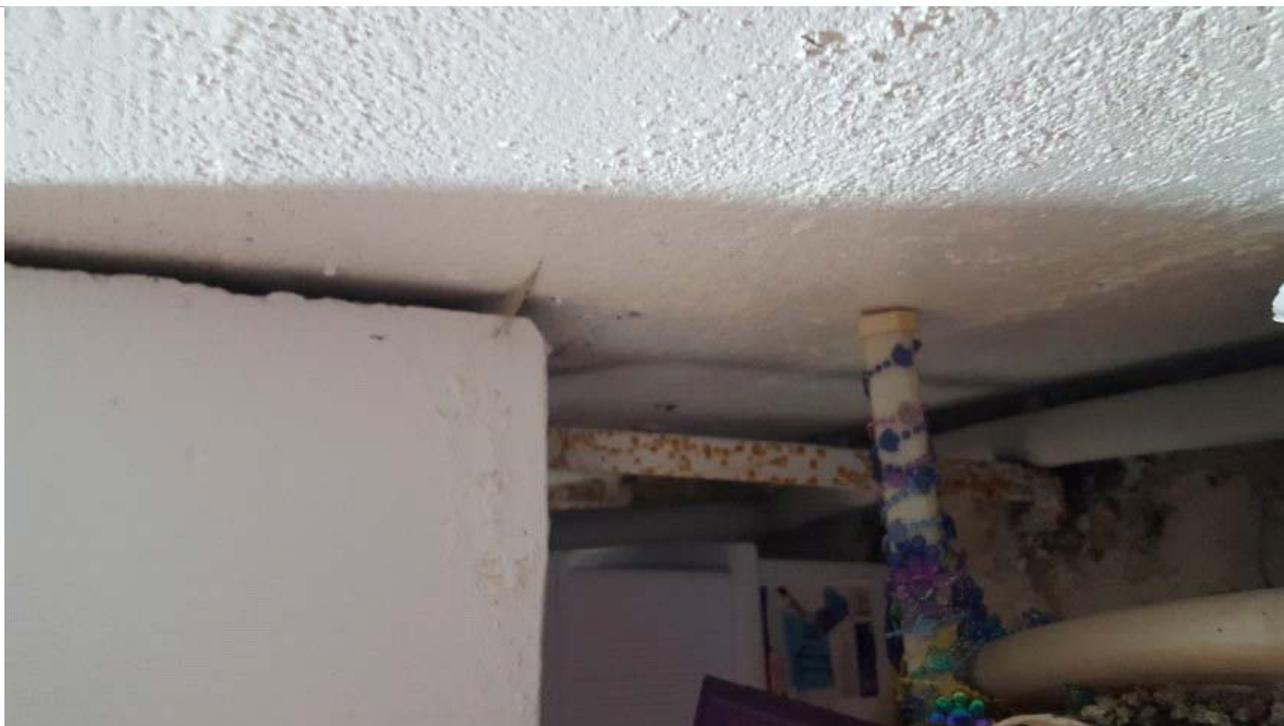
File Name:	20160907_161800	Date Taken:	9/9/2016	View Direction:	
Sample Location:	15809 Prospect, Partial Basement				
Comments	Sink Drain Pipe Run

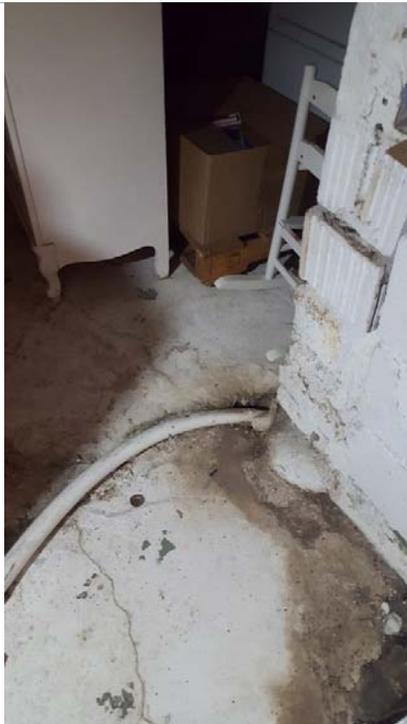
File Name:	20160907_161806	Date Taken:	9/9/2016	View Direction:	
Sample Location:	15809 Prospect, Partial Basement				
Comments	Sink Drain Pipe Run

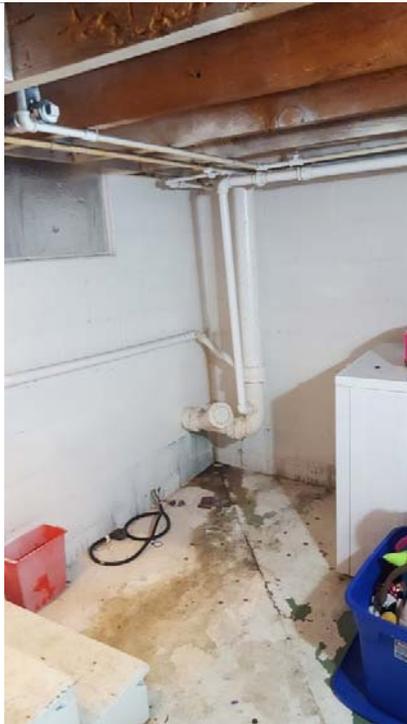
File Name:	20160907_161816	Date Taken:	9/9/2016	View Direction:	
Sample Location:	15809 Prospect, Partial Basement				
Comments	Water Piping

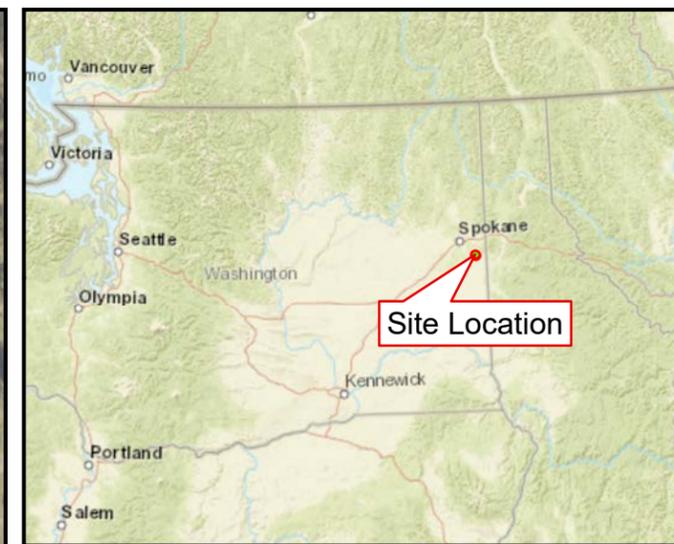
Figure 2-1
Interim Remedial Action Site Features and Proposed Infrastructure
Second Revised Interim Remedial Action Work Plan
Grain Handling Facility at Freeman,
Freeman, Washington

- ⊕ Monitoring Well
 - ⊗ Domestic Well
 - ▭ Grain Handling Facility at Freeman
 - ▭ Freeman School District
 - ◆ Proposed Treatment Plant
 - Proposed Injection Well
 - Proposed Extraction Well
 - Proposed Injection Pipeline
 - Proposed Extraction Pipeline
 - Cross Section Alignment (See Figure 2-2)
 - ➔ Typical Groundwater Recirculation Flow Lines
- Carbon Tetrachloride Concentration (Basalt Aquifer)**
- 10 ug/L
 - 100 ug/L
 - 400 ug/L

Refer to Figures 2-1 and 2-2 of *Third Revised Interim Remedial Action Work Plan, Grain Handling Facility at Freeman, Freeman, Washington, January 2020* for plume dimensions assuming active flushing of plume with carbon tetrachloride concentration greater than 1 ug/L; dilute plume with carbon tetrachloride concentration <1 ug/L will be reduced to below 0.63 ug/L over time due to volatilization, adsorption and mixing.

(10) Initial contaminant concentration is the estimated average concentration within the zone of active flushing (recirculation) based on available site data as shown on Figures 2-1 and 2-2 in the *Third Revised Interim Remedial Action Work Plan, Grain Handling Facility at Freeman, Freeman, Washington, January 2020*
