# Midway Metals Stormwater Sampling and Analyses

Final Report

September 2020

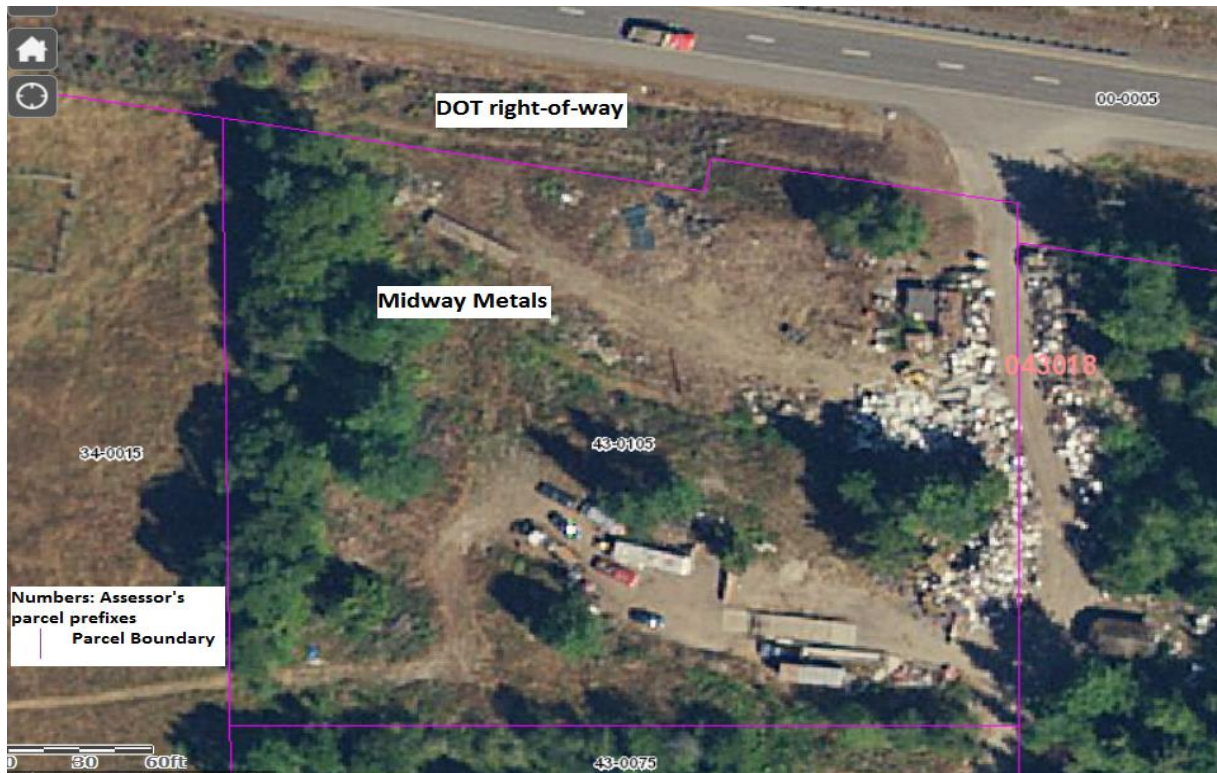
Figure 1: Study Area

Figure 1 is an aerial photograph delineating parcels in the study area. Midway Metals is in the center of the image (#43-0105). McDonald Creek, not in the image, is downstream (east) of the property.
