Industrial Properties Inc
NWRO
#661138

**RE: Underground Storage Tank Closure Report
 Industrial and Transfer and Storage Co., Inc.
 2450 6th Avenue South
 Seattle, Washington 98134
 Ecology Site ID # 001130**

Mr. Greg Wellington of LJ Melody & Company retained Clayton Group Services, Inc. (Clayton) to conduct a Phase I Environmental Site Assessment (assessment) of the Industrial Transfer Warehouse and Storage Yard, 2450 6th Avenue South, Seattle, Washington (the "subject property"). The objective of the assessment was to provide an independent, professional opinion regarding recognized environmental conditions, as defined by ASTM, associated with the subject property. This assessment was requested in association with a loan.

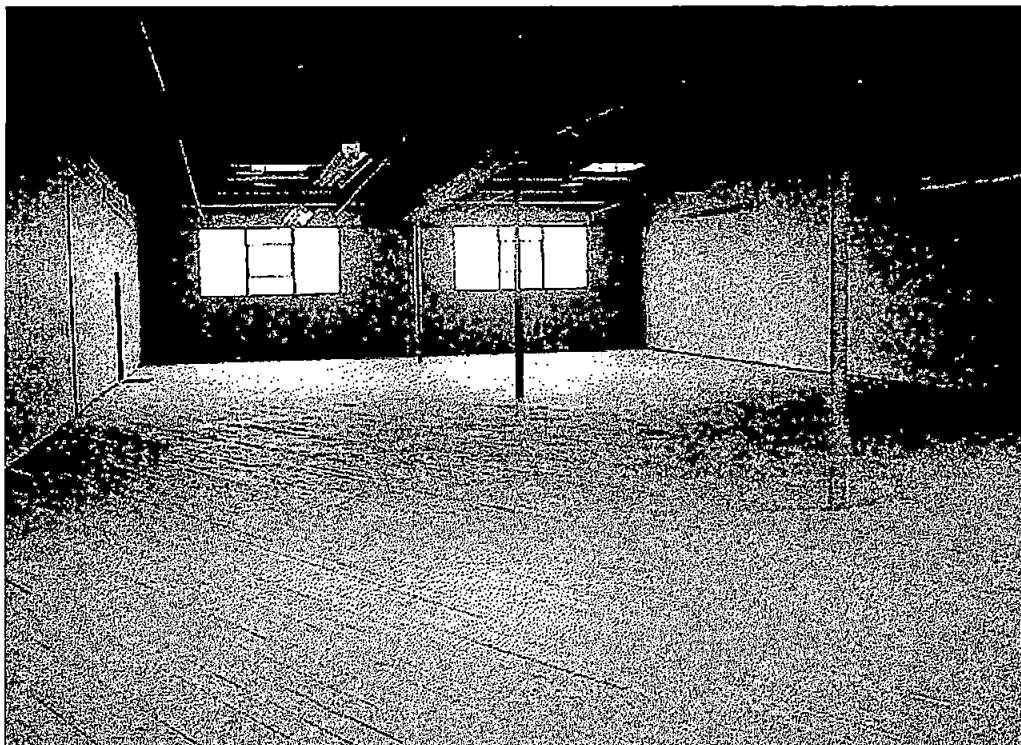
Subject	Typical warehouse space in Warehouse M	Clayton Project No. 75-02042	5
Site	2450 6th Avenue South		Date
Client	LJ Melody		22 Aug 2001
