Subject: Love's 413 Ellensburg Spill Assessment

Robinson Noble, Inc. is pleased to present this letter report documenting the limited subsurface investigation conducted at the subject property. Robinson Noble was contracted by Love's Travel Stops and Country Stores (Love's) to complete a limited subsurface investigation at the Love's Travel Stop #413 located at 1512 US-97 in Ellensburg, Washington. This letter report documents the limited subsurface investigation that was completed in August 2018 and a subsequent groundwater monitoring event completed in 2019.

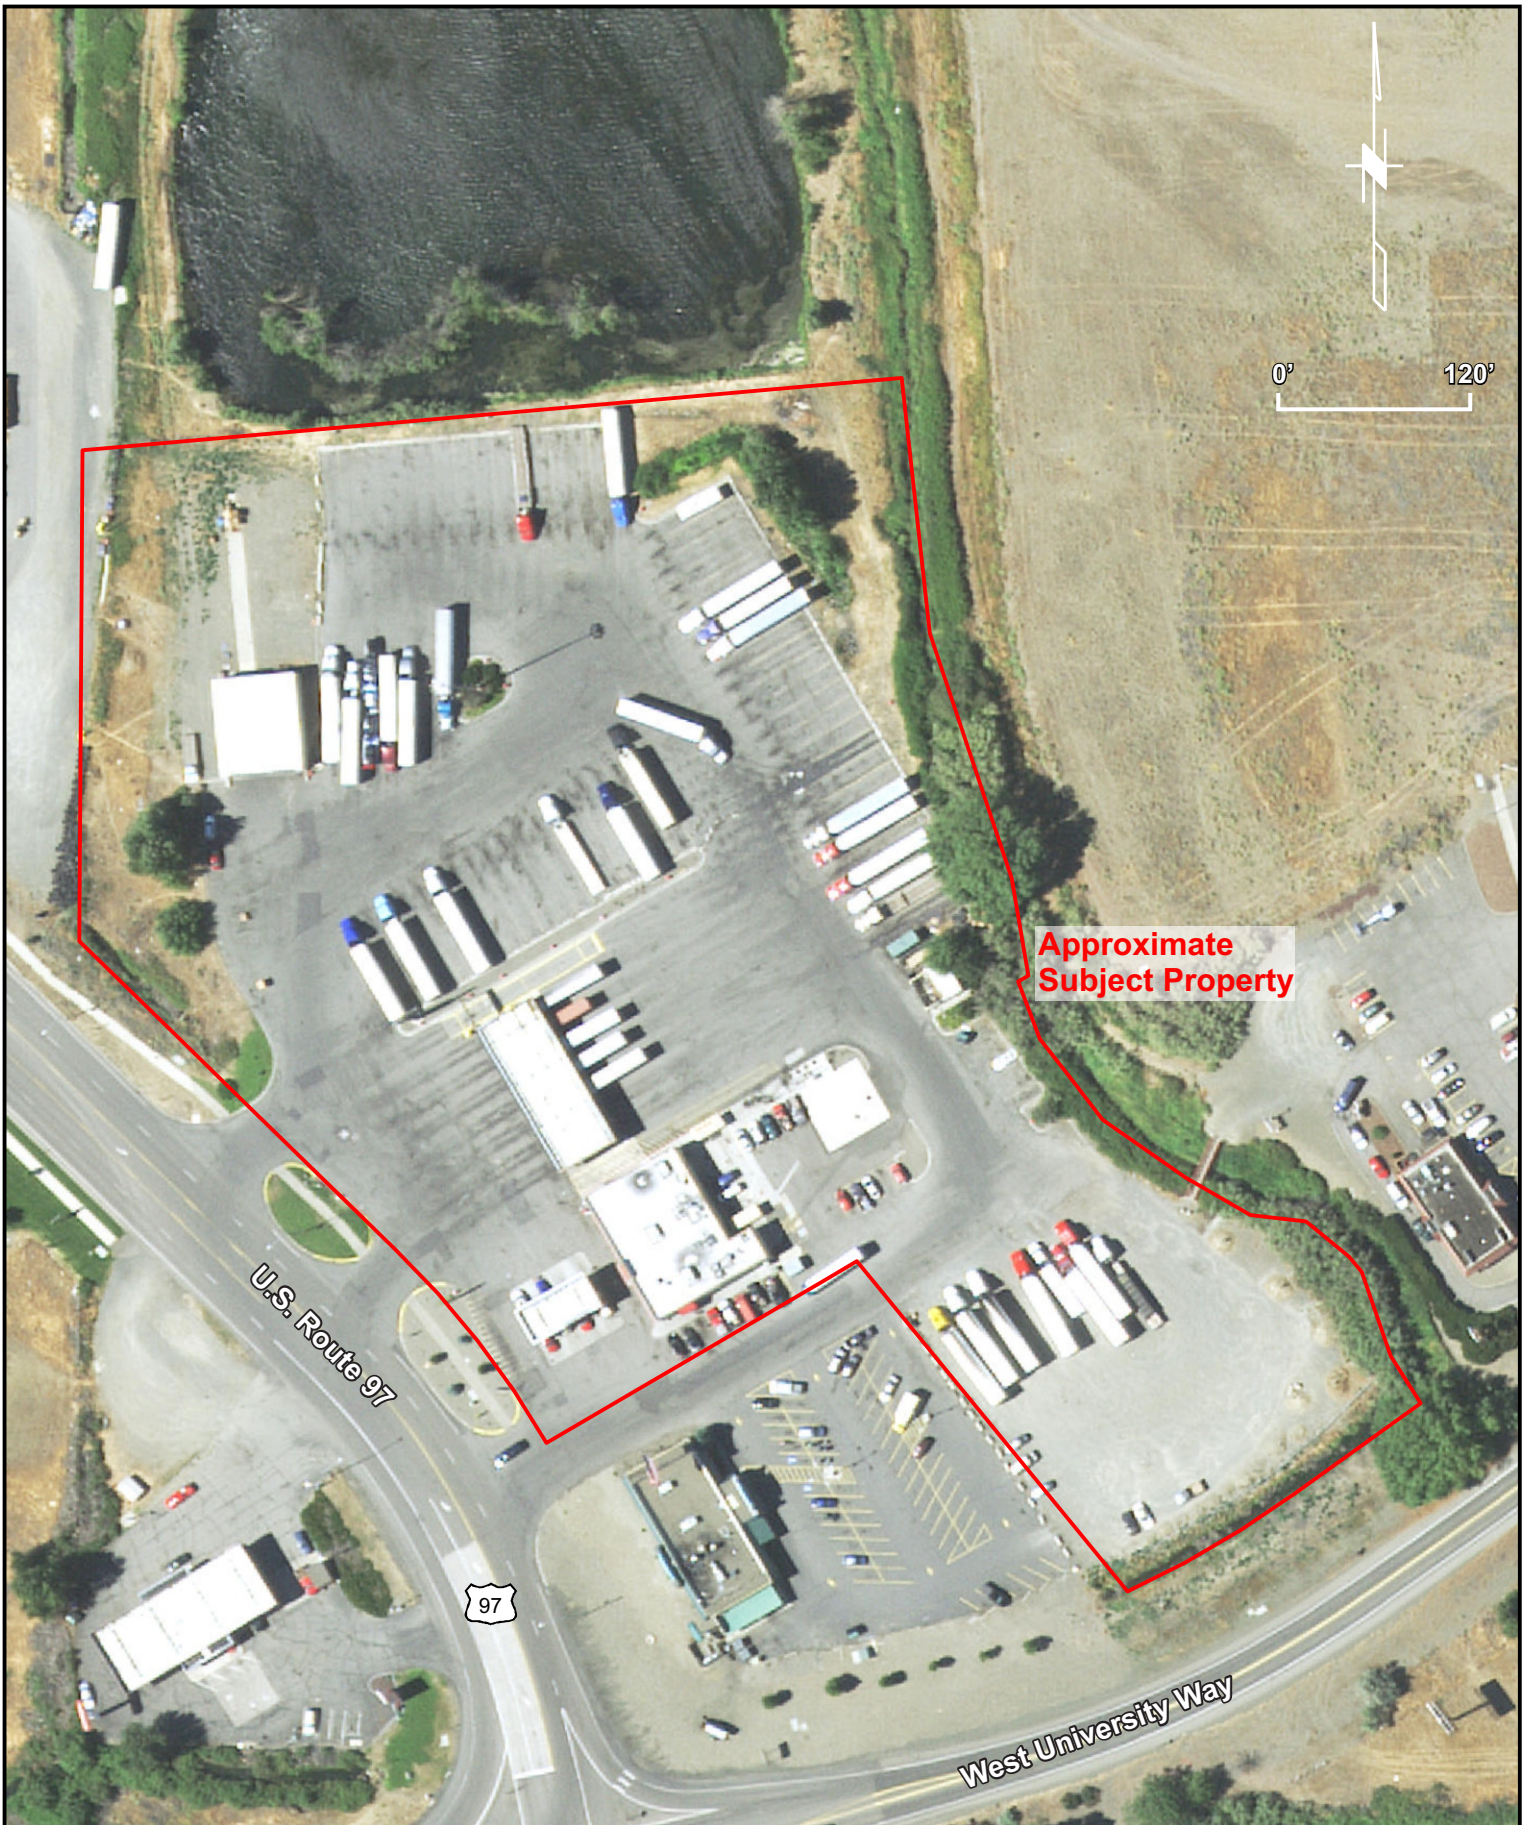
Figure 2
Aerial Map of Site

Approximate Subject Property

U.S. Route 97

West University Way

The subject property is comprised of one parcel identified by Kittitas County records as parcel number 376133. The address assigned to the property is 1512 US-97, Ellensburg, Washington. A general vicinity map is provided as Figure 1 in Appendix A. An aerial map of the subject site is presented as Figure 2 in Appendix A.
