# **UNDERGROUND STORAGE TANK INVESTIGATION REPORT**

**RICHLAND UPTOWN SHOPPING CENTER**

**Parcel 10**

**1364 Jadwin Avenue**

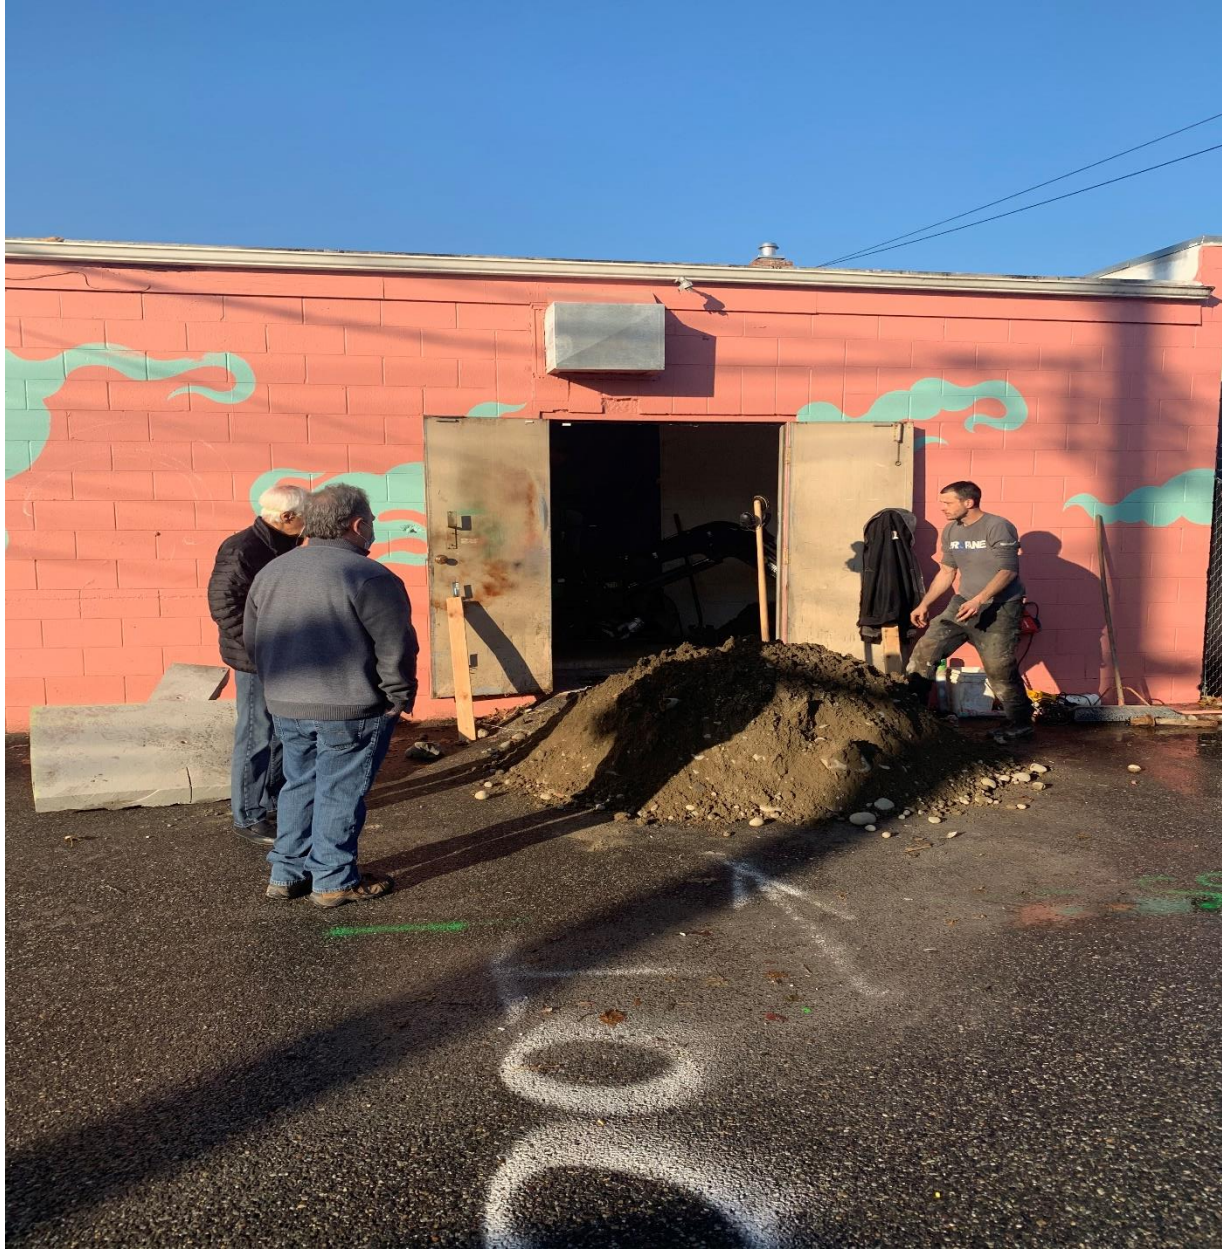
**Photograph 1 – Soil excavated from heating oil tank (HOT) excavation on November 11, 2020 (facing west).**

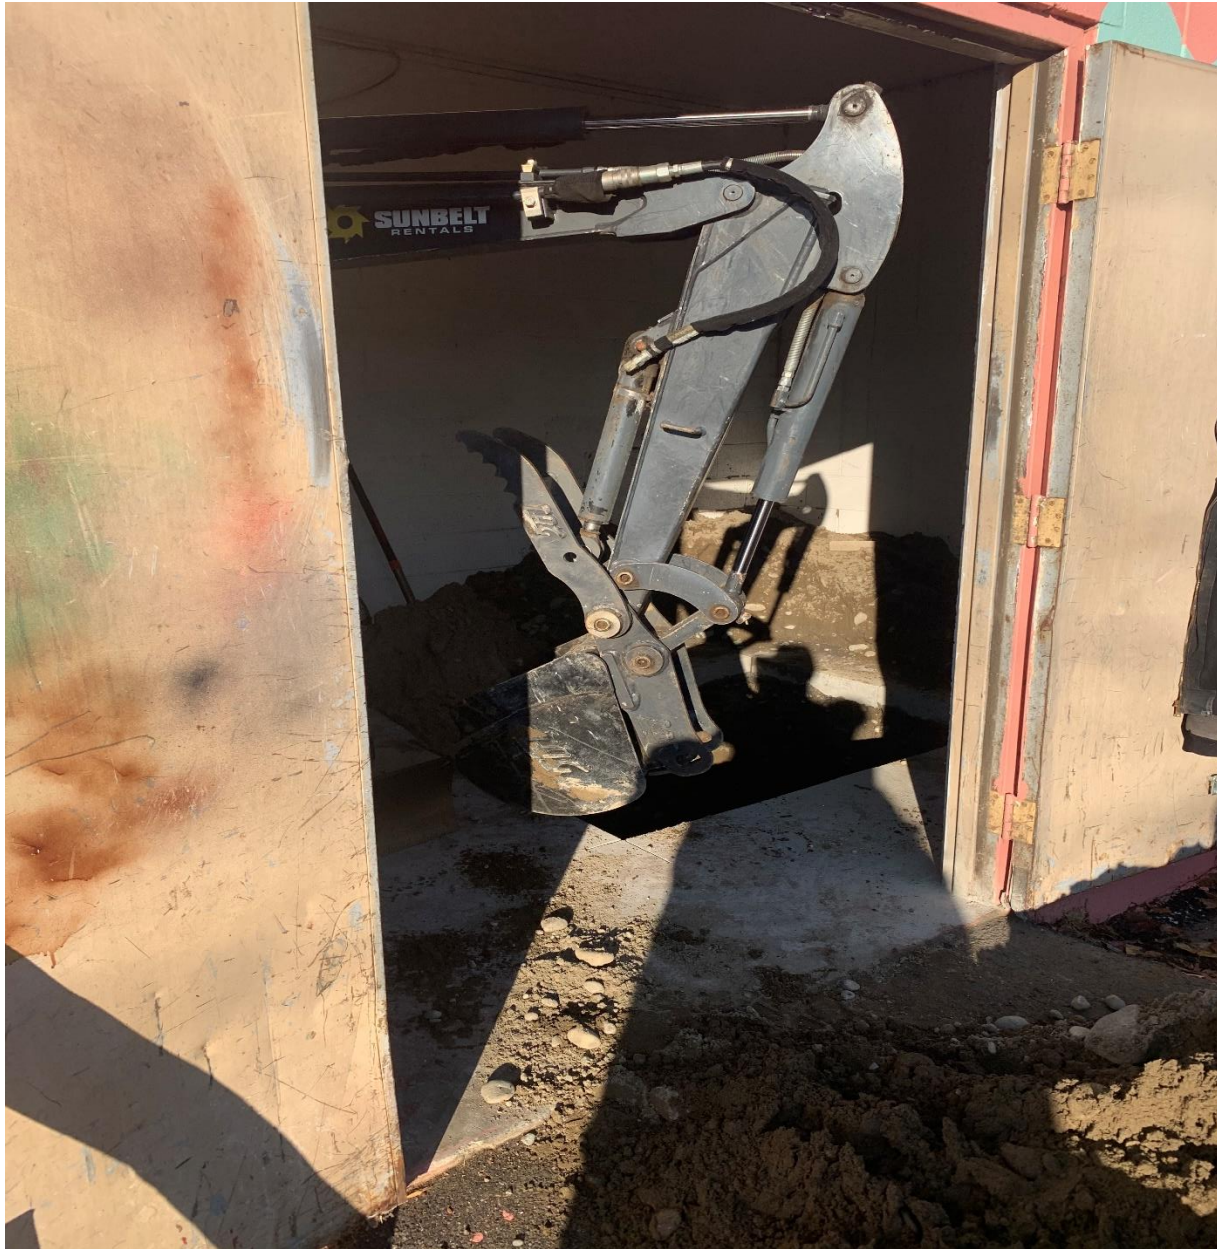
**Photograph 2 – Clarke Construction excavating soil from the HOT located inside the building at Parcel – 1364 Jadwin Avenue on November 19, 2020 (facing NNW).**

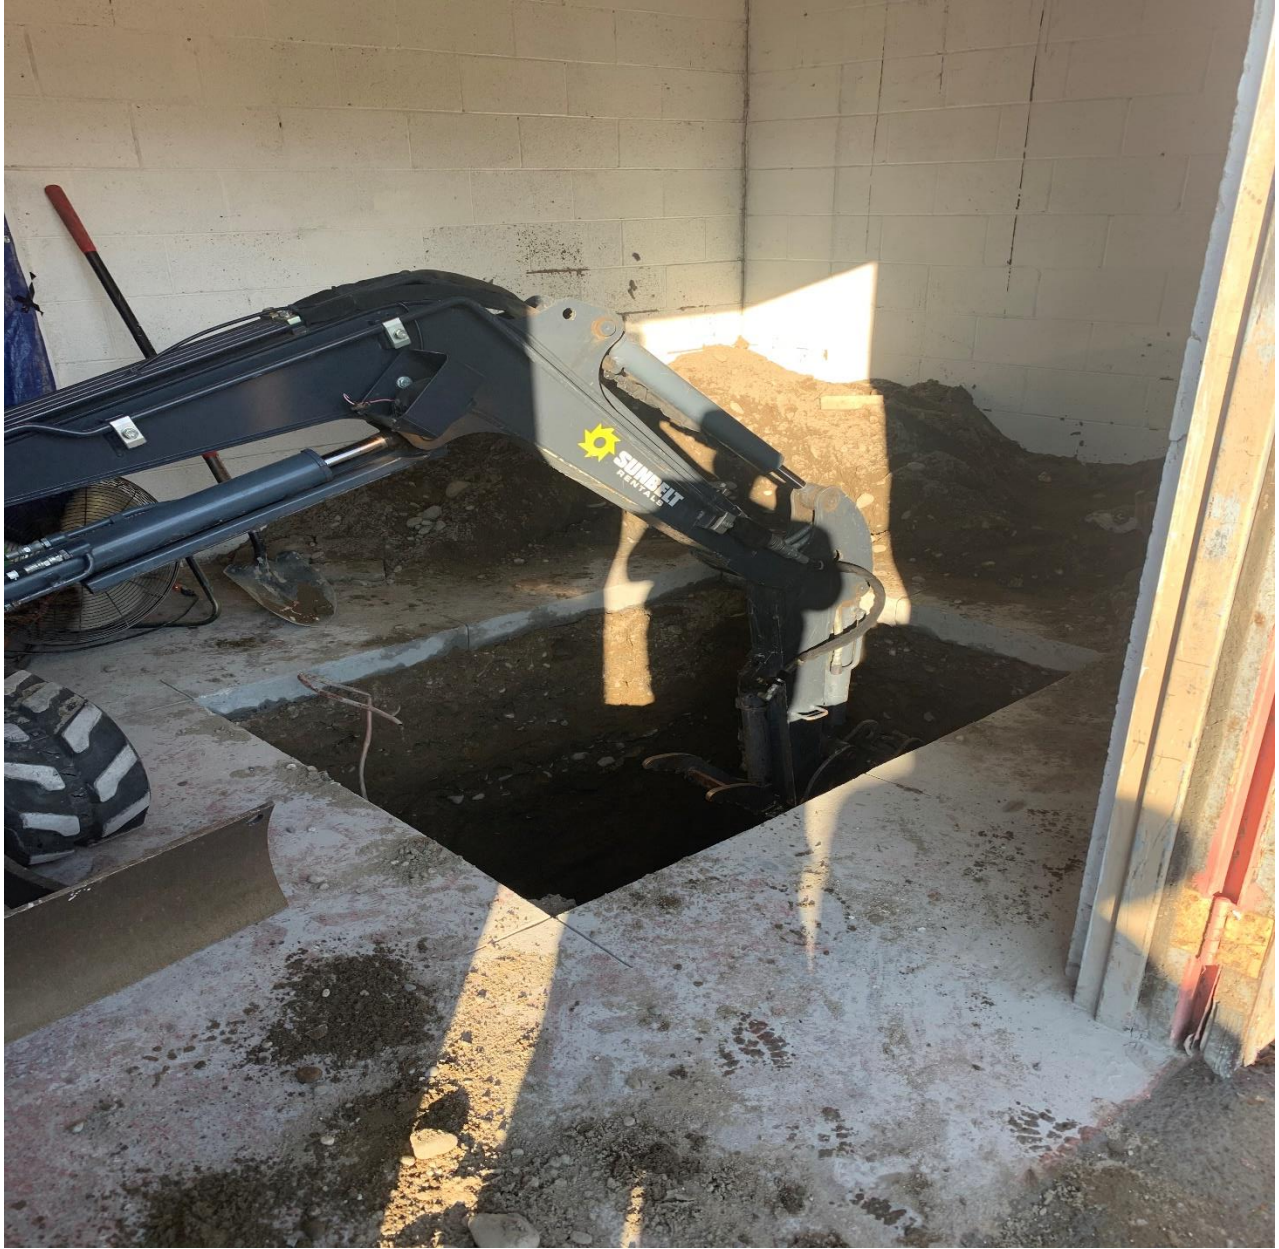
**Photograph 3 – HOT soil excavation close-up on November 11, 2020 (facing NNE).**

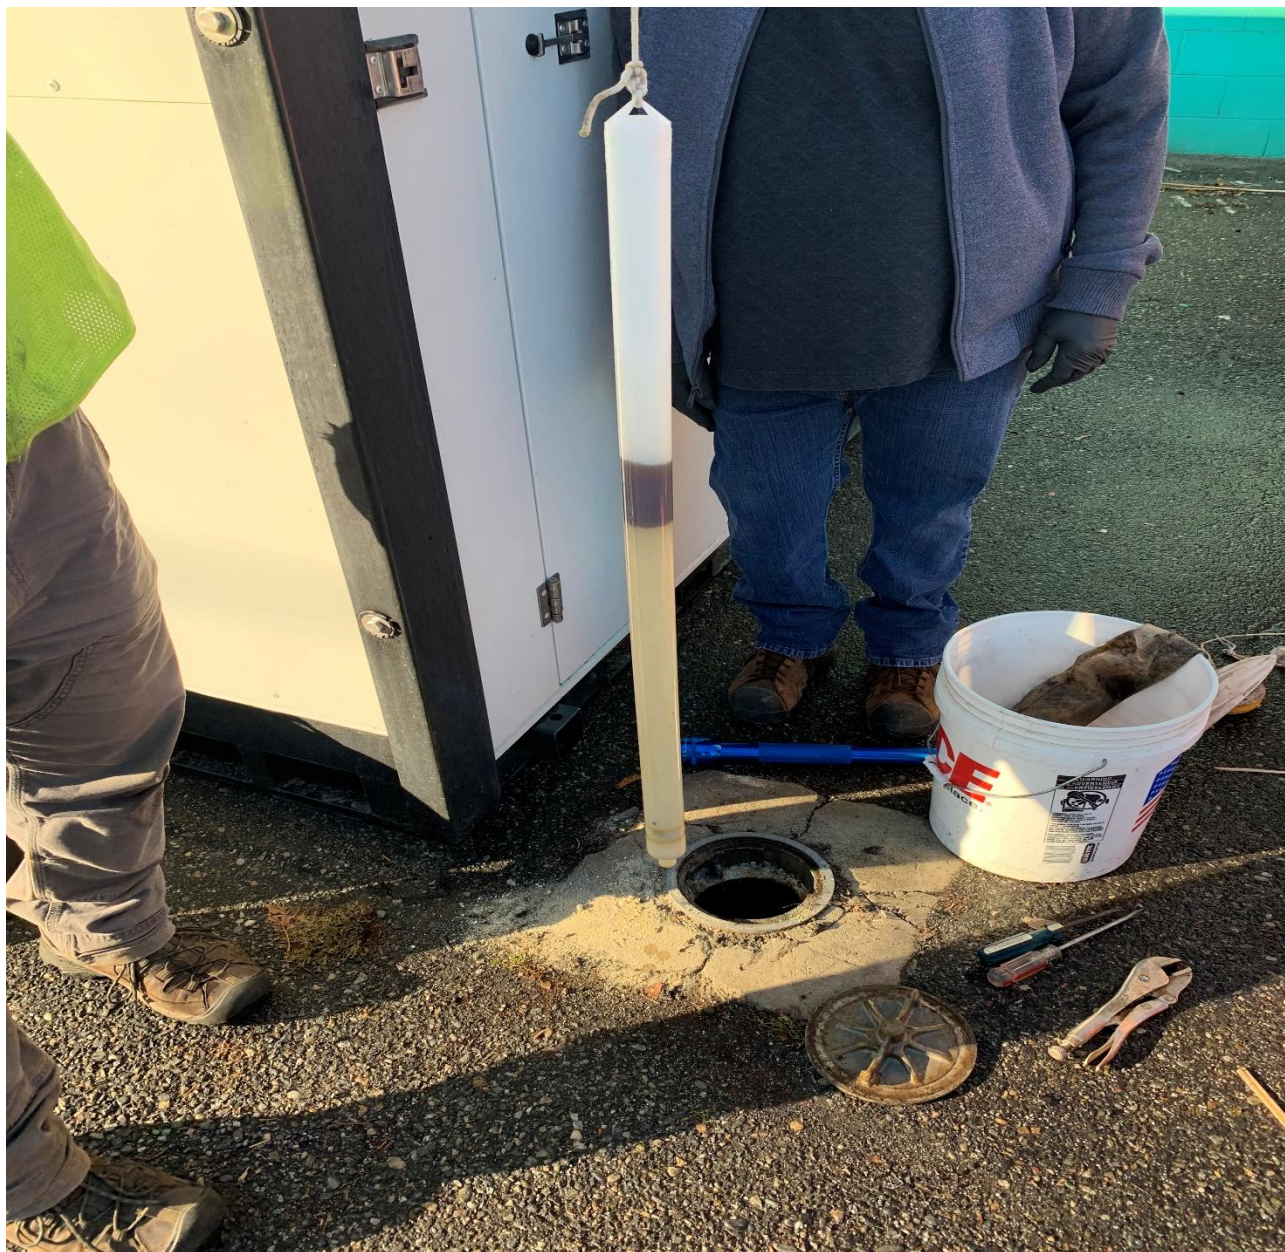
On November 11, 2020, LNAPL (0.25') was present in monitoring well MW-2; thus, a groundwater sample was not obtained for analysis. An approximation of the location of monitoring well MW-2 in reference to the HOT is illustrated on **Figures 2 and 3**. Furthermore, attempts to hand auger down deeper than 7 feet bsg in the HOT pit and obtain a groundwater sample were unsuccessful due to refusal via coarse gravel.

**Photograph 4 – Light, non-aqueous phase liquid (LNAPL) removed from monitoring well MW-2 on November 11, 2020 (facing west).**

The decision to not collect a groundwater sample from monitoring well MW-2 was made due to the fact that 0.25' of LNAPL were observed in the well. Approximately 0.5 gallon of LNAPL were bailed from monitoring well MW-2 and properly disposed. Attempts to hand auger down deeper than 7 feet bsg in the HOT pit and obtain a groundwater sample were unsuccessful due to refusal via coarse gravel. The depth-to-groundwater in monitoring well MW-2 was measured to be approximately 10.53 feet bsg.

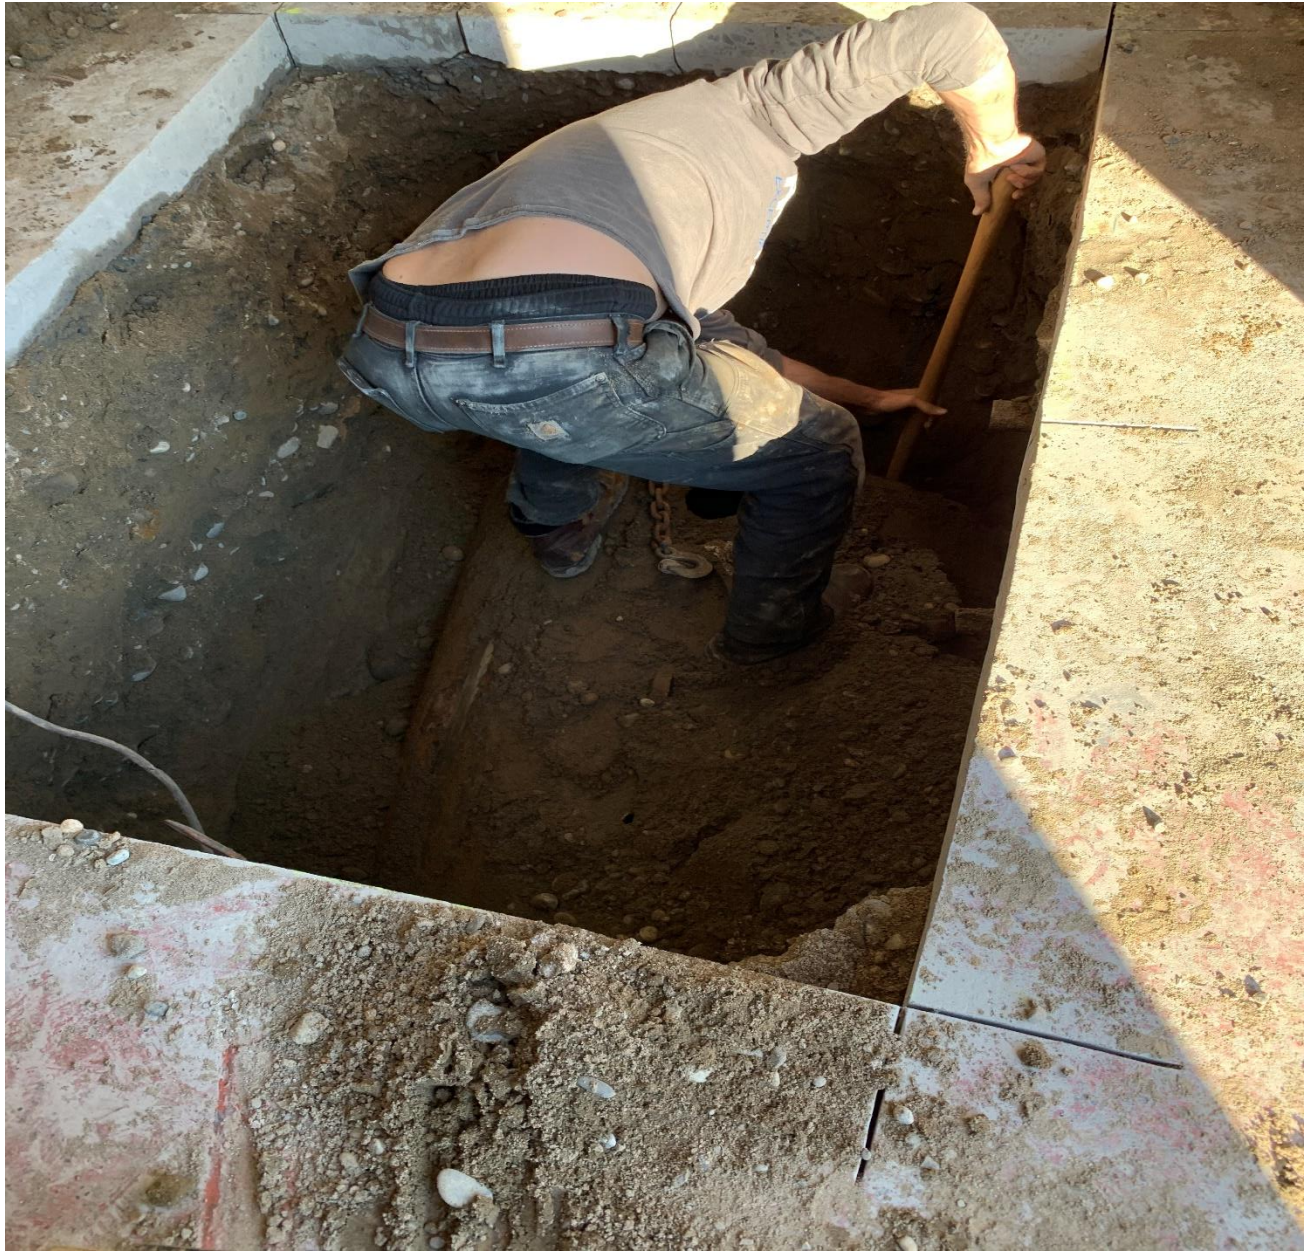
**Photograph 5 – Clarke Construction employee hand digging soil from north end of HOT on November 11, 2020 (facing north).**

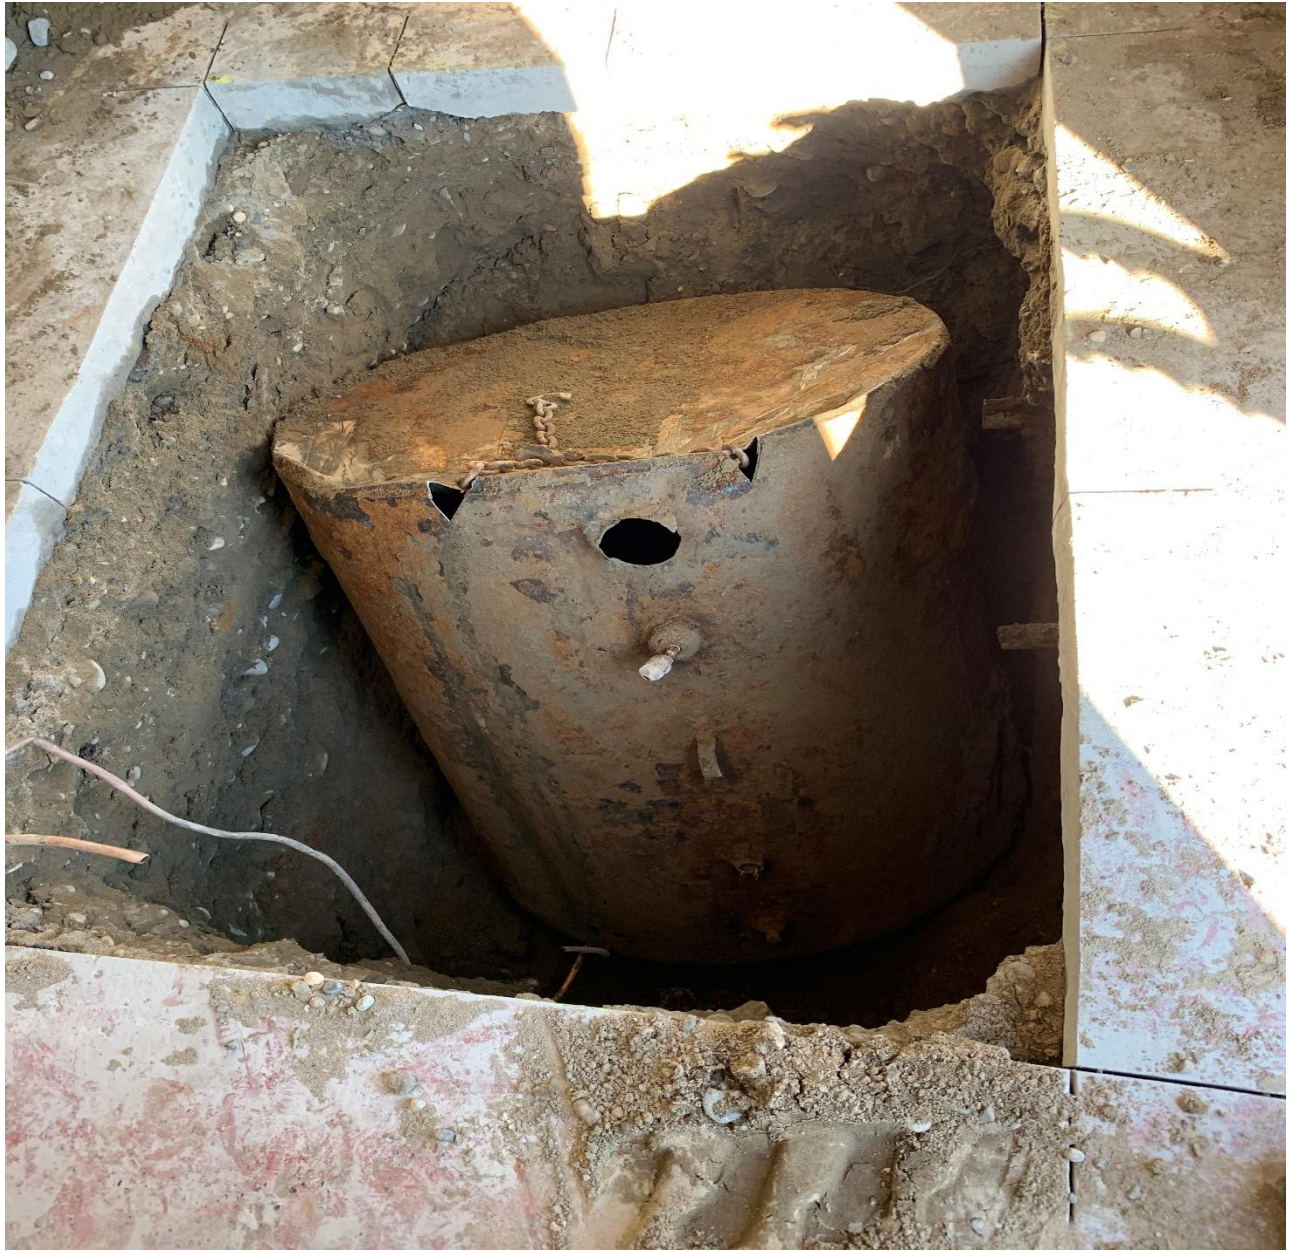
**Photograph 6 – 320-gallon HOT ready for removal from excavation on November 11, 2020 (facing north).**

The 320-gallon HOT was hauled offsite by Clarke on November 11, 2020 and recycled as scrap metal at Twin City Metals in Kennewick, Washington. A copy of the recycling receipt is included in **Appendix B**.

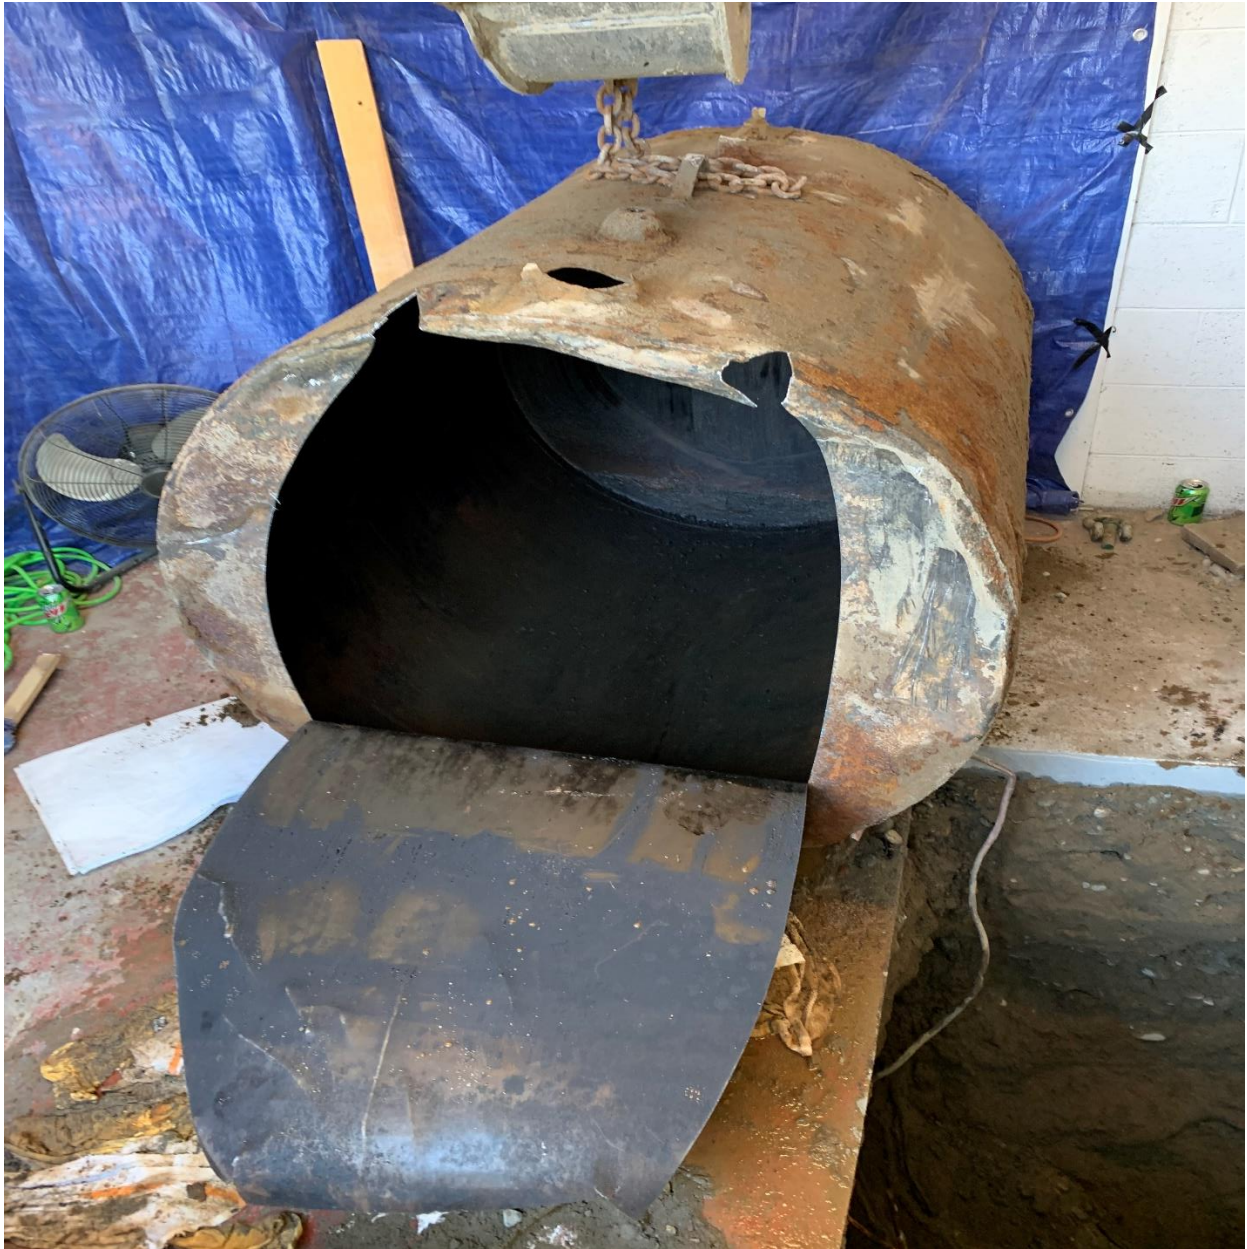
**Photograph 7 – Clean HOT interior (facing west).**

Approximately 15 gallons of water and 7.5 gallons of rinse water were removed from the tank interior and recycled at ORRCO on November 12, 2020. Included in the 25 gallons of recycled emulsified oil and water were approximately 0.5 gallon of LNAPL from monitoring well MW-2 and two gallons of decontamination water (25 gallons total). A copy of the "emulsified oil and water" receipt is included in **Appendix B**. All nitrile gloves, paper towels, bailers and rope were containerized in a plastic trash bag and disposed onsite as standard refuse.

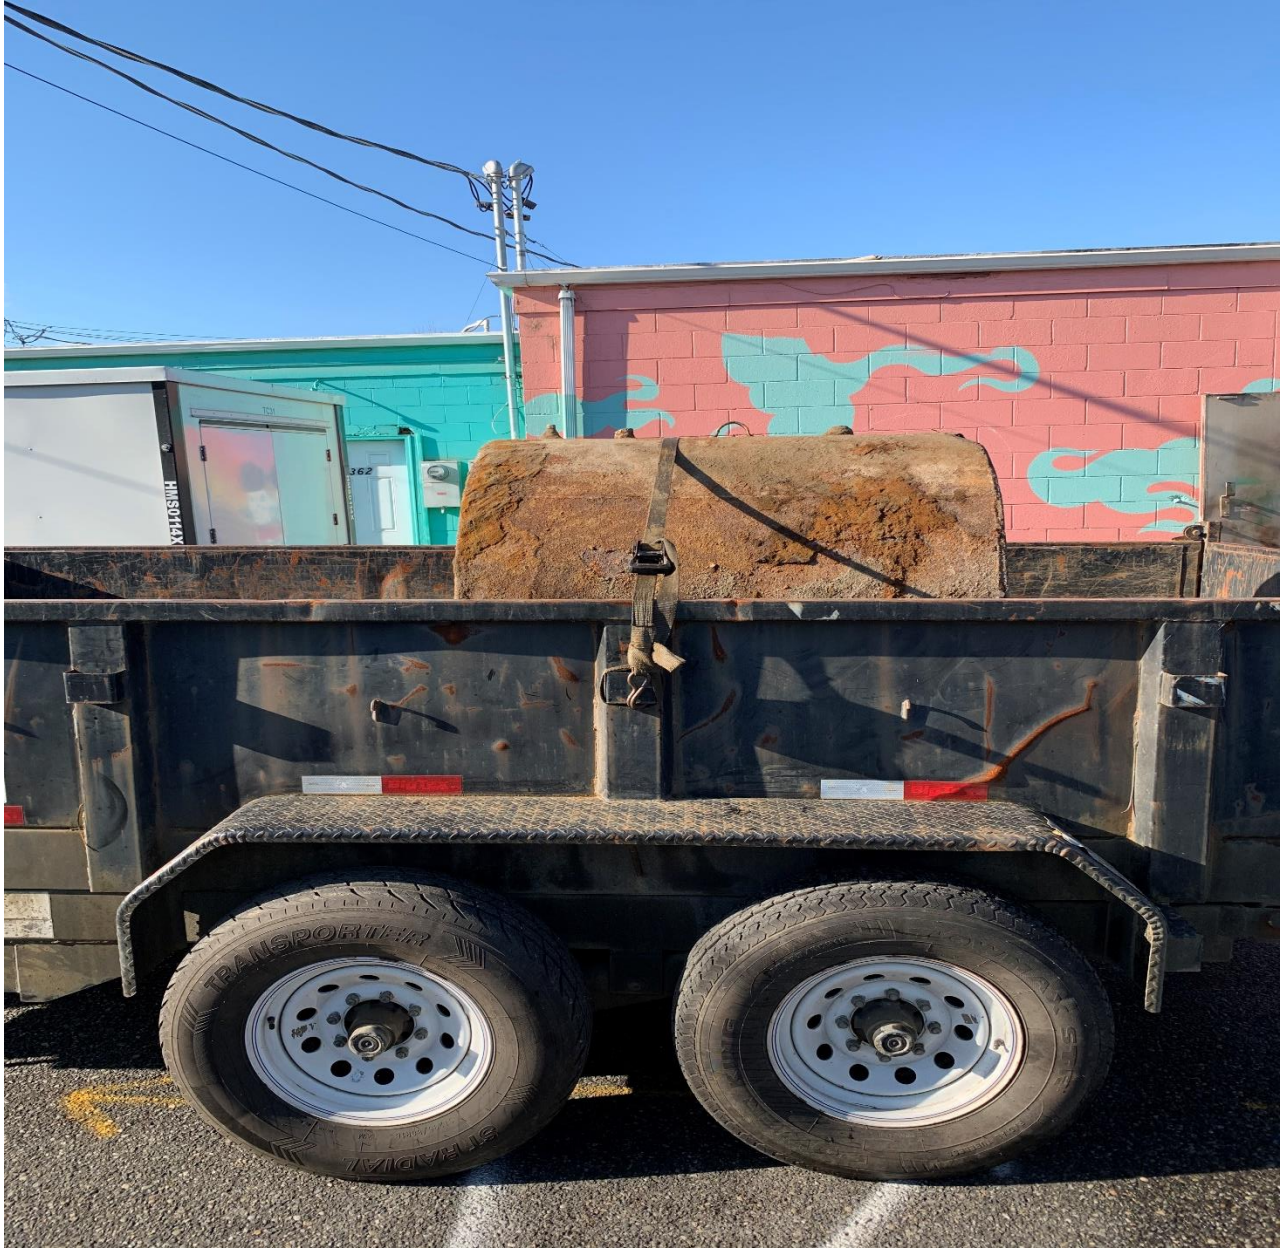
**Photograph 8 – HOT loaded and secured, prior to being recycled as scrap metal on November 11, 2020 (facing west).**

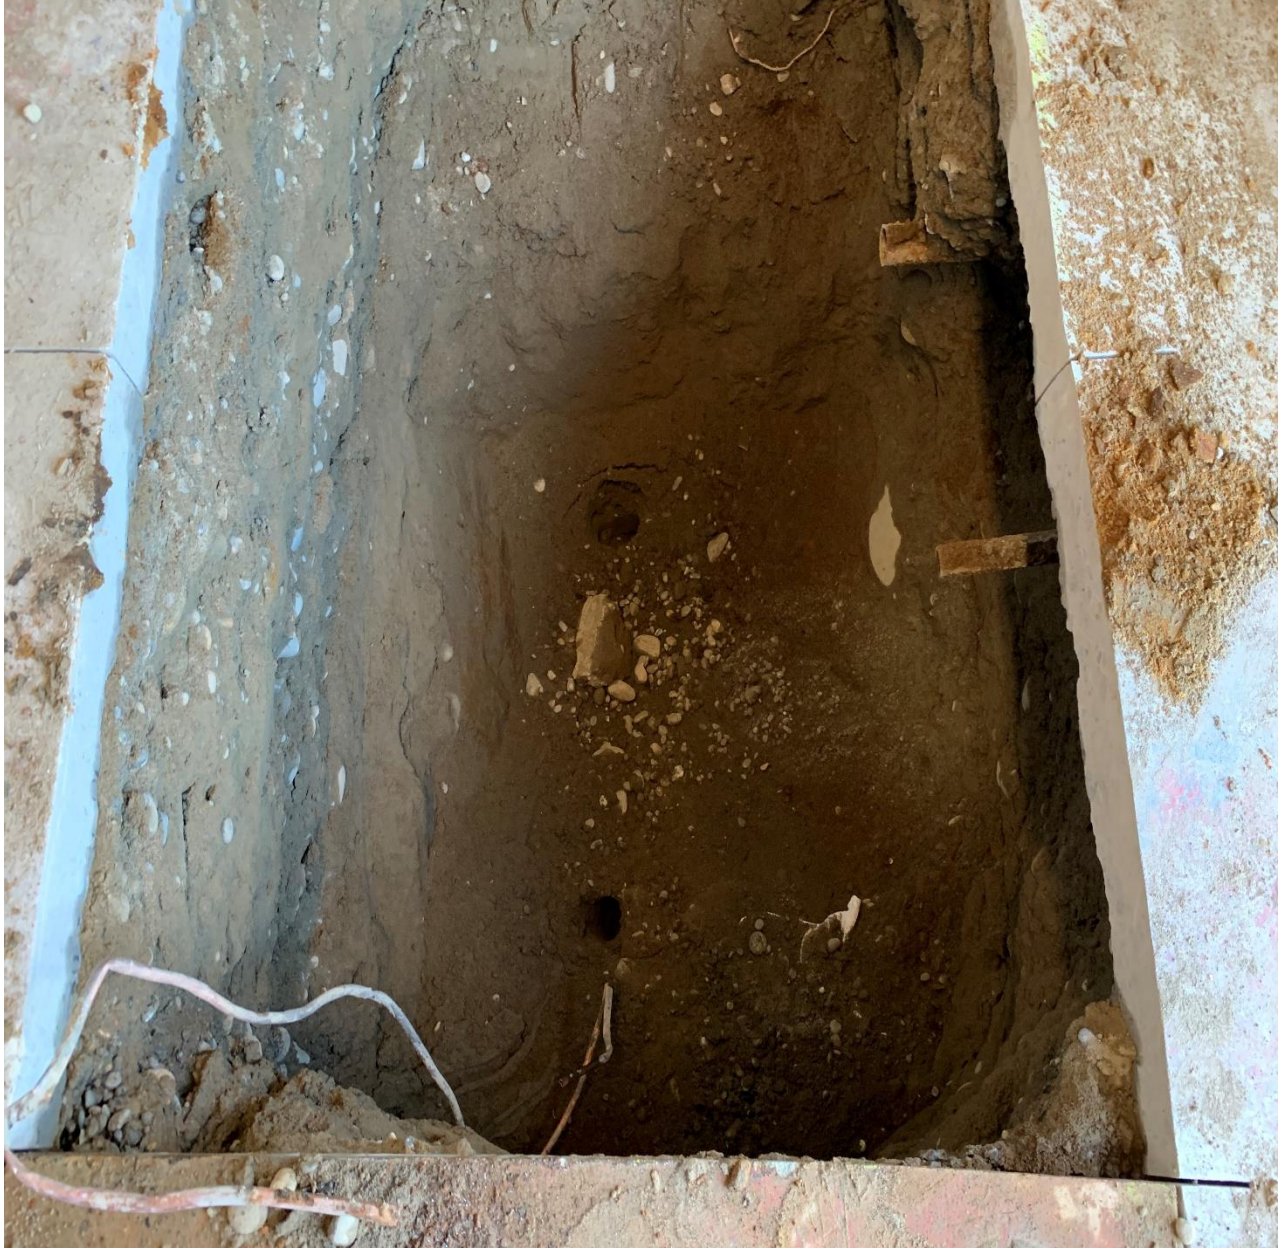
On November 11, 2020 and subsequent to using a small backhoe to remove the concrete, soil, and HOT, BMEC personnel were able to use a hand auger to collect soil samples from the bottom of the tank pit. Two soil samples were obtained, one from either end of the north-south oriented HOT, and from a depth exactly one foot below the bottom of the HOT. The bottom of the HOT was at about 6 feet bsg, thus the two soil samples (*N End-7'* [aka 11645-01-N7'] and *S End-7'* [aka 11645-02-N7']) were obtained from a depth of 7 feet bsg each and 6 inches off each end of the tank. Locations of the two soil samples (N End-7' and S End-7') are illustrated on **Figure 3**. Attempts to hand auger down deeper than 7 feet bsg were unsuccessful due to refusal via coarse gravel.

**Photograph 9 – Bottom of HOT excavation with hand auger boring holes at base of former tank on November 11, 2020 (standing on south end of tank pit facing north).**

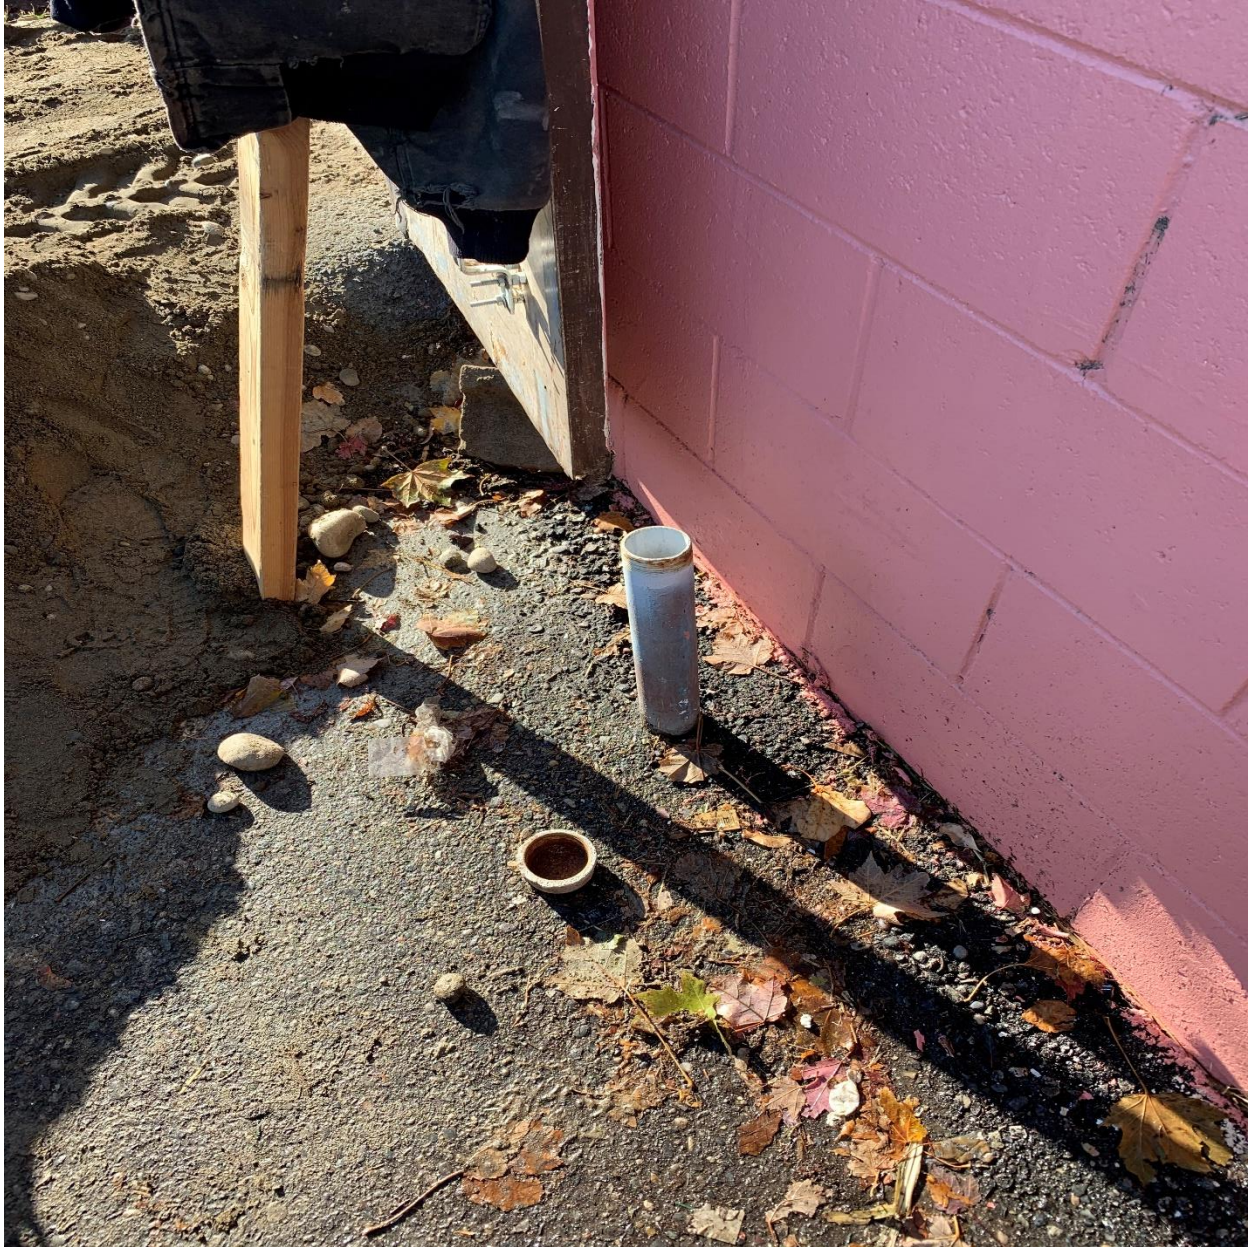
Clarke Construction (Clarke) of Longview, Washington was subcontracted by BMEC to decommission the HOT(s). Once onsite on November 10, 2020, Clarke began saw-cutting the concrete located above the HOT, as approximated in outline by the private utility locator. The HOT was located inside of the building on a covered patio surrounded by walls and a roof (**Figure 2**). Photographs of the field activities are included in **Appendix A**. Subsequent to exposure of the top of the HOT, approximately 15 gallons of water and 10 gallons of rinse water were removed from the tank interior and containerized in a 55-gallon drum for future disposal at Oregon Recycling Company (ORRCO) in Portland, Oregon on November 12, 2020. A copy of the "emulsified oil and water" receipt is included in **Appendix B**. Approximately 2.5 gallons of LNAPL and decontamination water were also included in the 25-gallon total of recycled emulsified oil and water. The HOT was slightly corroded, but in overall good shape without any obvious holes. Thus, BMEC surmises that 15 gallons of rainwater entered the tank via an uncapped fill port on the outside of the building. A photograph of the uncapped fill port is included in **Appendix A**.

**Photograph 10 – Fill port located on outside of the building did not have the cap on top of it when we arrived onsite on November 10, 2020 (facing SW).**

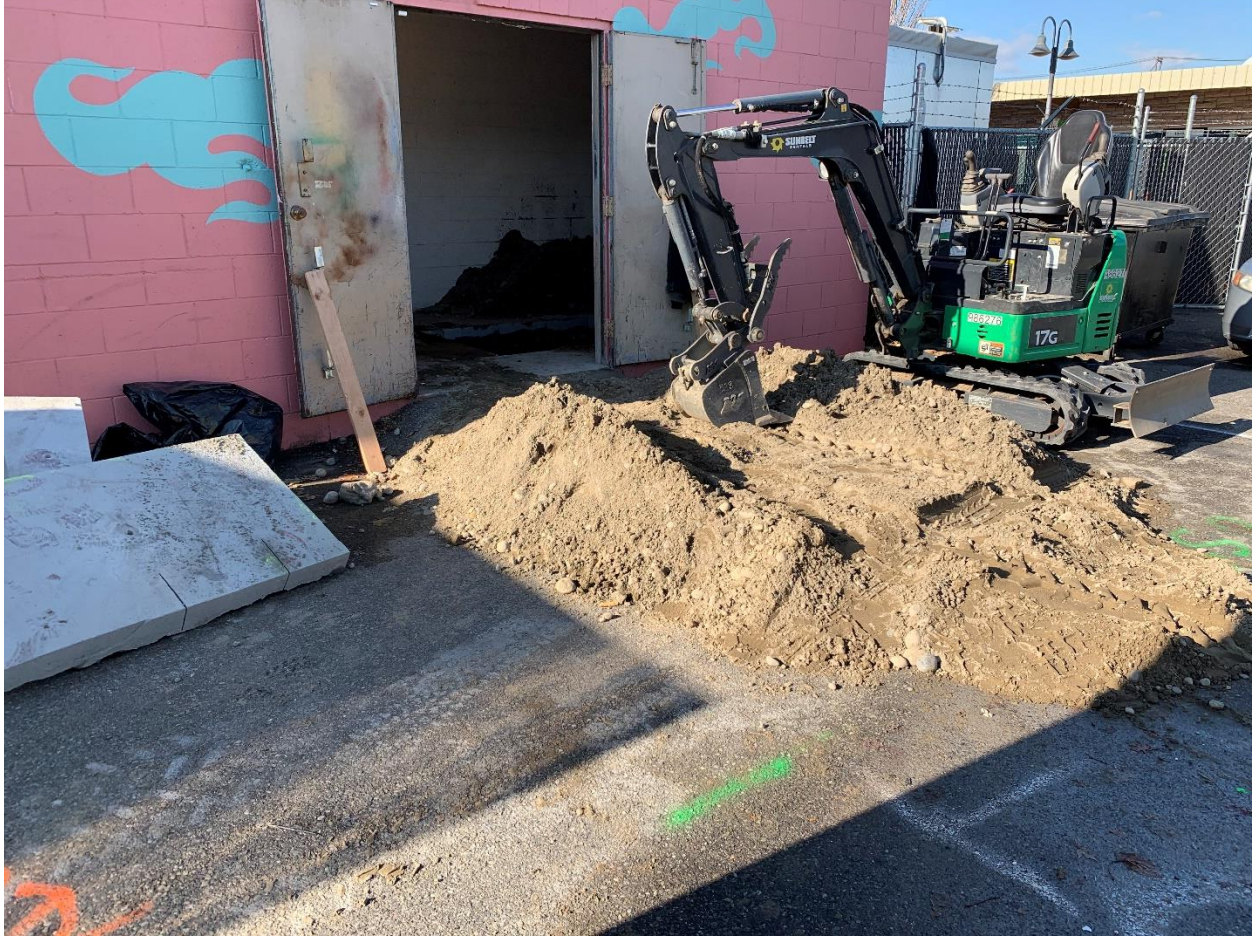
**Photograph 11 – Mini-backhoe use to excavate soil and HOT on November 10 and 11, 2020 (facing NW).**

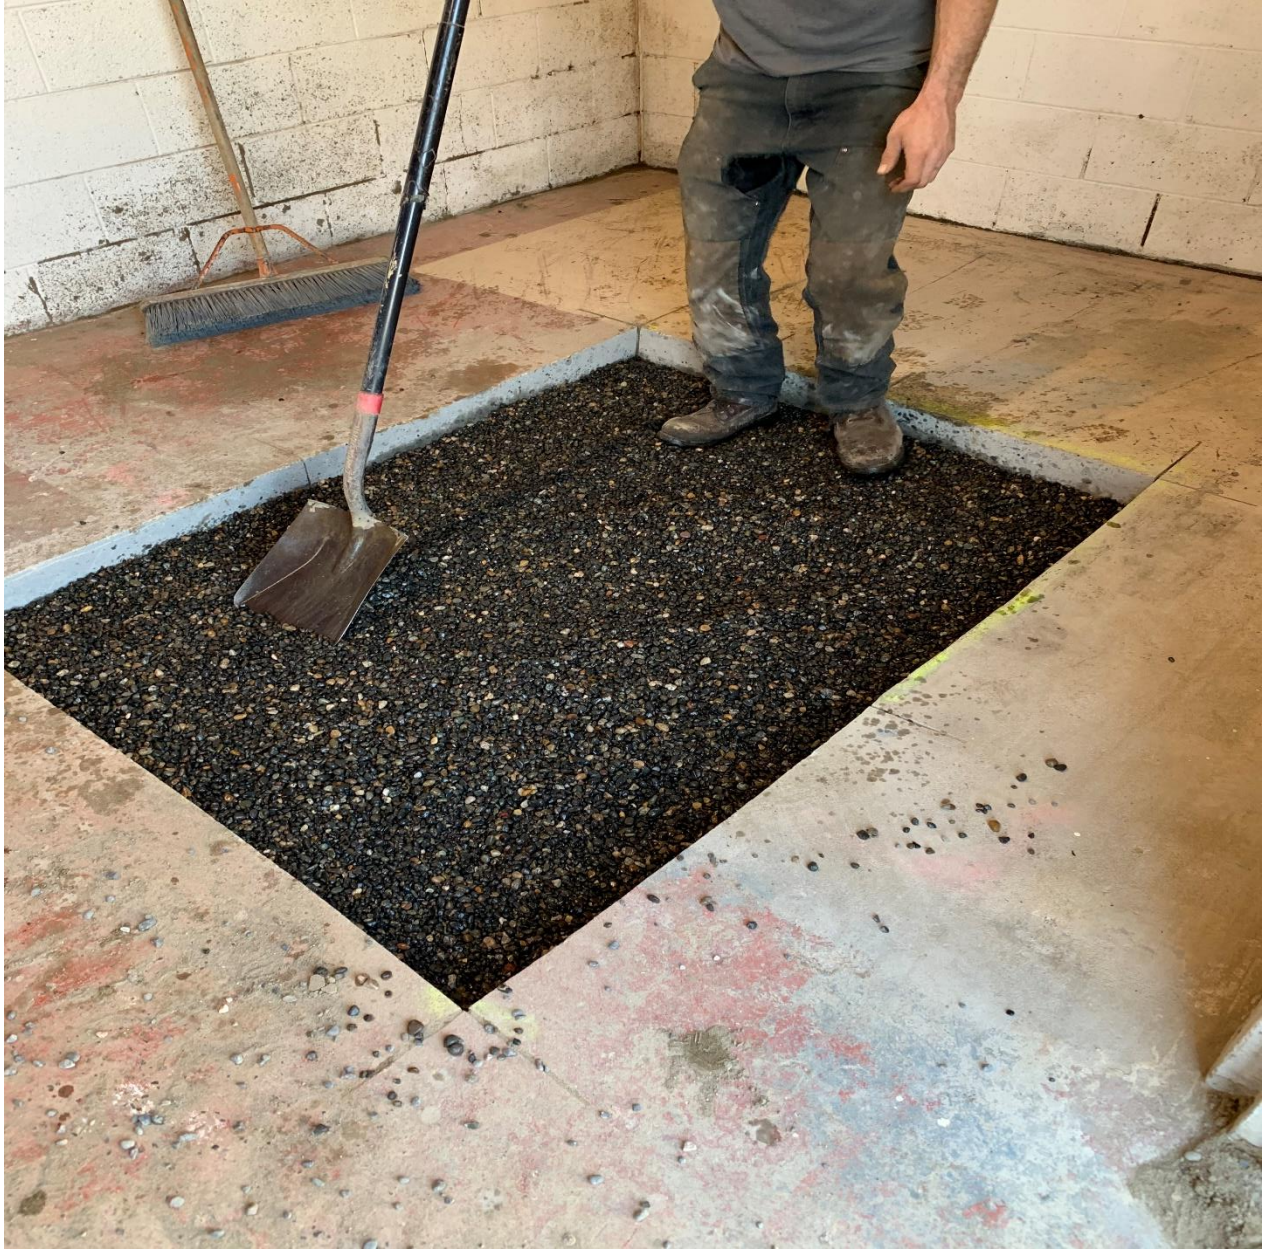
**Photograph 12 – Pea gravel backfill on November 11, 2020 (facing NW).**

Subsequent to tank removal, and soil sample collection, on November 11, 2020, Clarke placed the clean excavated soil back in the excavation, compacted it in 1-foot lifts, and backfilled with pea

gravel to a depth of about six inches bsg. The excavation was completed to surface grade with a 6-inch layer of cement.
