# Camp Bonneville Military Reservation

Vancouver, Washington

Figure 1 - Site Conditions Map

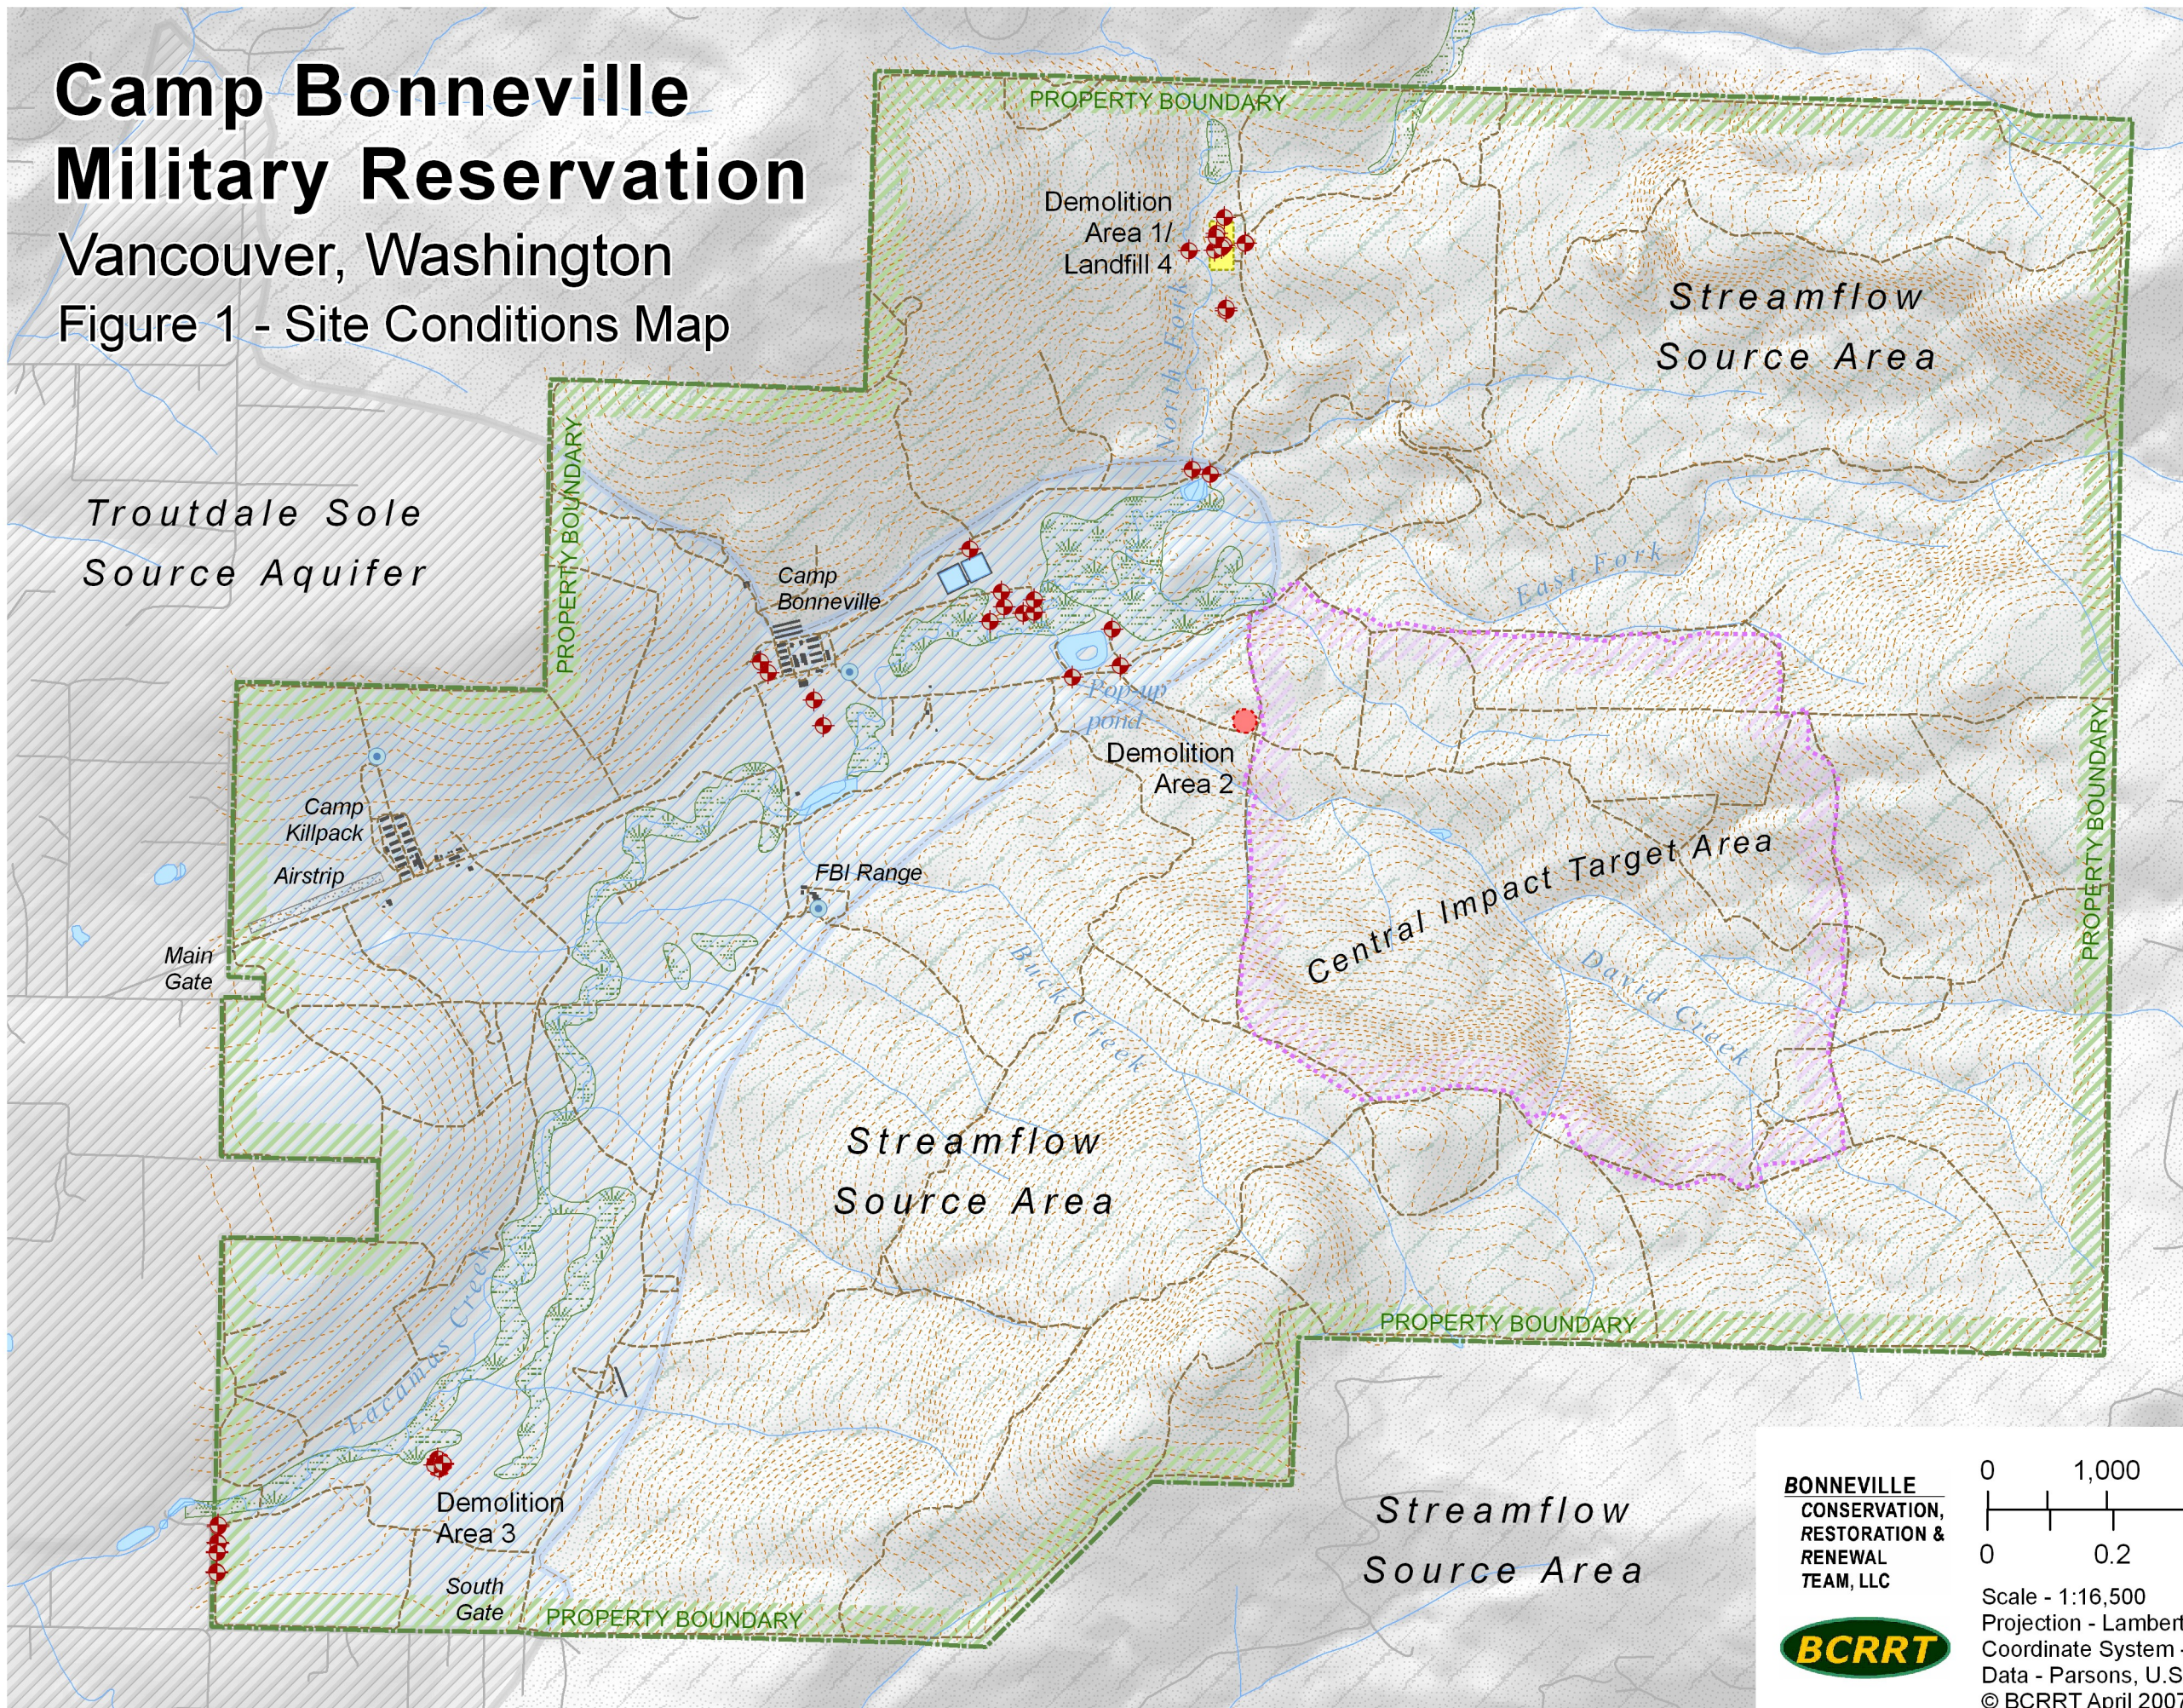
- Drinking water well
- Monitoring well
- Demolition Areas 2 & 3
- Demolition Area 1/Landfill 4
- Wetlands
- Troutdale Sole Source Aquifer
- Streamflow Source Area portion of the Troutdale Sole Source Aquifer designation
- Roads and trails
- Elevation contours (20-foot intervals)

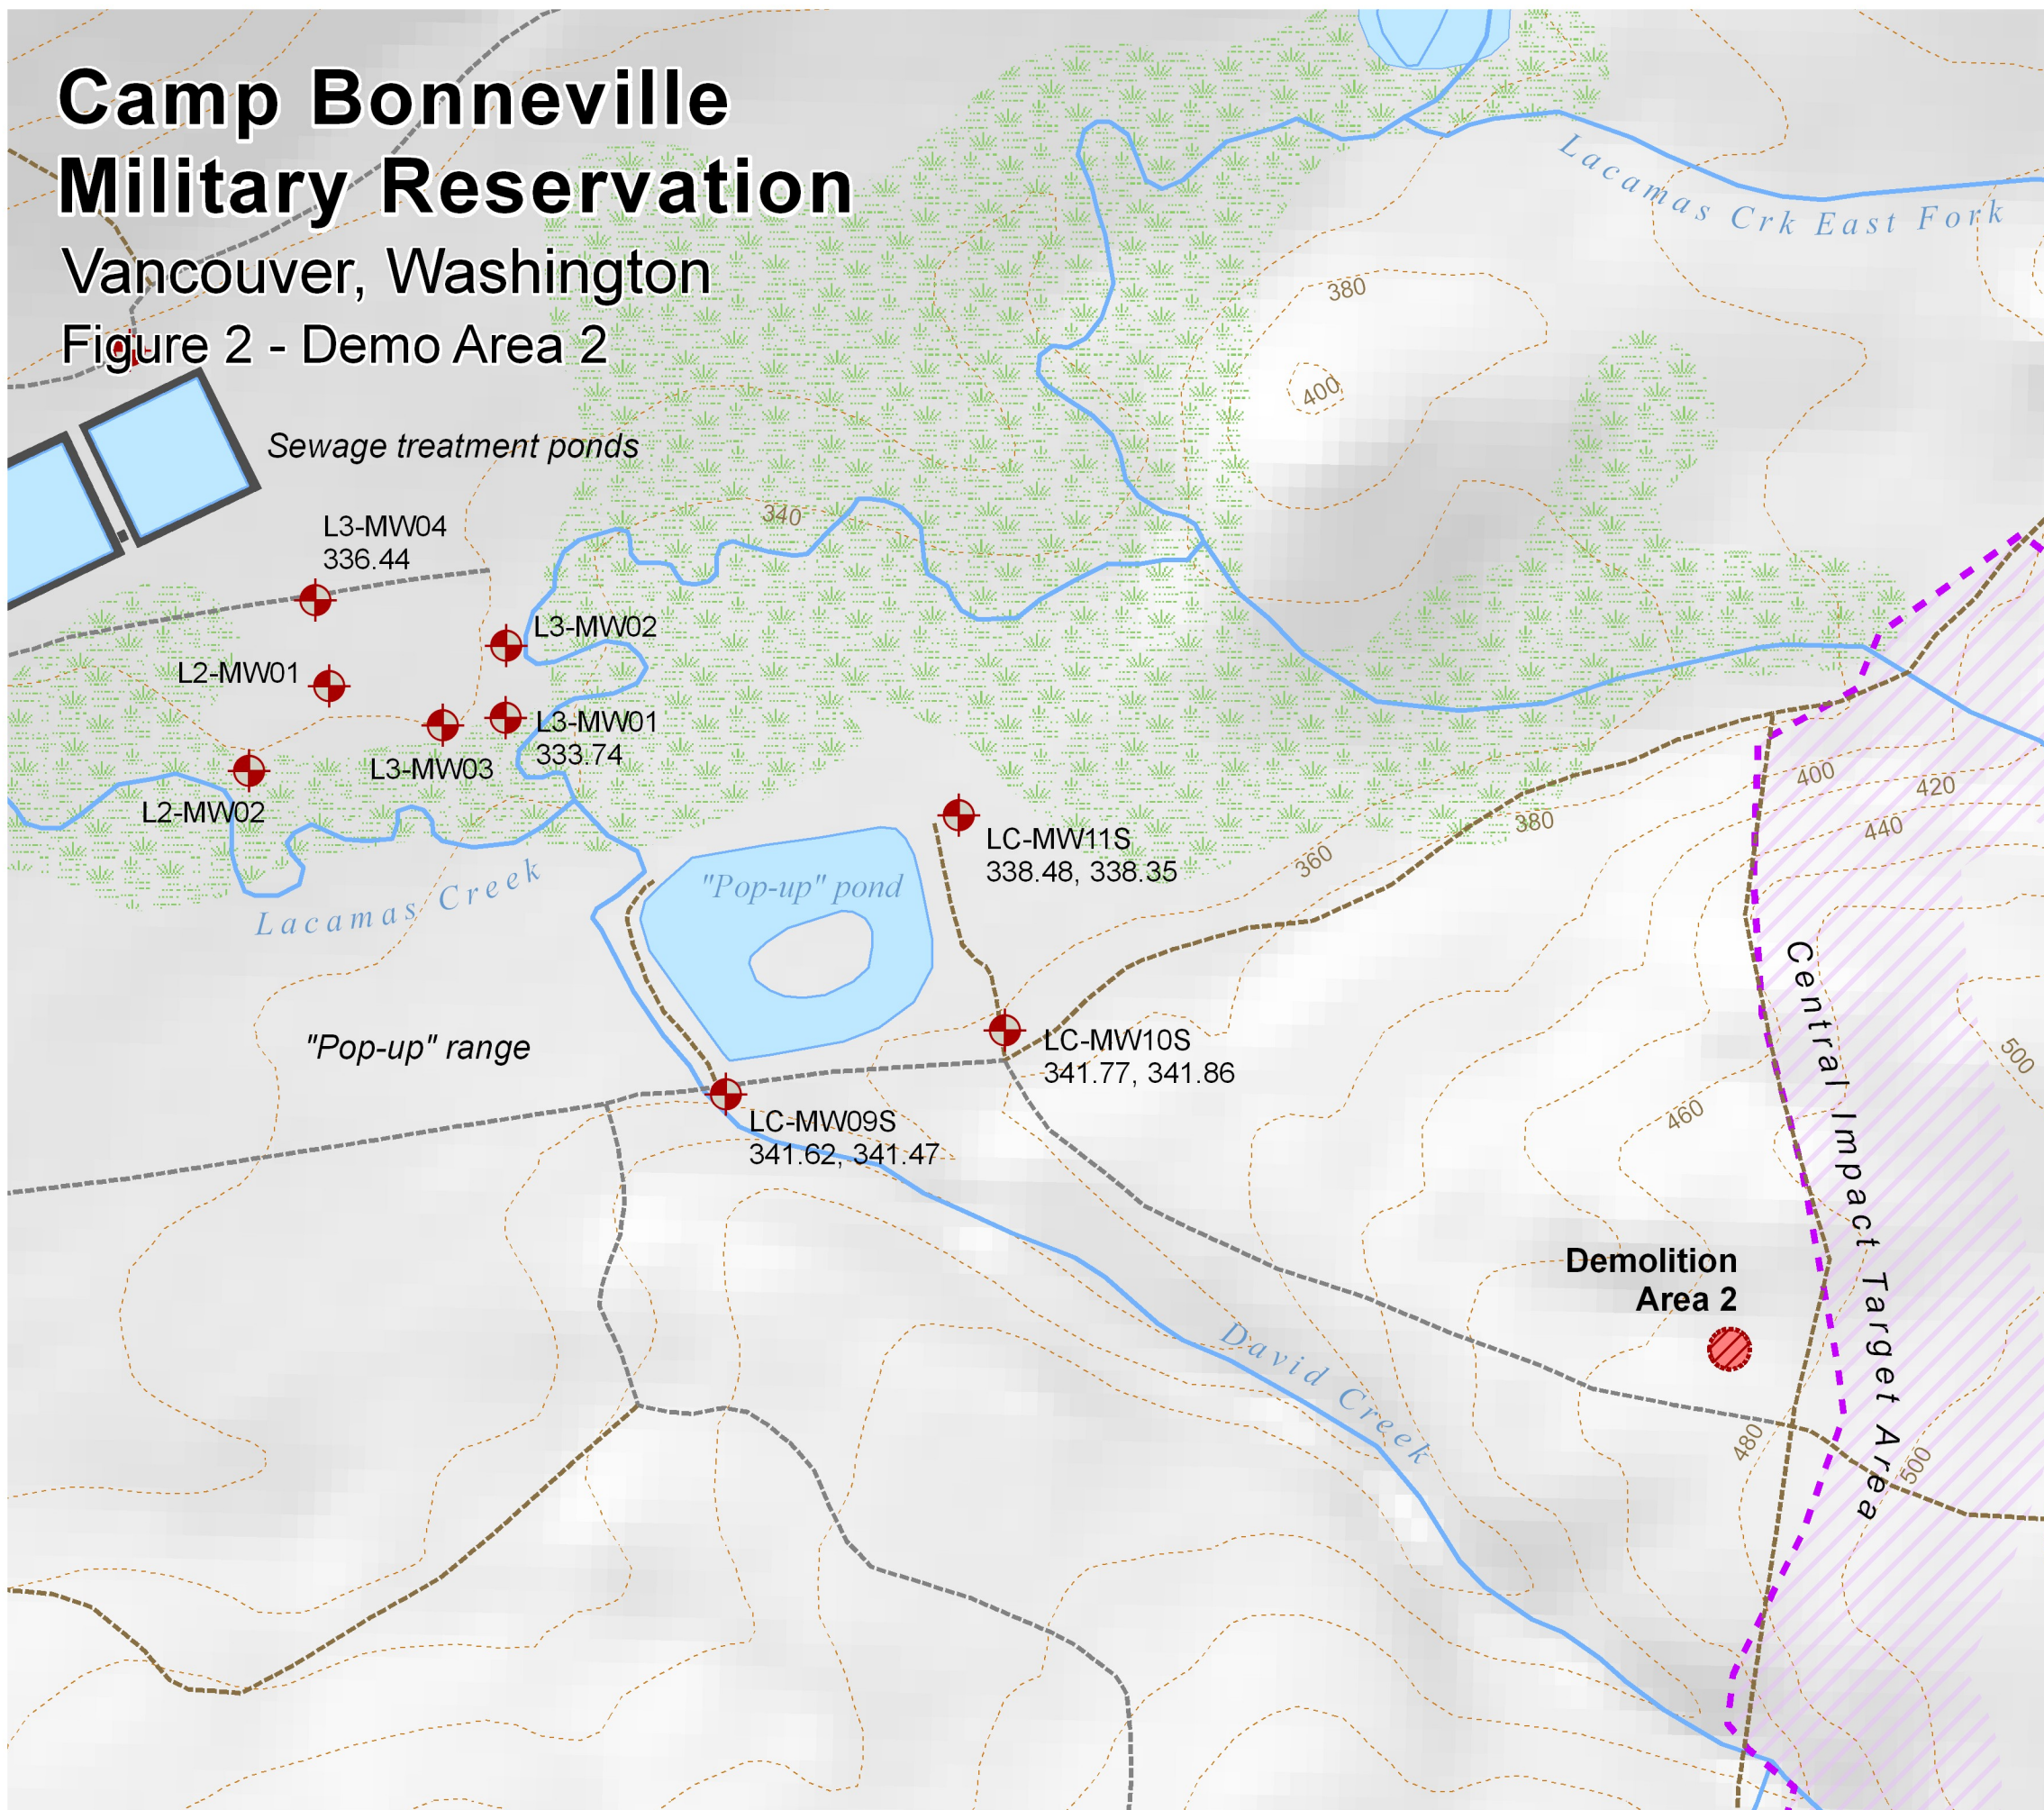
Figure 2 - Demo Area 2

- Monitoring well (ID number and groundwater elevation shown\*)
- Demolition area 2
- Wetlands
- CITA fence line
- Streams and creeks
- Elevation contours (20-foot intervals)

\* Groundwater sample date is Jan 2003 for the first number shown; For the three wells around the "Pop-up" pond, the second number shown is from June 2006.

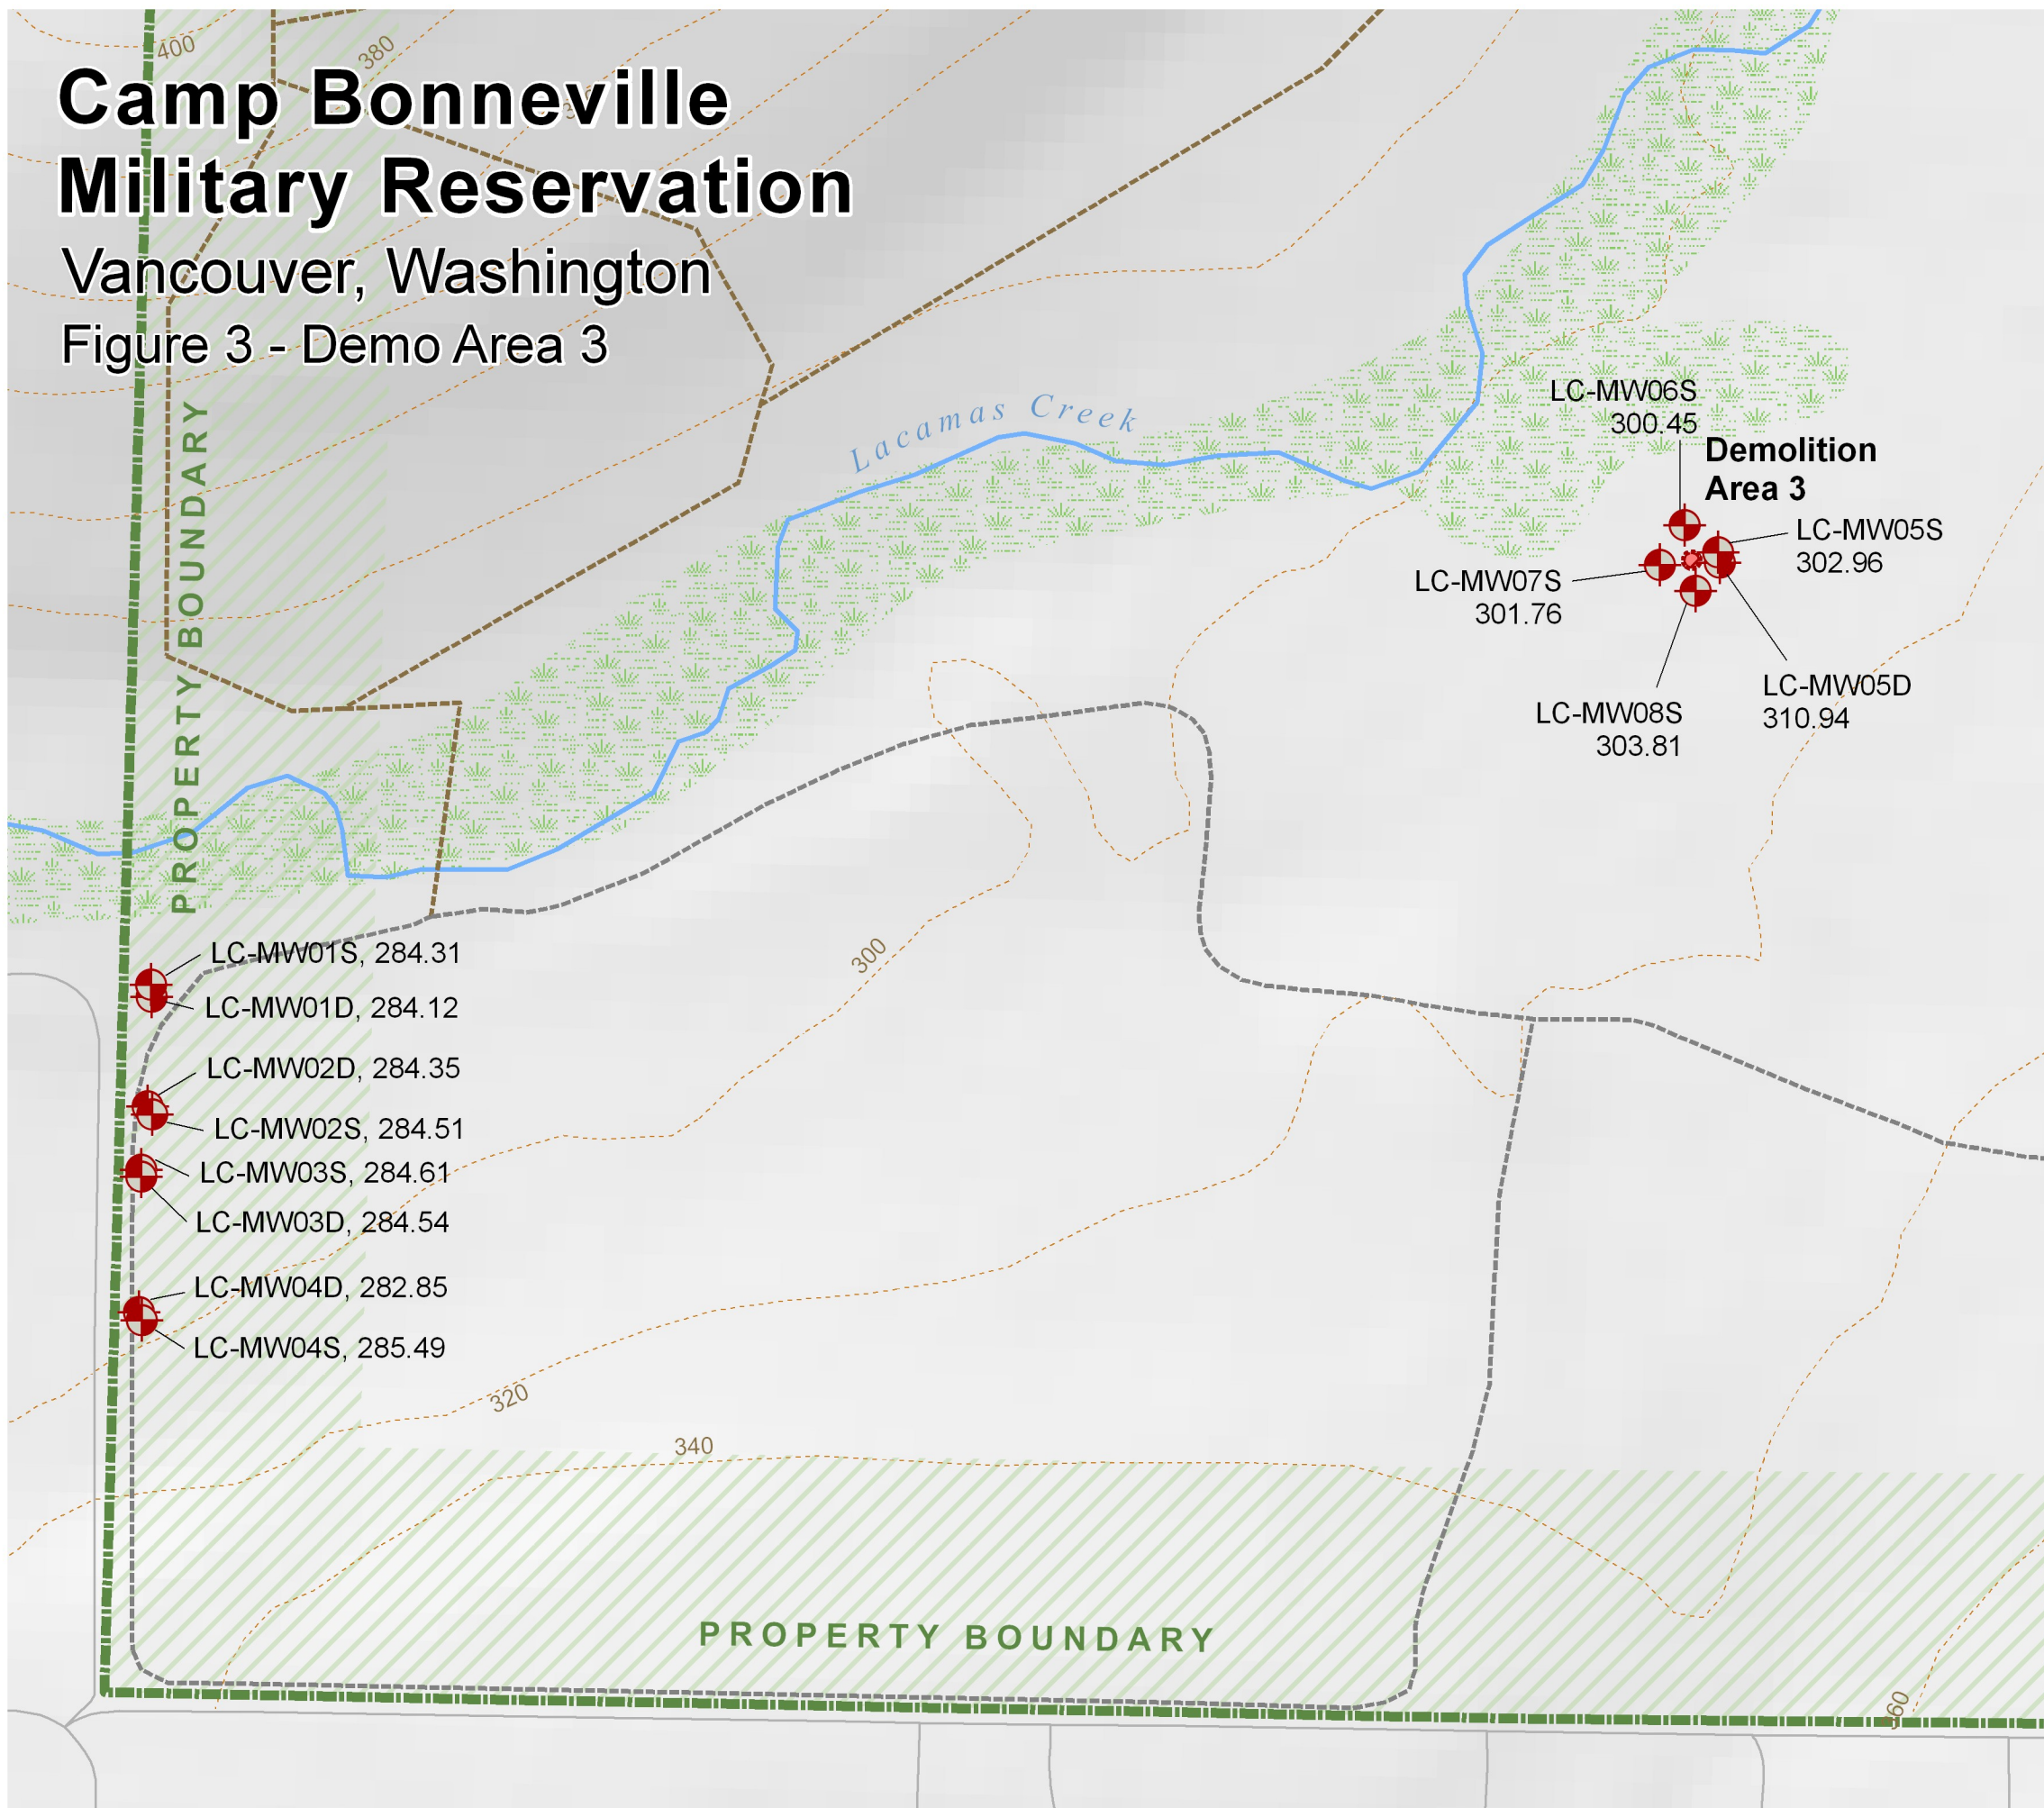
Figure 3 - Demo Area 3

- Monitoring well (ID number and groundwater elevation shown\*)
- Demolition area 3
- Wetlands
- Property fence line
- Streams and creeks
- Elevation contours (20-foot intervals)

\* Groundwater sample date June 2006.

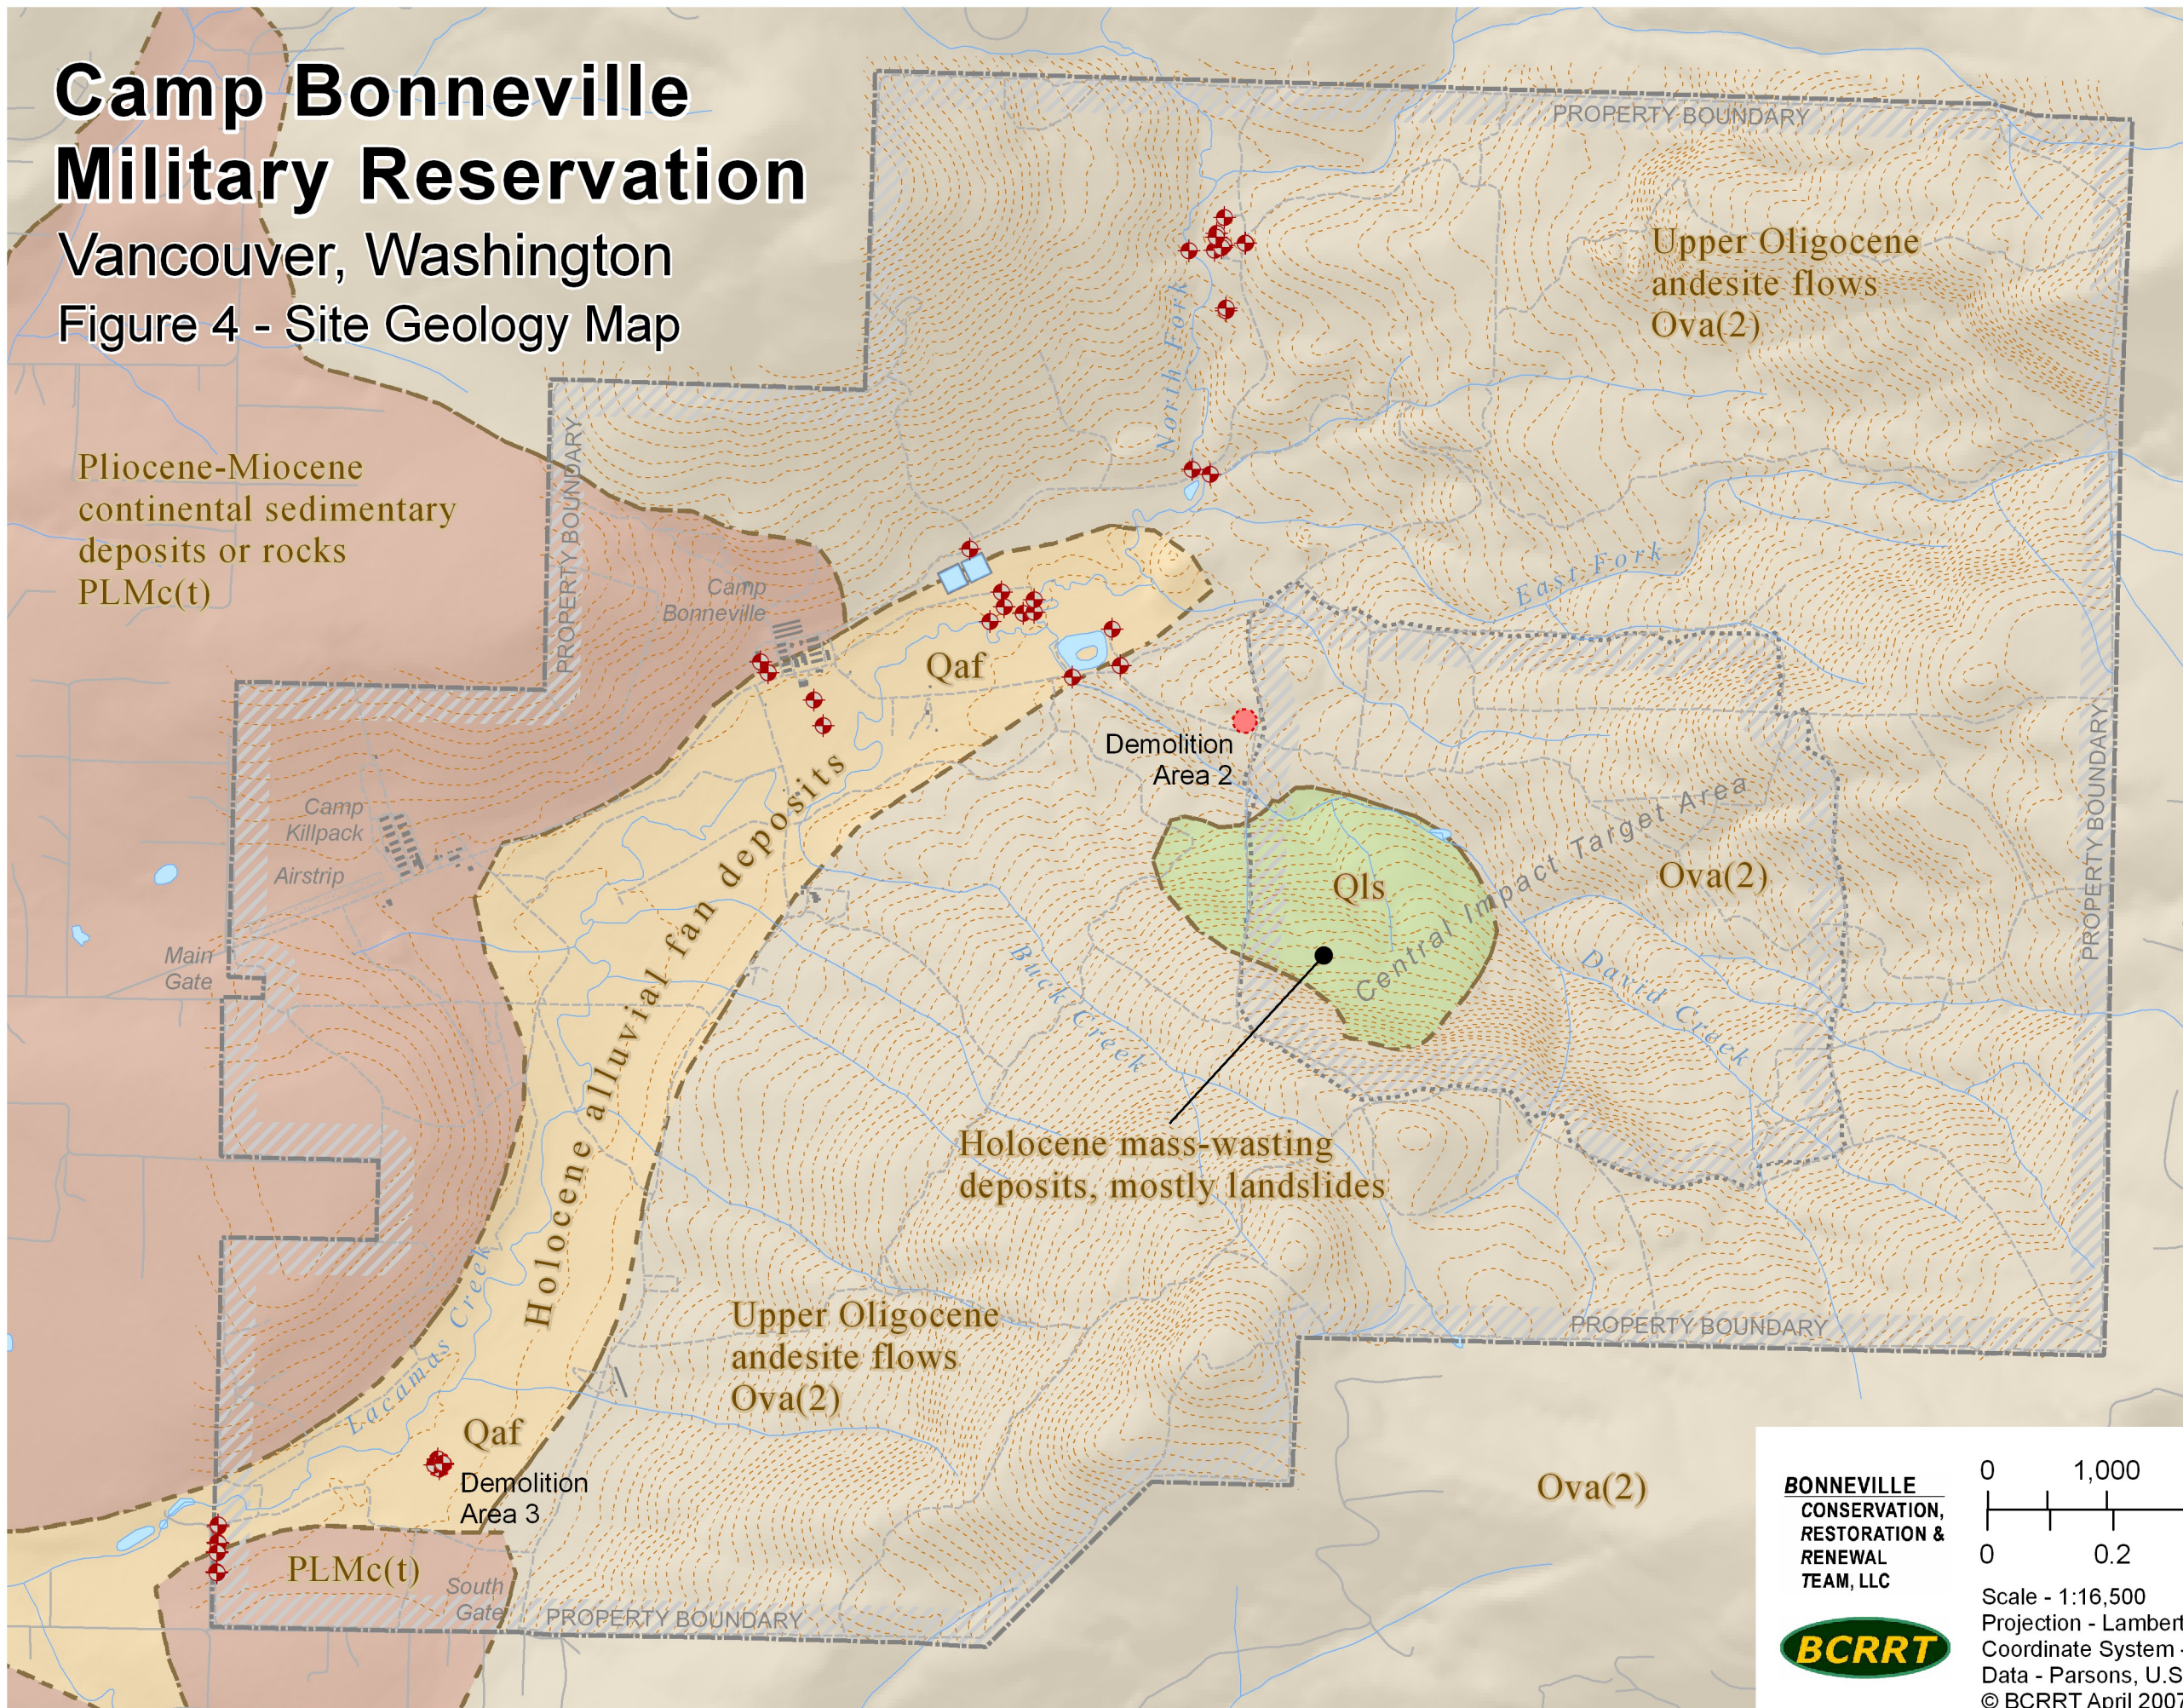
Vancouver, Washington  
Figure 4 - Site Geology Map

- Geologic Bedrock Formations**
-

Upper Oligocene andesite flows, Ova(2)
  -

Pliocene-Miocene continental sedimentary deposits or rocks, PLMc(t)
  -

Holocene alluvial fan deposits, Qaf
  -

Holocene mass-wasting deposits, mostly landslides, Qls
  -

\* Geology data from Washington State Department of Natural Resources, Division of Geology & Earth Resources. Digital 1:100,000-scale Geology of Washington State, December 2005.

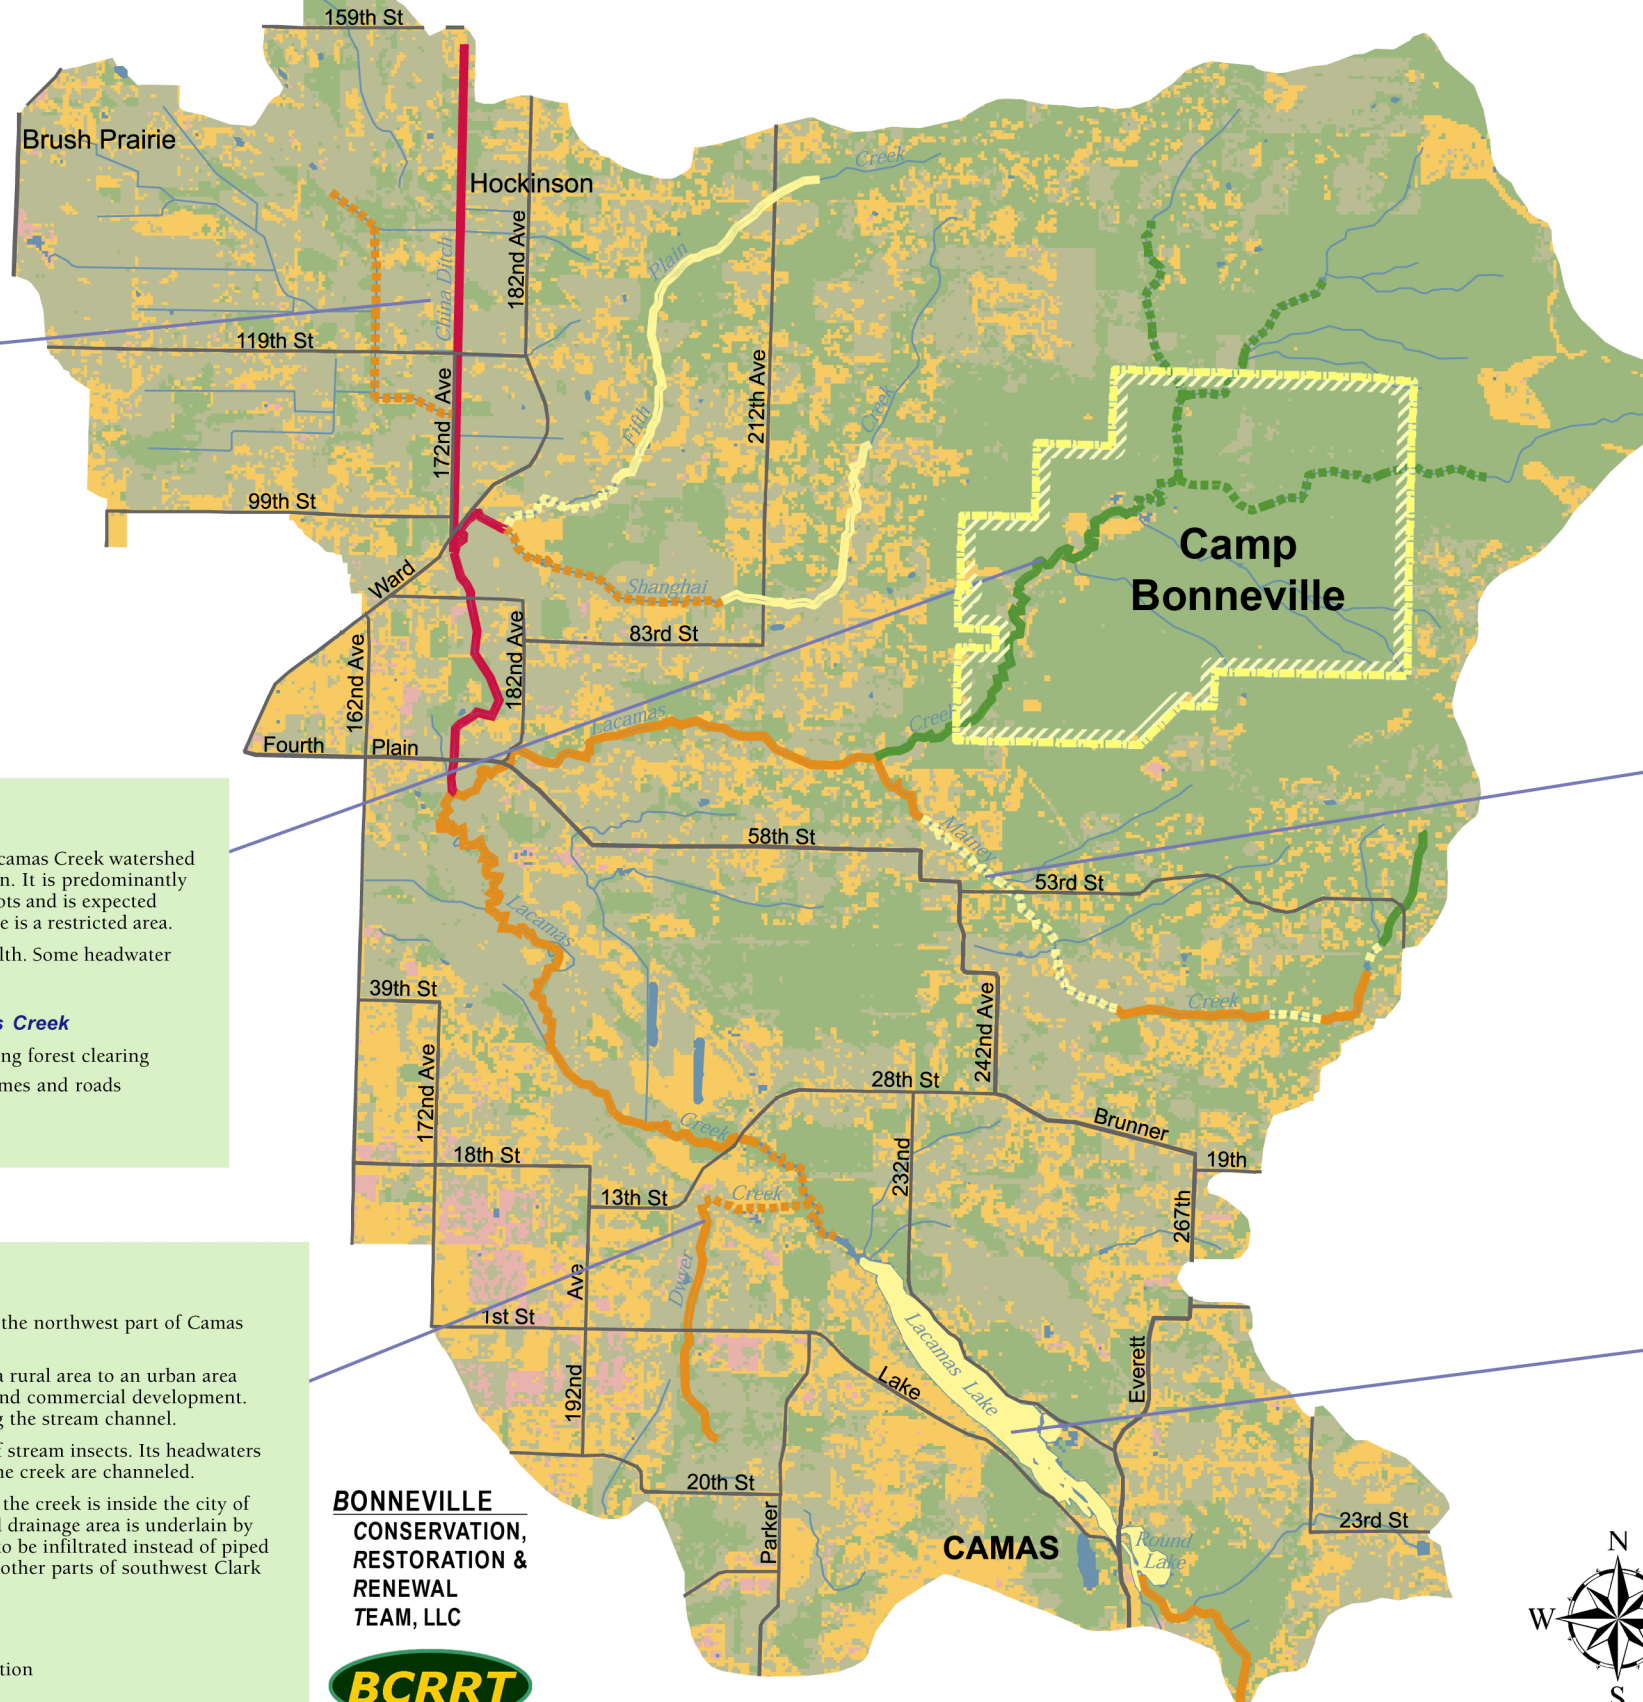
## Lacamas Creek Watershed Stream Health 2003

Stream Health Ratings	Description	Land Cover Key
Excellent	Pristine, superior, or unsurpassed condition; minimal human disturbance	Forest
Good	Healthy enough to support aquatic life and recreation	Grass/Shrubs
Fair	Degraded but may support aquatic life and recreation	Residential/ Recently cleared land
Poor	Inferior health, poorly suited for aquatic life and recreation	Commercial/ Industrial
Very Poor	Severely degraded health; unsuitable for aquatic life or recreation	
Unassessed	No data collected	
Probable	Predicted stream health

This figure is from the report "Monitoring Report: Lacamas Lake Annual Data Summary for 2005".

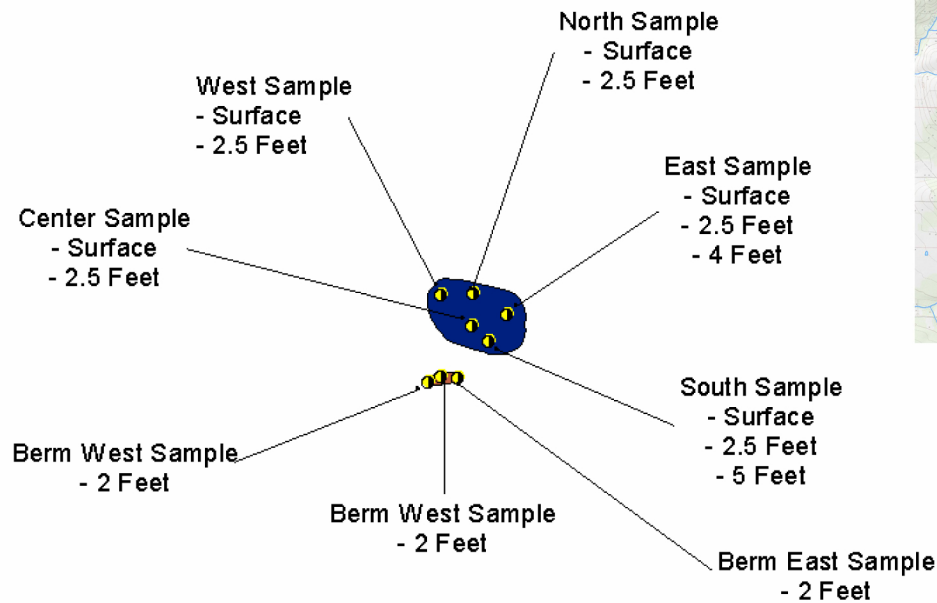
## Soil Sample Locations at Demolition Area 2

- Sample Points
- Demolition Areas
- Berm
- Demolition Area 2

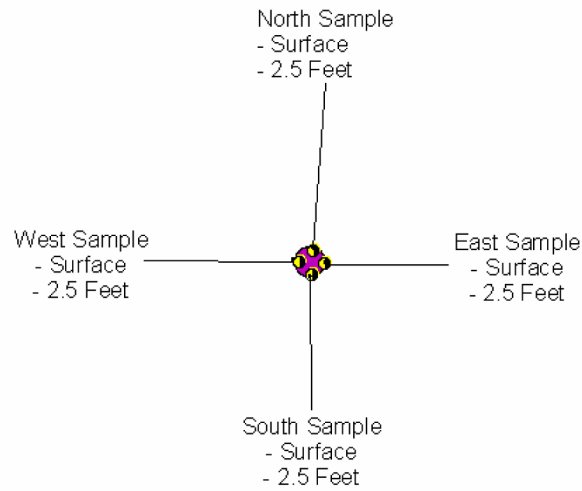
## Soil Sample Locations at Demolition Area 3

● Sample Points  
Demolition Areas  
■ Demolition Area 3
