Subject: Independent Cleanup Action – LUST Release #3910
– Status Report, dated November 19, 2020
Ecology FS ID: 63168342 / CS ID:9951

Filename: FSID63168342 - 20201119ICA-StatusReport - UST

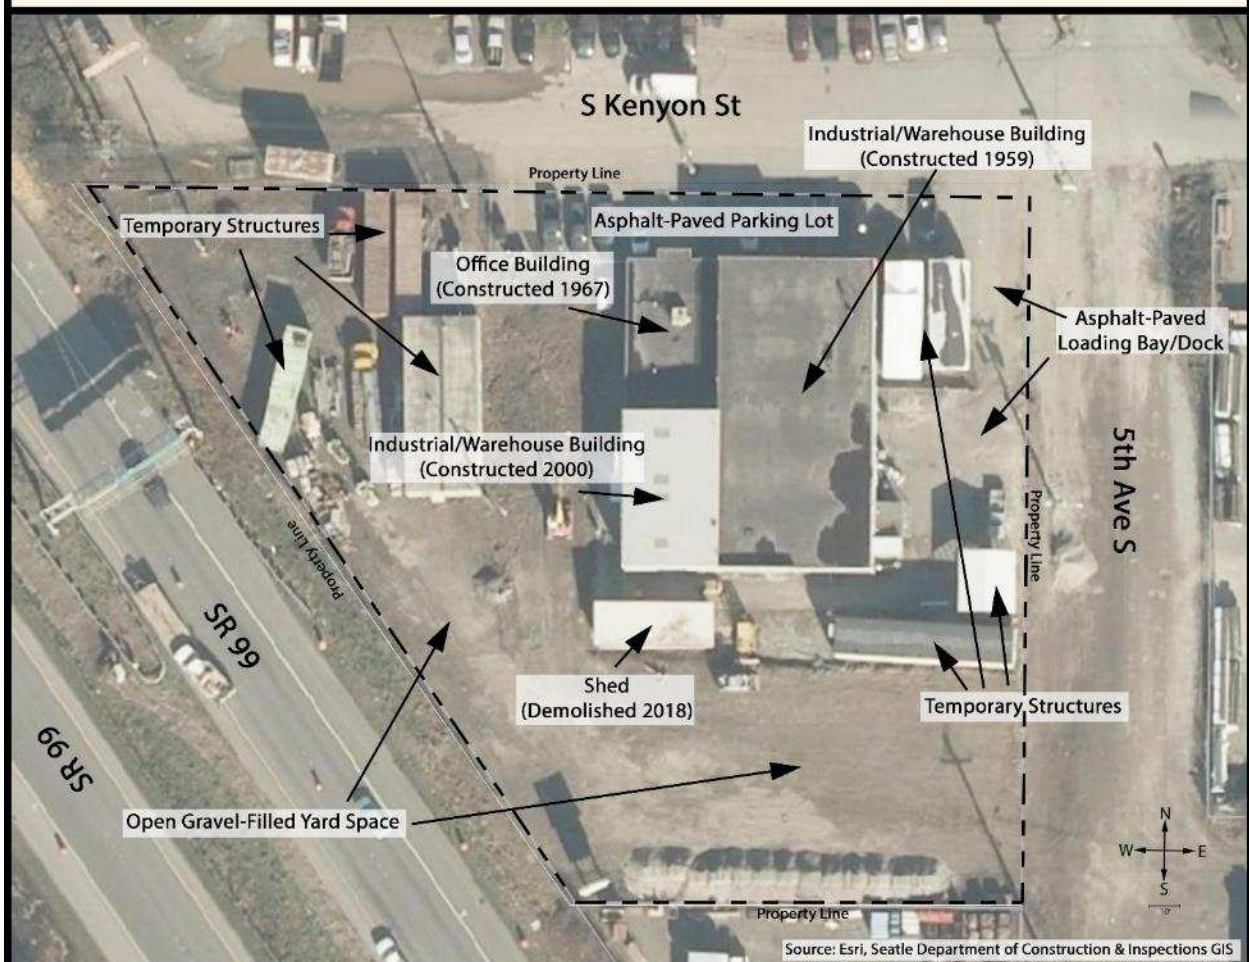
Diagram 2 Site Overview of 327 S Kenyon St

- A 5,000ft.² building constructed in 1959 used primarily as a factory and warehouse space.
- A 1,500ft.² office building constructed in 1967.

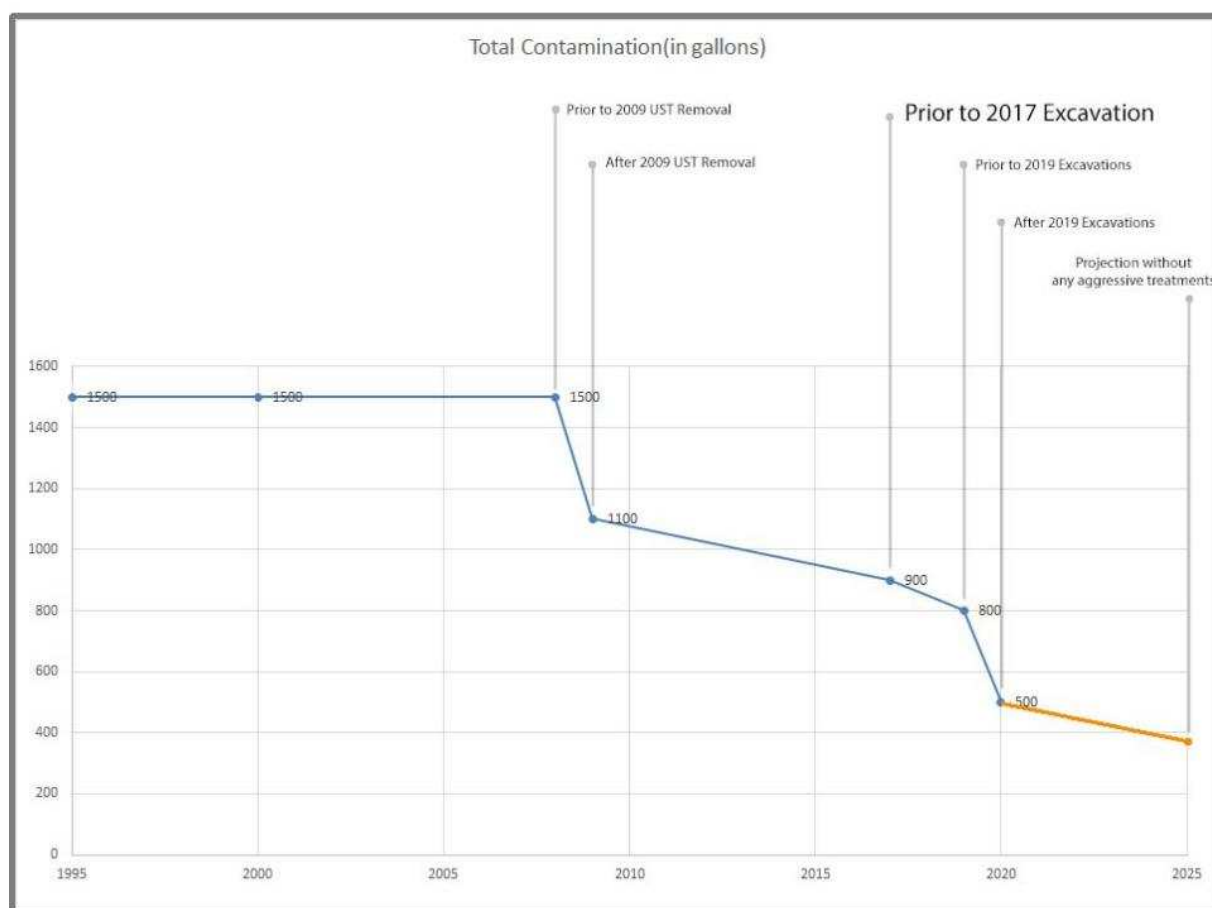
Diagram 10
Total Stoddard Solvent Contaminant Volume Estimate
of 327 S. Kenyon Over Remediation Timeframe

The graph above shows our estimate of pollution removed to date and an estimate of how much additional pollution may be removed in years ahead simply by natural attenuation from exhaust of remaining underground VOC's through the network of VES lines installed, even without motor driven vacuum or pressure applied. We believe this is the most sensible and economical way to proceed. It relies on natural bioremediation working over a long period of time to gradually make the soil healthy and corrode the remaining solvent by oxidation into non-polluting fractions.

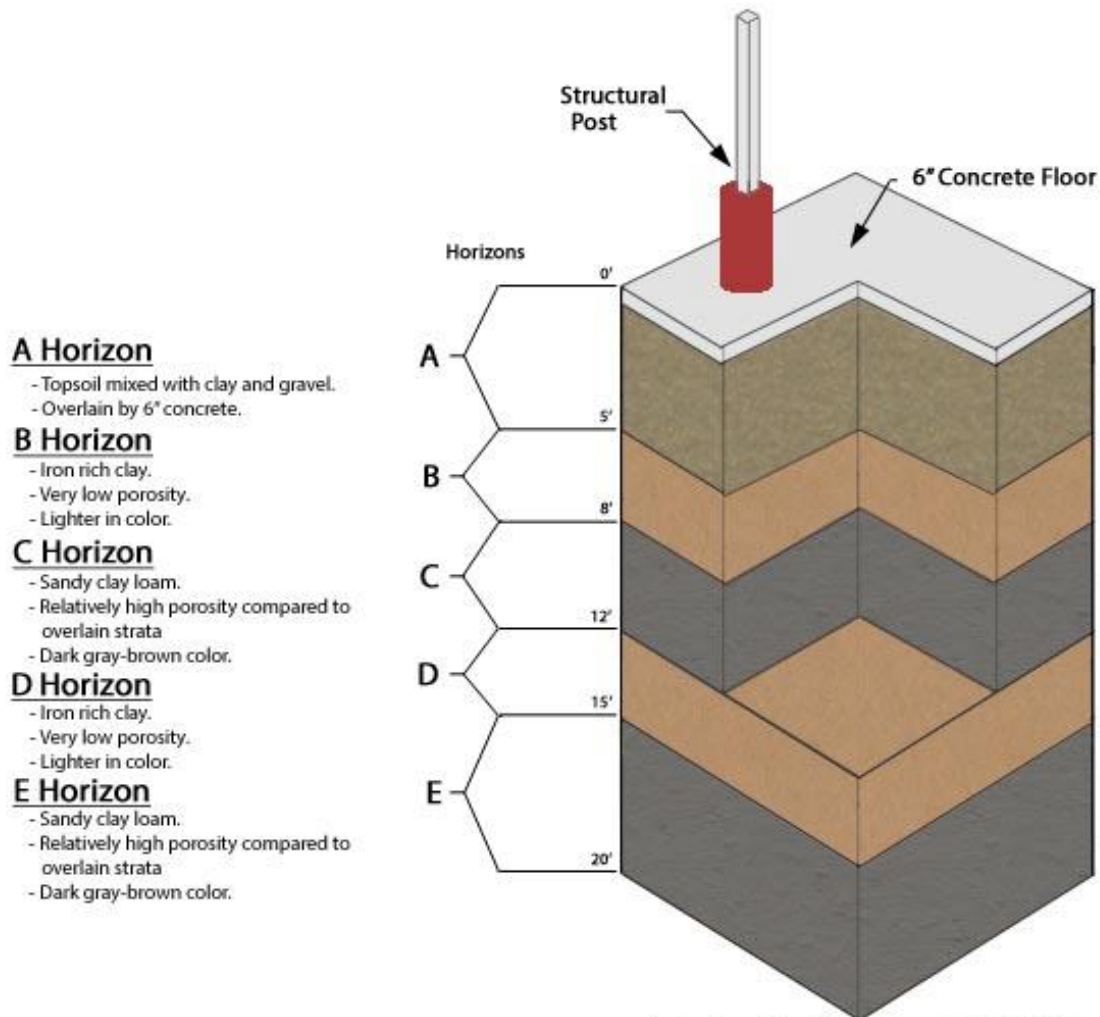
Soil Profile of Warehouse at
327 S. Kenyon St.
Seattle, WA 98108

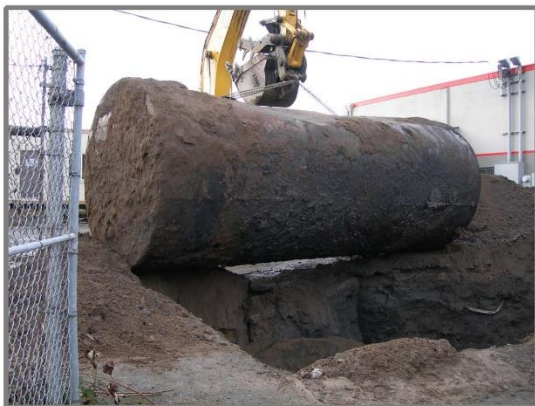
Frame 1-1: 7,500 gallon Underground storage tank(UST) removal. (3/3/2009)

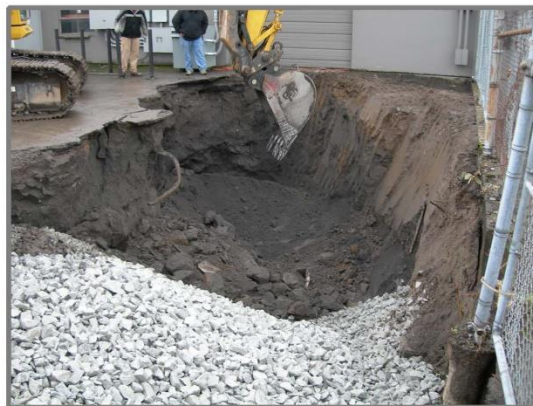
Frame 1-2: Soil was excavated to ~10ft. below grade around the location of the UST and along the feed line from the UST to the warehouse. (3/5/2009)

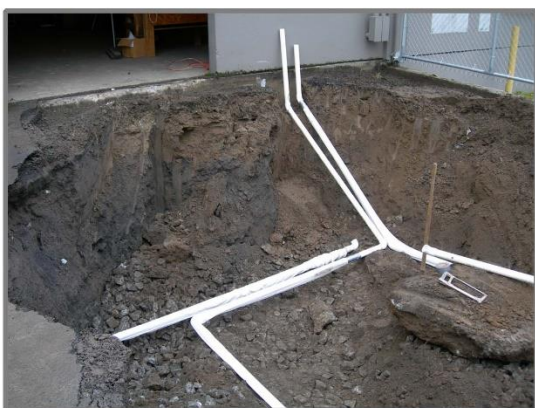
Frame 1-3: A vacuum extraction system(VES) was installed to pull vapor from the remaining contaminated soil surrounding the excavation. (3/5/2009)

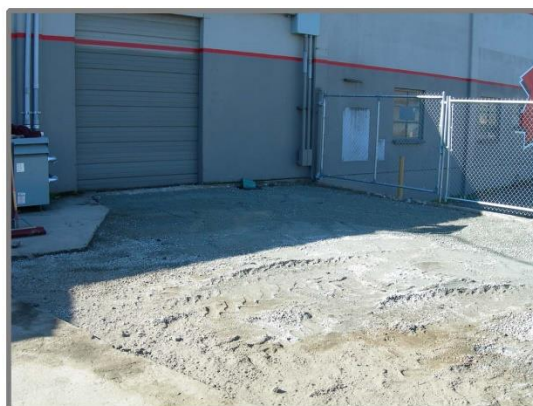
Frame 1-4: Excavation was filled with drain rock and closed. (3/6/2009)

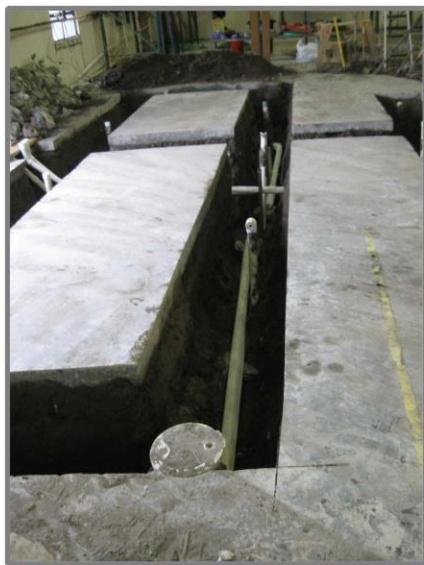
Frame 2-1: Trenches made in warehouse to install VES and water processing lines. (12/16/2009)

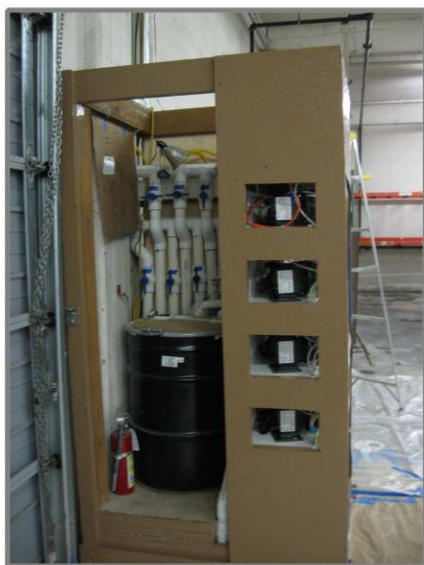
Frame 2-3: Cabinet to house paristaltic pumps, settling drum VES valves and H2O filters. (1/27/2010)

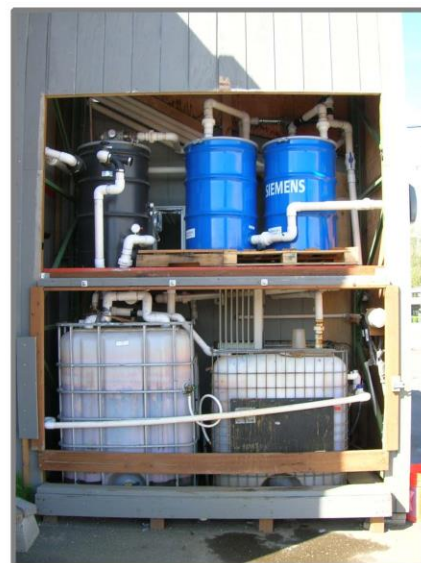
Frame 2-4: Processing Shed. Carbon filters in the steel drums and related plumbing are for the VES system. The two tank shown at the bottom are sediment tanks for processing the water from the paristaltic pumps. (1/2010)

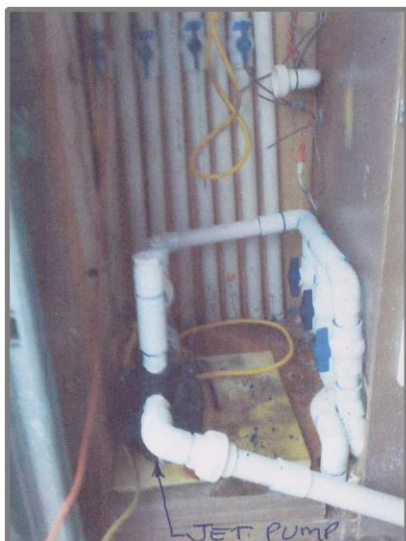
Frame 3-1: Inside the processing cabinet. The jet pump was used to push RegenOx ORC or alternatively hydrogen peroxide treatment to a drain field under the warehouse. (6/2011)

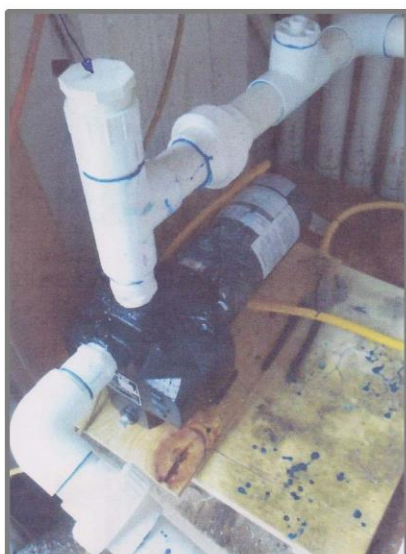
Frame 3-3: In January 2013, we began a series of hydrogen peroxide treatments. An 8% H₂O₂ solution was further diluted with water to 0.16% and injected via a jet pump. (6/2011)

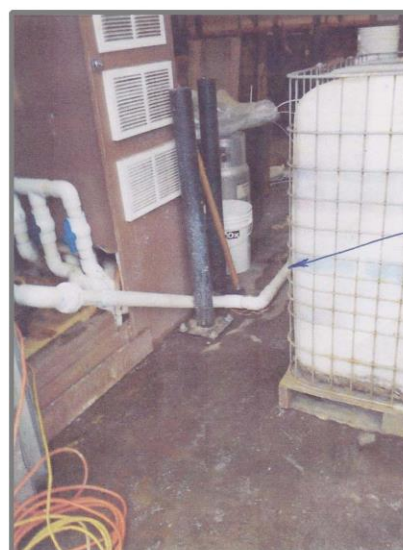
Frame 3-4: (Looking SW)In total from 6/2011 to 12/2013, two RegenOx ORC treatments and four hydrogen peroxide treatments were conducted. (6/2011)

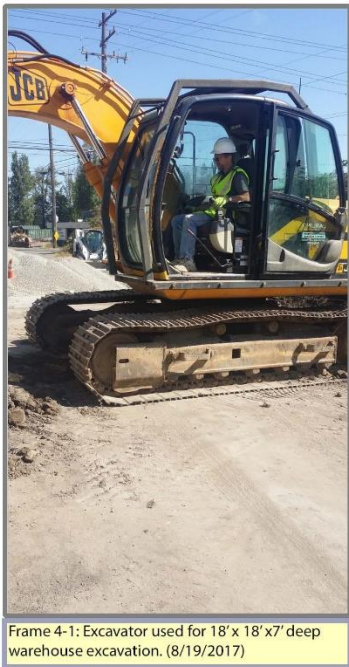
Frame 4-1: Excavator used for 18' x 18' x 7' deep warehouse excavation. (8/19/2017)

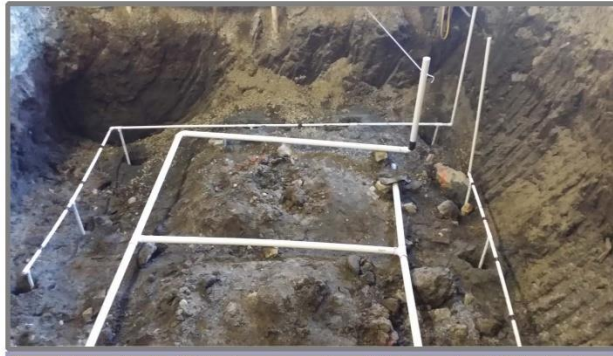
Frame 4-2: (Looking North)Warehouse excavation at 7' below grade with VES plumbing installed. (8/20/2017)

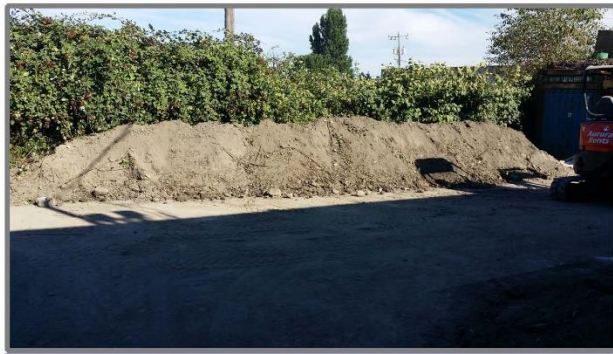
Frame 4-3: (Looking ESE)Excavation stockpile in the yard east of the warehouse. (8/20/2017)

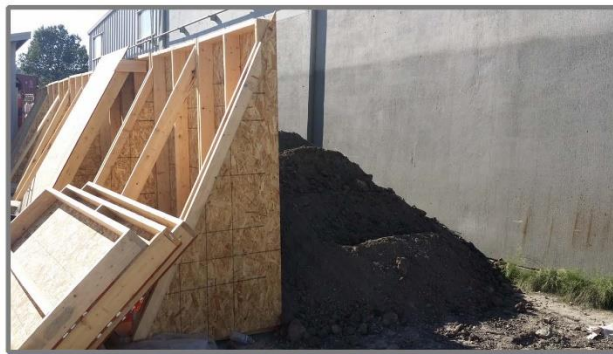
Frame 4-4: (Looking NW)Additional stockpile south of the warehouse. (8/20/2017)

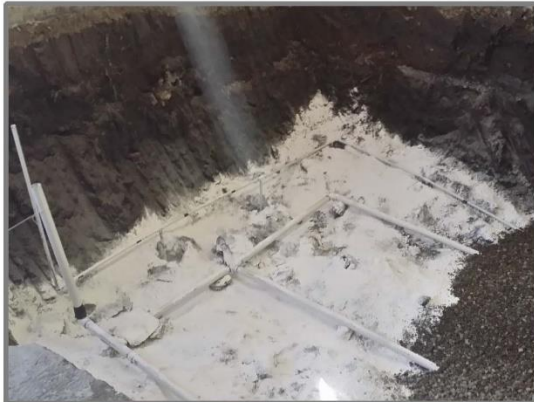
Frame 5-1: Application of lime in excavation prior to being filled with drain rock. (8/21/2107)

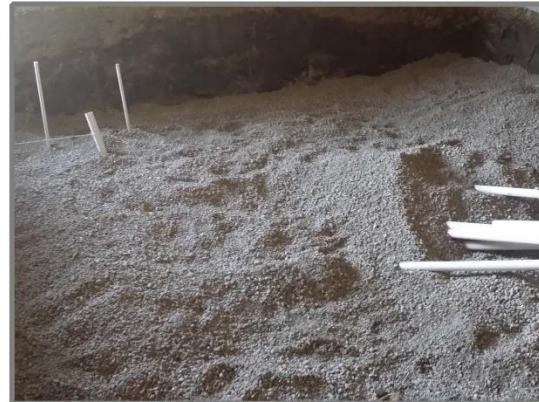
Frame 5-2: (Looking ESE)Excavation partially filled with drain rock. (8/21/2017)

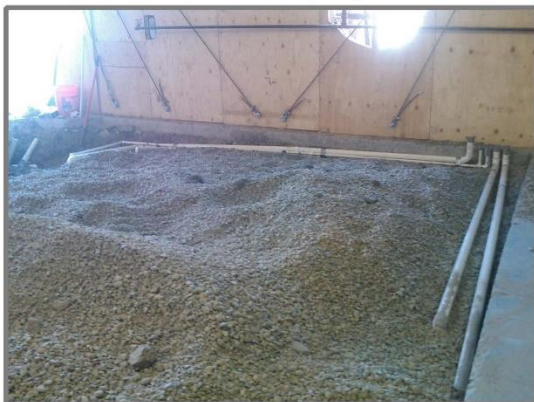
Frame 5-3: (Looking ENE)Excavation filled to grade with grade-level VES plumbing shown. (8/22/2017)

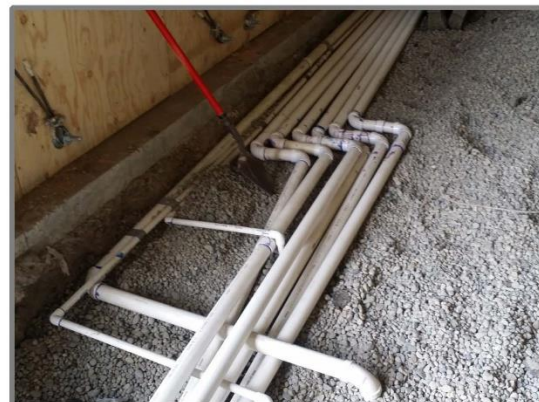
Frame 5-4: (Looking SE)Grade-level VES plumbing network leading south along the east wall of the warehouse to the processing shed. (8/23/2017)

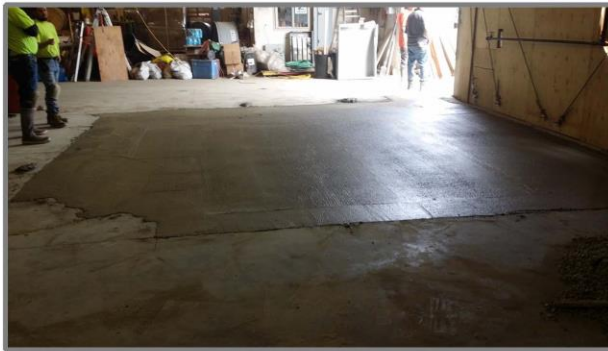
Frame 6-1: Excavation closed with vapor barrier and reinforced concrete. (8/24/2017)

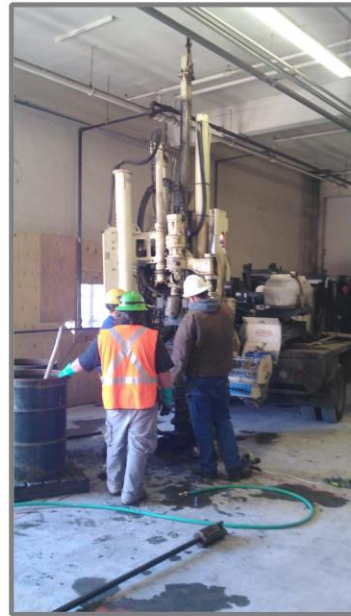
Frame 6-2: Borings for new well installation.
Installation performed by ESN Northwest Inc.
(11/6/2017)

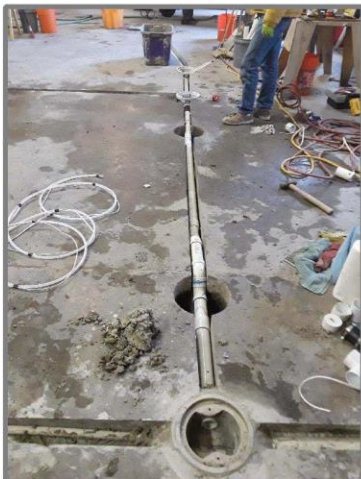
Frame 6-3: A total of eight 2" production wells were installed. Six in the warehouse and two outside. Over the next two years, seven more production wells would be installed. Four inside and three outside. (11/12/2017)

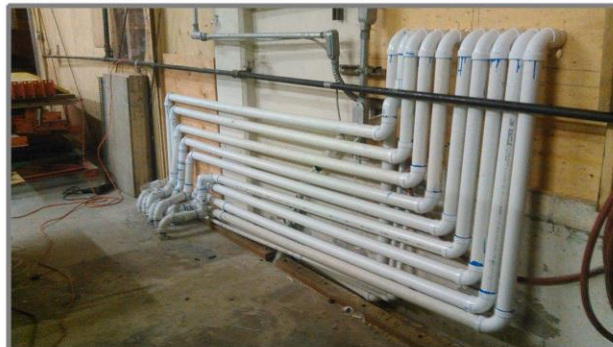
Frame 6-4: Water treatment and new VES lines from the six warehouse production as well as the two outdoor lines converge at the processing sheds on the other side of this wall. (11/28/2017)

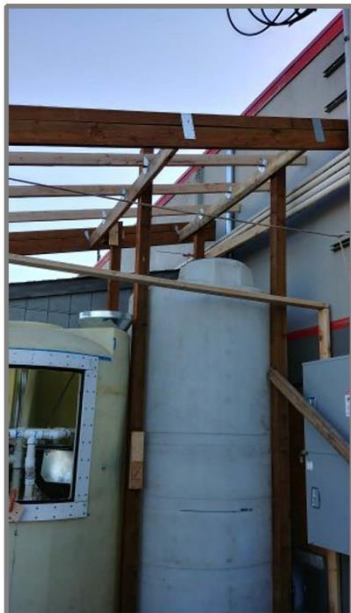
Frame 7-1: Construction of the new sediment tank(right) and Air Stripper 1(left). (3/31/2018)

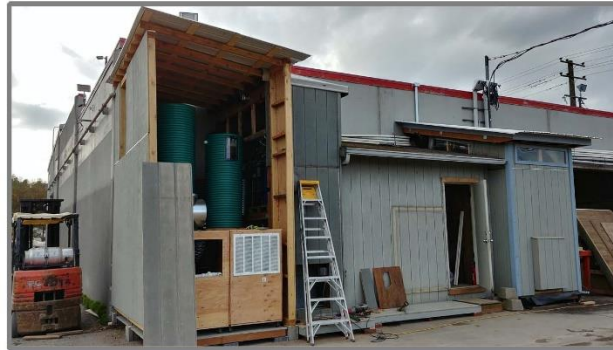
Frame 7-2: Construction of the upgraded processing system included a 750-gallon sediment tank and Air Stripper 1 in the shed on the right of the image and Air Strippers 2 and 3 in the shed on the left. (4/21/2018)

January through April of 2018 was spent primarily fabricating Packed-Tower Air Strippers 1, 2 and 3 and constructing two additions to the Processing Shed to house the Sediment/Clarifier tank and the three air strippers. See Appendix B-8 – Frame 7-2.

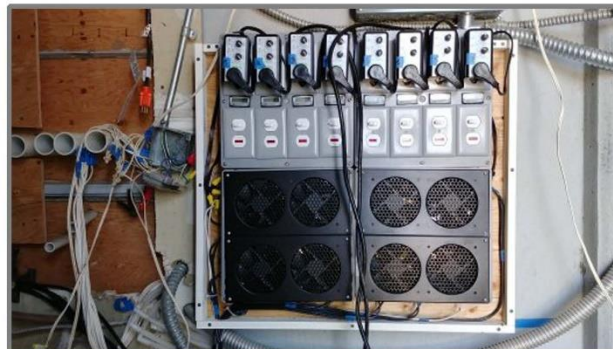
Frame 7-3: Controller panel for the production well inline pumps. Each pump was capable of pumping ~2gpm. However, to avoid overloading the treatment system and wearing out the pumps, each pump was set to run on a time cycle appropriate for each well. (5/24/2018)

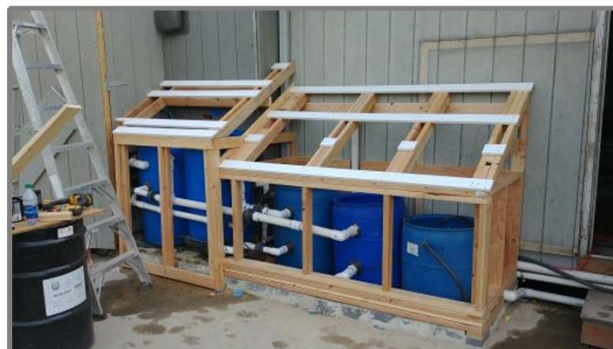
Frame 7-4: From left to right; two drums used to cycle treatment water through Air Strippers 2 & 3 to provide multiple pass throughs and overflow protection, two drums containing organoclay filter material and a return line drum that fed cleaned water back into the ground. (6/8/2018)

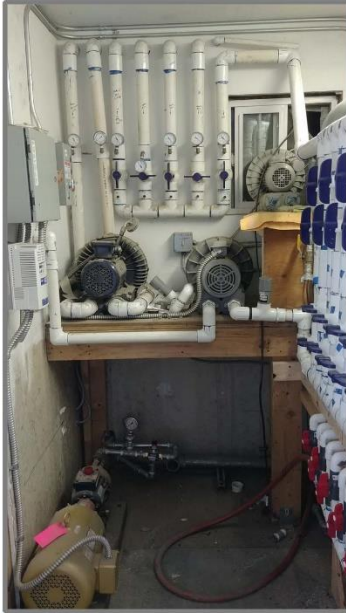
Frame 8-1: (Inside Central Processing Shed)Pumps for VES. The larger black pump on the left blows clean air into the ground through the VES plumbing. The gray pump to its right pulls vacuum from the wells and sparge lines into a carbon filtration system on the other side of the wall to the south. On the wall to the left(east wall) are controllers for the two pumps. (8/22/2018)

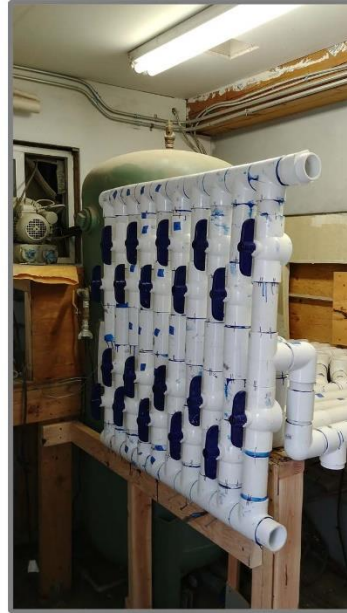
Frame 8-2: (Inside Central Processing Shed)Upgrade of the VES system. The valves shown control whether a well is being blown into with clean air via the blower or VOCs being pulled through the vacuum pump to a carbon filtration system. (8/22/2018)

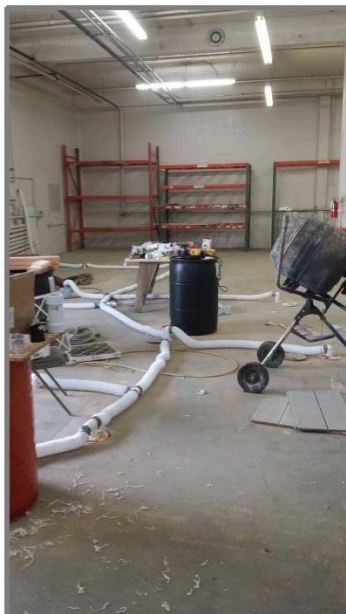
Frame 8-3: (Looking S) Additional VES lines added for each production well that was installed in the warehouse in 2017. (12/21/2018)

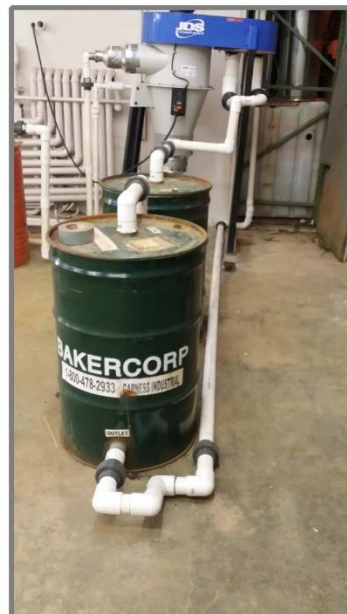
Frame 8-4: (Looking E) Additional vacuum pumps and carbon filters(black steel drums) added to the VES system. (5/20/2019)

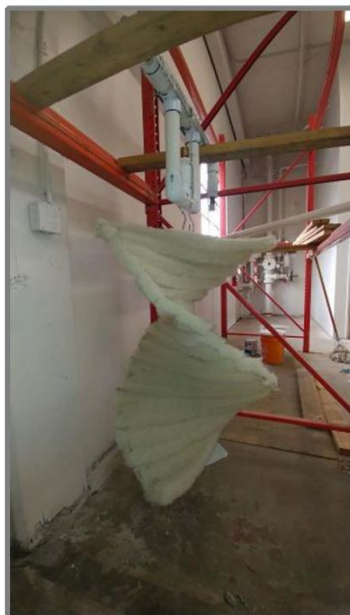
Frame 9-1: Interior design of Air Stripper 2. A brass nozzle sprays water up and the resultant mist falls through the helical media below. (12/1/2018)

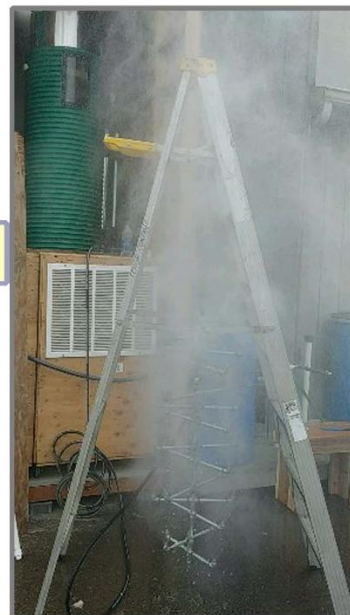
Frame 9-2: Demonstration of Air Stripper 3's spray nozzle system. (4/30/2018)

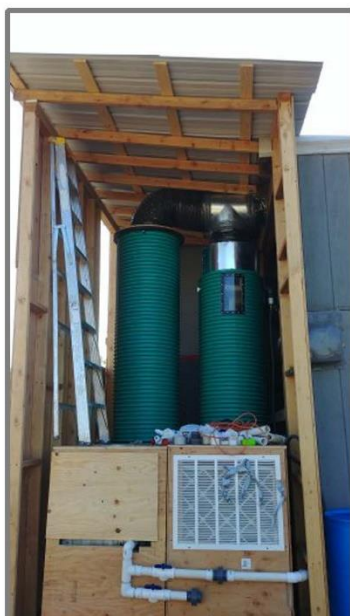
Frame 9-3: (Looking W)South processing shed with Air Strippers 2 and 3 completed. (5/6/2018)

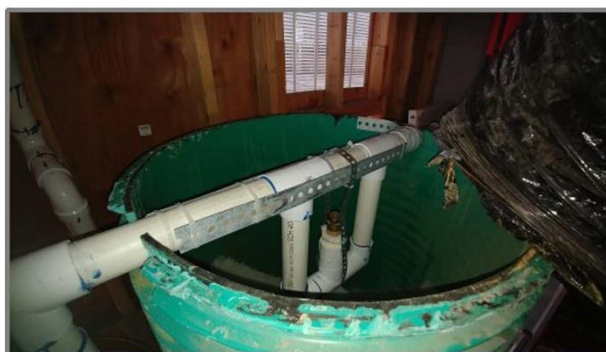
Frame 9-4: In the fall of 2018, Air Stripper 3's original design was replaced with one that was the same as Air Stripper 2(shown above). (5/6/2018)

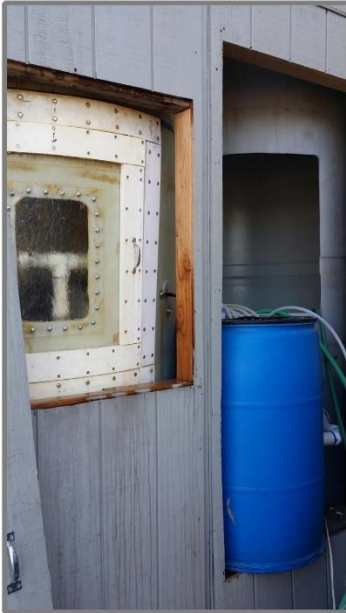
Frame 10-1: (Looking SW) North processing shed completed with blue inflow drum collecting water from wells. The water then feeds into a 7,500 gallon sediment tank(shown behind the inflow drum) before feeding into Air Stripper 1(shown on left). (5/11/2018)

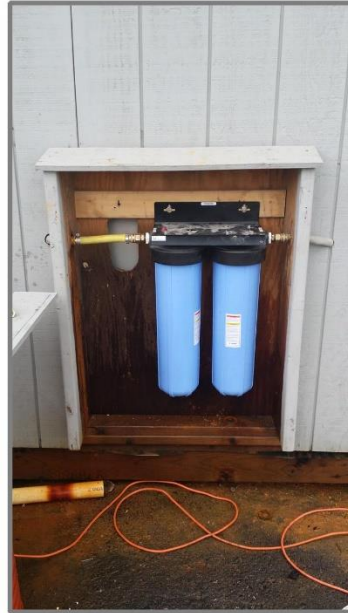
Frame 10-2: (Looking W) Water from the sediment tank is sent through these water filters before entering Air Stripper 1. (2/19/2019)

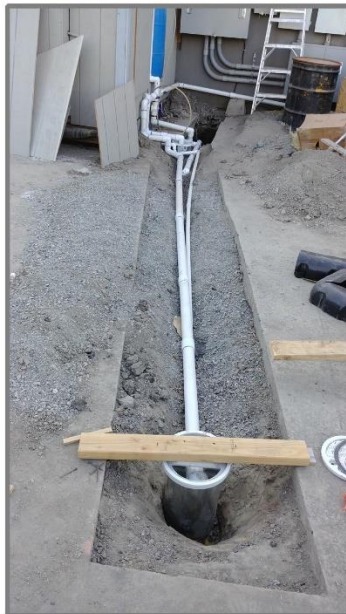
Frame 10-3: (Looking SW) A trench was dug in an area just south of the location of the UST southwest to the north processing shed. VES lines and two processing wells were installed at that time. (9/4/2018)

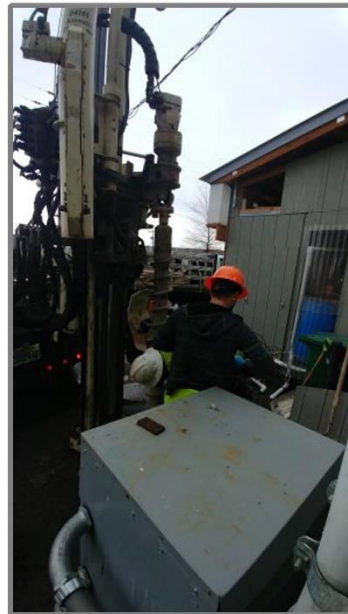
Frame 10-4: (Looking SE) In addition to the two wells shown in Frame 11-3, an additional well was installed later in front of the central processing shed. (2/18/2019)

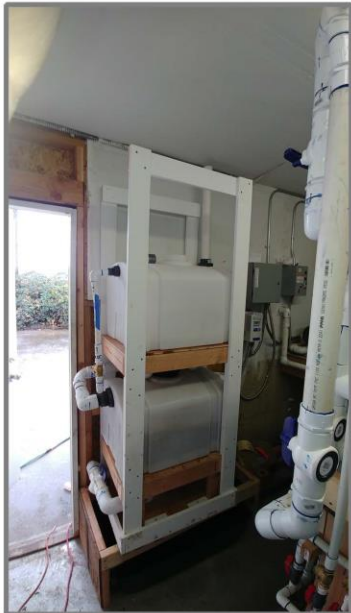
Frame 11-1: Two additional organoclay filters were added to the processing system. (11/22/2018)

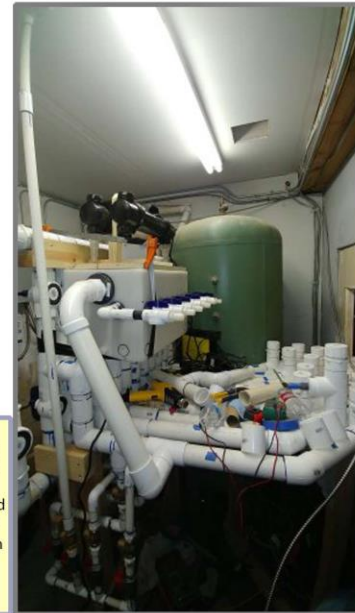
Frame 11-2: The last step prior to treated water being returned to the ground was for it enter a small holding tank where it could be mixed with a controlled amount of hydrogen peroxide and then pass through a UV bath (black apparatus shown in the photo). (12/1/2018)

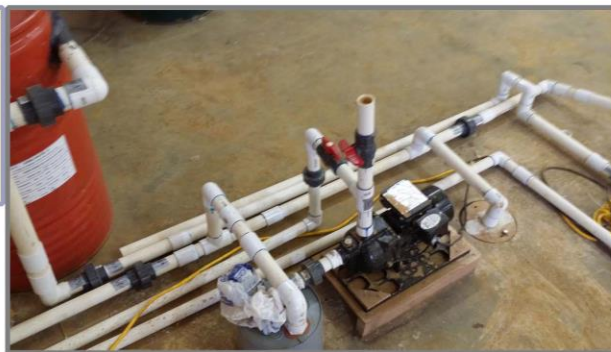
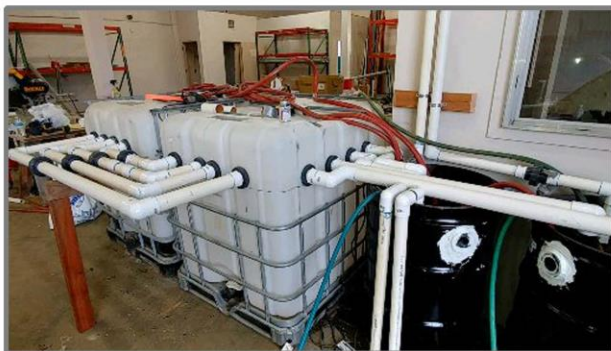
Frame 11-3: Replaced several inline pumps with jet pumps to increase the processing throughput by ~100%. (5/20/2019)

Frame 11-4: To handle the increased amount of water being pumped by the jet pumps, two additional 250 gallon sediment tanks along with 2 drums to transfer water to the rest of the system were added. (3/24/2019)

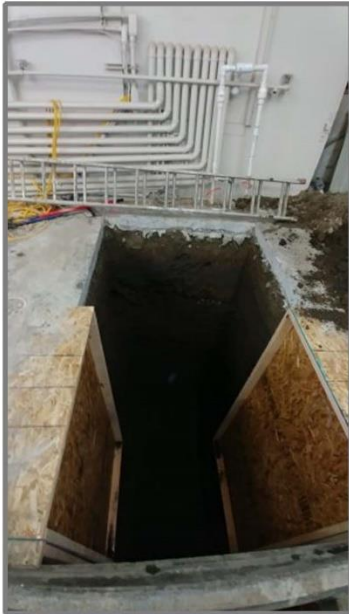
Frame 12-1: (Looking E)5' x 10' x 10' deep exploratory excavation in the SE corner of the warehouse. Testing showed that this area was at the southernmost extent of the zone of contamination. (7/4/2019)

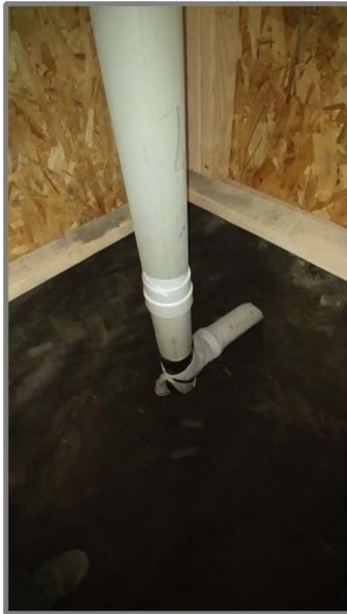
Frame 12-2: (Looking NE)At ~10ft. below grade, this 2" perforated lines was installed horizontally to the east under warehouse wall. It was then plumbed to allow passive venting, VES extraction, and in-situ treatment injection. (8/12/2019)

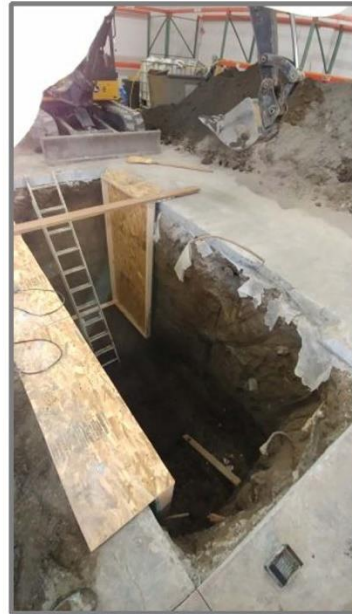
Frame 12-3: (Looking SW)5' x 10' x 10' deep exploratory excavation ~30' north of the warehouse's south wall and ~20' east of the warehouse's west wall. Testing showed that only the northeast corner of the excavation contained contaminated soil. (7/2/2019)

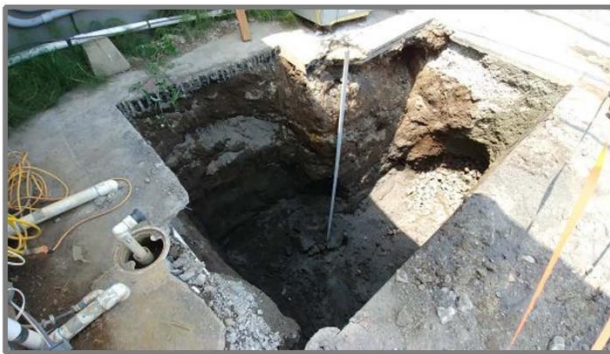
Frame 12-4: (Looking NW)This 10' deep excavation was in an area known to still be contaminated. Located just north of the the north processing shed, the main purpose of this excavation was to remove what was thought to be some of the most contaminated remaining soil left and to install a gallery of horizontal treatment lines to the east under the warehouse wall and to the south under the processing sheds. (7/2/2019)

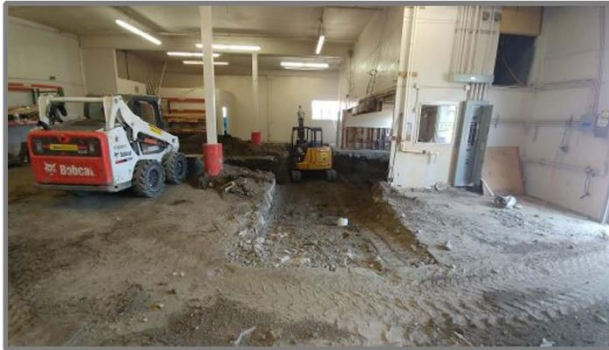
Frame 13-1: (Looking N) After a thorough survey to fully map out the full extent of the contaminated soil, it was determined that the best course of action was to excavate as much of the contaminated soil as possible. Within the warehouse, this was accomplished in four separate phases. Phase 1 being a roughly 20' x 12' x 10' deep area at the north end of the warehouse. Phase 2 a somewhat larger ~20' x 20' x 10' deep area just to the south and connected to Phase 1. Phase 3 being a smaller ~10' x 10' x 10' deep area to the west of the warehouse garage door. Phase 4 a ~18' x 25' x 10' deep area mostly overlapping to 2017 excavation. (8/3/2019)

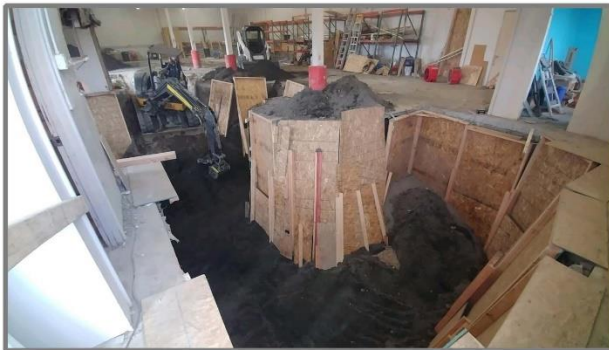
Frame 13-2: Shoring was installed along the side walls of the excavations to ensure the stability of the workspace. (8/29/2019)

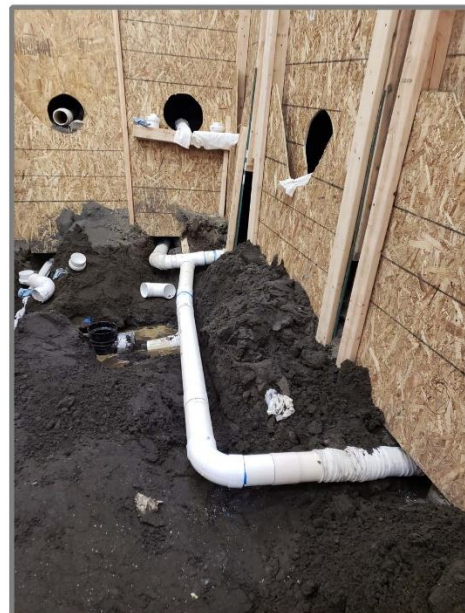
Frame 13-4: The gallery of horizontal lines at ~10'-11' depth were connected to a central collector pipe. There is one collector pipe in each of the four phases. (9/20/2019)

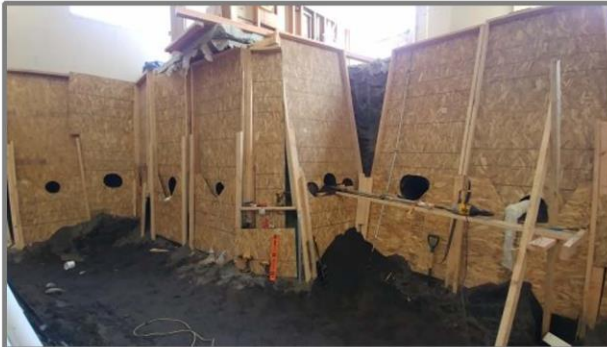
Frame 14-1: (Looking NE)A 1 1/2" drill was used to create 6" diameter x 10' long borings for the 1 1/2" and 4" gallery of lines going under the walls of the warehouse. (8/24/2019)

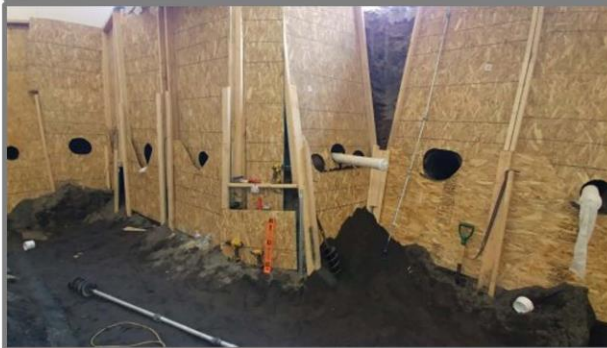
Frame 14-2: (Looking NE)Between the four phases, the gallery of horizontal lines totals 62: (8) 1 1/2" lines at 8' below grade, (30) 4" lines at 8' below grade and (24) 4" lines at ~10'-11' below grade. Additionally, there is (1) 4" line at ~10'-11' below grade in the south exploratory trench and (1) 1 1/2" and (2) 4" lines at ~11' below grade, (1) 1 1/2" and (1) 4" line at 8' below grade and (1) 1 1/2" line at 6' below grade in the outdoor trench north of the north processing shed. (8/24/2019)

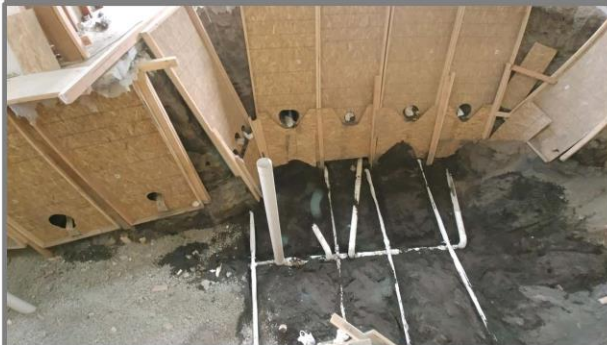
Frame 14-3: (Looking E)In addition to the horizontal lines in each phase, a network of 1 1/2" sparge lines sitting at bottom of the excavation ~10'-11' below grade and connected to the phase's collector line was installed. (8/31/2019)

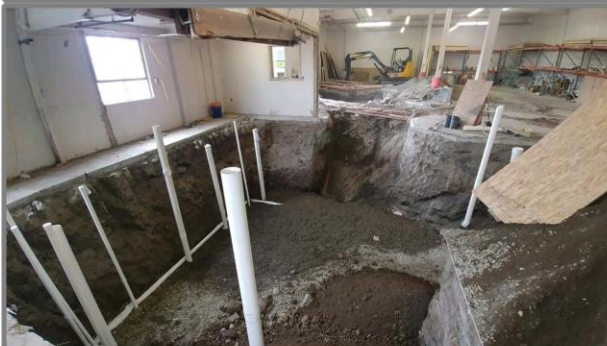
Frame 14-4: (Looking S)As work was completed inside each excavation phase, the shoring was removed and clean soil and drain rock was used to fill in the excavated area. Phases 1 and 2 were excavated together and filled sequentially as the work inside was completed. Work then moved onto phase 4 at the south end and then to phase 3 west of the garage door. (9/4/2019)

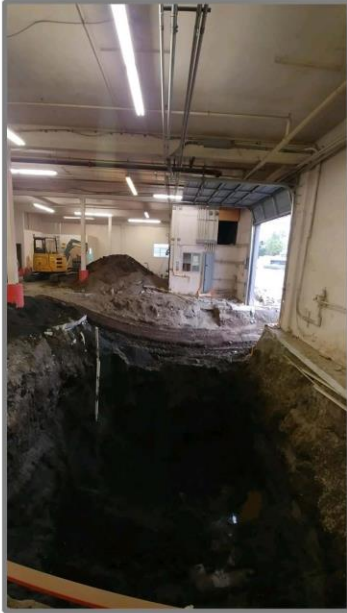
Frame 15-1: (Looking S)
Due to access restrictions,
Phase 4 was excavated,
worked in and partially
filled prior Phase 3 being
excavated. (9/20/19)

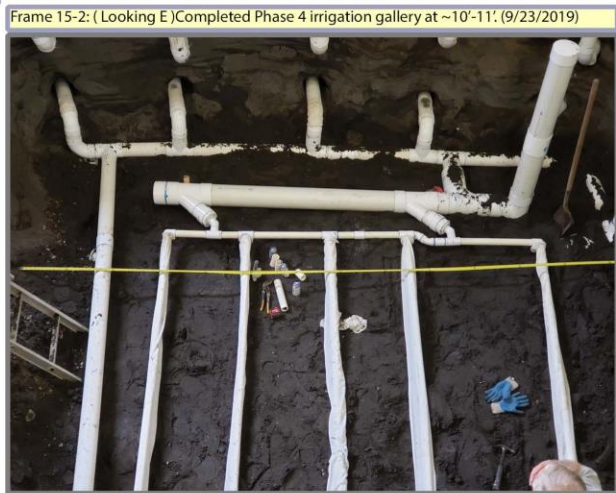
Frame 15-2: (Looking E) Completed Phase 4 irrigation gallery at ~10'-11'. (9/23/2019)

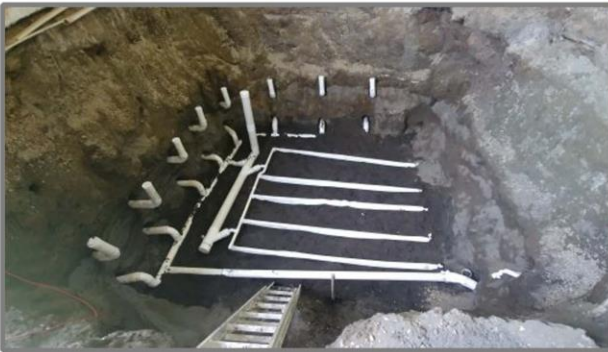
Frame 15-3: (Looking S) The
horizontal borings for the
irrigation gallery were
mostly aimed to access the
contaminated soil that we
weren't able to directly
excavated. This was mostly
under walls, support
columns and other
structural elements of the
warehouse. (9/23/2019)

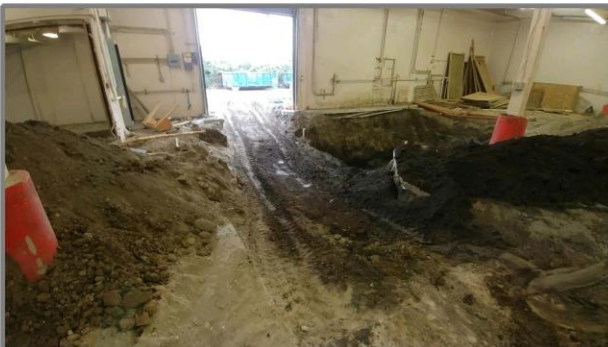
Frame 15-4: (Looking SE) Clean
soil was stockpiled inside the
warehouse(shown on the left
side of the image).
Contaminated soil was mostly
placed directly into boxes to be
hauled away by Republic
Services Inc. Small temporary
stockpiles were made(see the
right side of the image) when
space in the boxes ran out.
(9/20/2019)

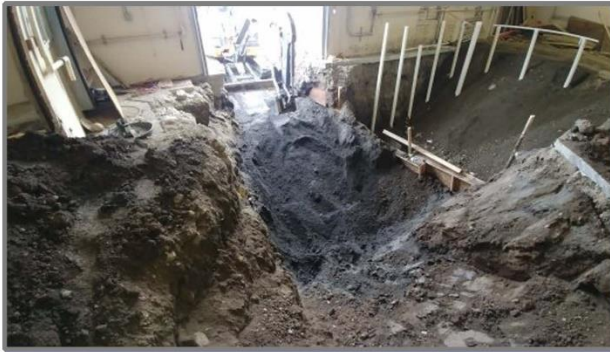
Frame 16-1: (Looking ESE)Phase 3 of the excavation was completed last as it's location necessitated a pathway for equipment to drive through while completing the other three phases. (9/27/2019)

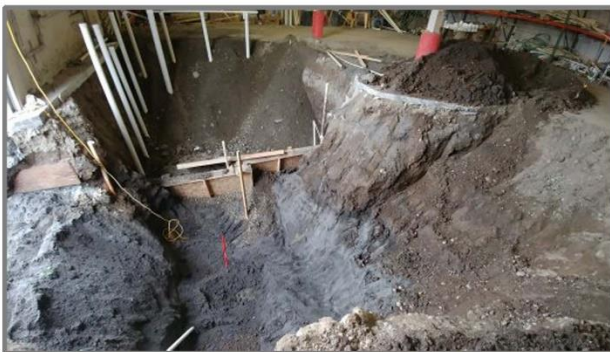
Frame 16-2: (Looking S)Due to logistical constraints, phase 3 wasn't able to be excavated as fully as the other phases. A depth of ~10'-11' was still reached, but the footprint was smaller. (9/27/2019)

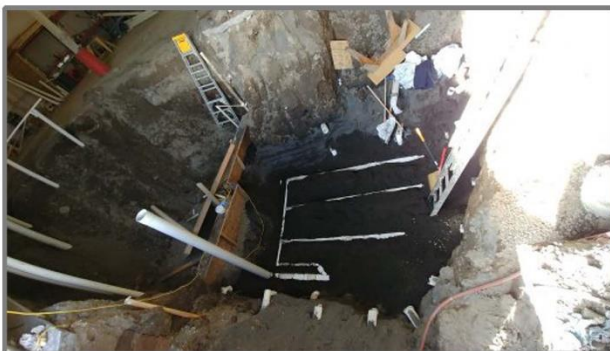
16-4: (Looking WSW)As with the other phases, phase 3's irrigation gallery consisted of: 4" pull/vent lines bored 8'-10' out horizontally from the perimeter of the excavation at ~10'-11' below grade, a gallery of sparge lines located ~10' below grade and 4" vent/treatment lines at ~8' below grade. (10/2/2019)

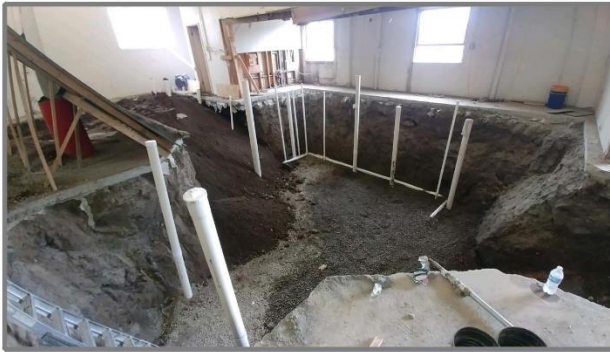
Frame 17-1: (Looking NE)The excavation were filled in with a mix of clean soil, 3/8 minus drain rock, pit run and gravel borrow. (9/20/2019)

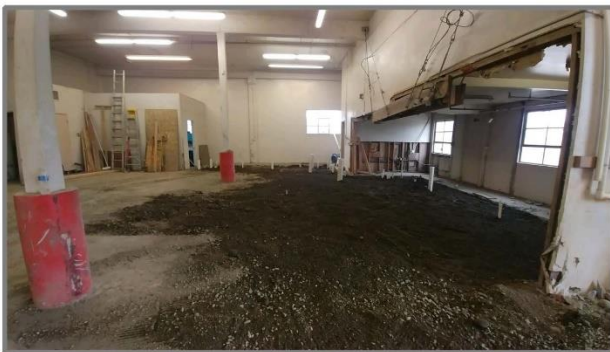
Frame 17-2: (Looking South)Drain rock was used to fill the bottom several feet with the other material(mostly pit run) overlain on top to grade. (9/20/2019)

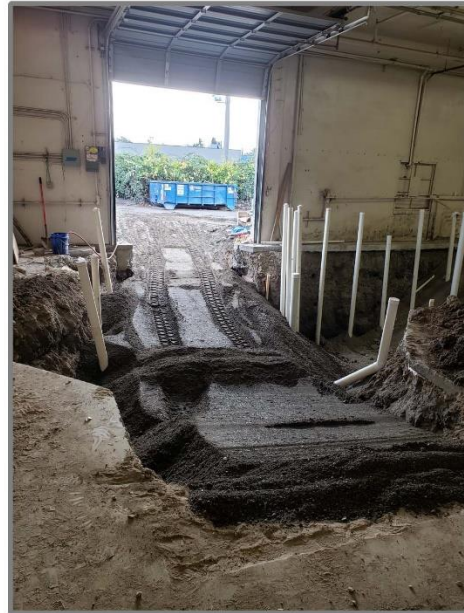
Frame 17-3: (Looking ESE)The plumbing in phase 3 had to be routed in such a way to allow equipment to pass through the area during the excavatiop infill. (10/4/2019)

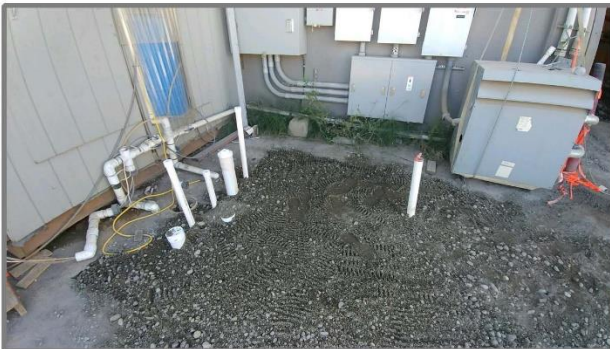
Frame 17-4: (Looking WSW) The three small trenches were also filled in at this time. (9/20/2019)

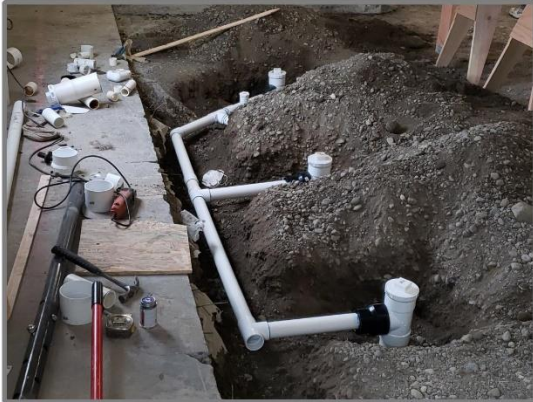
Frame 18-1: (Looking SWS)At grade plumbing for the irrigation/VES gallery. Each of the horizontal lines at ~8' below grade has it's own access point at grade and the collector lines for the ~10'-11' below grade gallery from each phase have a 6" access point at grade as well. (11/9/2019)

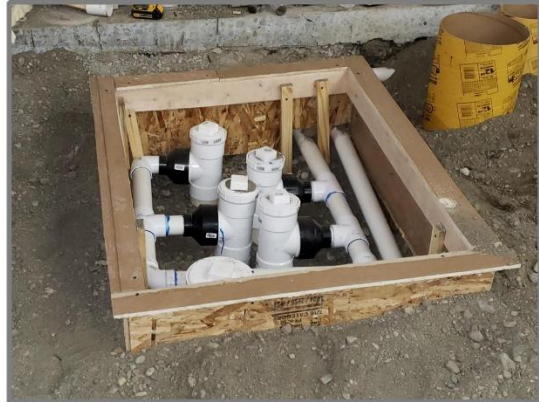
Frame 18-2: (Looking ESE)Some grade-level access points for the irrigation/VES gallery were too tightly clustered together for each to have their own monument. In situations like that shown above, a box form was built with the intention of an enclosure with a custom fitted steel plate covering to be made for each one. (11/28/2019)

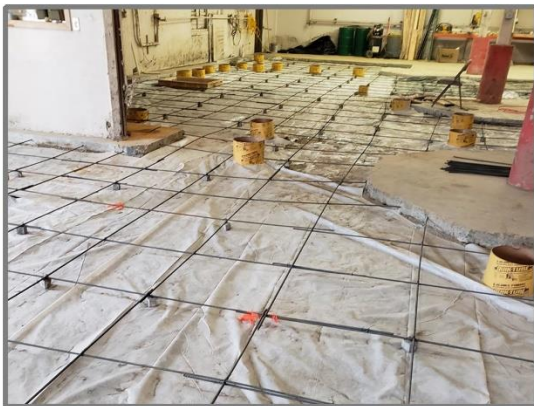
Frame 18-3: Before closing the excavation, a vapor barrier and rebar were installed. (12/17/2019)

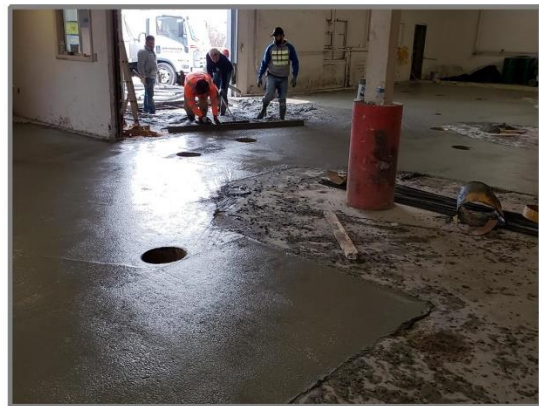
Frame 18-4: (Looking SE)Lucas Construction LLC of Marysville, WA was contracted to prepare and pour the concrete for the excavation. (12/18/2019)

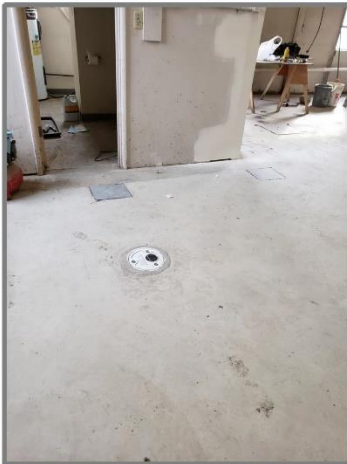
Frame 19-1: (Looking ESE)Each grade level access point has either a monument or a custom fit steel plate covering. In total there are (27) 10" and (8) 8" monuments. (2/24/2020)

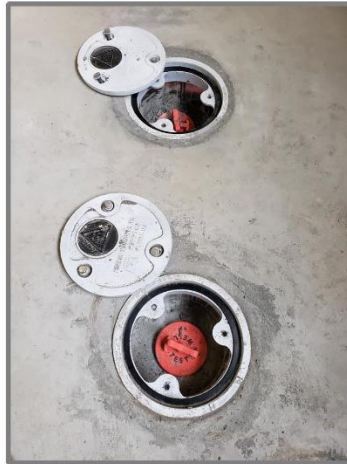
Frame 19-2: Each monument has a locking cap atop the access point as shown. (2/24/2020)

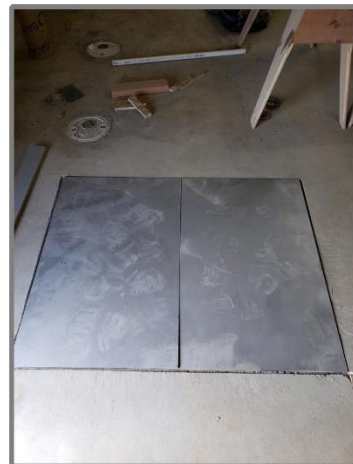
Frame 19-3: (Looking S)This steel plate covering, located immediately southwest of the garage door in the warehouse(enclosure shown in Frame 18-2), is the largest of eight custom fit enclosures. (3/11/2020)
