Subject: Independent Cleanup Action – LUST Release #3910
– Status Report, dated November 19, 2020
Ecology FS ID: 63168342 / CS ID:9951

Filename: FSID63168342 - 20201119ICA-StatusReport - UST

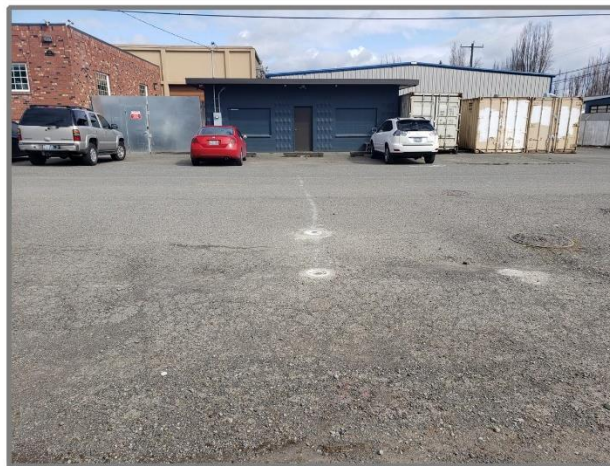
Frame 19-4: (Looking N)Two monitoring wells located to the north of the warehouse. The nearer of the two is located at the north property line. The farther monitoring well is at where we have determined is the current northernmost extent of soil contamination. (4/3/2020)

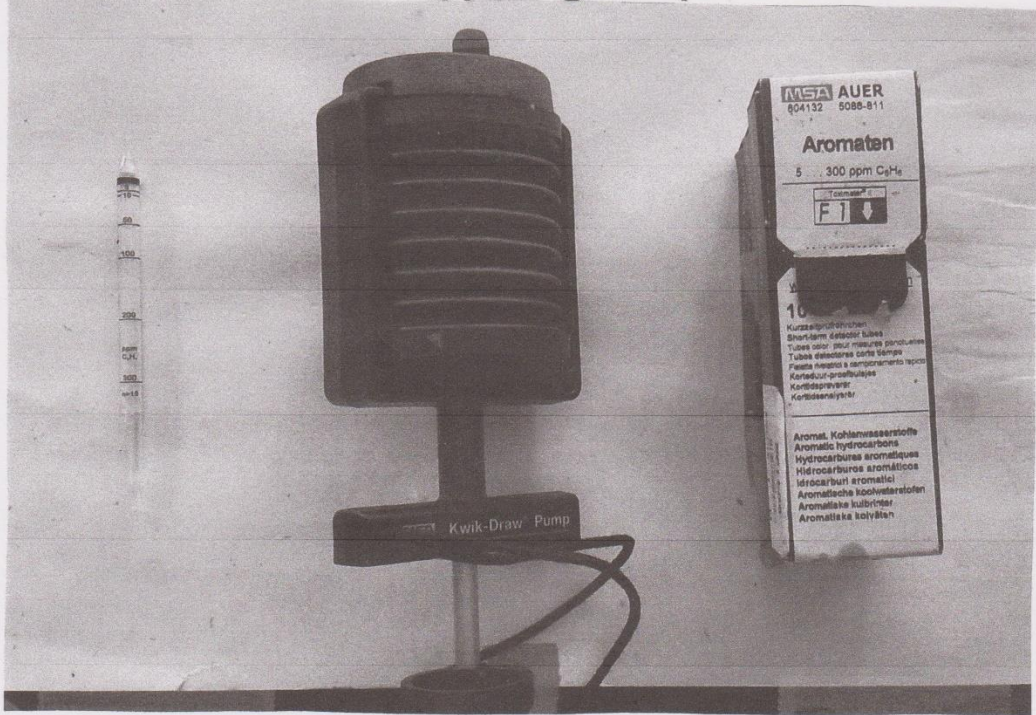
Kwik-Draw® Sampling Pump

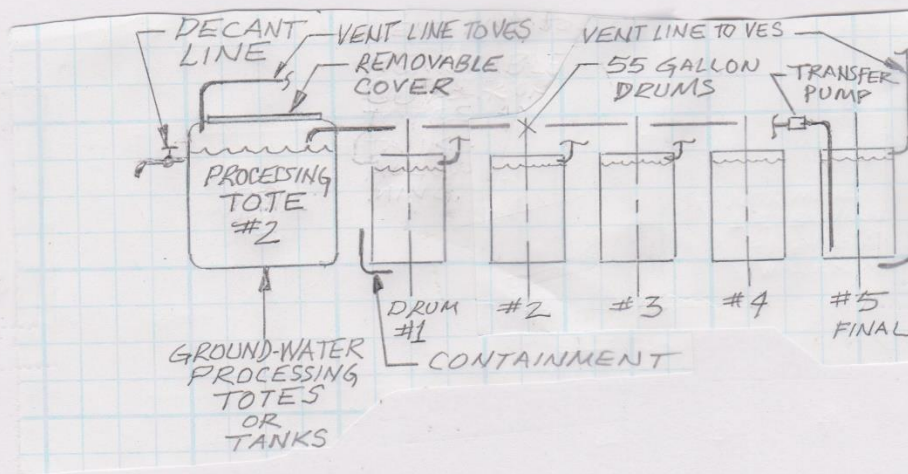
FREE PRODUCT PRODUCTION (FROM TANK SKIMMING & DECANTING)

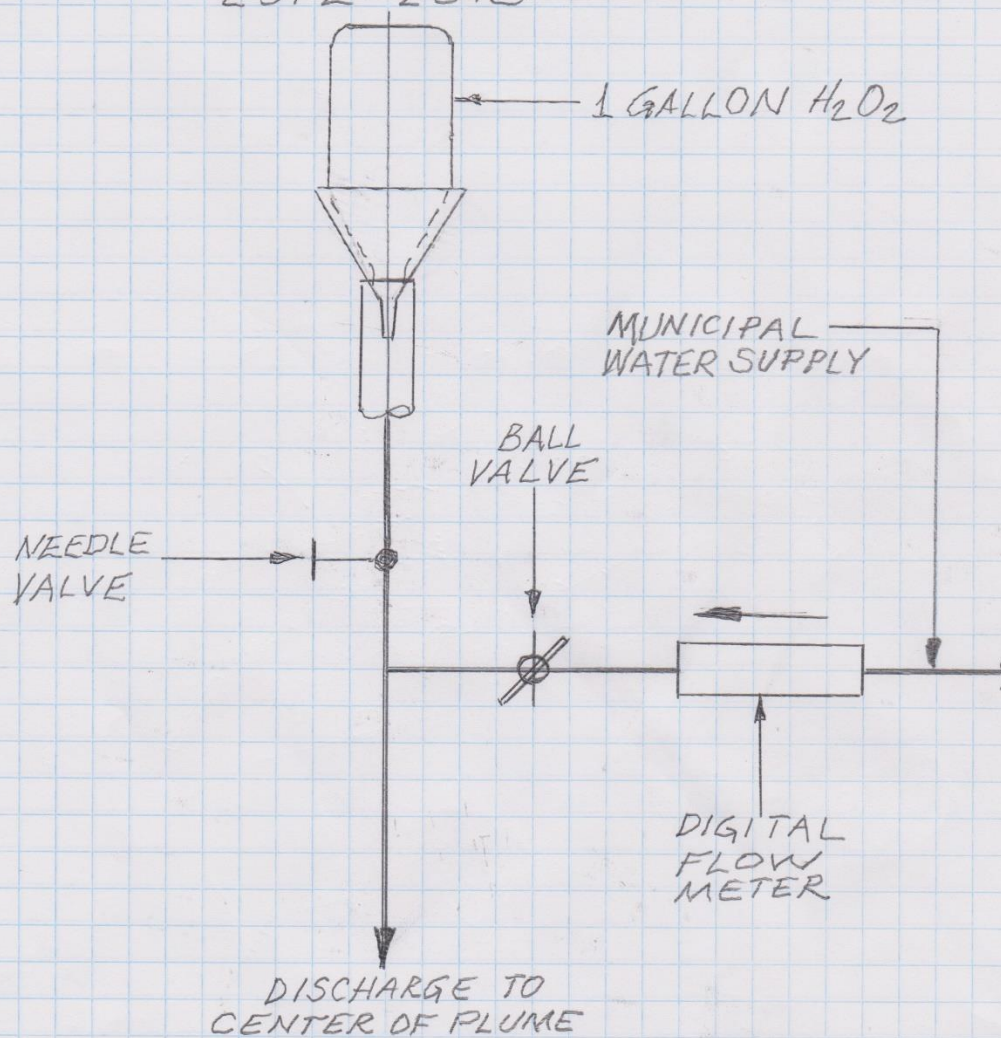
SCHEMATIC DIAGRAM
 H_2O_2 TREATMENT SYSTEM
2012-2013

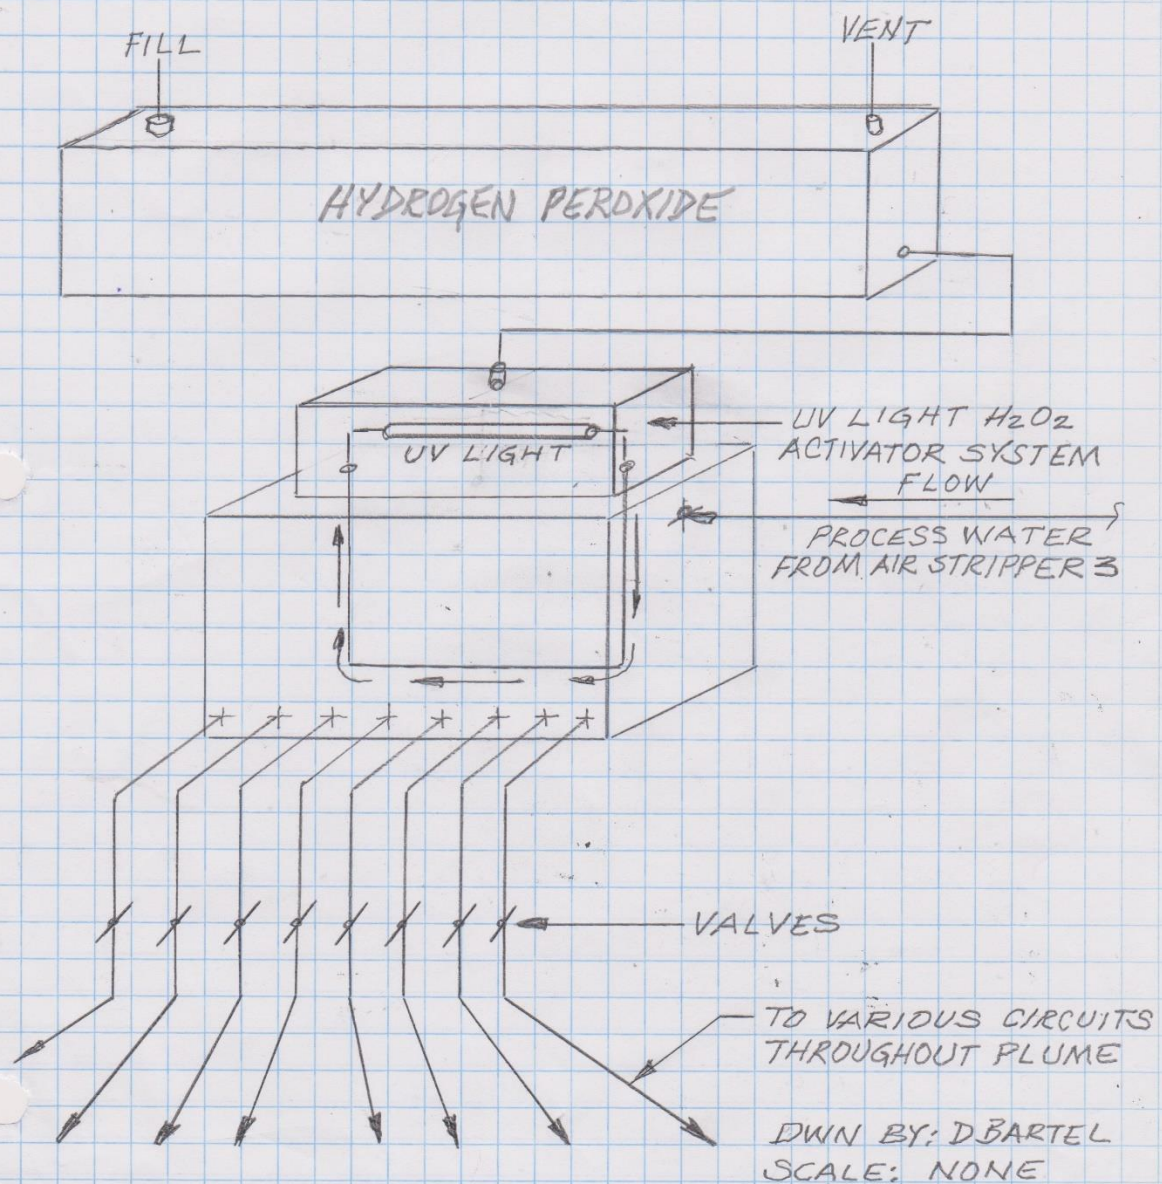
SCHEMATIC DIAGRAM
H₂O₂ TREATMENT SYSTEM
2018

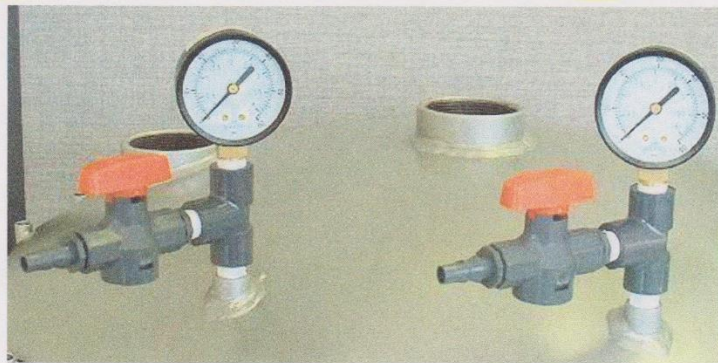
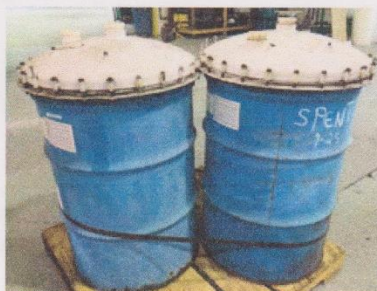
AHP-55 Optional Connection Kit

Sold pre-assembled. Allows user to easily connect AHP-55's in series and in parallel. Connections are 1" female cam lock in and out. Allows easy switch of flow direction for occasional backwashing. (note: to prevent clogging, never backwash into another carbon filter in the train. This will only foul the following canister. Instead backwash into an empty drum and allow sediments to settle. Once settled, decant the clear liquid on top and dispose of the slurry below). Comes pre-assembled as shown. 1/4" PVC Valves, 0-60 psi gauges. Recommended for first time purchase of AHP-55 vessels.
