# Remedial Investigation Report

Former DeBock's Texaco  
100 West Wine Country Road  
Grandview, Washington  
Washington Department of Ecology Cleanup Site ID 6910  
Voluntary Cleanup Program File Number CE0488

EES Project #2093-01  
November 23, 2020

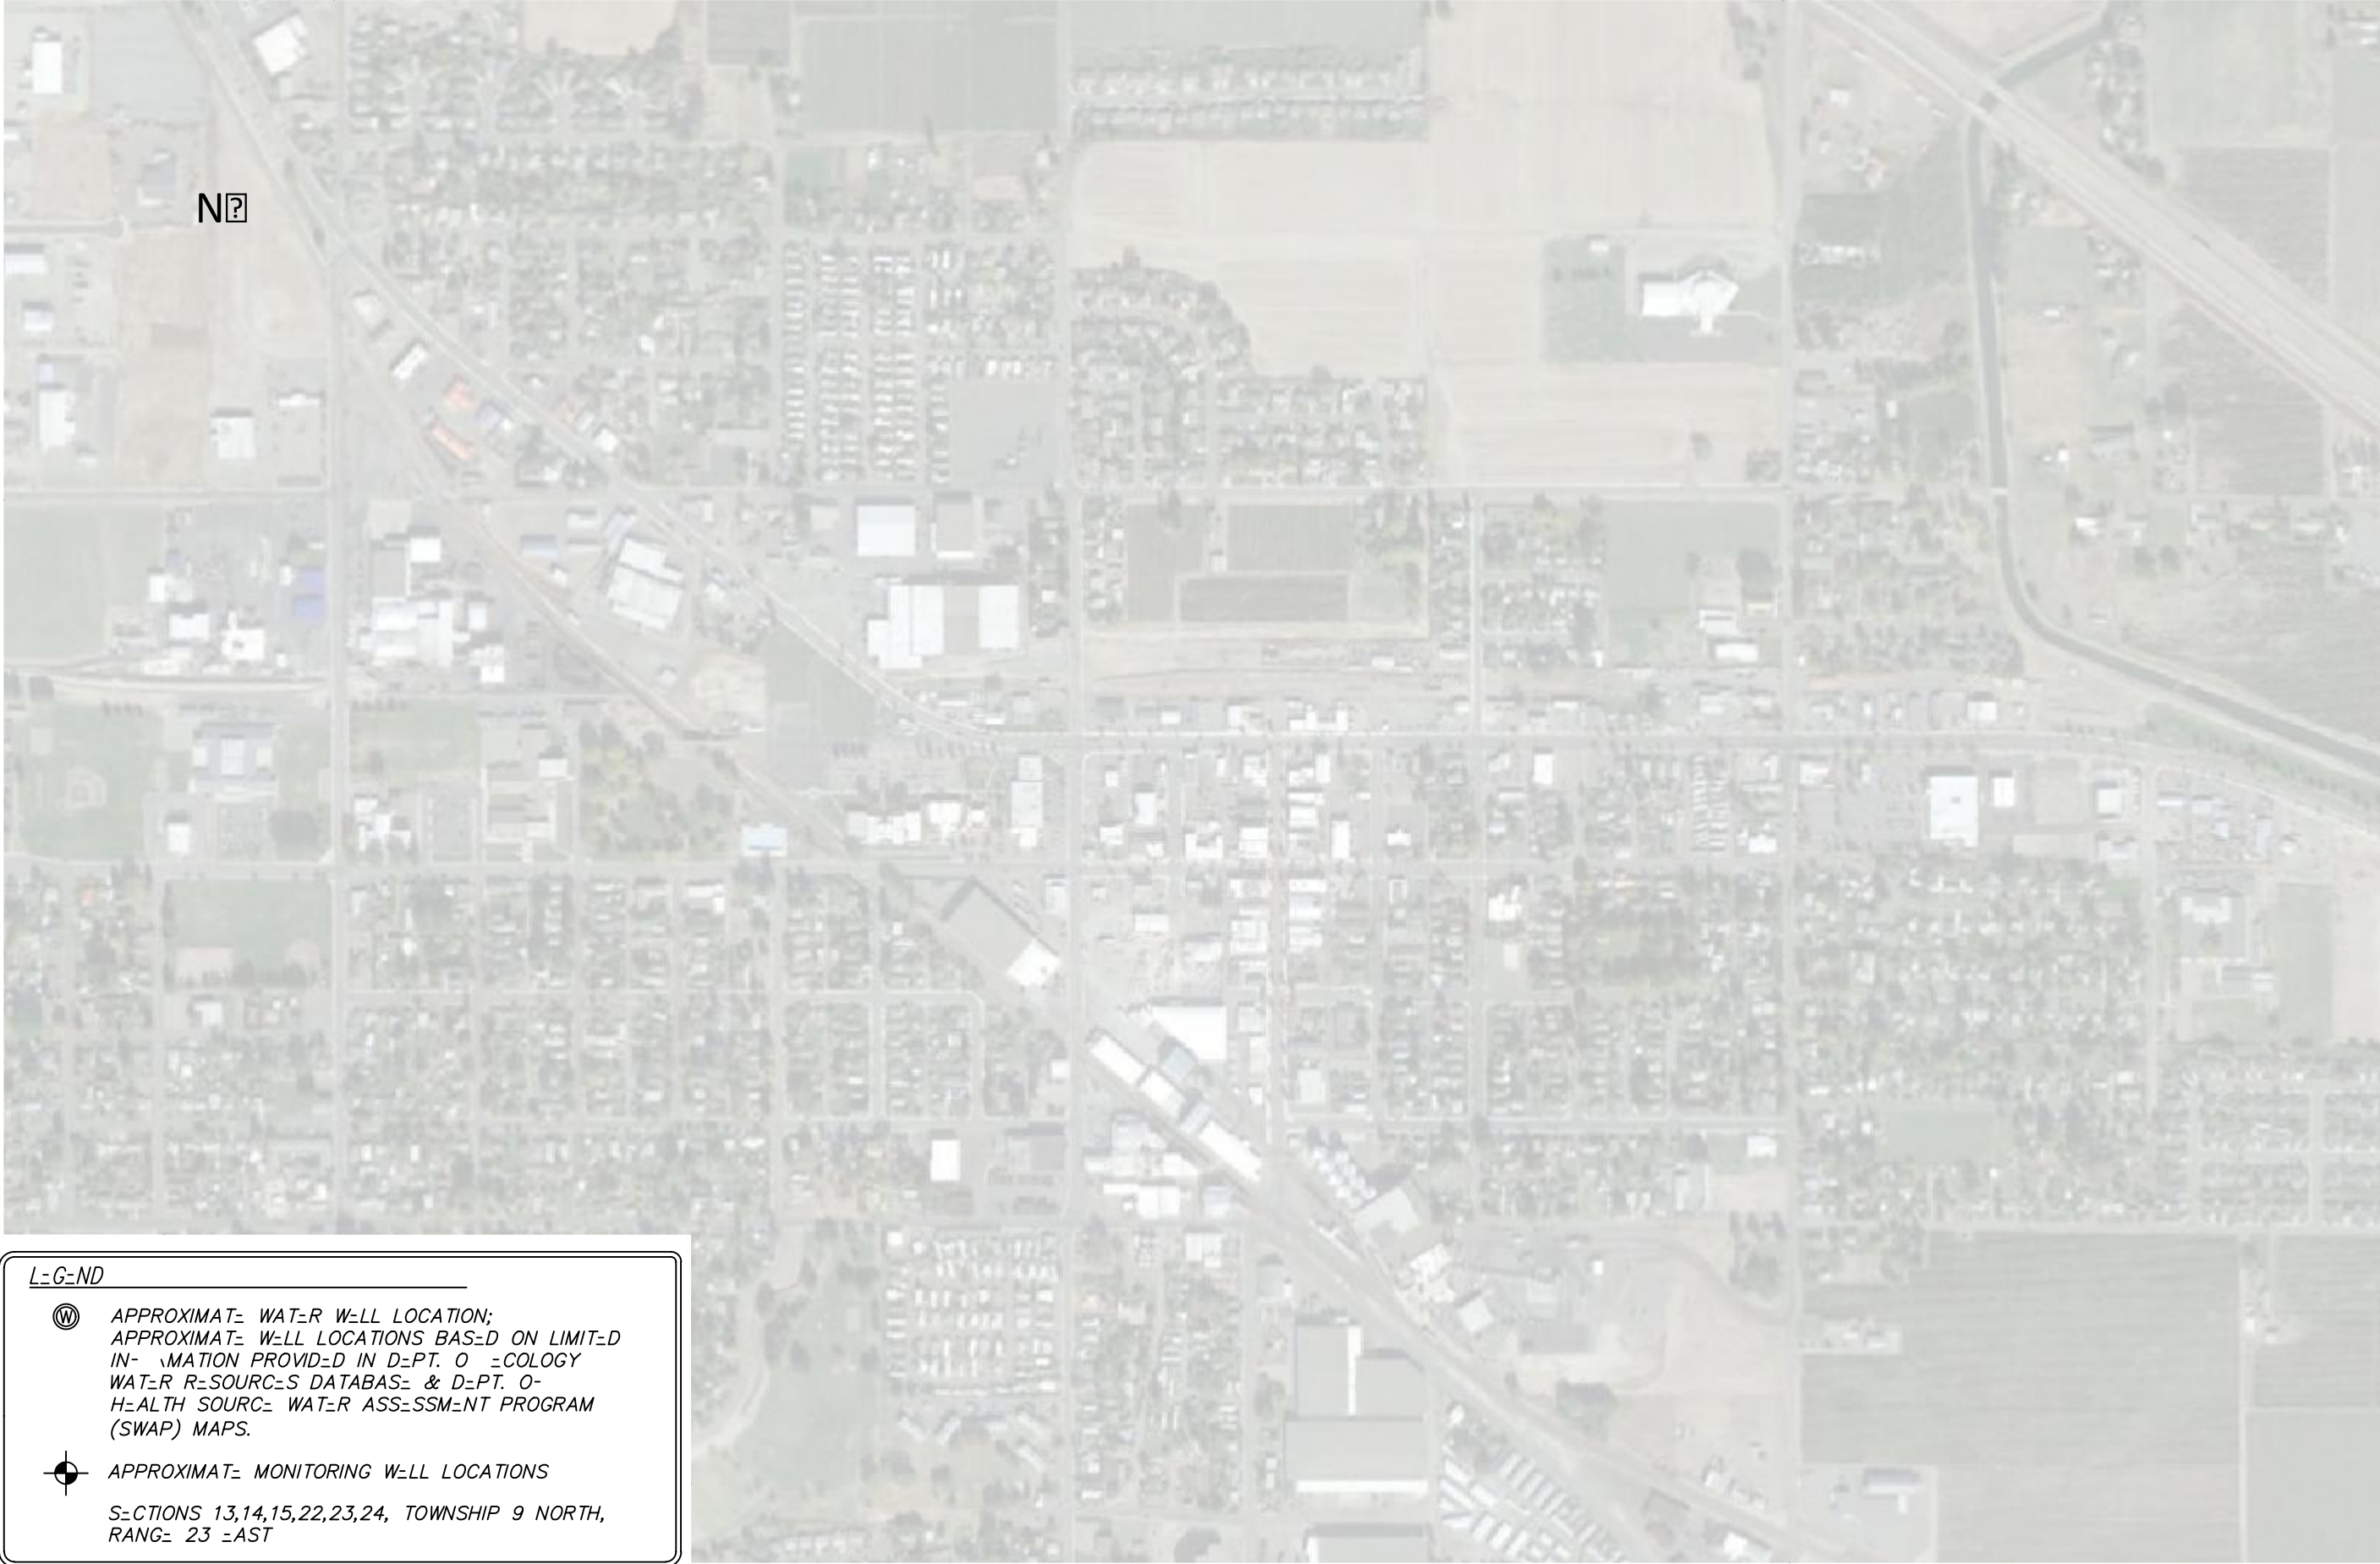
⊙ APPROXIMATE WATER WELL LOCATION;  
APPROXIMATE WELL LOCATIONS BASED ON LIMITED  
INFORMATION PROVIDED IN DEPT. OF GEOLOGY  
WATER RESOURCES DATABASE & DEPT. OF  
HEALTH SOURCE WATER ASSESSMENT PROGRAM  
(SWAP) MAPS.

⊙ APPROXIMATE MONITORING WELL LOCATIONS  
SECTIONS 13,14,15,22,23,24, TOWNSHIP 9 NORTH,  
RANGE 23 EAST

The well search was limited to the northwest and northeast quarters of Section 23; and the southern halves of the southwest and southeast quarters of Section 14 of Township 9 North, Range 23 East of the Willamette Meridian. Identified wells are summarized on Table 8 and illustrated on Figure 4.

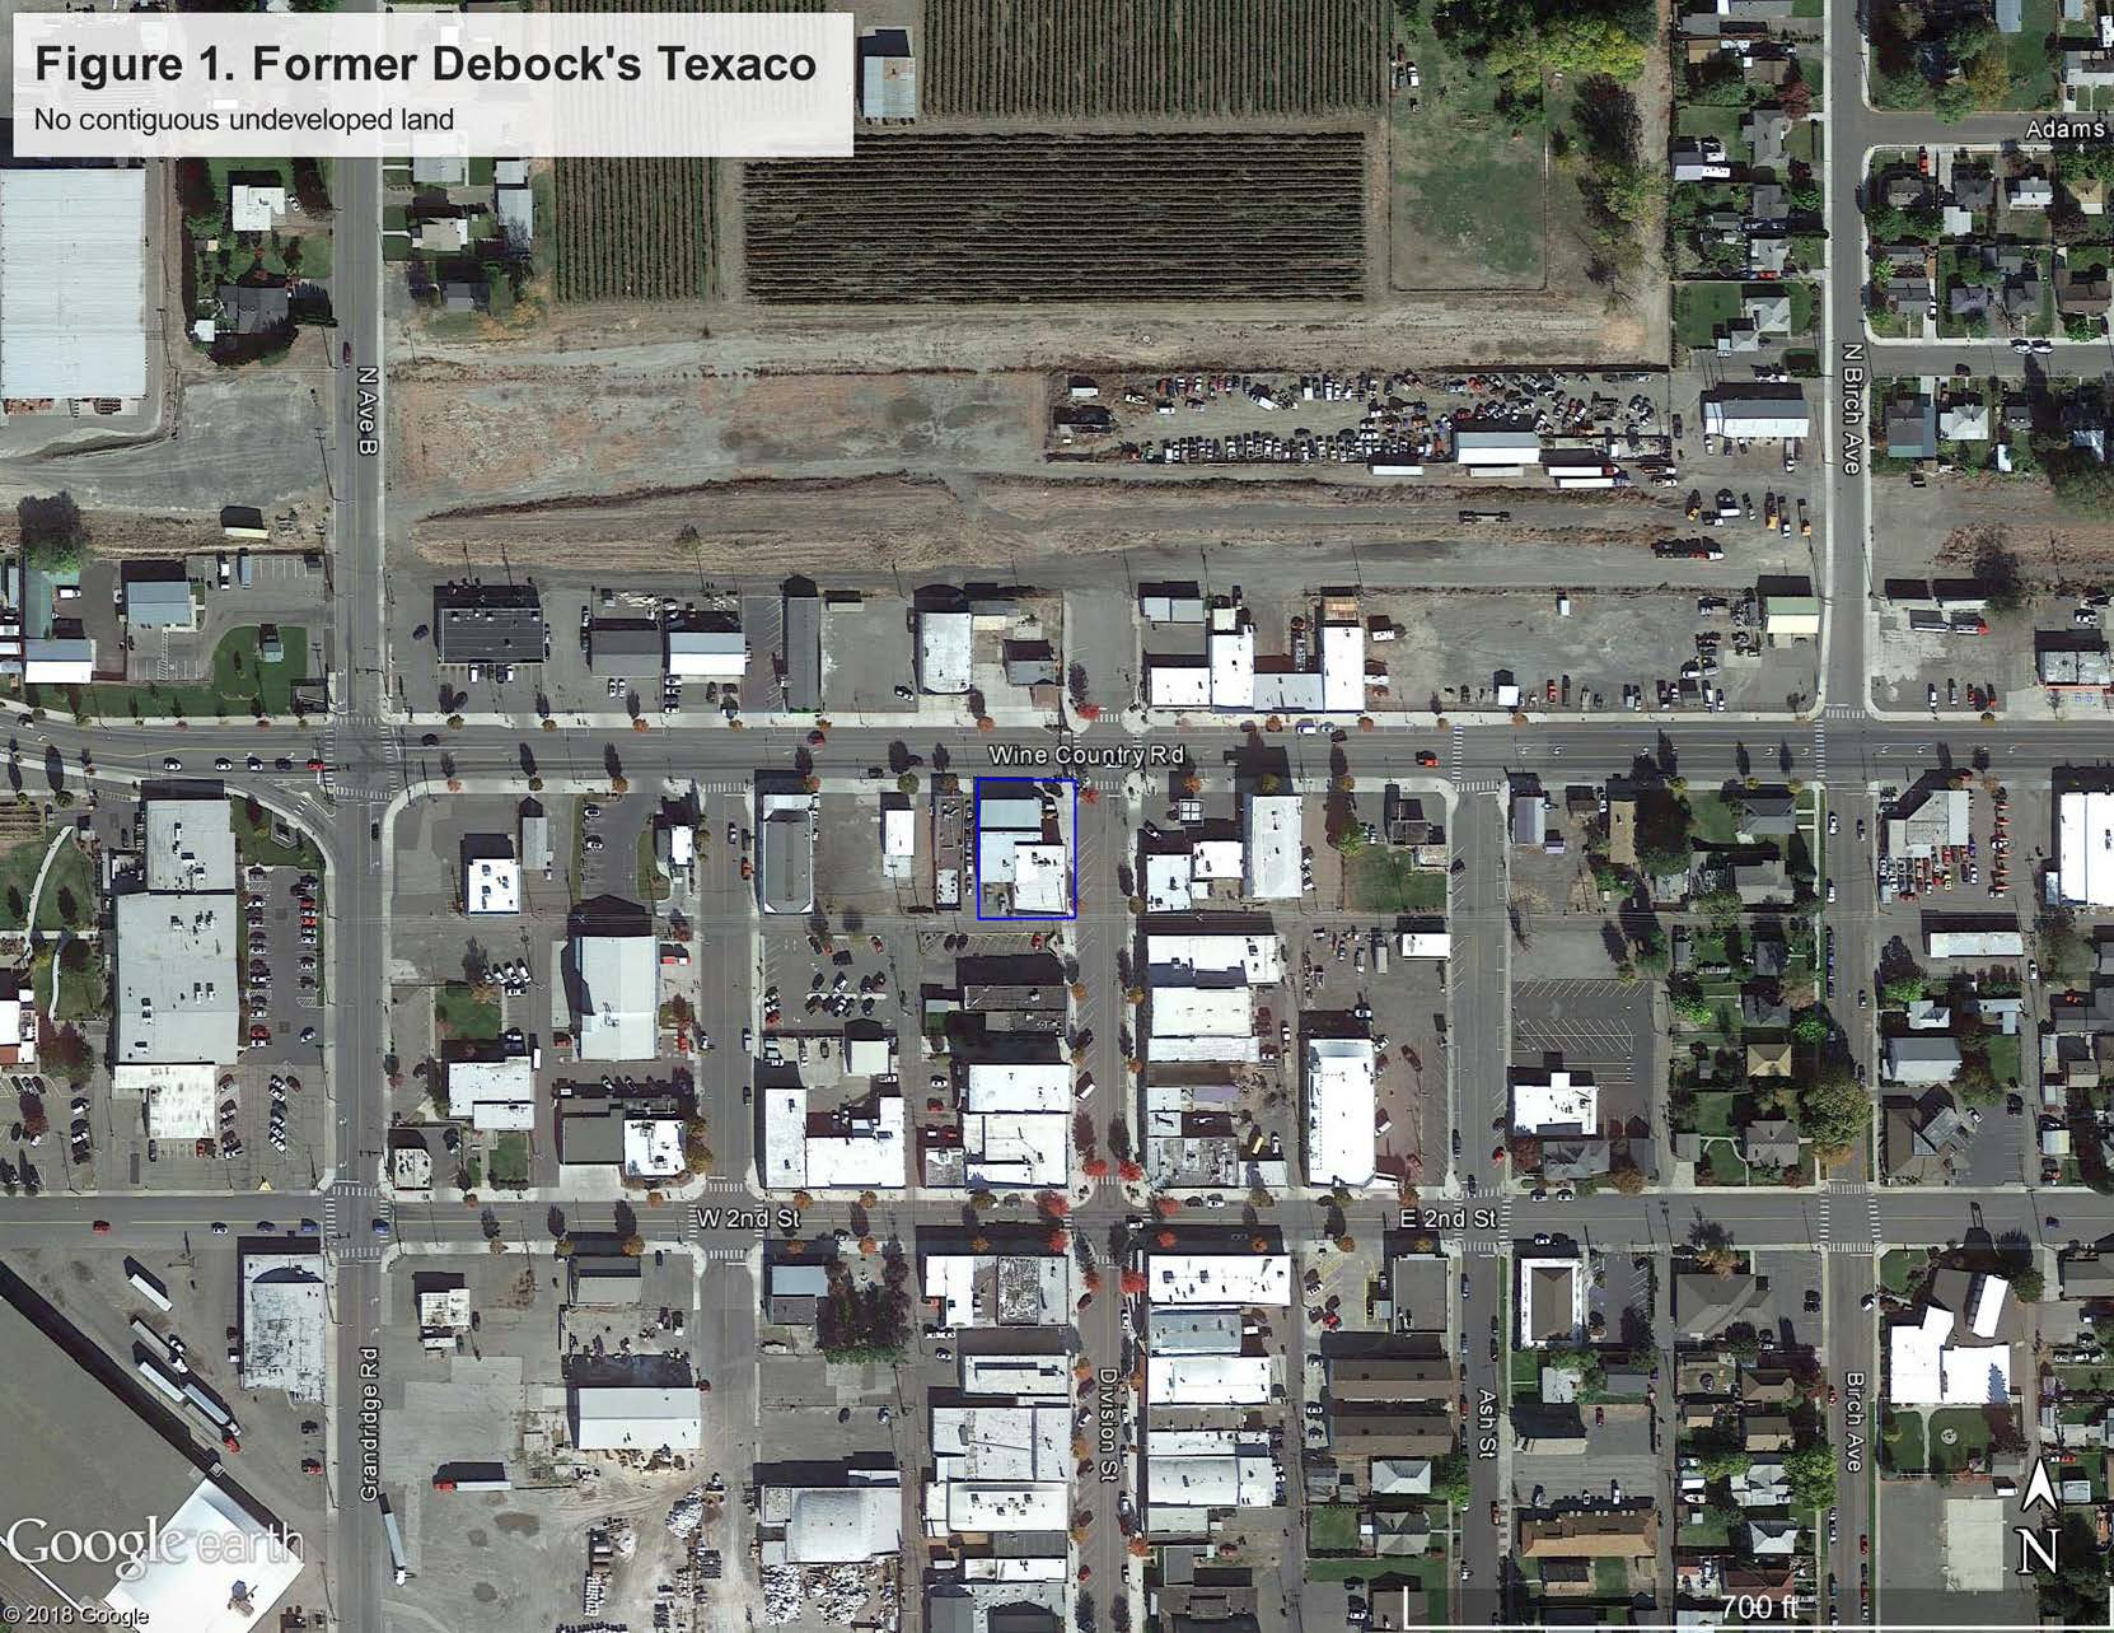
# Figure 1. Former Debock's Texaco

No contiguous undeveloped land

The desktop analysis found no contiguous undeveloped land within 500 feet of the site (Figure 1). The site is isolated from any natural cover by at least 200 feet of roads and buildings. The only vegetation adjacent to the site is street trees.
