**Scougal Rubber
Final Remedial Action Plan**

**FINAL REMEDIAL ACTION PLAN
SCOUGAL RUBBER
SEATTLE, WASHINGTON**

**Scougal Rubber
6239 Corson Avenue South
Seattle, Washington 98108**

**Pacific Groundwater Group
2377 Eastlake Avenue East, Suite 200
Seattle, Washington 98102
206.329.0141
www.pgwg.com**

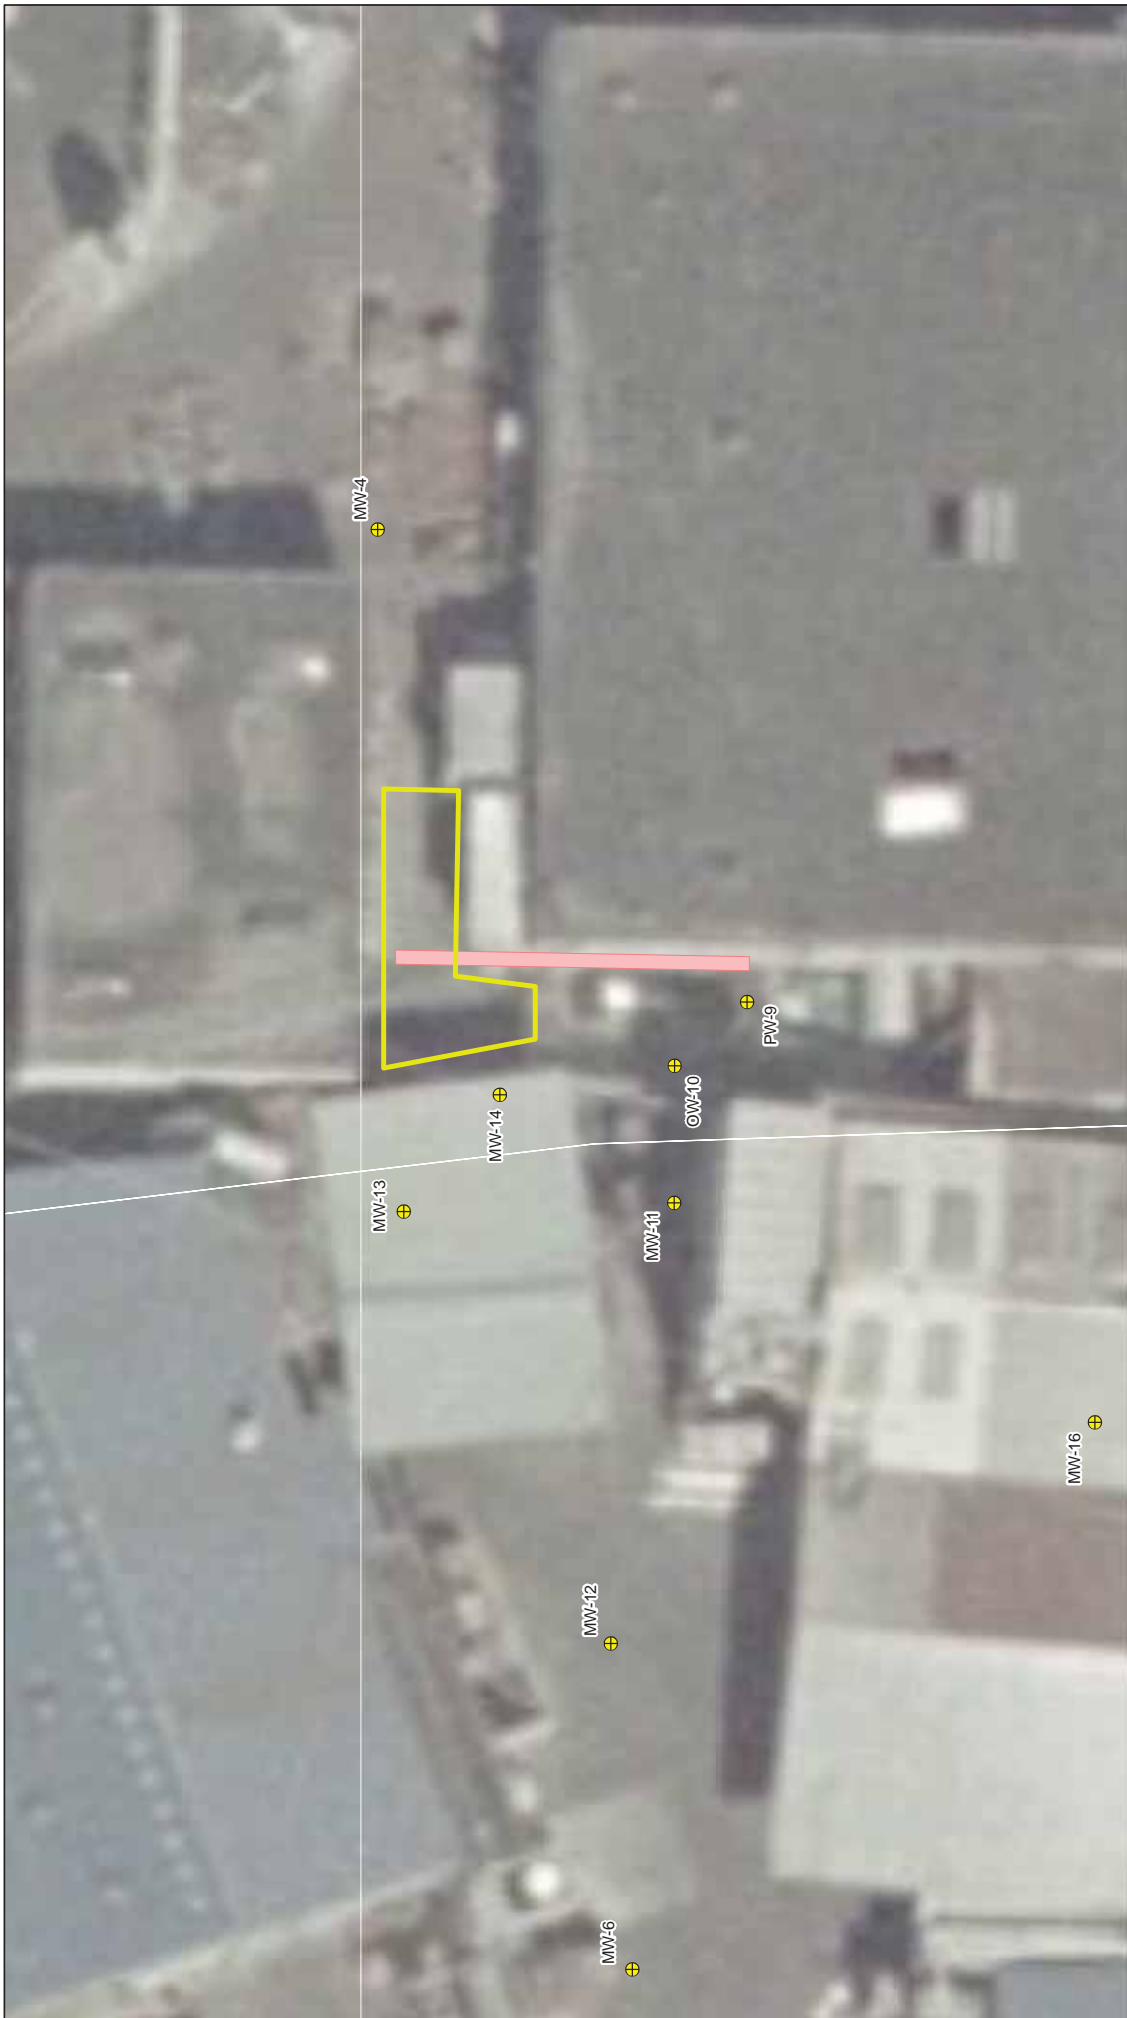
Figure 3
Excavation &
Infiltration Areas

- ⊕ Monitoring Well
- ▭ Excavation Area (Infiltration Gallery)
- ▭ Infiltration Trench

PGG proposes a combination of excavation and in situ chemical oxidation to remediate chlorinated solvents and petroleum hydrocarbons in soil and groundwater at Scougal Rubber. Remedial excavations and infiltration areas are shown in Figure 3.
