VAPOR INTRUSION ASSESSMENT
INTERIM REMEDIAL ACTIONS
VAPOR INTRUSION PRIORITY WORK PLAN
PRECISION ENGINEERING, INC., SITE

Prepared for
DICK MORGAN
December 30, 2020
Project No. 1803.01.02

Prepared by
Maul Foster & Alongi, Inc.
1329 N State Street, Suite 301, Bellingham, WA 98225

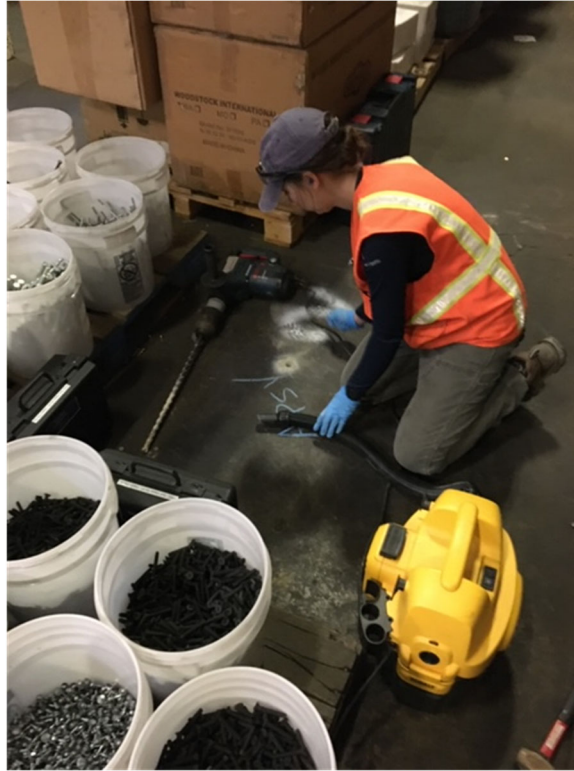
Sub-slab soil gas vapor pin installation on January 31, 2020.

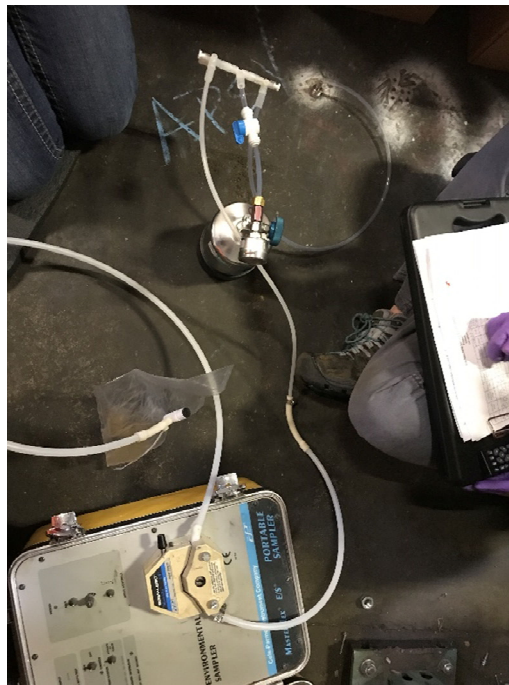
Photo No. 2.

Sub-slab soil gas sampling setup, excluding the helium shroud, on February 1, 2020.

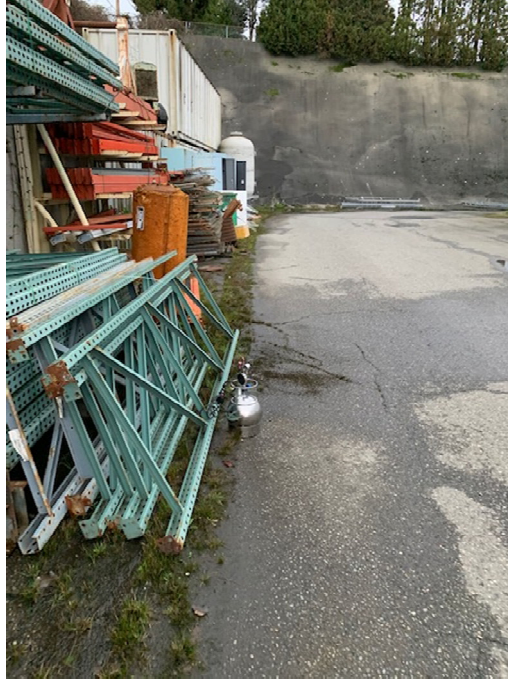
Six-liter Summa canister deployed outside for ambient air sample collection during the initial vapor intrusion assessment on February 1, 2020.

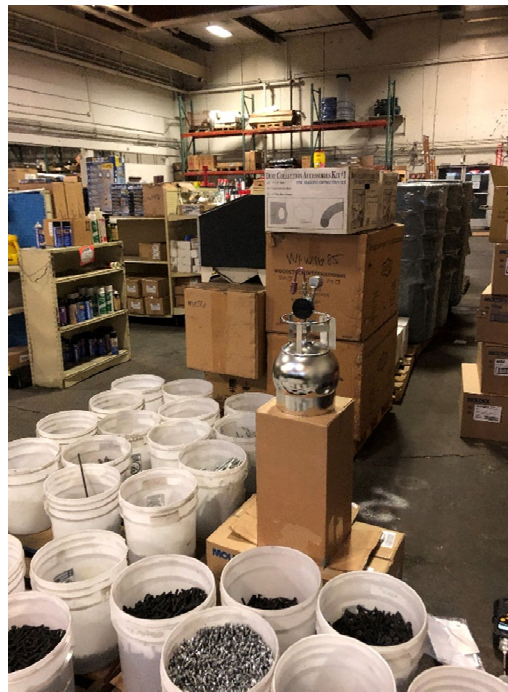
Photo No. 4.

Six-liter Summa canister deployed in Warehouse 1 during the initial vapor intrusion assessment on February 1, 2020.

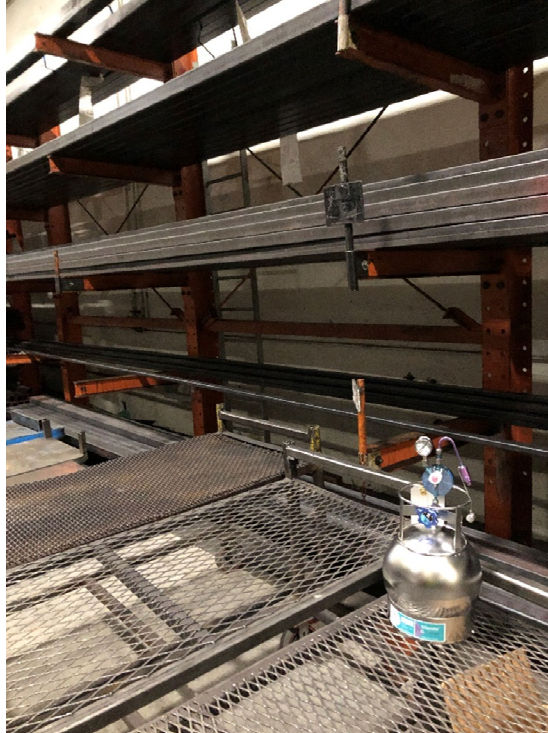
Six-liter Summa canister deployed in Warehouse 2 during the initial vapor intrusion assessment on February 1, 2020.

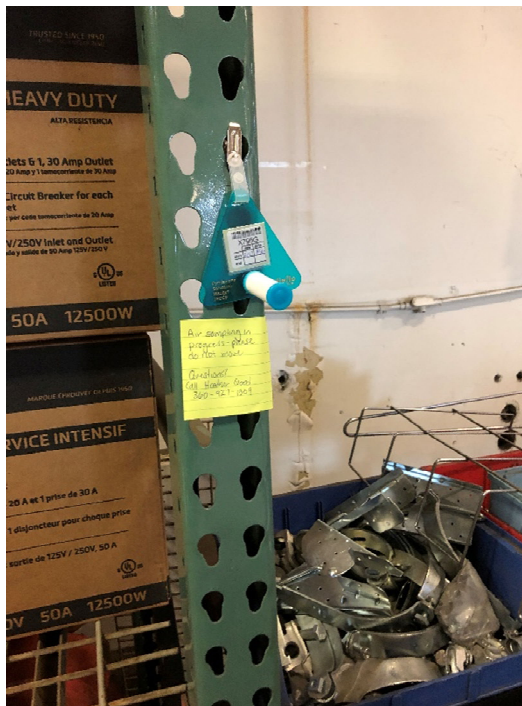
Photo No. 6.

Radiello R130 passive sampler deployed in Warehouse 1 on February 1, 2020.

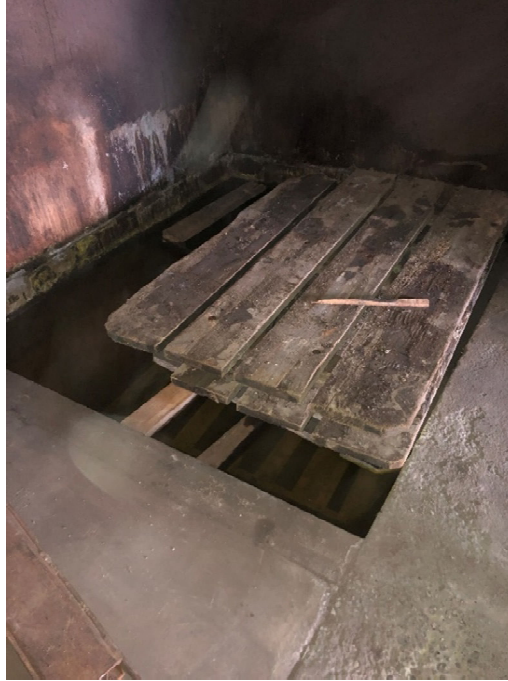
The former evaporator pit was a 140-cubic-foot concrete pit that was left exposed after Precision ceased operations on the Site. Standing water observed in the pit was attributed to groundwater seepage, which was later confirmed by the presence of a crack in the concrete bottom of the pit observed during its decommissioning (see Section 6.1). A water sample was collected from the pit on February 11, 2020, using a disposable bailer, and was analyzed for total petroleum hydrocarbons (diesel- and residual-oil-range organics), arsenic, chromium, and TCE.

Evaporator pit prior to decommissioning.

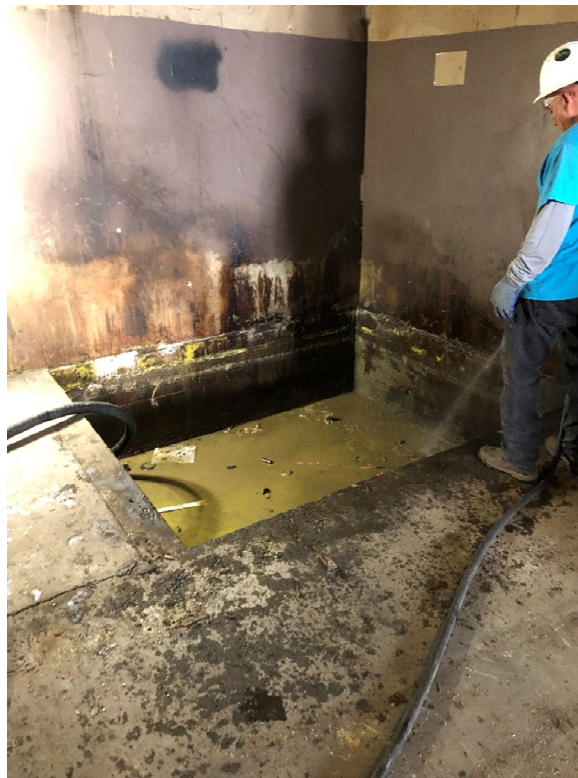
Photo No. 12.

Evaporator pit rinsed as a vacuum truck removes liquid waste from the pit.

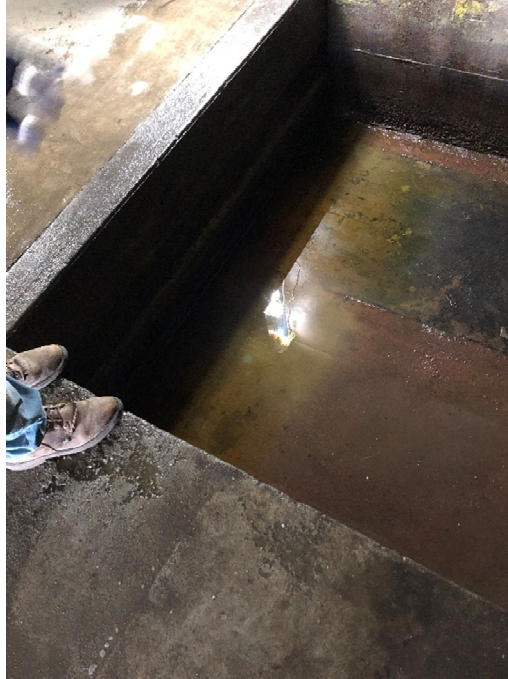
Groundwater seeping into the evaporator pit after being rinsed out.

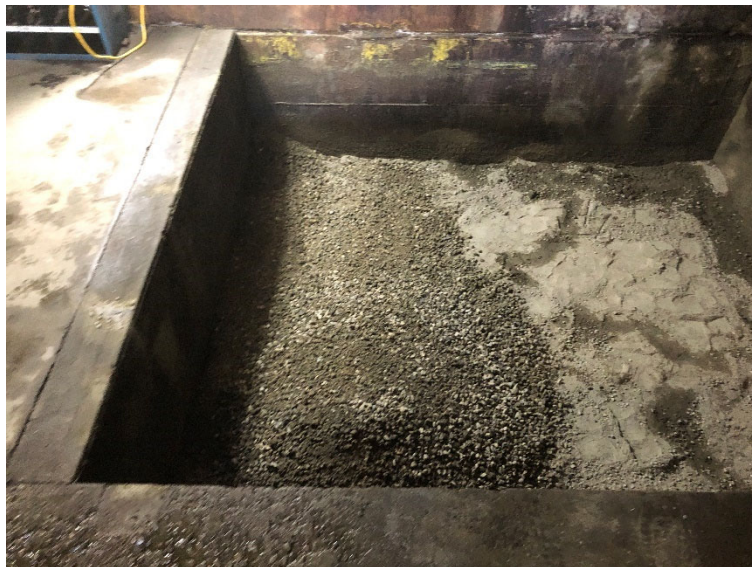
Photo No. 14.

Base of the evaporator pit, filled with dry-mix concrete.

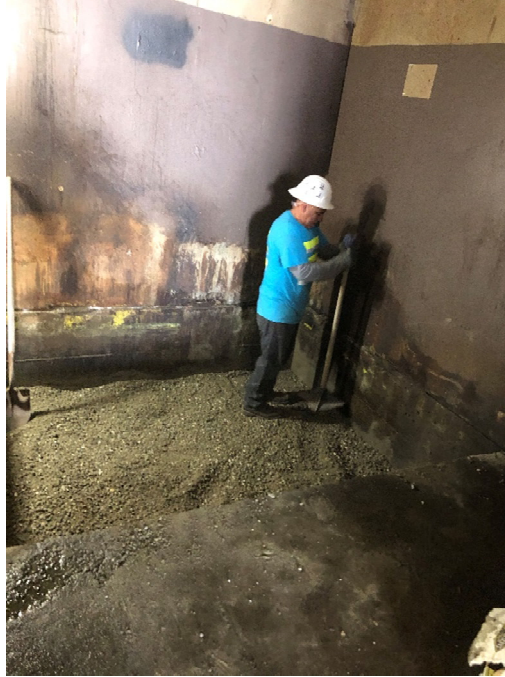
Gravel in the base of this evaporator pit being compacted in 6-inch lifts, using hand tools.

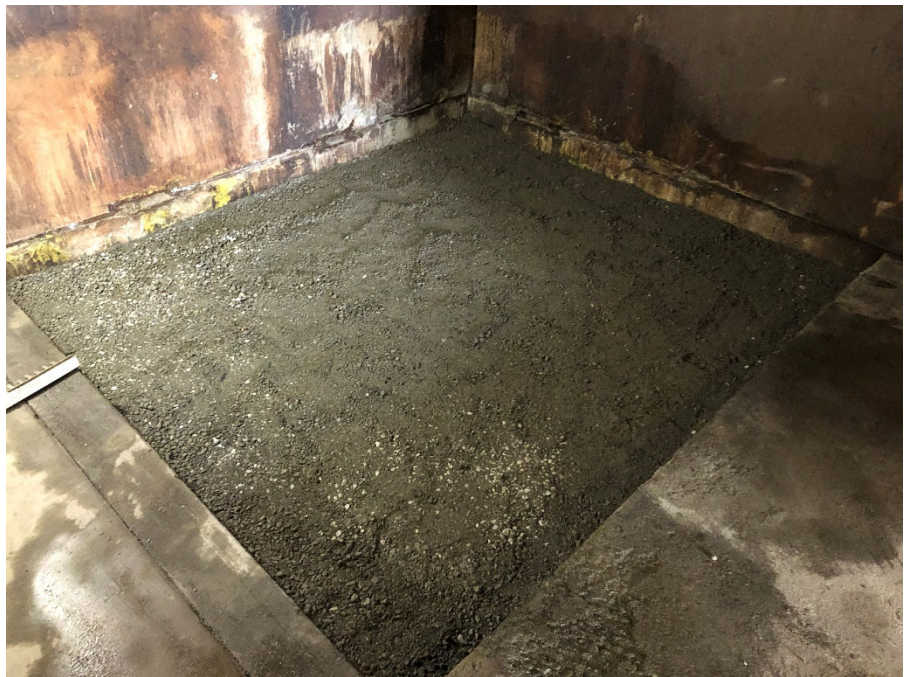
Photo No. 16.

Final gravel surface in the evaporator pit, leveled and prepped for concrete.

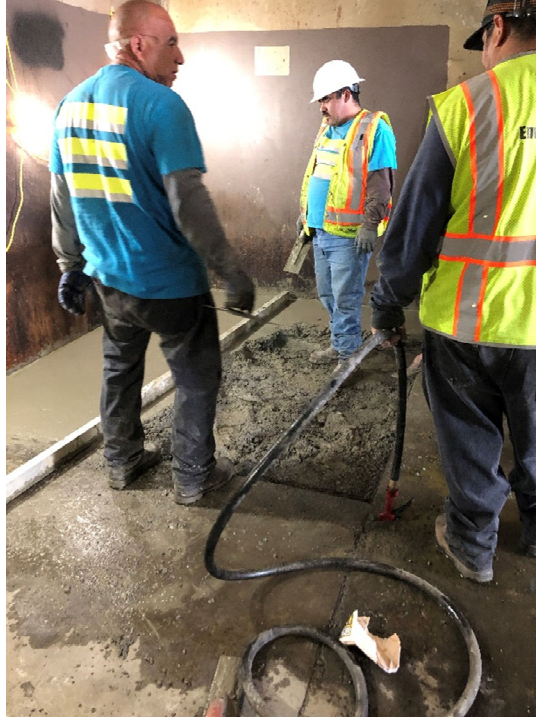
Concrete being poured and leveled in the evaporator pit to match the existing slab grade.

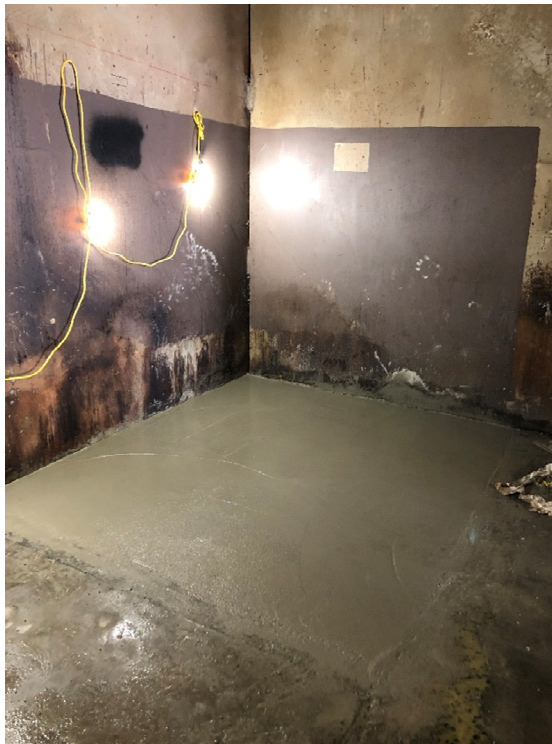
Photo No. 18.

Decommissioned and filled evaporator pit.

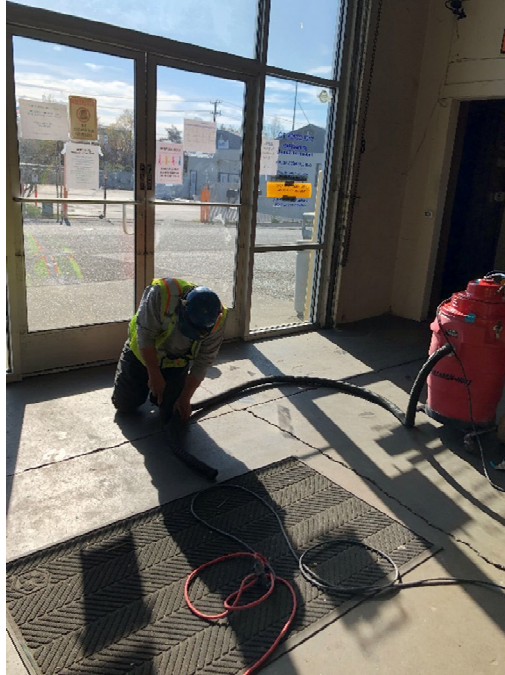
Crack being cleaned with a vacuum prior to the application of sealant.

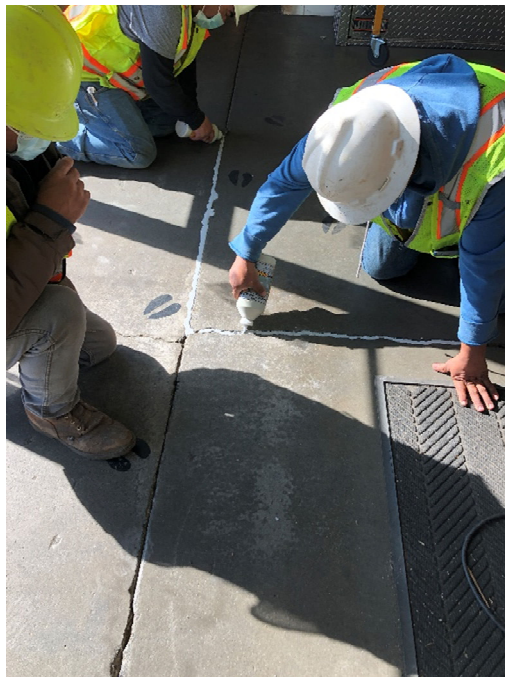
Photo No. 22.

Sealant being applied to a clean crack.

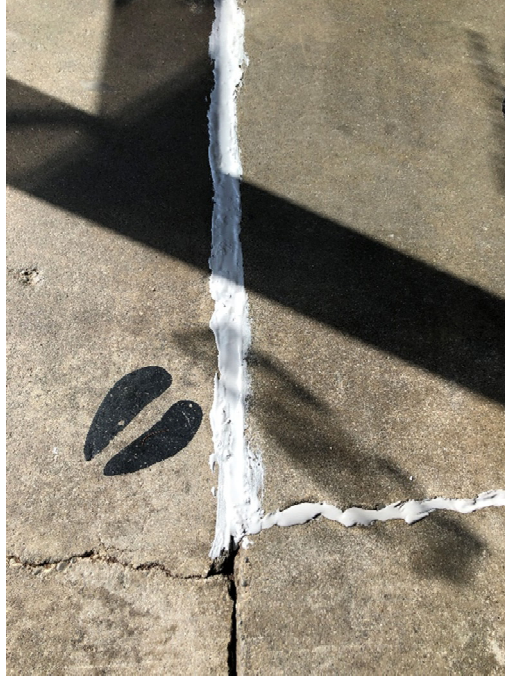
Sealant smoothed into a crack after application.

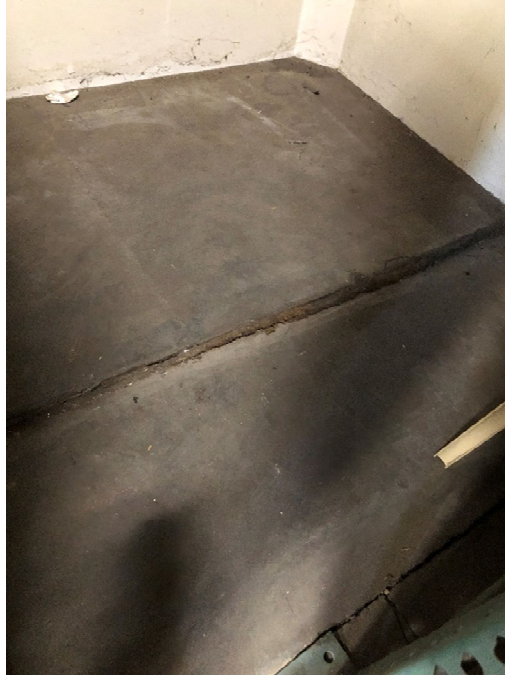
Uneven slab joint that could not be sealed.

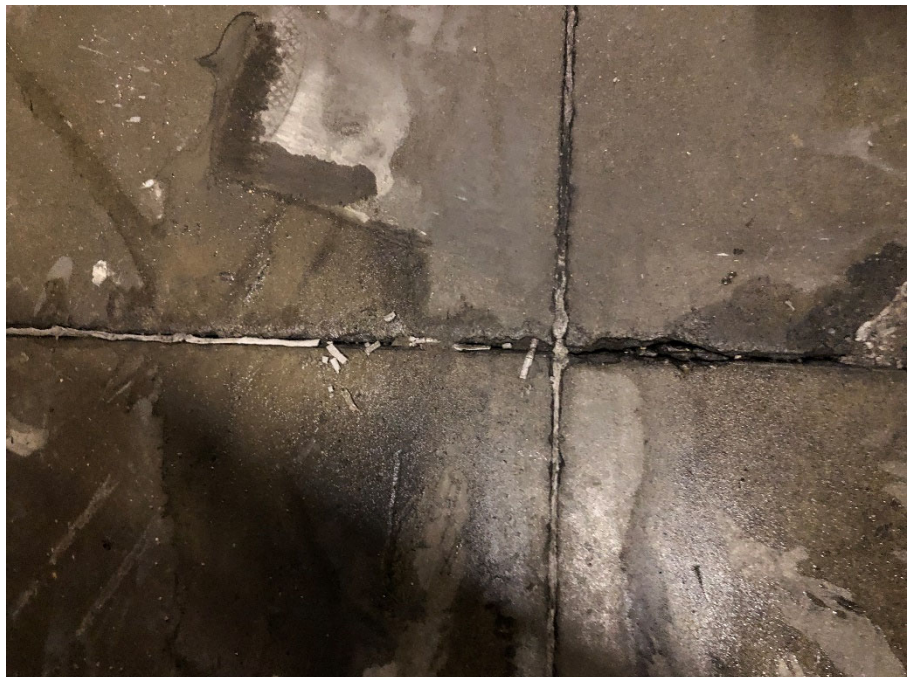
Crack prone to groundwater seepage after being sealed.
