Re: Action Required at 1303 W. Reynolds Ave, Centralia WA 98531 and
4020 Harrison Ave, Centralia WA 98531

Washington State Department of Ecology
Hazardous Waste & Toxics Reduction Program
Compliance Inspection Report

EPA RCRA #:	Facility Site ID#:	Inspection Date: 01/24/08	Address: Bonagofski-Reynolds Road Property 1303 W. Reynolds Road Centralia WA 98531
Dangerous Waste   Compliance	Inspectors: Nannette Brooks, Inspector 360-407-6242 Nbro461@ecy.wa.gov Dee Williams, Inspector (360) 407-6348 Sharon Huff, Project Manager (360) 407-6300		Contact: Victor Bonagofski (address above) Property Owner: Picese Trust (Bonagofski, co-trustee)
	Business Overview, Generator Status: Alleged illegal wrecking. See ERTS # 603470

EPA RCRA #:	Facility Site ID#:	Inspection Date: 01/24/08	Address: Bonagofski – Harrison Property 4020 Harrison Ave., Centralia WA 98531
Dangerous Waste   Compliance	Inspectors: Nannette Brooks, Inspector 360-407-63 Nbro461@ecy.wa.gov Dee Williams, Inspector 360-407-6348 Sharon Huff, Project Manager 360-407-6300		Contact: Victor Bonagofski 1303 W. Reynolds Ave. Centralia, WA 98531 Property Owner: Golden Unicorn (Bonagofski, co-trustee)
	Business Overview, Generator Status:

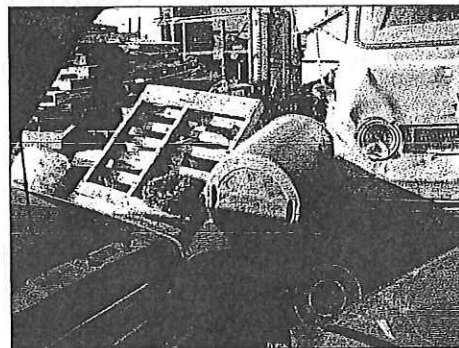
- There were several containers on-site, including blue plastic 55-gallon drums, rusted metal drums, several 1- and 5-gallon buckets, and various sized compressed air cylinders. Containers were not adequately labeled, and contents were unknown.

Plastic drums and pallets.

All tanks, drums or other containers used to accumulate waste must be in good condition and compatible with the waste. They must be kept closed except to add or remove waste, and must be stored in a manner that minimizes impacts to the environment. Tanks and containers should be placarded as "waste pending designation" or with their known content. They also must be marked with the date that waste was placed into the container. If you determine that the waste is dangerous, then accumulation tanks and containers must be managed to meet the WAC 173-303-640 (tank) and -630 (drum) requirements.

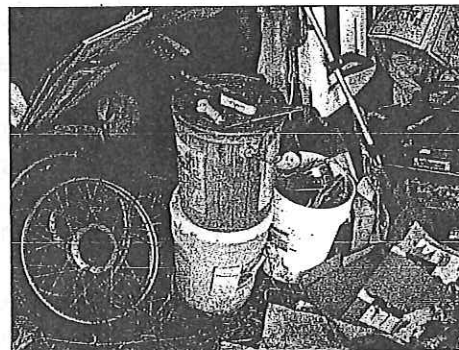
Buckets with Unknown Content

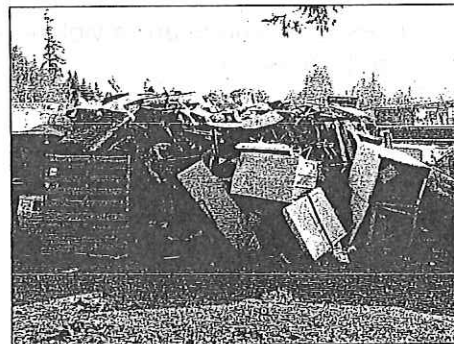
- There were several stacks of pallets, scrap metal (including appliances), and black plastic bags full of glass bottles, aluminum cans, and plastic bottles scattered through out the property.

Scrap pile.

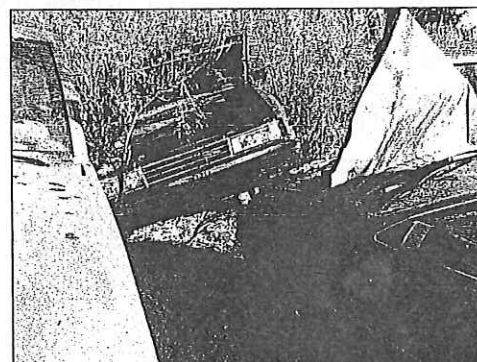
- There were several junk cars scattered throughout the property. These cars did not look operable. Black berry bushes were growing through the windows, and many were missing tires or were resting on their sides.

Cars stacked on-site.

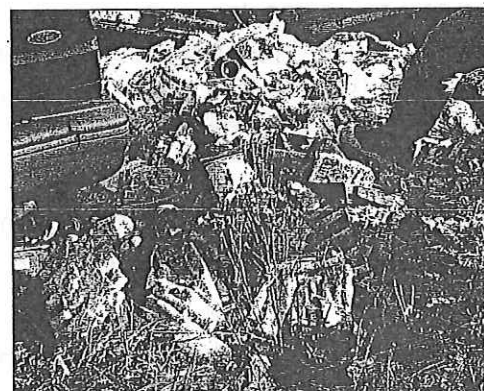
- There was a wood structure collapsed, and sliding down a hill into a creek.
- There was a pile of what looked like weathered fireworks and debris, resting in/among cars. The pile was approximately three-foot tall and was spread over a 10-foot square area. There were several empty cardboard rolls (formerly containing fireworks chemical) and several rolls that still contained fireworks material.

Fireworks piled up near cars.

Ecology inspectors also observed oily stains on the ground under/around automobiles, and observed fireworks (or similar) stacked and spilled on the ground. Oil from engine blocks or transmissions may contain halogenated hydrocarbons, metals or other contaminants. Fireworks may contain sulfur, salt peter (potassium nitrate), and charcoal. Each tube may have 1 to 3 grams of this material, depending on the manufacture. The composition for the flaming ball it launches into the air will usually be made of a combination of potassium perchlorate, sulfur, aluminum, copper oxide, barium sulfate or carbonate, strontium, iron oxide, and titanium.

septic or sewer lines. Within 30 days of receipt of this letter, cleanup hazardous debris (fireworks) off soil and place it into containers that can be closed, labeled and managed to prevent releases. Move all lead-acid batteries, air cylinders, aerosol cans, buckets, jugs and other containers holding material to an area that is protected from the weather. These materials must be inventoried and stored, labeled and managed to prevent releases.

Within 30 days of receipt of this letter, cleanup any soil contaminated with oil, lead acid, fireworks residue, or other hazardous material. Soil must be placed into containers that can be closed, labeled and managed to prevent additional releases.

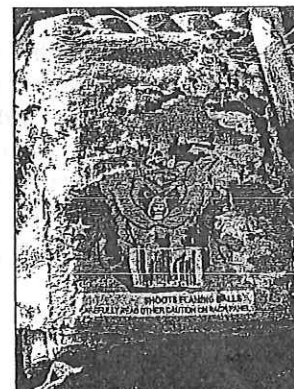
Fireworks package cover.
