Site Assessment Report

Dills Property – 701 Buena Loop Road, Buena, WA
AEC Project Number 12-061

Washington State Department of Ecology
15 West Yakima Avenue, #200
Yakima, Washington 98901

October 23, 2012

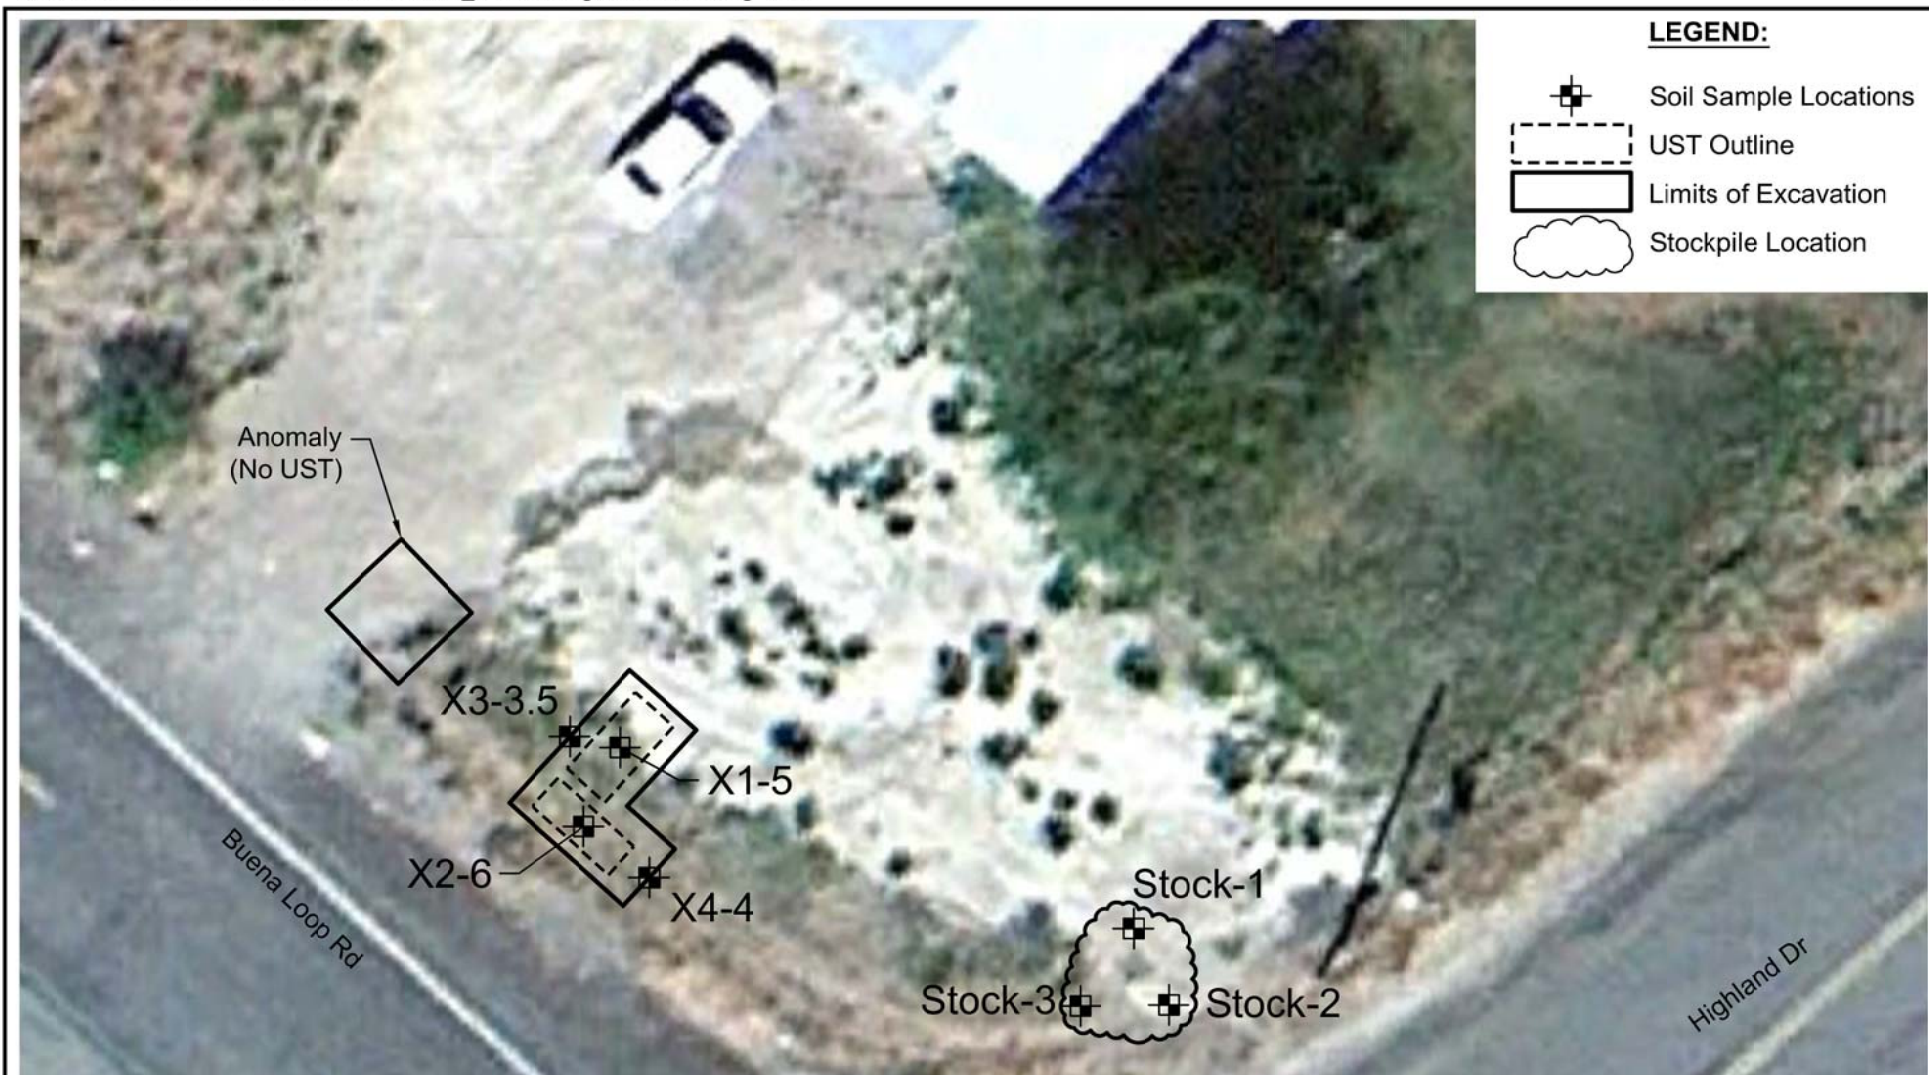
Figure 2
SOIL SAMPLE LOCATIONS

A geophysical survey was performed at the site for GeoEngineers to locate potential USTs. Three magnetic anomalies were identified at the site. The approximate location of these anomalies is shown on Figure 2.

At the conclusion of excavation, AEC collected four confirmation soil samples from the excavation and three stockpile samples at locations shown on Figure 2. Two sidewall samples were collected from the excavation at a depth above the water table at approximately 3.5 and 4 feet bgs. A floor sample was collected below the bottom of each UST at a depth of 5 to 6 feet bgs. The soil samples were placed in a cooler packed with ice along with chain-of-custody documentation. The cooler was shipped to Friedman & Bruya Laboratory in Seattle, Washington for analysis.
