FINAL REMEDIAL ACTION

**Orchard Park Independent
Retirement Living
Ecology VCP No. CE0287
620 North 34th Avenue
Yakima, Washington**

AEG Project #: 07-139

Date of Report: June 3, 2010

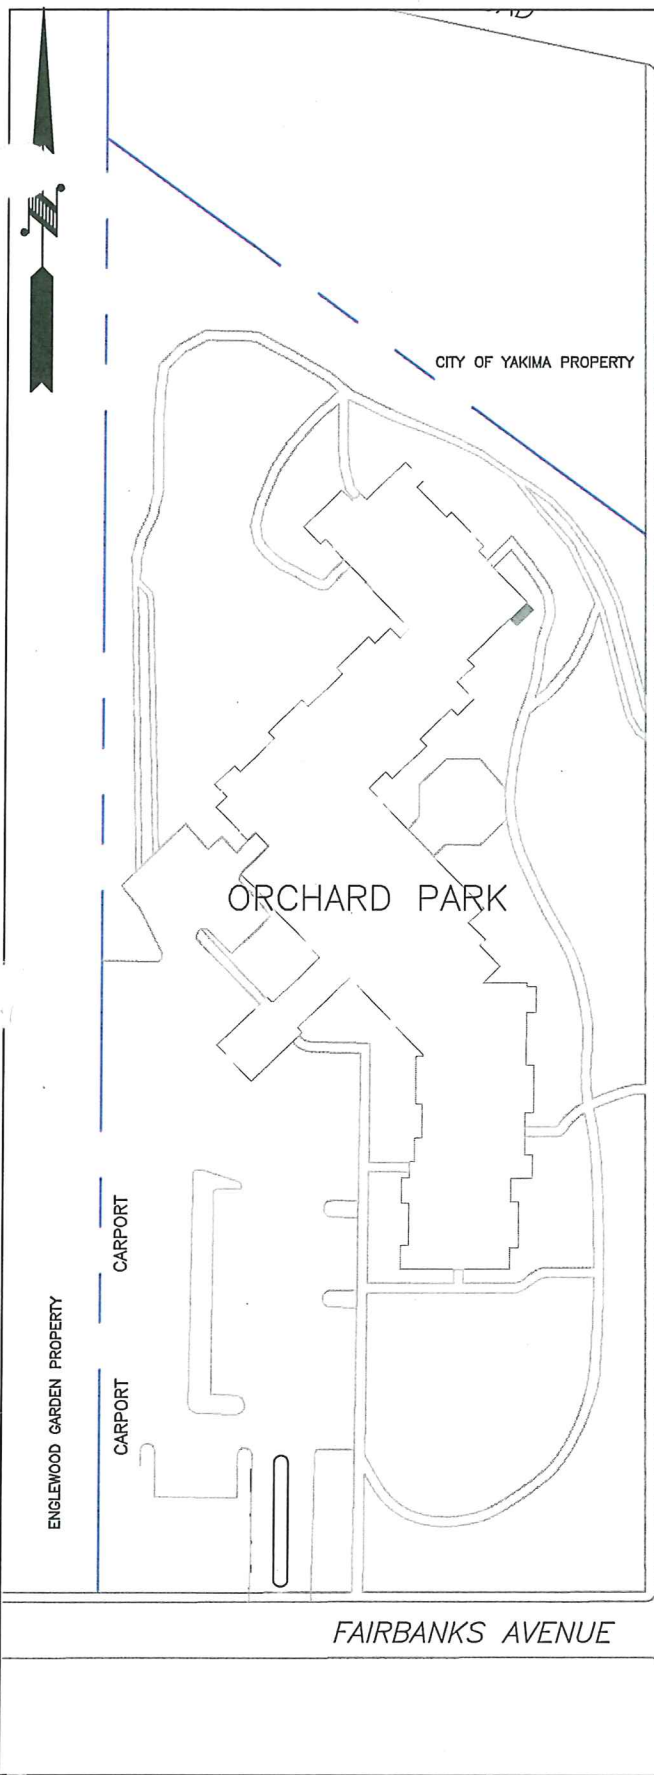
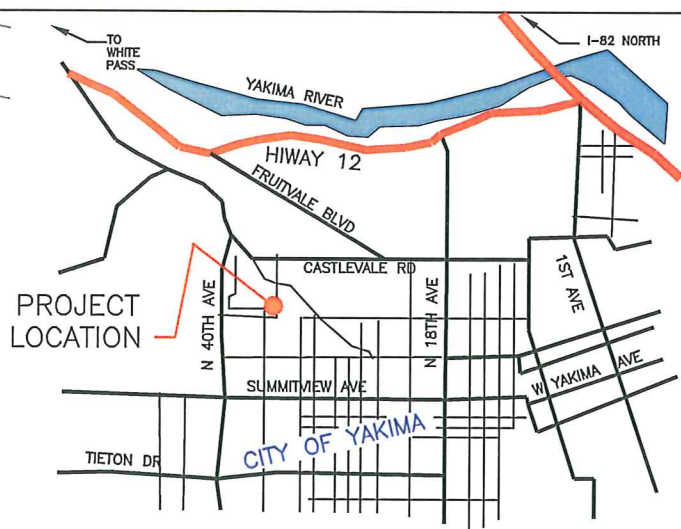
FIGURE 1
SITE AND VICINITY MAP

AEG was retained to oversee the excavation, characterize the area of MCS, and dispose of the MCS offsite at a regulated landfill. Figure 1, *Site & Vicinity Map*, presents the layout of the Site. Photographs of excavation activities are presented in Appendix A, *Site Photographs*.

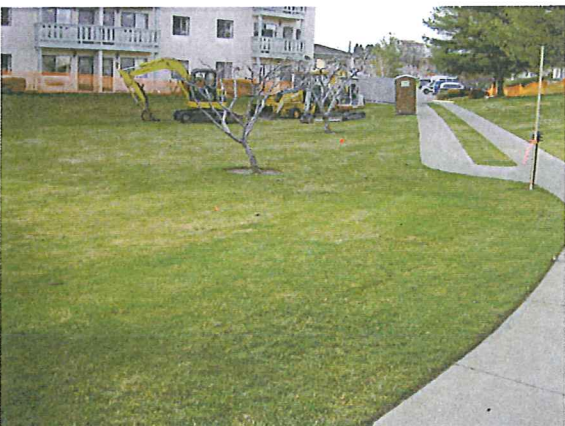
Photo #3: View of Zone 1, looking at the northwestern portion of the facility building. Photo displays primary portion of Zone 1, though zone extends south and east of photo.

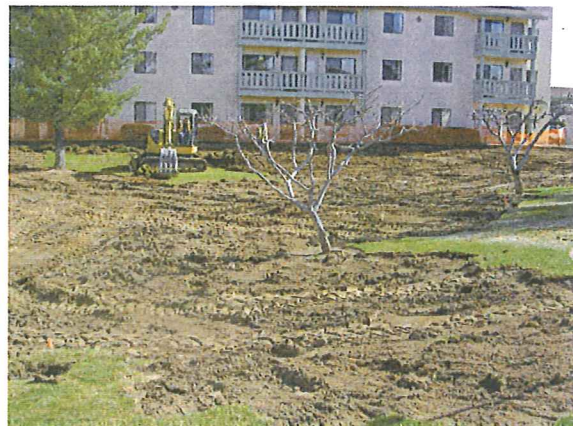
Photo #4: View of Zone 1, looking at northwestern portion of the facility building, during excavation.

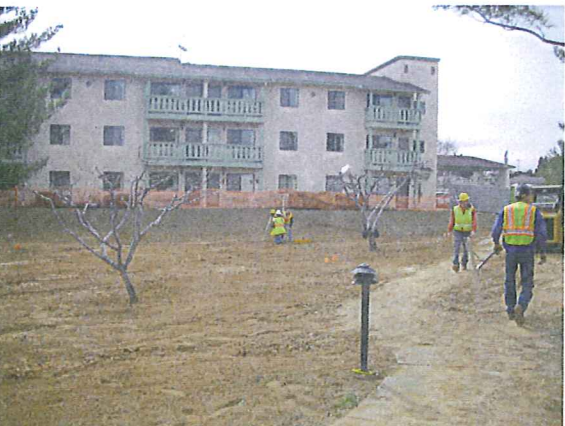
Photo #5: View of Zone 1, looking at the northwestern portion of the facility building, with the clean imported topsoil being raked into place.

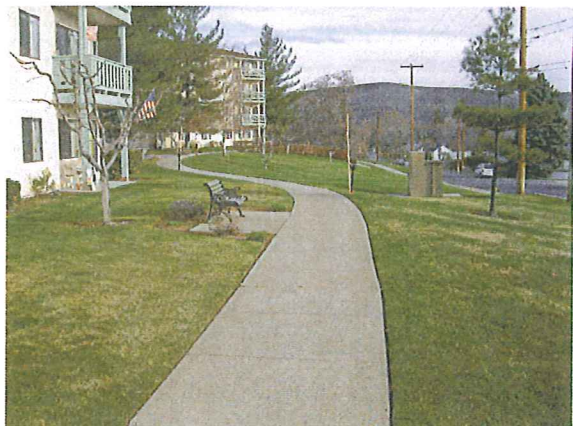
Photo #6: View of Zone 2, looking at the eastern side of facility building.

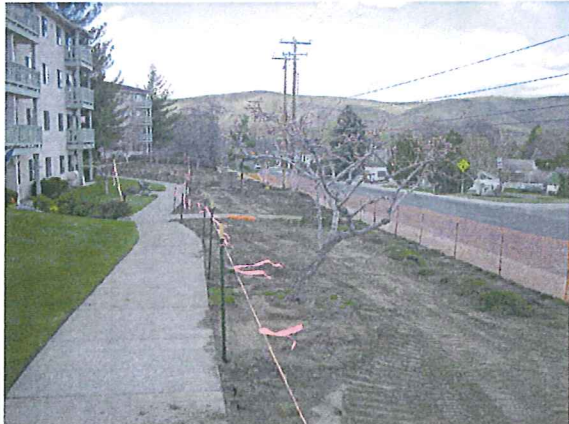
Photo #7: View of Zone 2, looking at the eastern side of the facility building, during the excavation.

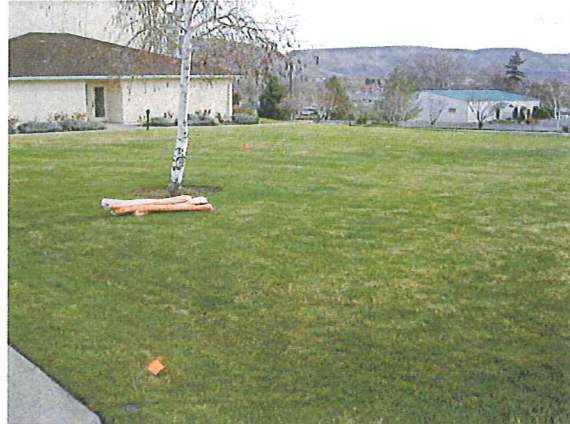
Photo #8: View of Zone 3, looking at the southern end of the facility building.

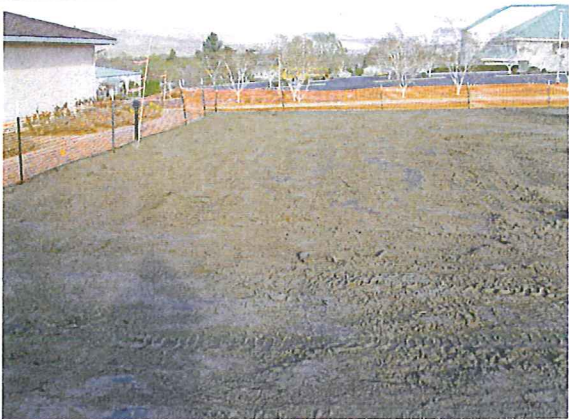
Photo #9: View of Zone 3, looking at the southern end of the facility building, during excavation.

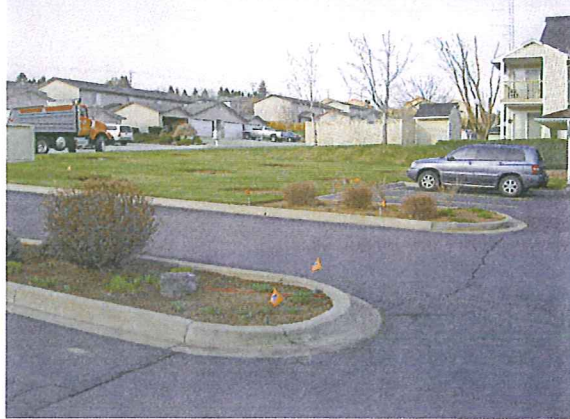
Photo #10: View of Zone 4, looking to the southwest.

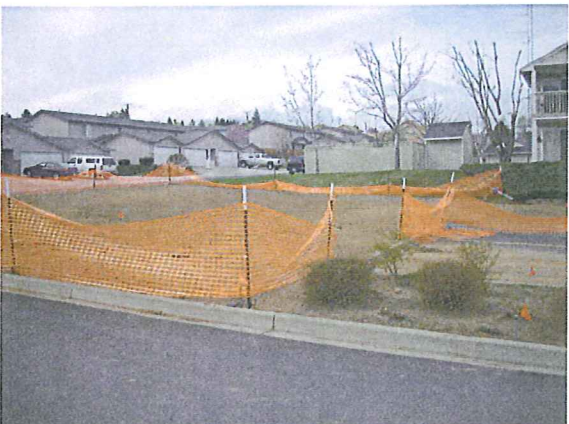
Photo #11: View of Zone 4, looking to the southwest, after clean imported soil has been brought in and raked into place.

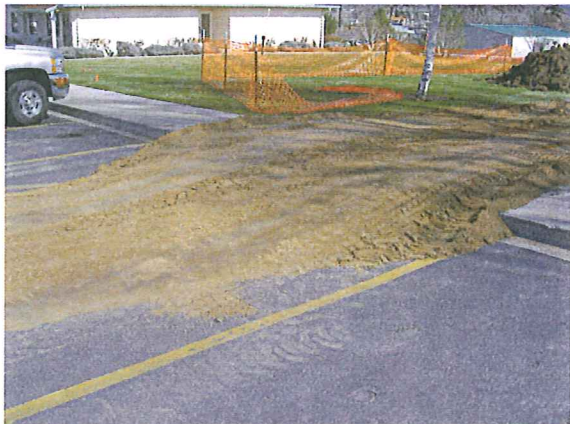
Photo #12: Entrance point to Zones 2 and 3. Ramp created to allow access of excavation equipment.

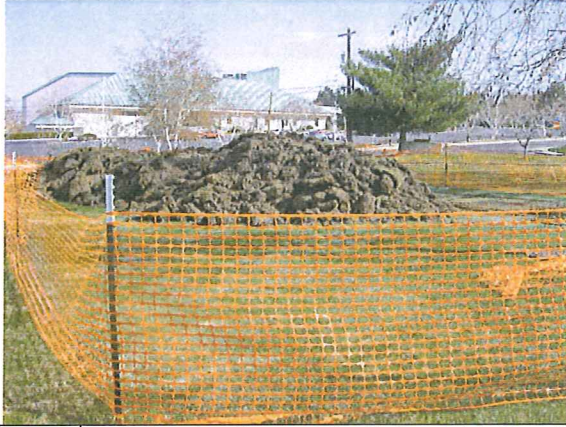
Photo #13: Stockpile point of excavated soil. Located in Zone 3. View of stockpile is facing south, from the southern end of the facility building towards 34th Ave N.

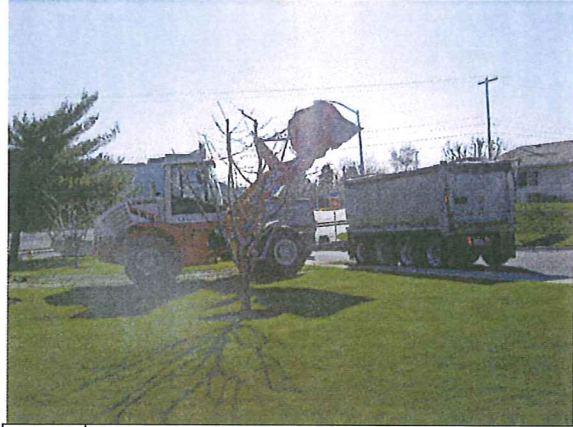
Photo #14: Excavated soil being loaded into truck and pup for transportation to waste facility. Truck is parked on Fairbanks Ave. which intersects 34th Ave N.

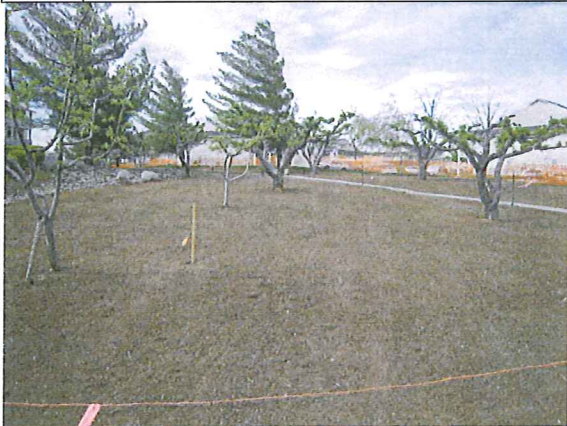
Photo #15: View of Zone 1 during the Final Walkthrough.

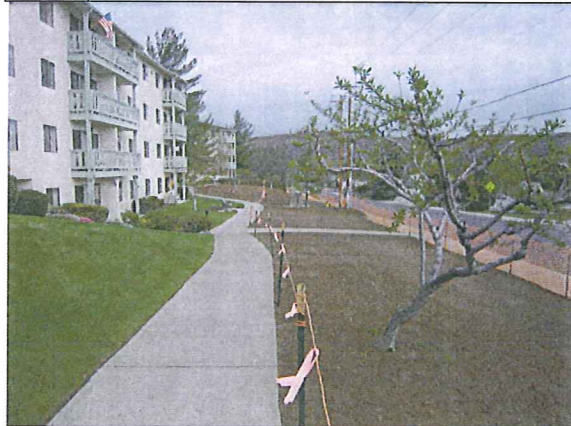
Photo #16: View of Zone 2 during the Final Walkthrough.

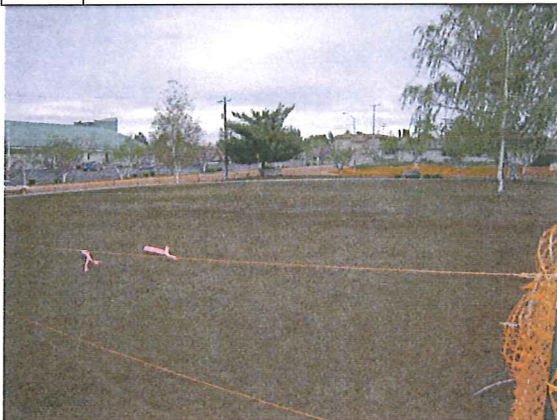
Photo #17: View of Zone 3 during the Final Walkthrough.

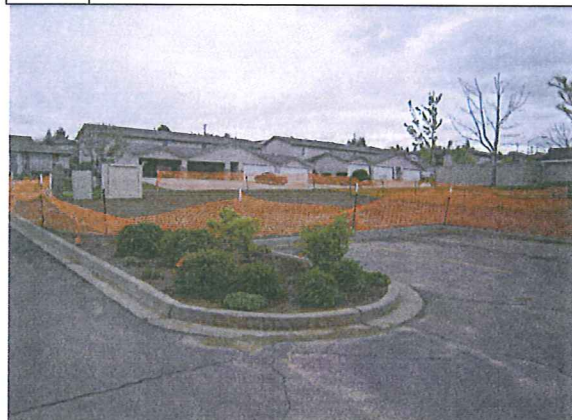
Photo #18: View of Zone 4 during the Final Walkthrough.
