WORK PLAN FOR REMEDIAL INVESTIGATION South Park Marina Seattle, Washington

Project No. 190293-001-1.1 • February 2, 2021 • Final

For submittal to the Washington State Dept of Ecology

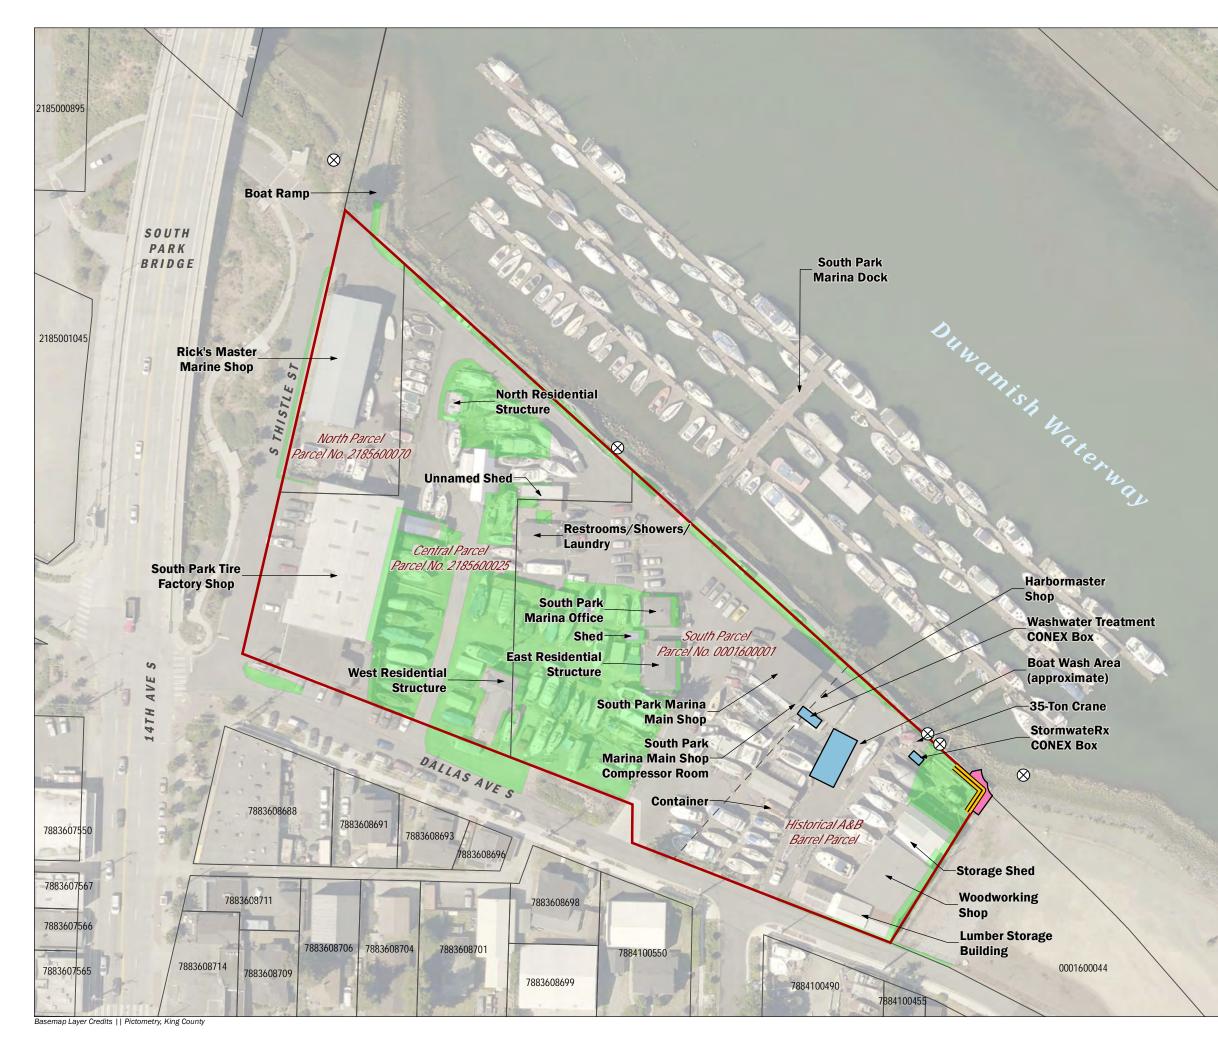
DEC-2020	AY / TDR	FIGURE NO.
CONSULTING	PROJECT NO. 190293	REVISED BY:	2.2

Current Property Features

As discussed in Sections 2.2.3 and 2.3.1.3, the Central Parcel has historically been used as a gasoline service station, as a radiator repair shop, for automotive maintenance and repair, as a mobile home park, and for boat storage for over 90 years, beginning prior to the 1930s. Potential contaminant sources associated with historical (Figure 2.1) and current (Figure 2.2) operations on or near the Site include:

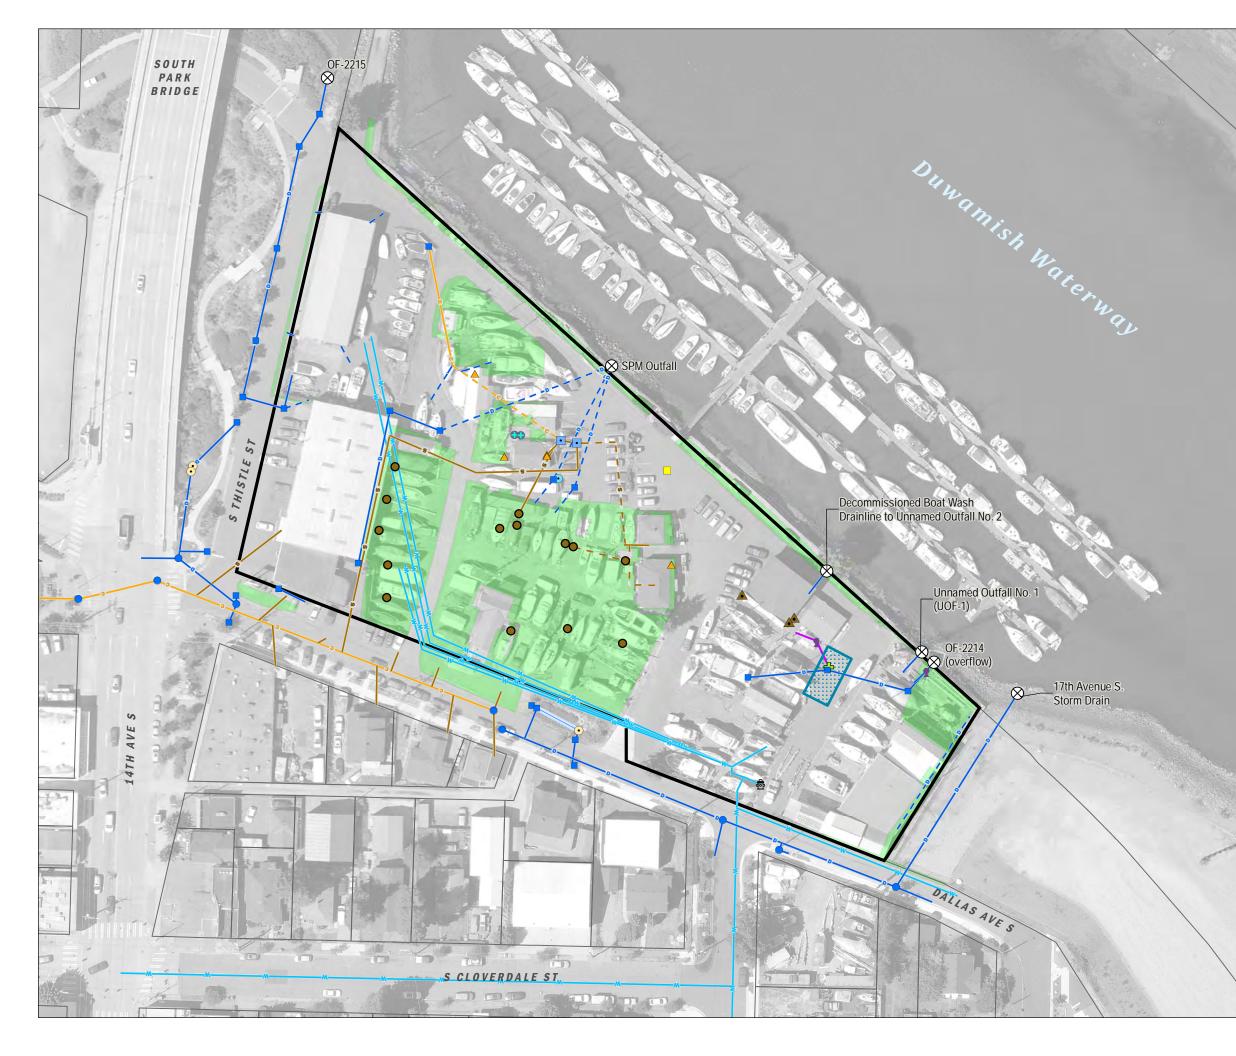
-	Catch Basin		
	Cleanout		
•	Discharge Location		
	Manhole		
\otimes	Outfall (Existing and Dec	commissioned)	
2	Pump Vault		
•	Sanitary Sewer Hook Up		
•	Sanitary Sewer Vault

- :	Septic Tank		
A :	Sewer feature investigat	ed 2/22/17-2/23/	17
•	Shower Drain		
.	Vessel Wash Wastewate	r Catch Basin	
•	Water Utility Vault		
e	Hydrant		
	Boat Wash Pad		
	Water Line Pipe		
c	Combined Sewer Pipe		
c	Combined Sewer Pipe (i	nferred)	
s	Sanitary Sewer Pipe		
	Sanitary Sewer Pipe (inf	erred)	
D	Storm Sewer Pipe		
— — -D ;	Storm Sewer Pipe (infer	red)	
	Bioswale		
,	Vessel Wash Collection	Pipe	
	Pervious Surface (grave	l)	
	Site Boundary		
\sim	King County Tax Parcel

The following section describes utilities observed by Aspect during a site walk on November 21, 2019, as well as utilities identified in previous reports. Figure 2.3 depicts utility information gathered from the City of Seattle (City Development Service Office's [DSO], 2020) and as modified by TIG Environmental through camera and topographic surveys and a dye tracer investigation (2019).

Subsurface features of the former septic systems and sanitary sewers associated with the historical mobile home park, historical residences, current residences, and current restroom, laundry, and shower building have not been completely mapped (TIG Environmental, 2019). However, readily apparent surface features, such as some historical sanitary sewer hook ups, are mapped throughout the Central and South Parcels (Figure 2.3). During the PLP site walk on November 21, 2019, Aspect noted several additional unmarked sewer/septic features, which will require further mapping during the RI. A septic tank may have been historically present near the center shoreline of the Central Parcel, as depicted on Figure 2.3. The location of this potential septic tank was noted from a 1968 King County permit, but the tank could not be located using ground-penetrating radar (TIG Environmental, 2017).

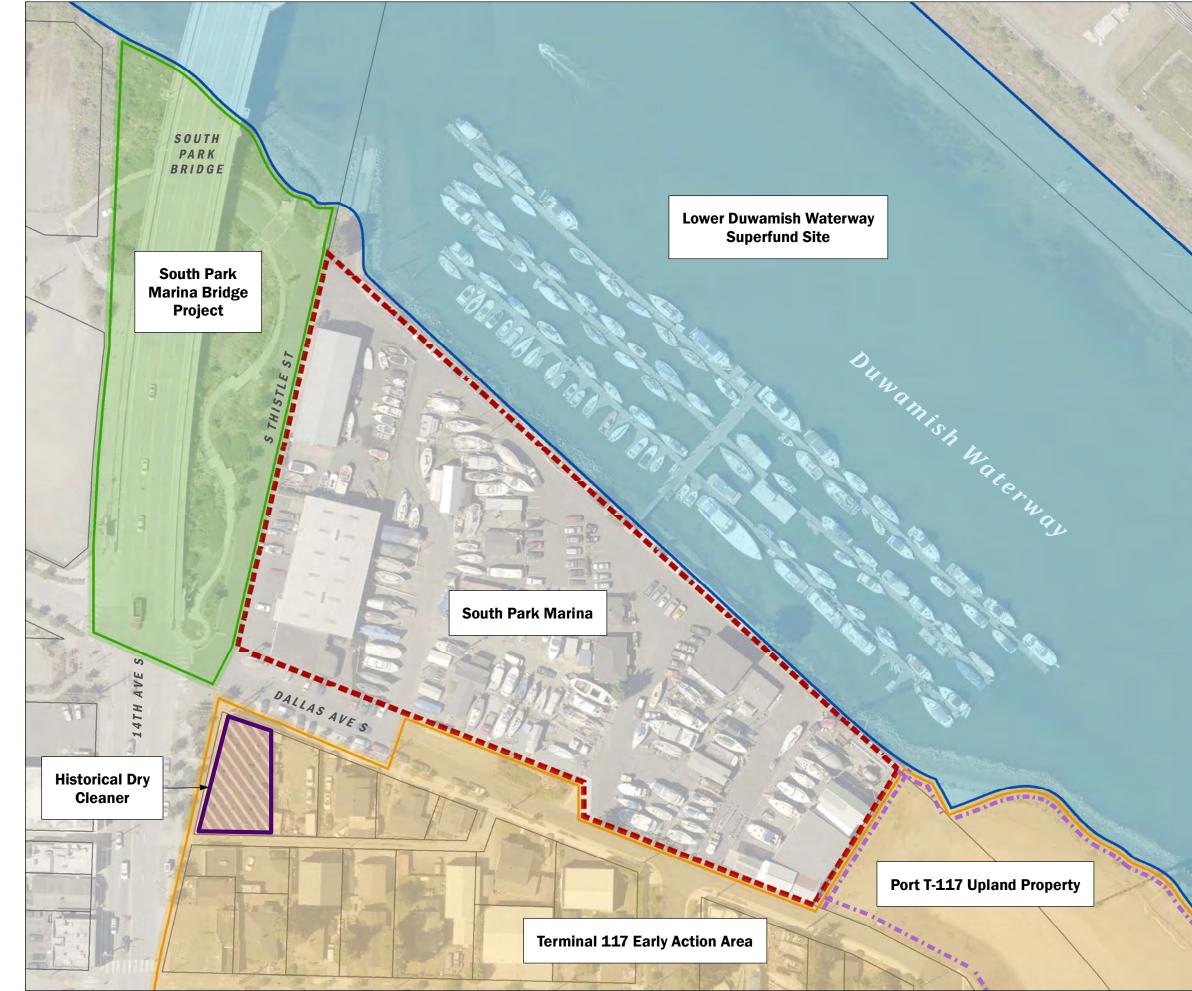
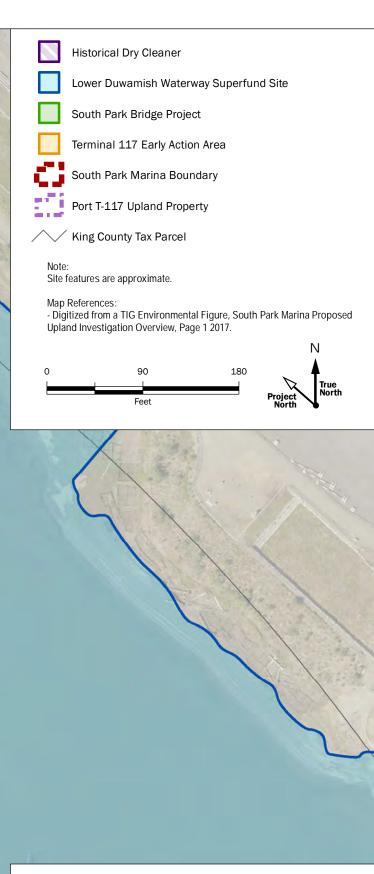
Aspect	NOV-2020	AY / TDR	FIGURE NO.		
CONSULTING	PROJECT NO. 190293	REVISED BY:	2.5

Surrounding Sites RIWP South Park Marina Seattle, Washington
