SITE CHECK REPORT

Performed at:
Gearjammer Truck Plaza
2310 Rudkin Road
Union Gap, Washington 98903

AEROTECH
Environmental Consulting Inc.

January 29, 2021

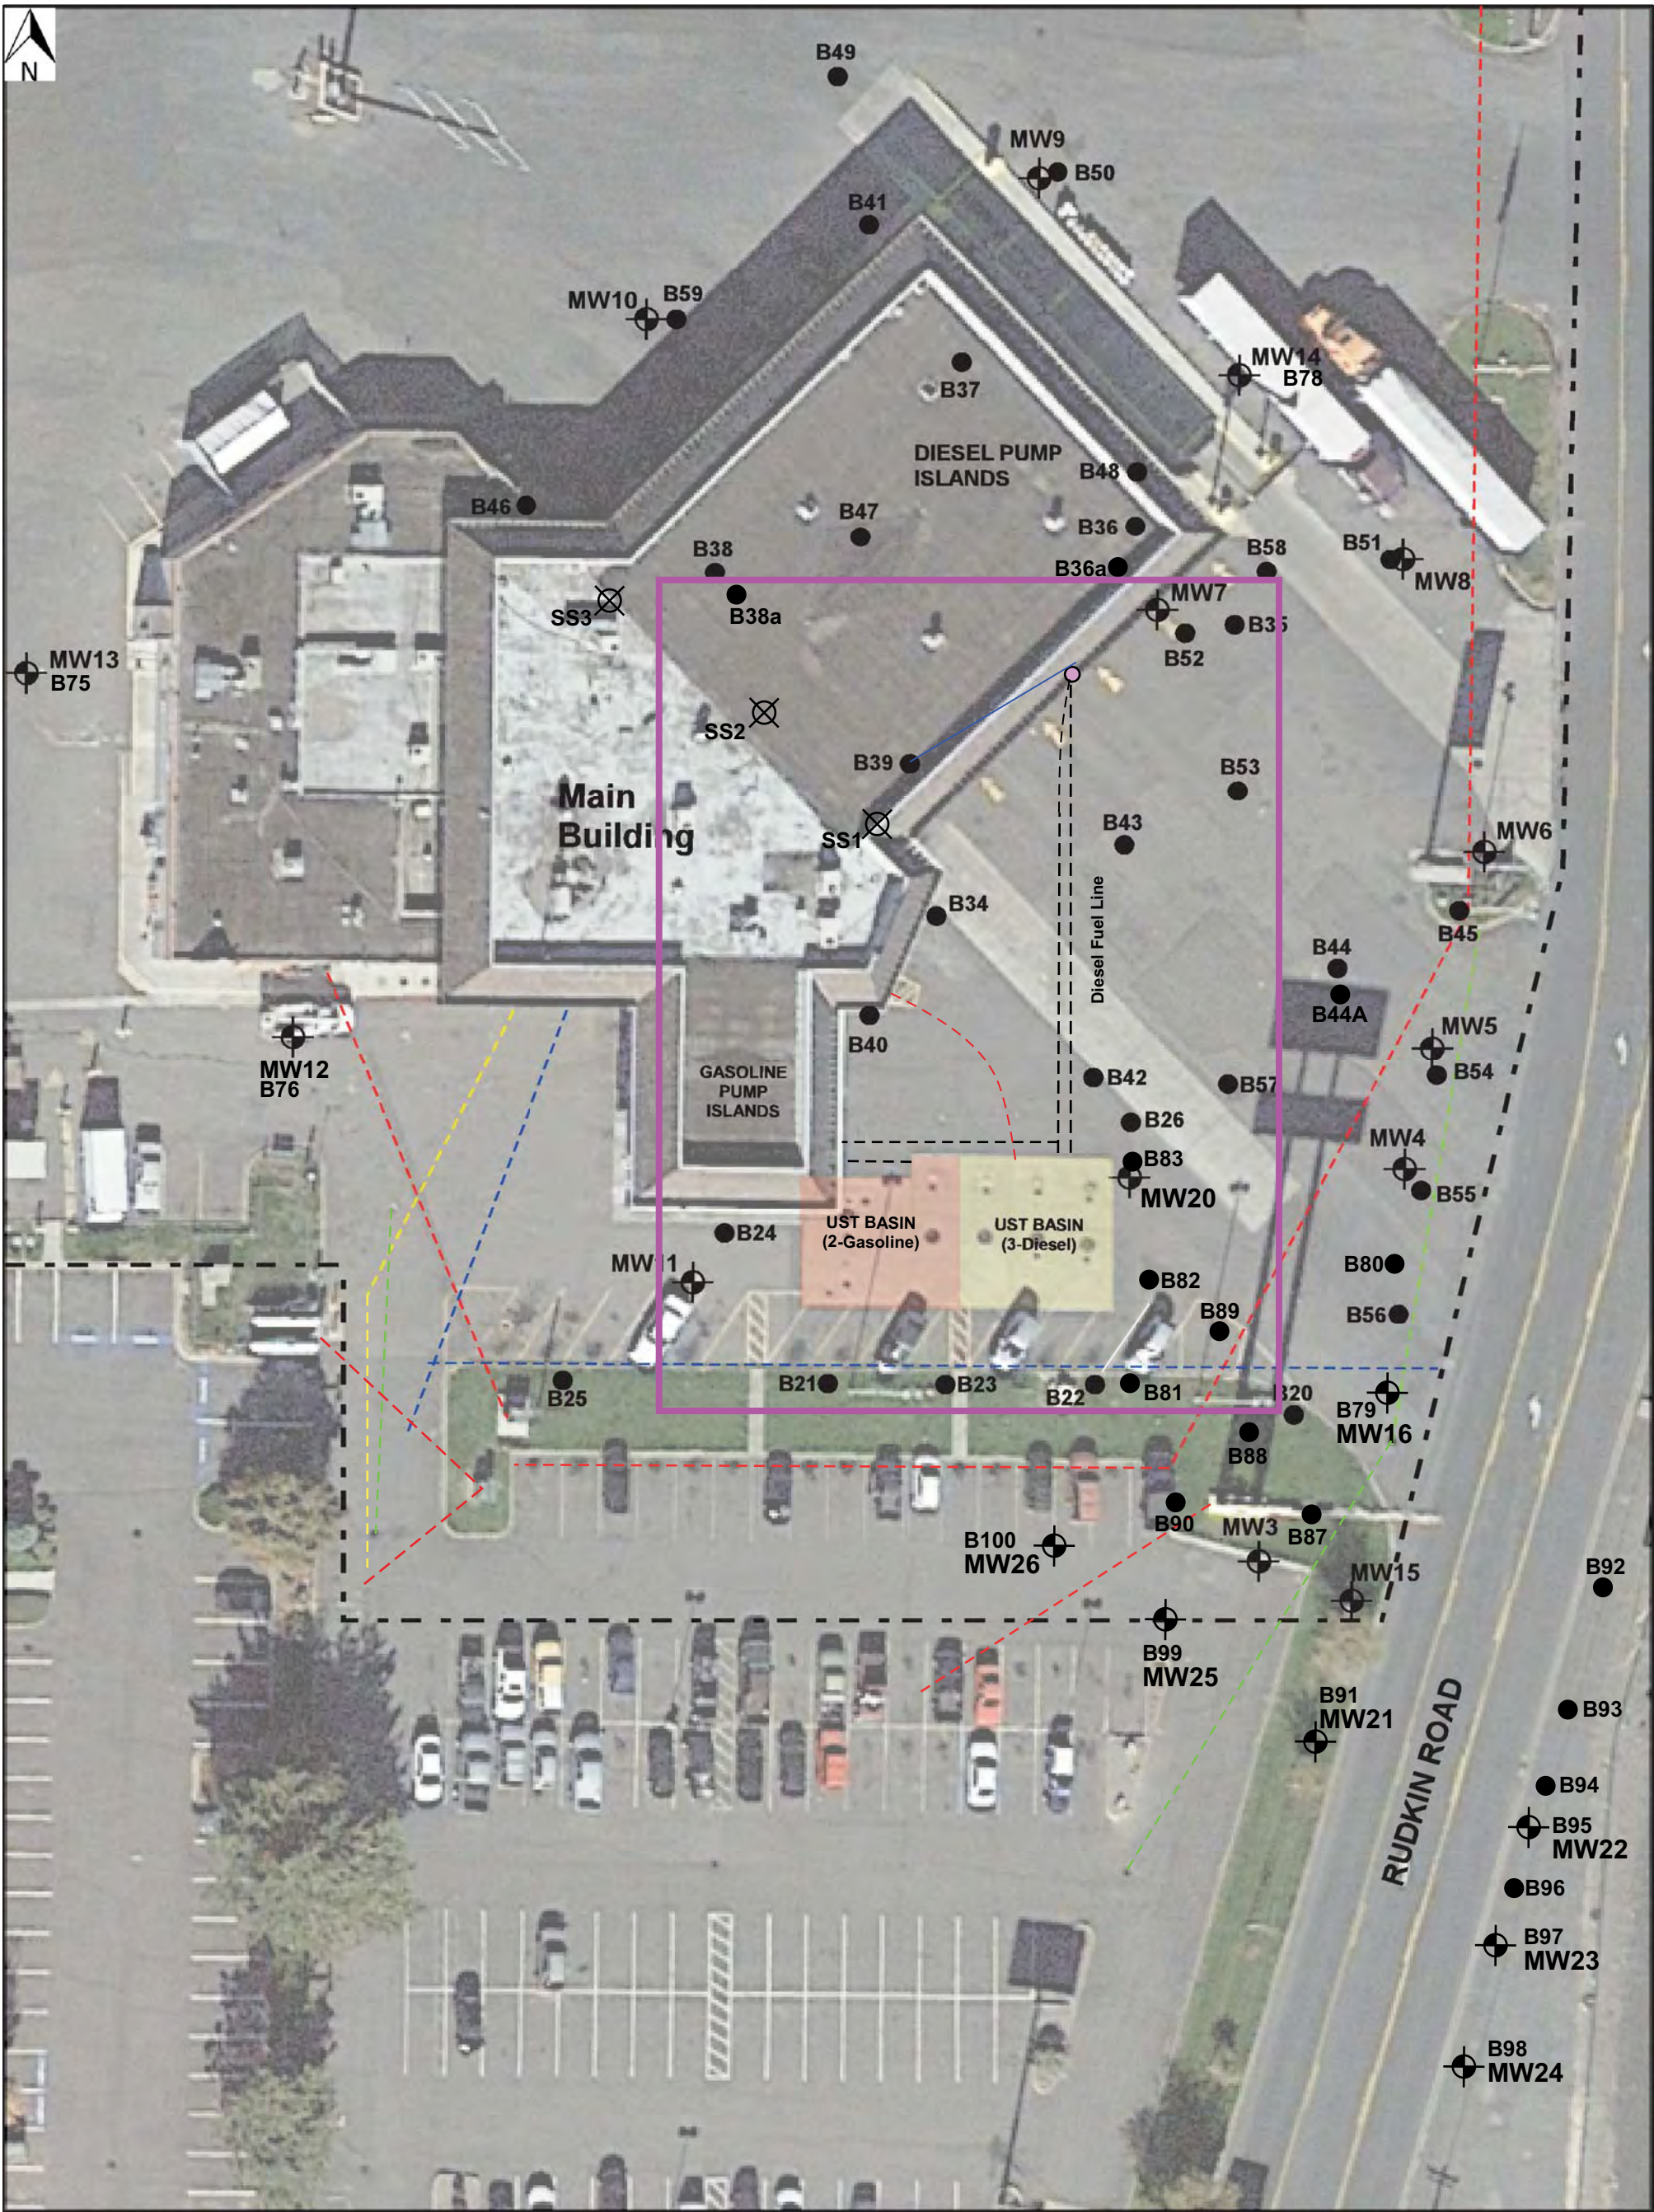
EXPLANATION			
MW26	Groundwater Monitoring Well		Property Boundary
B96	Soil Boring	SS3	Subslab Sampling Point
	Water		Extent of Figures 5 & 6 (AOC for Site Check)
	Gas		
	Electrical		
	Storm Water

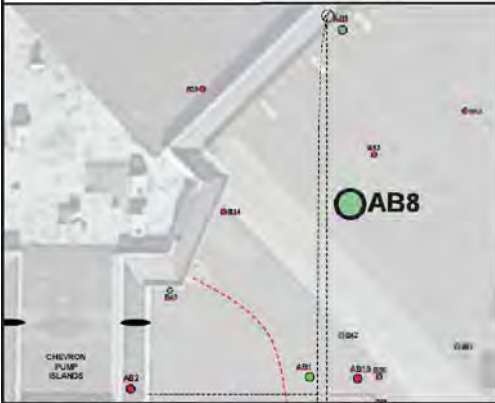
Depth (Ft)	Recovery	Sample Interval	Blow Counts	PID Reading	USCS Classification	Description	Well Construction
1				0.0	SM	Surface: Asphalt	
2						(FILL) Silty SAND: dark brown to black, fine to medium-grained, silt, some medium subrounded gravel, dry	
3							
4				2.3	GW	SAND AND GRAVEL with COBBLES: Brown-Grey subrounded well graded gravel with coarse sand and cobbles; dry	
5							
6							
7							
8				0.0	GW	As above	
9							
10							
11							
12				0.1	GW	As above	
13							
14				0.3	GM	GRAVEL & SAND: Light to dark grey subrounded, well graded gravel with well graded sand and silt, saturated.	
15							
16							
17						Boring terminated at 15 feet below ground surface.	
18						Concrete from 0 to 1 feet bgs	
19						Bentonite from 1 to 15 feet bgs

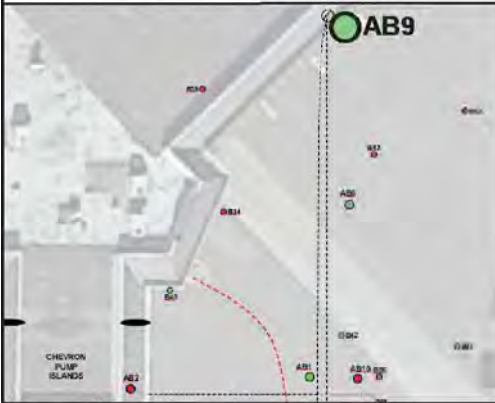
Depth (Ft)	Recovery	Sample Interval	Blow Counts	PID Reading	USCS Classification	Description	Well Construction
1				0.0	SM	Surface: Asphalt (FILL) Silty SAND: dark brown to black, fine to medium-grained, silt, some medium subrounded gravel, dry	
2							
3							
4							
5							
6						Boring terminated at 4 feet below ground surface.	
7						Concrete from 0 to 1 feet bgs	
8						Bentonite from 1 to 4 feet bgs	
9							
10							
11							
12							
13							
14							
15							
16							
17							
18							
19

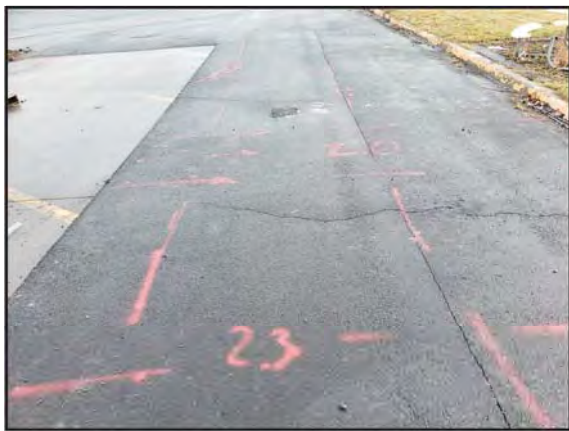
Marked Subsurface Utilities South of UST Basin in the Vicinity of AB4

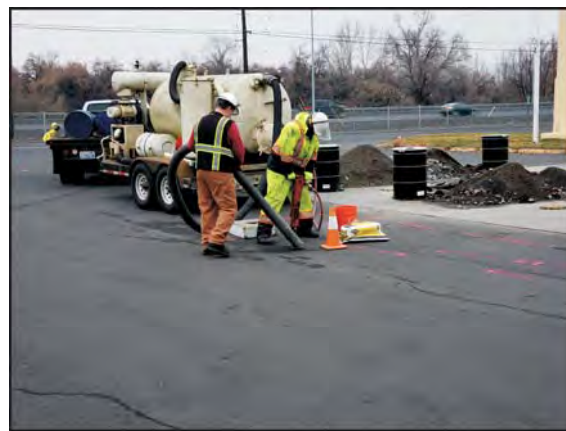
Air-knife Operations at Soil Boring AB1

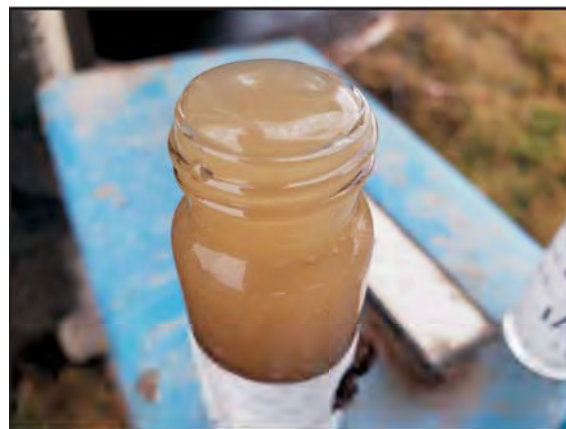
Grab Groundwater Sample Collected from AB5; Side View of the 40 ml VOA with the Observed Slight Sheen on the Meniscus

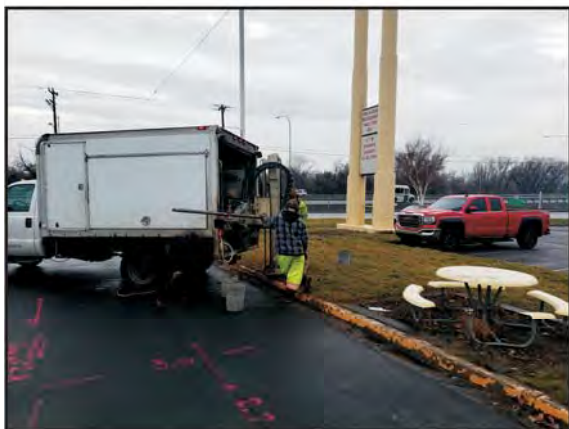
Heavy Duty Direct Push Drill Rig at Soil Boring Location AB5

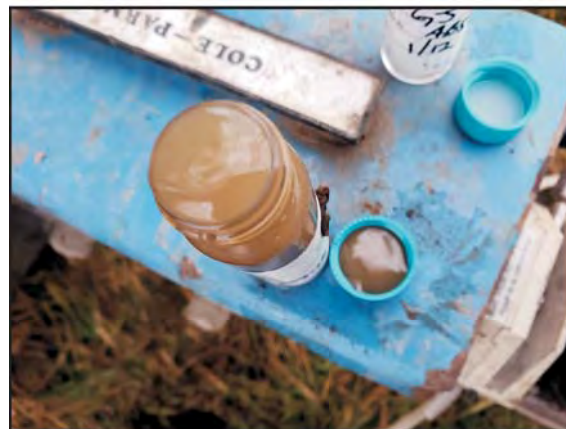
Grab Groundwater Sample Collected from AB5; Top View of 40 ml VOA with a Slight Sheen on the Meniscus
