INTERIM ACTION WORK PLAN

ALLEY AREA OF BLOCK 38 WEST SITE BETWEEN REPUBLICAN STREET AND MERCER STREET SEATTLE, WASHINGTON

Agreed Order No. DE 17963 Facility Site Identification No. 62773 Cleanup Site Identification No. 15008

February 3, 2021

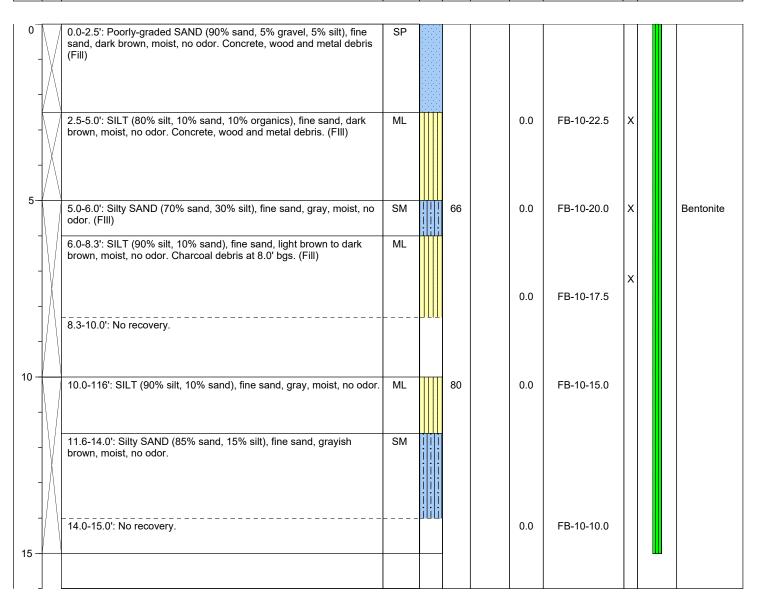
Depth (feet bgs.)	Sample Interval	Lithologic Descriptio	n scs	USCS Graphic	% Recovery	Blow Counts 8/8/8	PID (ppm)		Sample Analyzed	Boring/Well Construction Details
-------------------	-----------------	-----------------------	-------	--------------	------------	-------------------	-----------	--	-----------------	--

Monument Type:NAFilter Pack:NACasing Diameter (inches):NASurface Seal:ConcreteScreen Slot Size (inches):NAAnnular Seal:NAScreened Interval (ft bgs):NABoring Abandonment:Bentonite

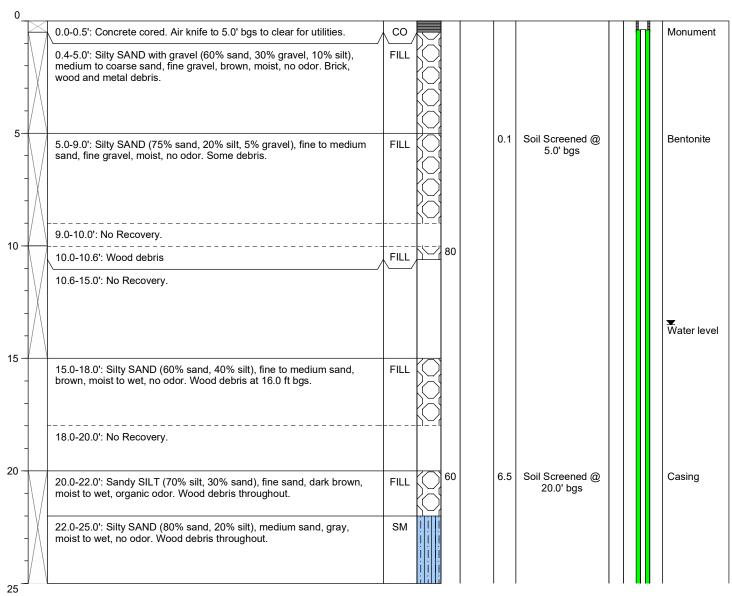
Sample Interval Lithologic Description	SCS	SCS Gr	% Recovery Blow Counts 8/8/8	PID (ppm)	Sample ID	Sample Analyzed	Boring/Well Construction Details
---	-----	--------	------------------------------	-----------	-----------	-----------------	--

Monument Type: Flush Mount
Casing Diameter (inches): 2.0
Screen Slot Size (inches): 0.010
Screened Interval (ft bgs): 72.0-85.0

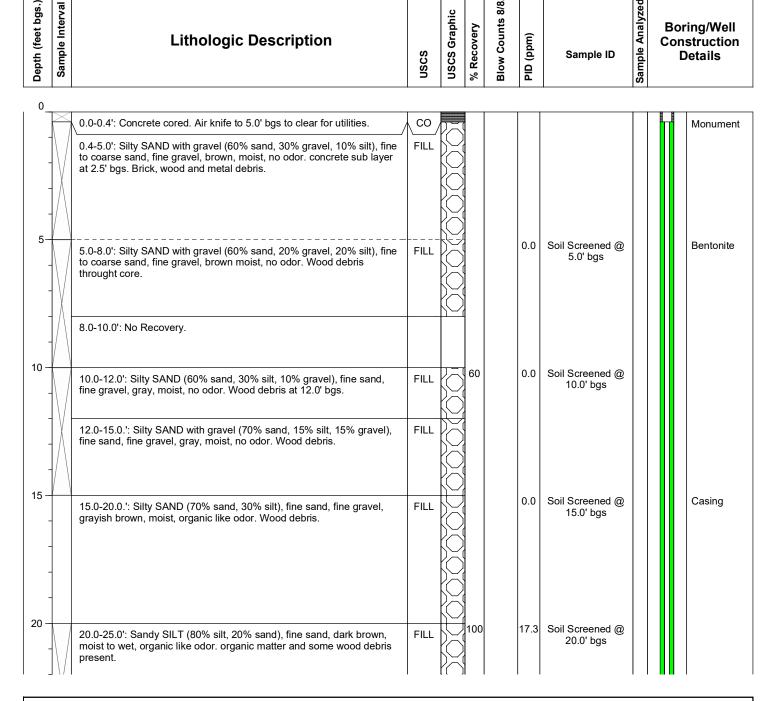
Sample Analyzed **USCS Graphic** low Counts **Boring/Well** Recovery (mdd) **Lithologic Description** Construction Sample ID **Details**

Well Construction Information Ground Surface Elevation (ft): Monument Type: Flush Mount Filter Pack: 12/20 Sand Casing Diameter (inches): 20 Surface Seal: Concrete Screen Slot Size (inches): 0.010 Annular Seal: Bentonite Screened Interval (ft bgs): 90.0 - 100.0 **Boring Abandonment:**

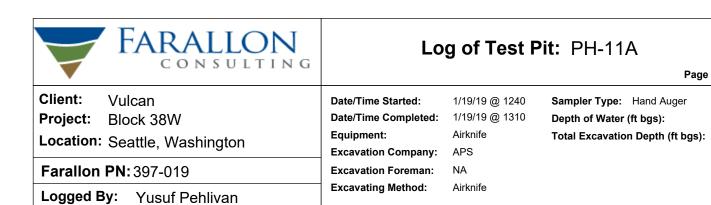
0	0.0-0.9': Concrete.	СО		
	0.9-3.8': Well-graded SAND with silt and gravel (60% sand, 30% gravel, 10% silt), fine to coarse sand, fine and coarse gravel, dark brown, moist, trace rocks, brick, wood, and metal debris.	SW- SM		
_	3.7-4.2': Utility Conduits.			
	4.2-4.4': Wood, wet. Unable to advance further.	WD

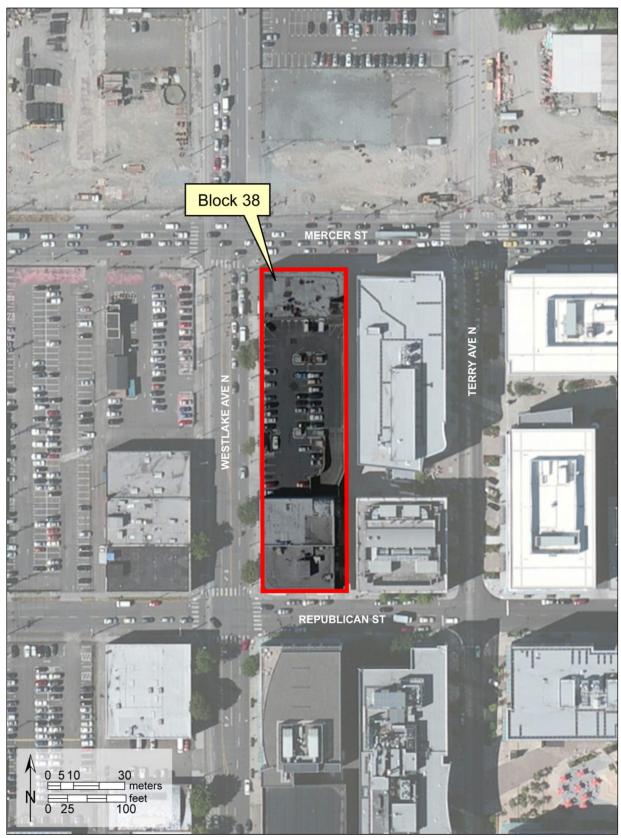
Figure 2. Aerial photograph showing project area.

The project is in the South Lake Union neighborhood in Section 30 of Township 25 North, Range 4 East, Willamette Meridian (Figure 1). The Block 38 site is a half-block area bounded by Westlake Avenue N of the west, Mercer Street on the north, a mid-block alley on the east, and Republican Street on the south (Figure 2). Project plans include construction of a 12-story office/retail building with four levels of below-grade parking. The existing structures on the parcel will be demolished. Geotechnical investigations were completed within the existing buildings and in the alley (Figure 3).

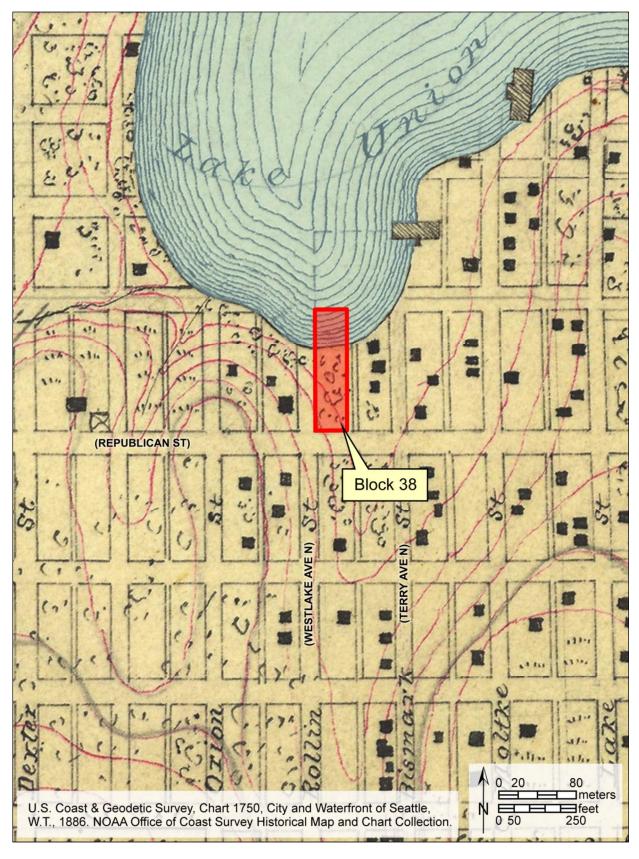
Figure 4. Project area and Lake Union Shoreline in 1886.

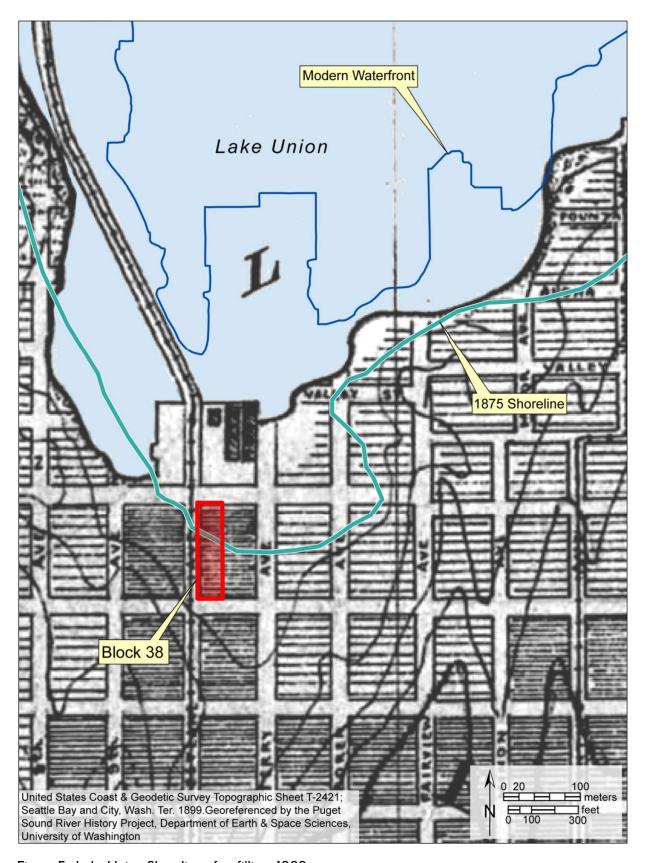
Figure 5. Lake Union Shoreline after filling, 1889.
