Reference: Former Bingo Fuel Stop Annual 2019 Groundwater Monitoring and Sampling Report, Agreed Order No. DE 02TCPCR-3976

- **Site Name:** Former Bingo Fuel Stop
- **Site Address:** Interstate 90 Eastbound Off-Ramp and Thorp Highway South, Thorp, Washington

Client/Project
BURNS BROS INC. / BINGO FUEL STOP
2019 GROUNDWATER MONITORING REPORT
THORP, WASHINGTON

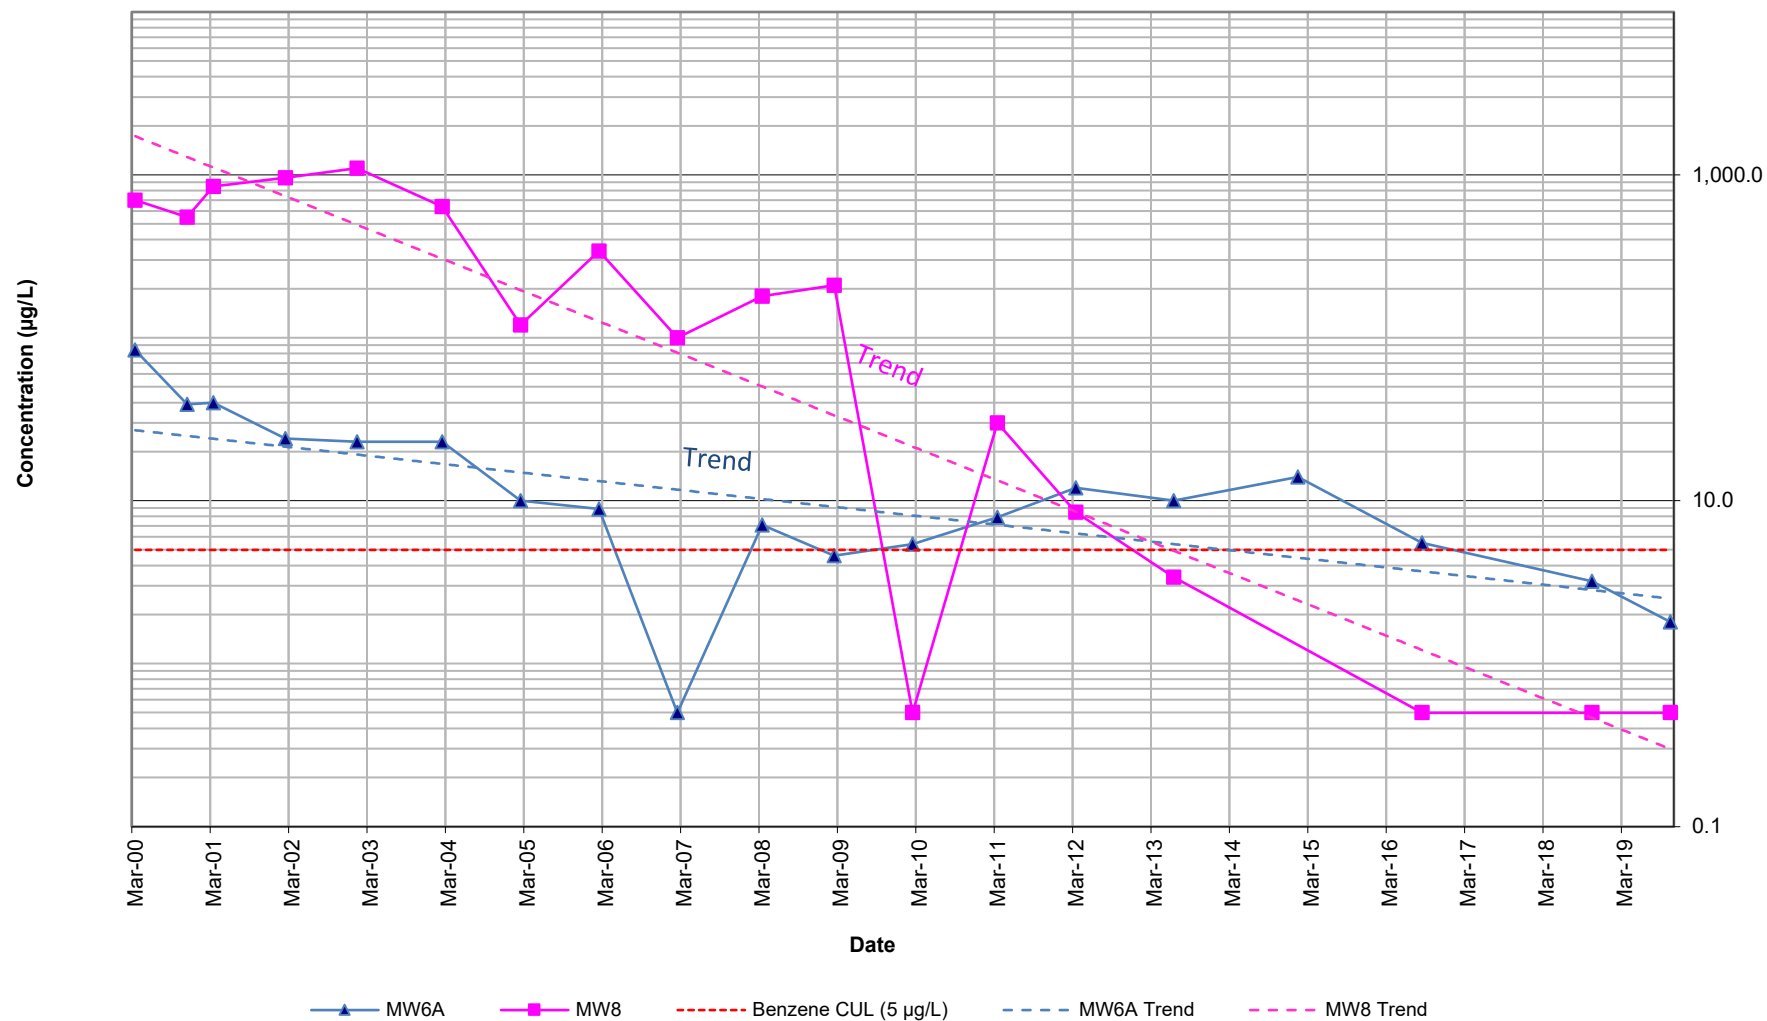
Benzene Concentrations in Groundwater Samples

Notes: Non-detect results are reported at one half the method detection limit
 µg/L - micrograms per liter

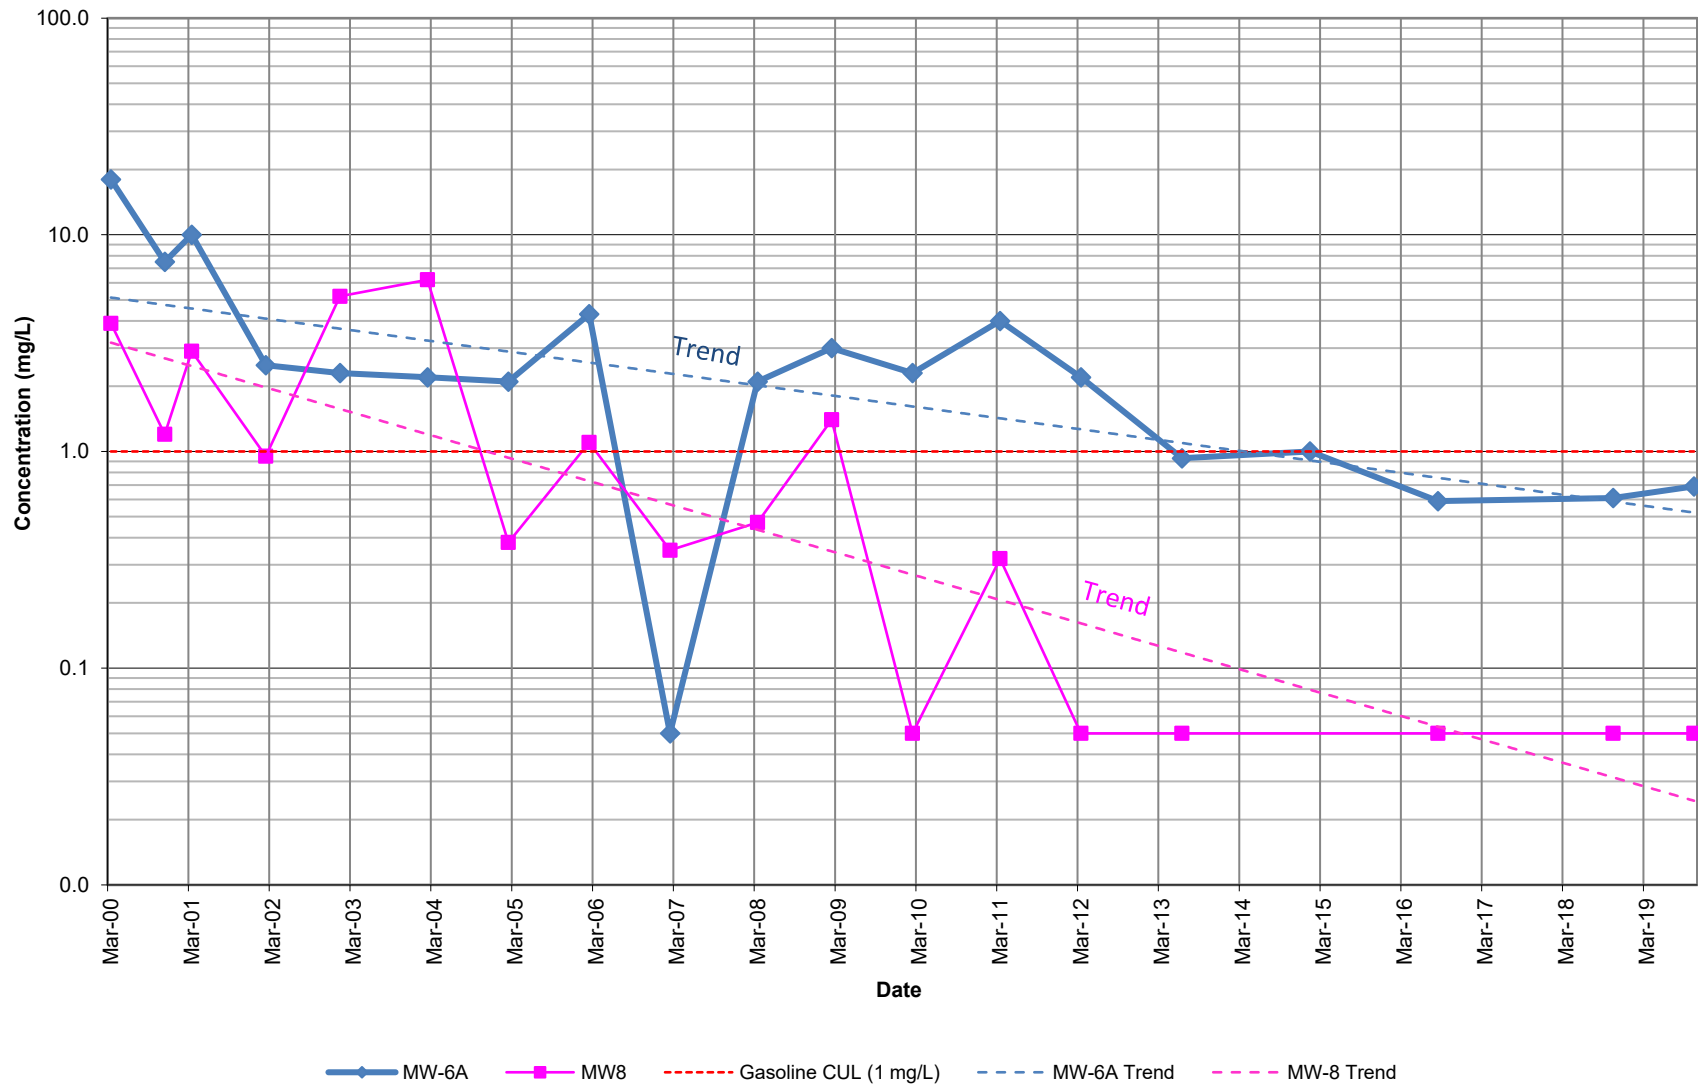
Gasoline Concentrations in Groundwater Samples

Notes: Non-detect results are reported at one half the method detection limit
mg/L - micrograms per liter

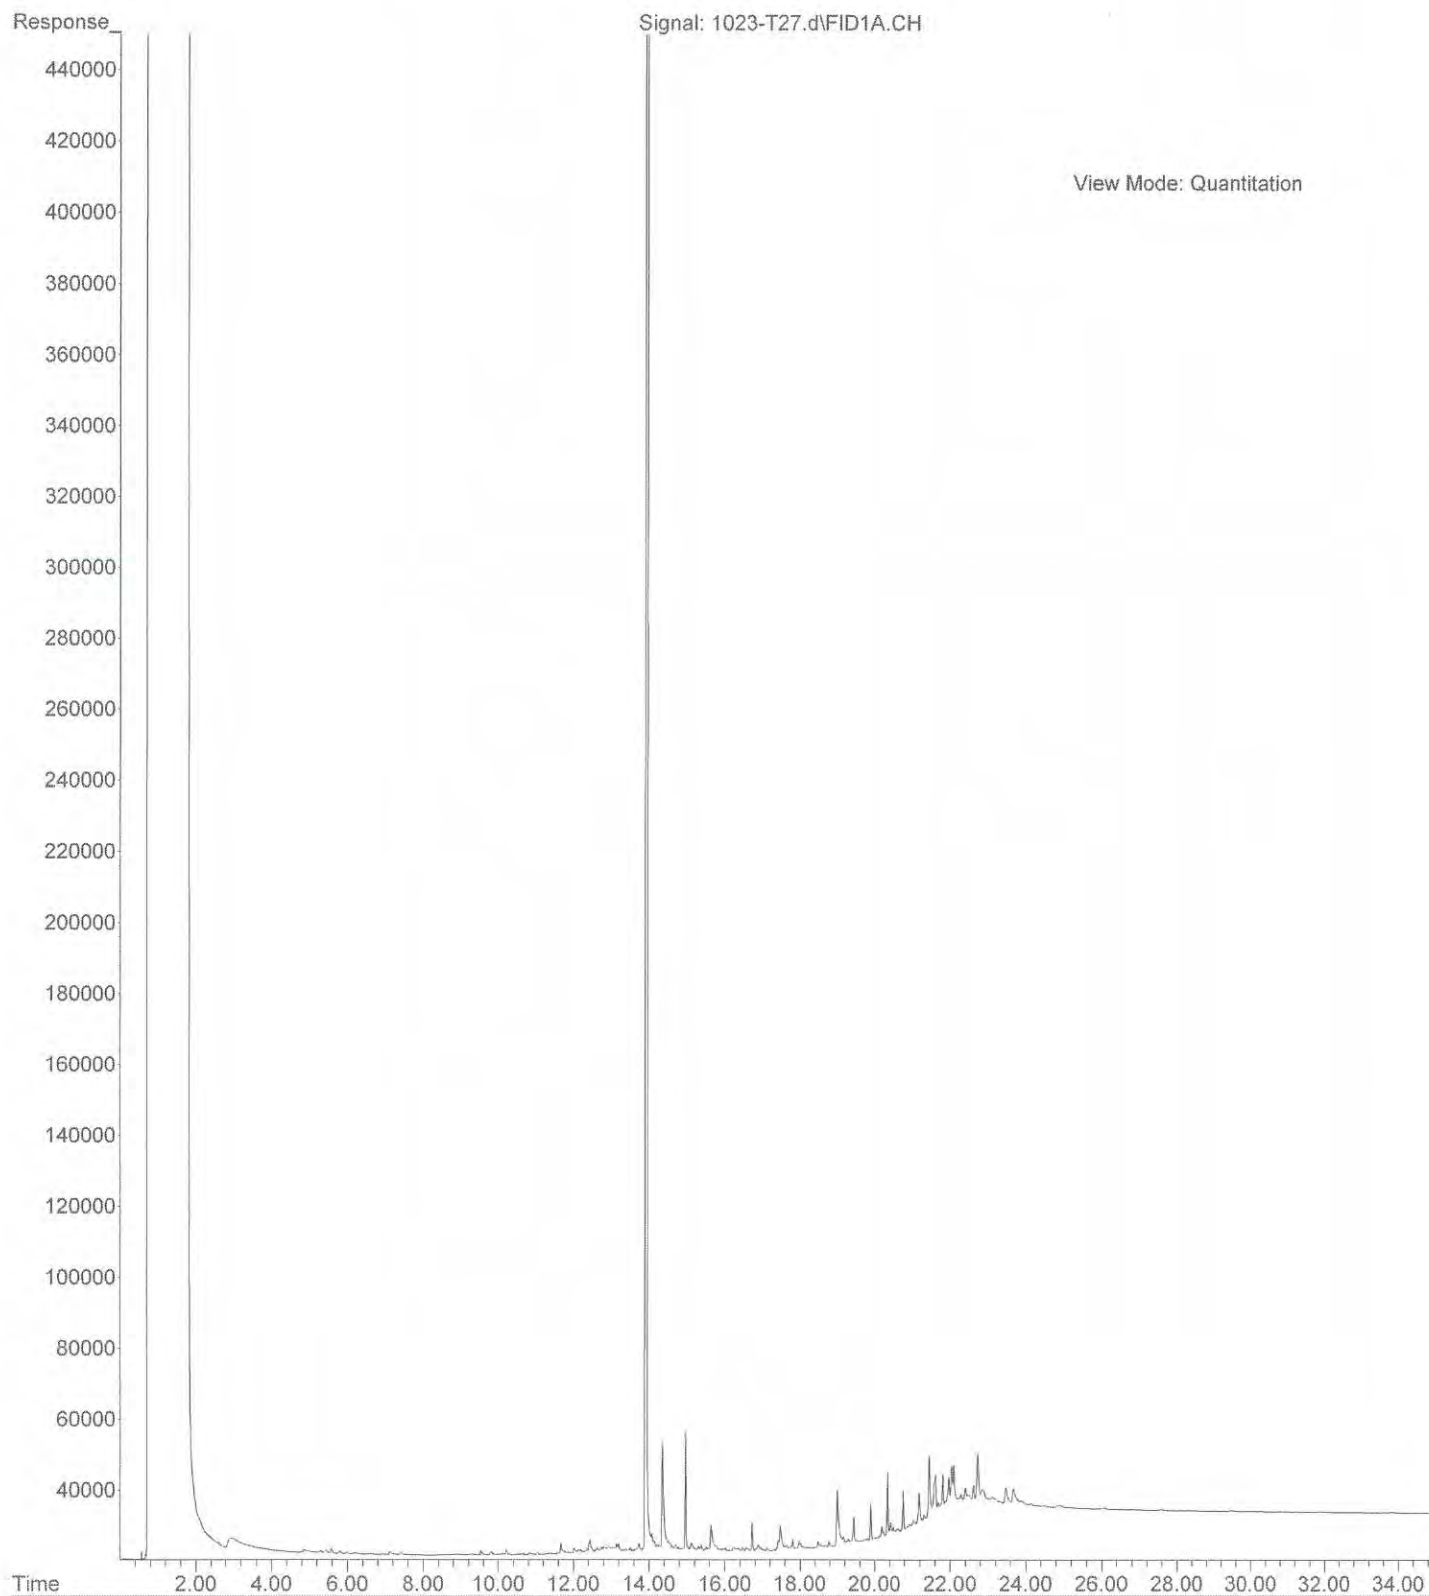
File :X:\DIESELS\TERI\DATA\T191023\1023-T27.d
Operator : JT
Acquired : 24 Oct 2019 1:07 using AcqMethod T190827F.M
Instrument : Teri
Sample Name: 10-276-03
Misc Info :
Vial Number: 27

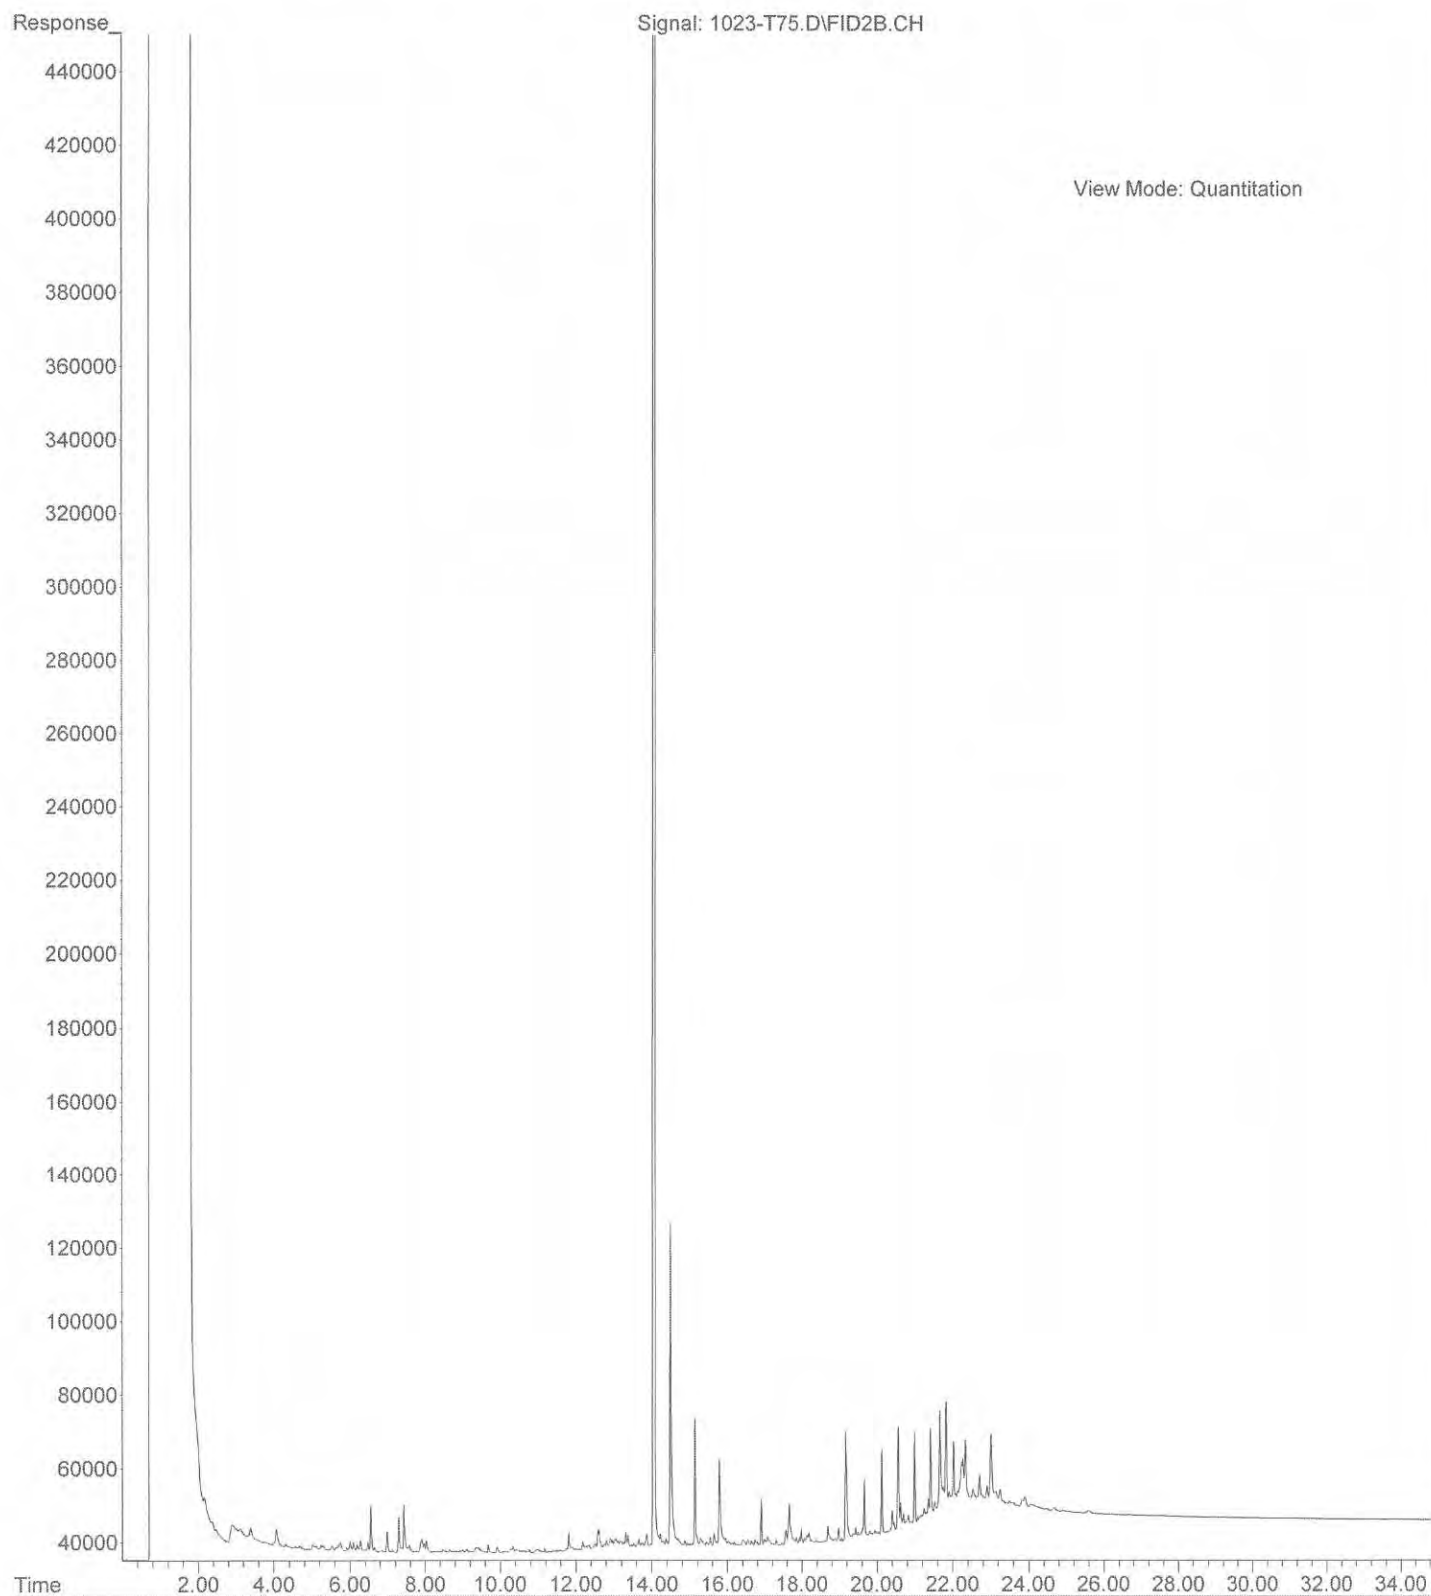
File :X:\DIESELS\TERI\DATA\T191023.SEC\1023-T75.D
Operator : JT
Acquired : 23 Oct 2019 23:43 using AcqMethod T190827F.M
Instrument : Teri
Sample Name: 10-276-04
Misc Info :
Vial Number: 75
