Groundwater Monitoring and Independent Cleanup Report

KCHA Former Park Lake Homes
Maintenance Center Site
9800 8th Avenue SW
Seattle, Washington
VCP No. NW3033

for
King County Housing Authority

February 5, 2021

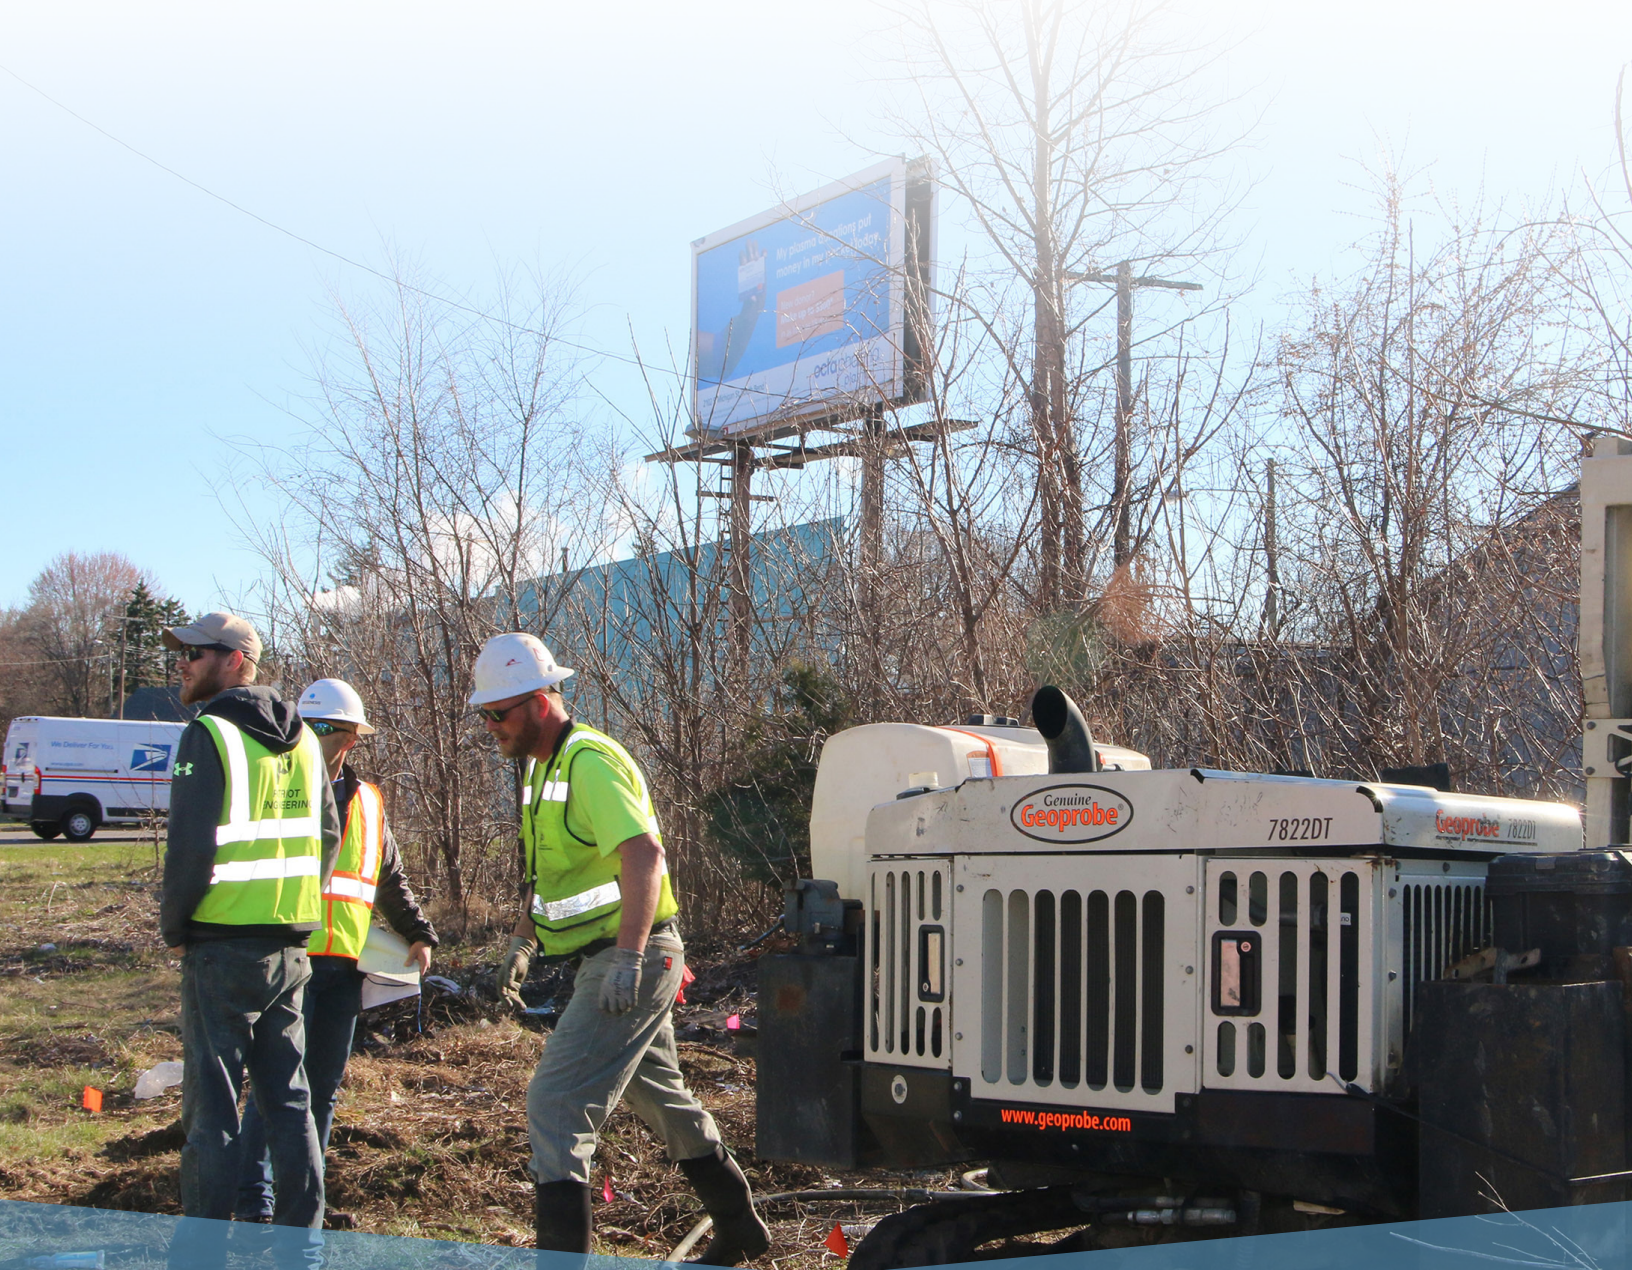
PetroFix Groundwater Sampling Technical Bulletin

PetroFix In Monitoring Wells Post Injection

During injection, PetroFix[®] may flow into nearby monitoring wells, as evidenced by sampling the well and finding the water color to be black. This occurrence is not uncommon and is simply the result of the PetroFix material transporting through the natural flux zones of the aquifer. To ensure that

As a rule of thumb, if a sample is transparent it is safe to analyze. Samples that have minimal PetroFix impact may be light to dark gray in color. It is recommended to use a small glass sampling container such as a 40-mL VOA vial to determine this. If sampling at least four weeks post-PetroFix

If PetroFix is observed in a groundwater well during application, the well can be flushed with clear water (i.e., no reagent). More information on a clear water well flush can be found in the "PetroFix Well Flushing" Technical Bulletin.

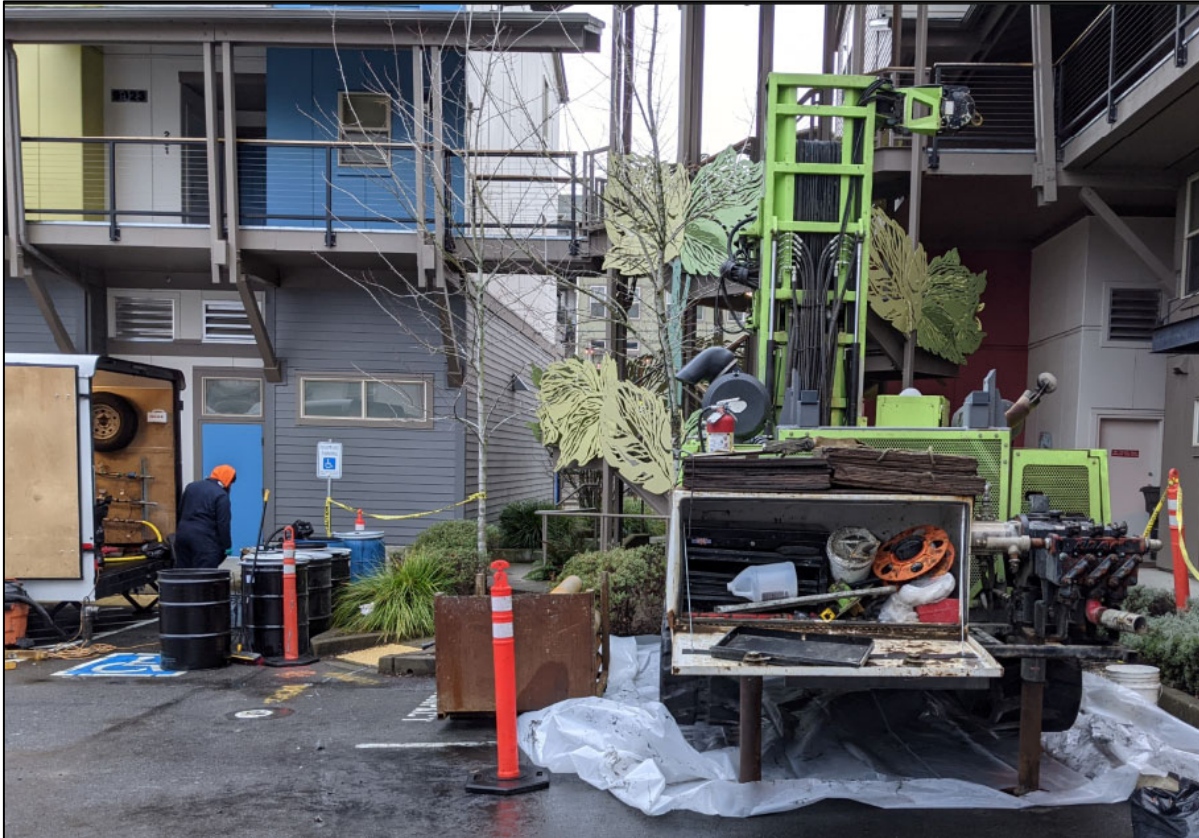
Photo 1: Sonic rig setup during injection activities. Photograph illustrates secondary containment and designated work zone in the parking lot area.

A sonic rig (Terra Sonic TSi 150 Compact Crawler) was used on December 7 through 9, 2020 to successfully complete the remaining injection borings IB-2, IB-3 and IB-4, each to total depths 17.5 to 18 feet bgs. Approximately 80 to 300 gallons of PetroFix™ mixture was injected per boring, with a total of 680 gallons across the treatment area (combined total for both injection events). The injection mixture ratio in December was adjusted to approximately 1 pound of PetroFix per 1.3 gallons of water to accommodate reservoir flow rates.
