# Former E.A. Nord Door Site

## Summary of Source Control Evaluation to Assess Data Gaps for Completion of RI/FS

Prepared for: JELD-WEN, Inc.

January 2019

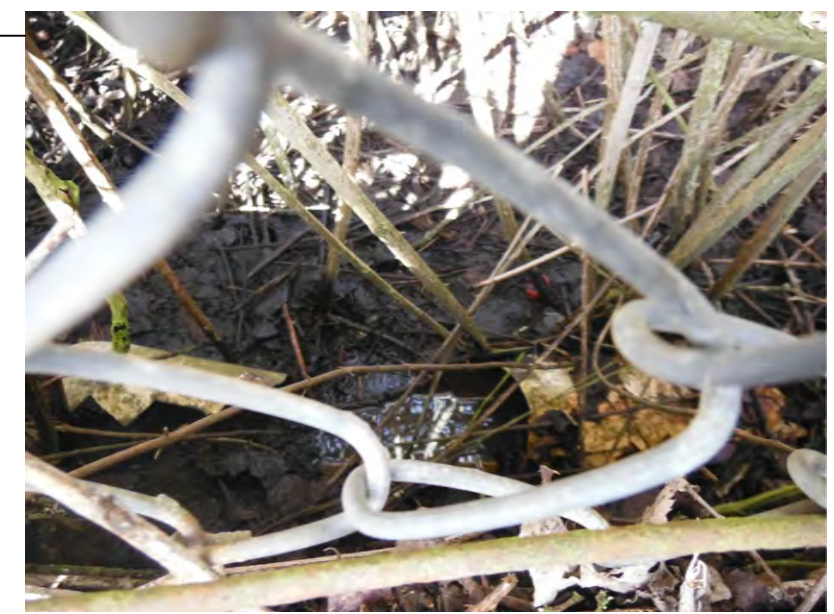
- Two (2) composite soil samples were collected: one composite sample from the approximate area of the disconnected discharge pipe (NTD-SED-A); and, one composite sample from the approximate original terminus of the discharge pipe (NTD-SED-B). These sample locations are shown on **Figure 4**.
- The composite soil samples consisted of three aliquots of soil of similar volume collected with a decontaminated stainless steel spoon and gently composited in a decontaminated stainless steel bowl and then placed directly into laboratory-provided containers with appropriate preservative (with the exception of volatiles analysis, which was collected per the 5035 method from in-situ soil).

(COMPOSITE SAMPLE LOCATION NTD-SED-B) PHOTO OF END OF OUTFALL PIPE

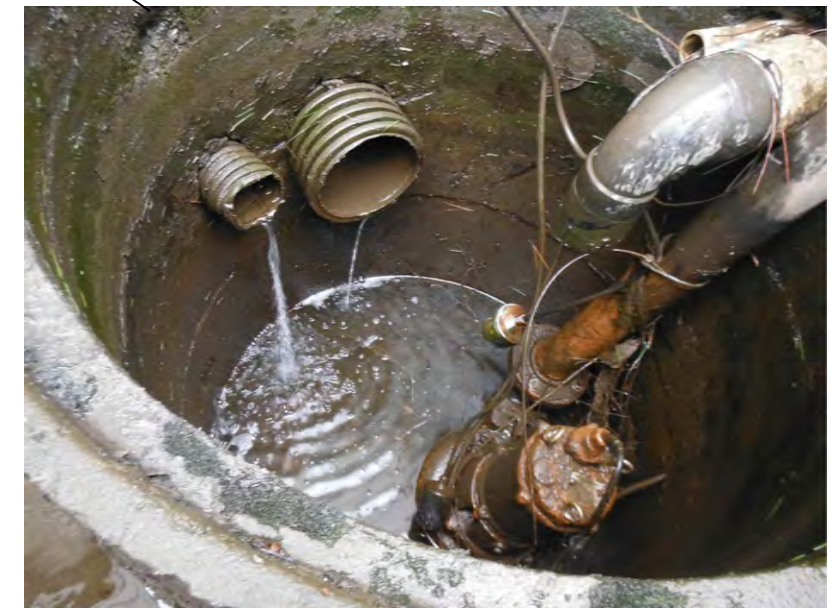
Inlets to the NTD sump include a 3-inch inlet and 8-inch inlet on the southwest side of the sump. The 3-inch line was found to be connected to the adjacent strip drain in the NTD and also tied to a roof downspout at the corner of the Main Warehouse Building (identified as DS-1 on Figure 4). The 8-inch line was found to be connected to a roof downspout within the Main Warehouse Building (identified as DS-2 on Figure 4). In addition, two weep holes or ring lift holes were observed during the water sampling activities (described below).

PHOTO OF THE NORTH TRUCK BAY SUMP

- Plugged the two weep holes and confirmed that water is not entering the sump through the plugged weep holes.
- Cleaned dirt and debris from the NTD area and stockpiled that material on plastic and covered with plastic, per Ecology's recommendation.
- Replaced the sump pump and redirected the sump discharges to an on-site catch basin west of the NTD area.
- Temporarily redirected the roof downspout at the NE corner of the building to drain across the sidewalk and into the City of Everett stormwater drainage system. The roof downspout was reconnected and drains to the NTD trench drain/sump where it is pumped to the on-property stormwater catch basin.
- The current property owner has engaged in on-going communications with the Port of Everett and the City of Everett regarding drainage from West Marine View Drive onto the property and in the NTD area.

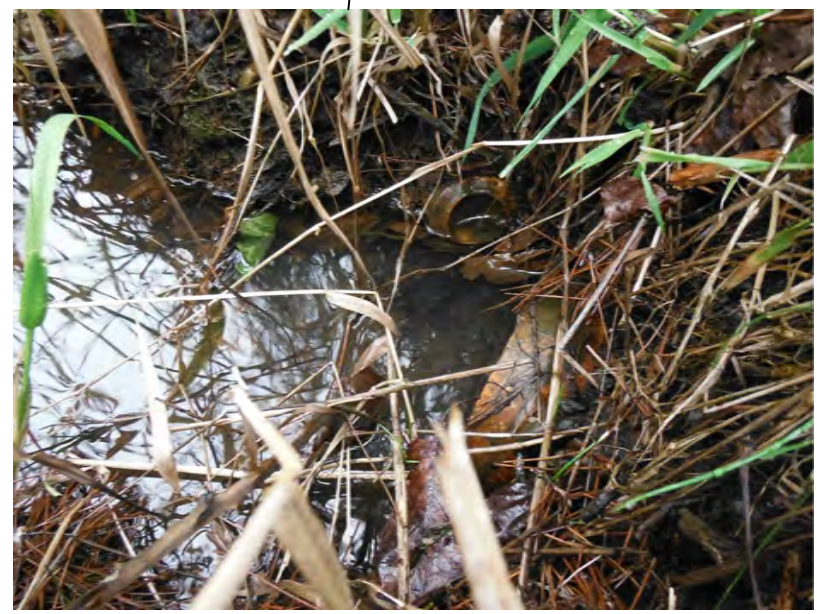
PHOTO OF OUTFALL-1 (COMPOSITE SAMPLE LOCATION NTD-SED-A)

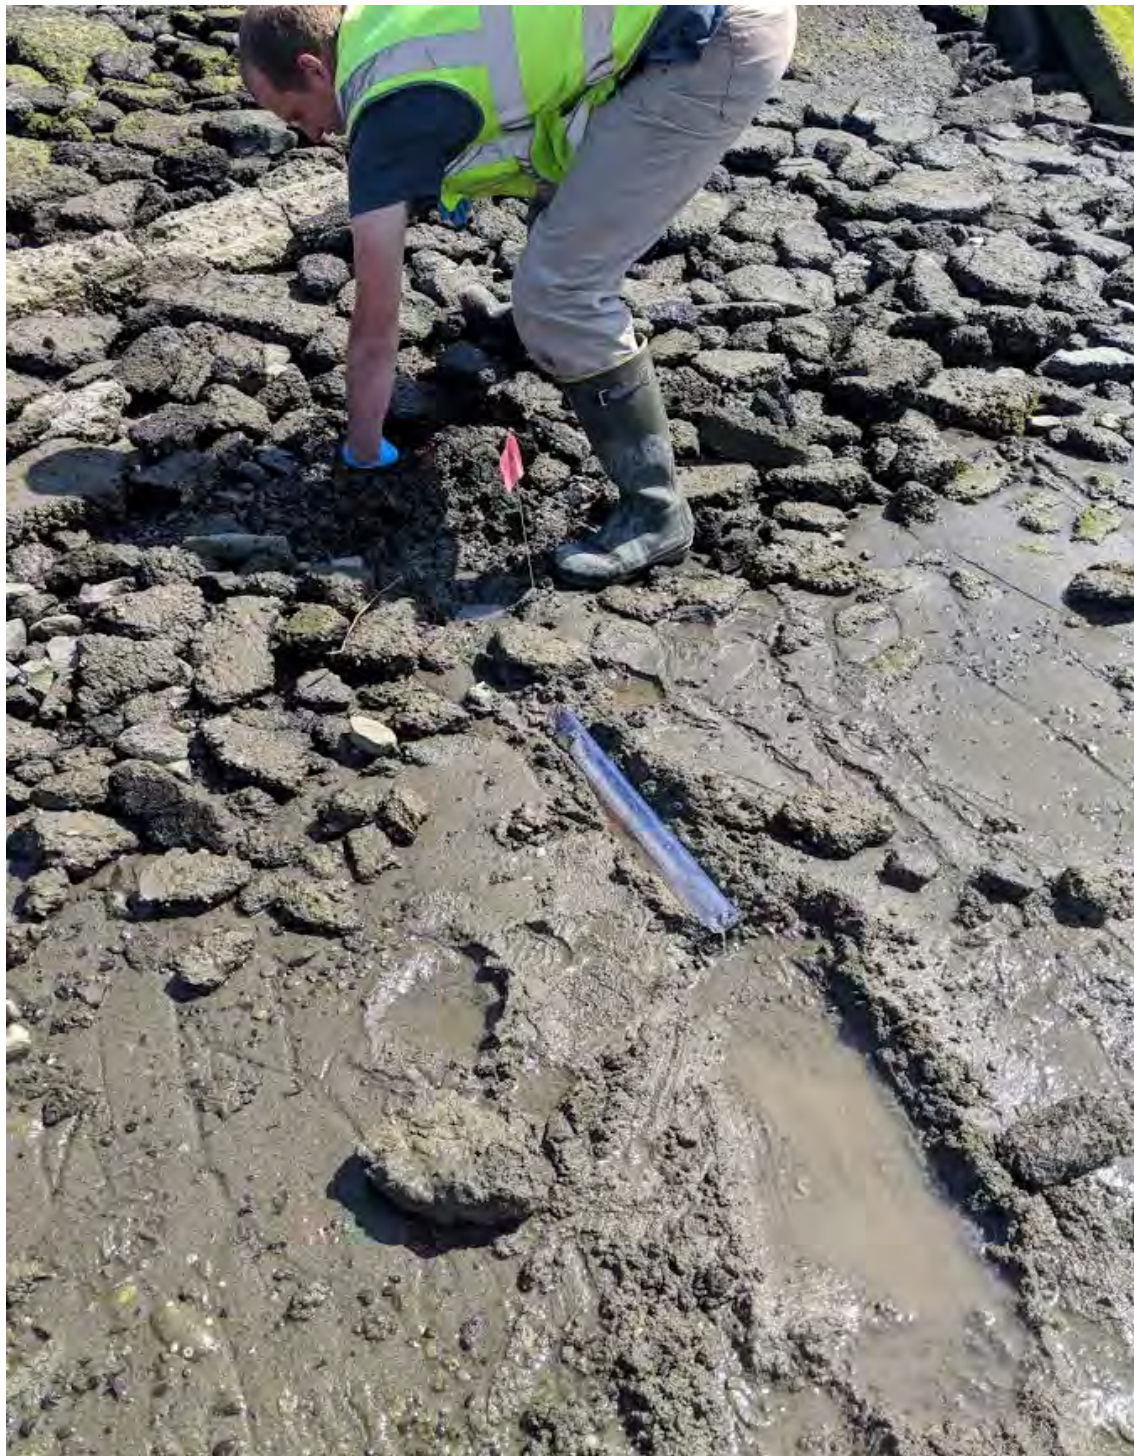
**Photo Sheet 1**  
**Former E.A. Nord Facility**  
**Everett, WA**

Example of Seep Sampling Set-up

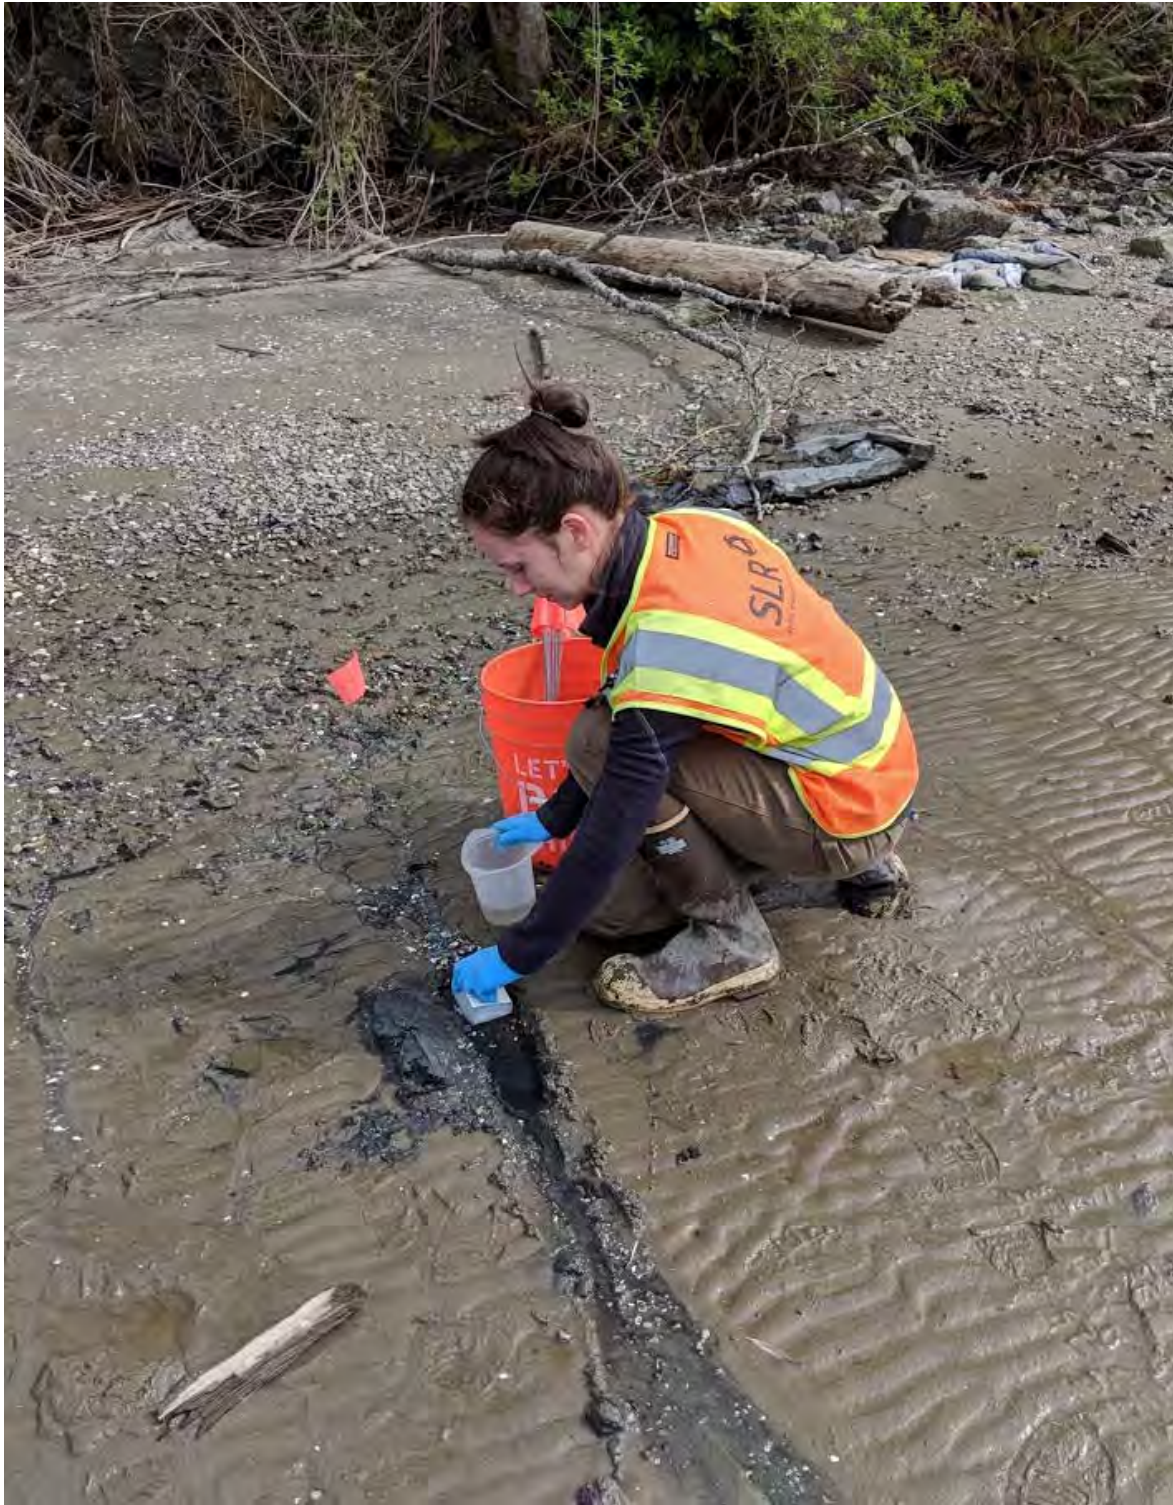
The groundwater flow from Seep location Seep-S-16 was observed to have a lack of groundwater seep flow during the seep sampling event. An alternate location was selected approximately 18 feet to the north of the original location. While this alternate location produced a slightly better flow, a channel in the sediment was constructed due to the low flow of the seep and the shallow grade of the shoreline. This method potentially introduced potentially-impacted sediment into the groundwater seep sample. Field notes for this sample location indicate the water was very turbid and black (see **Attachment 3**).

Groundwater Seep Sample Location Seep-S-16 (adjacent to knoll area)

To assess the upland groundwater conditions that may be contributing to the groundwater seep concentrations measured at Seep-S-16, JELD-WEN proposes to install one permanent groundwater monitoring well in the upland area adjacent to the shoreline and Seep-S-16, pending access and safety issues. This monitoring well will be installed by a Washington-licensed drilling subcontractor and will be properly developed per Ecology guidelines. Upon completion of well installation and development activities, one groundwater sampling event will be conducted for PCB Congeners during outgoing tidal conditions. JELD-WEN understands that Ecology may request additional sampling events for PCB congeners to represent the cyclical nature of the groundwater system, or analysis of additional site COPCs at this well location.
