**UST REMOVAL &
INDEPENDENT CLEANUP ACTION**

Former Woodinville Auto Auction Property
13820 - NE 195th Street
Woodinville, Washington
(UST Site #619552, ERTS #610841)

NORTH WOODINVILLE 195, LLC

ENVIRONMENTAL ASSOCIATES, INC.

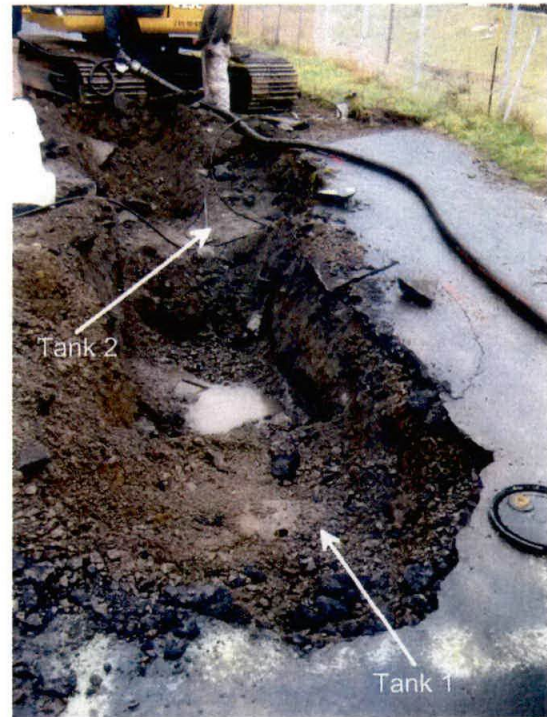
Photo 2: View of top of tanks 1 and 2 after excavation of overlying soils.

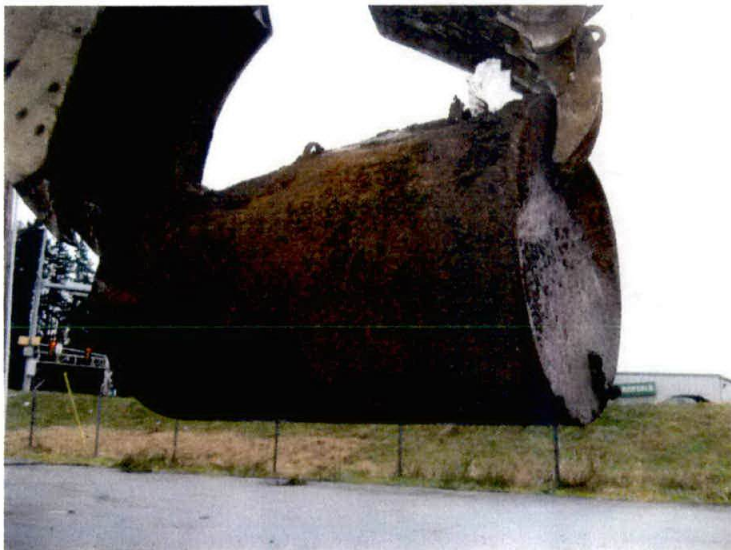
Photo 4: View of tank 1 after removal.

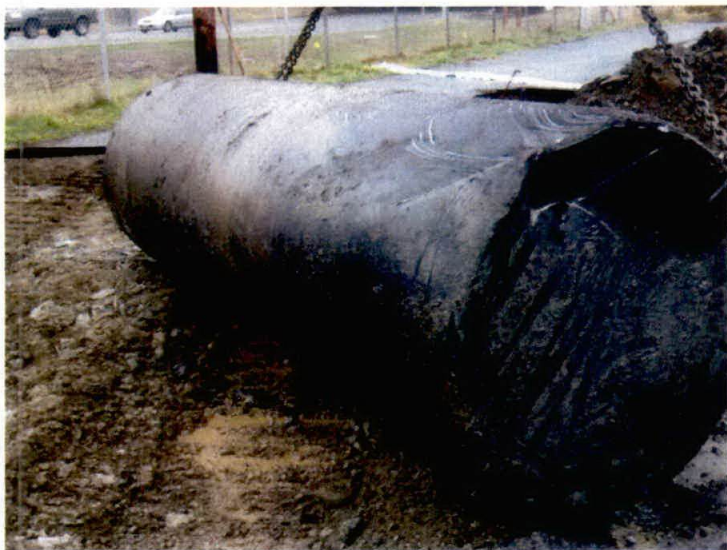
Photo 1: View of Tank 2 after removal.

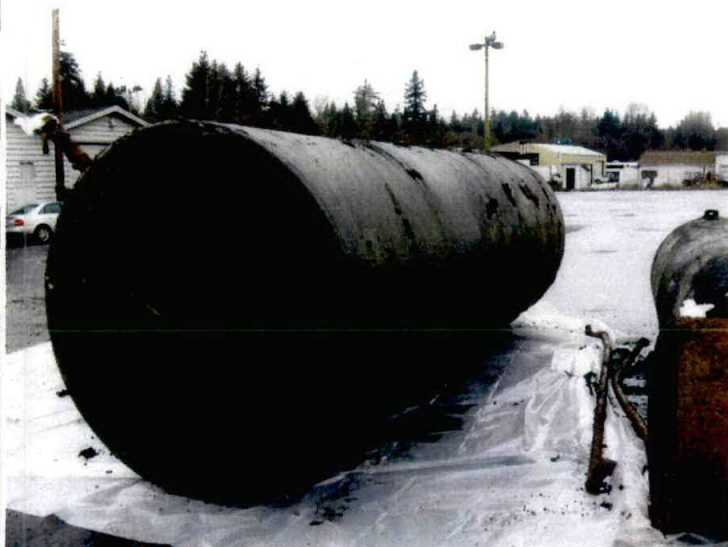
Photo 3: View of Tank 3 after removal.

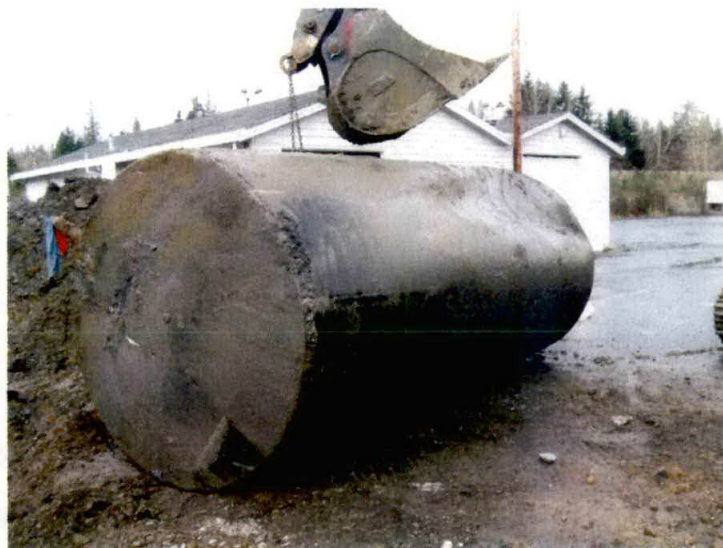
Photo 4: View of Tank 4 after removal.

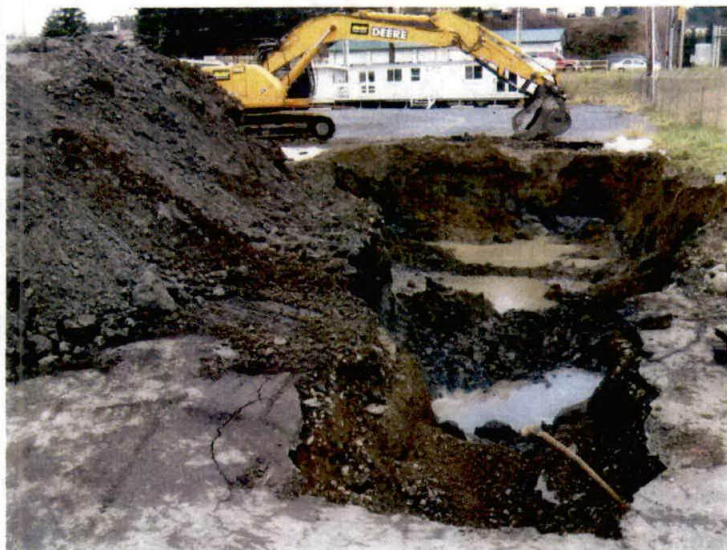
Photo 1: View of limits of excavation at the end of the day, January 13, 2009.

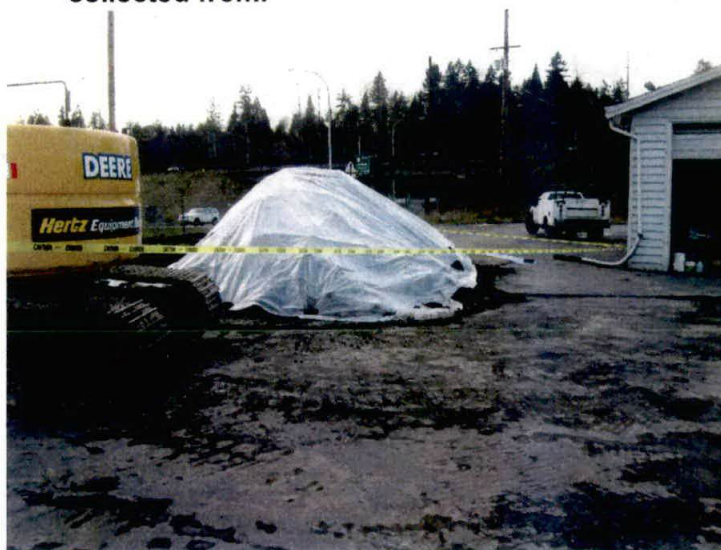
Photo 4: View of stockpile at conclusion of work on January 13, 2009.

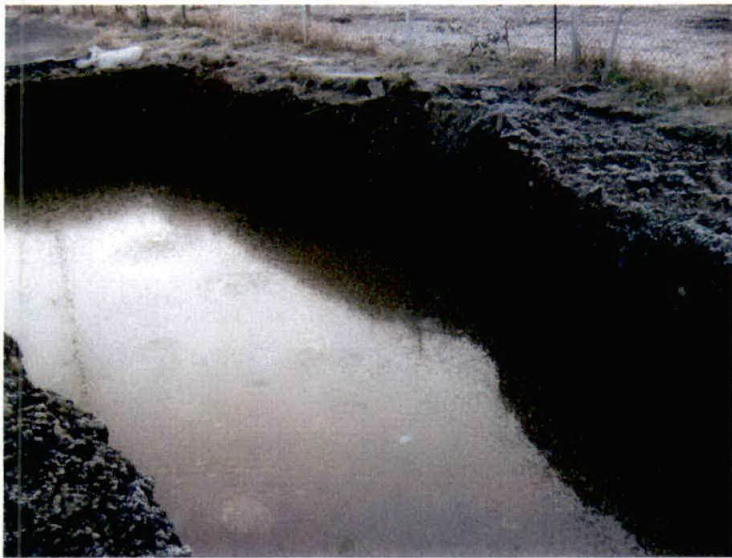
Photo 1: Water accumulated in excavation between 1/13/09 and 1/19/09.

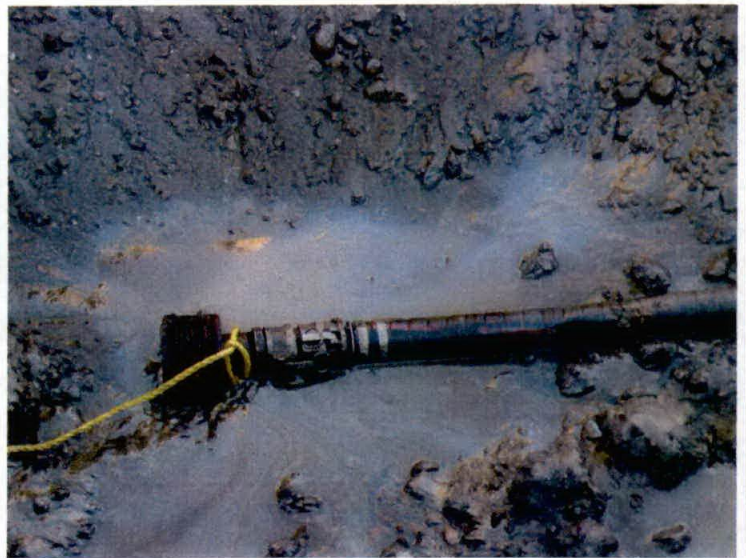
During the tank removal and excavation process, an iridescent "sheen" was noted atop the water table in the remedial excavation. Petroleum impacts were also encountered in soils below the water table. Given these observations, EAI recommended and the client authorized utilizing a vacuum truck to pump the groundwater from the excavation.

Photo 2: Example of sheen noted on water pumped from excavation on 1/19/09.

On January 19, 2009, approximately 12,200 gallons of groundwater were pumped from the tank excavation by Marine Vacuum Service. To document groundwater conditions and provide a point of comparison for future monitoring activities, a sample of groundwater was collected from this accumulated water on January 19, 2009. After allowing groundwater in the tank excavation to recharge, an additional 3,000-gallons was pumped from the excavation on January 21, 2009.

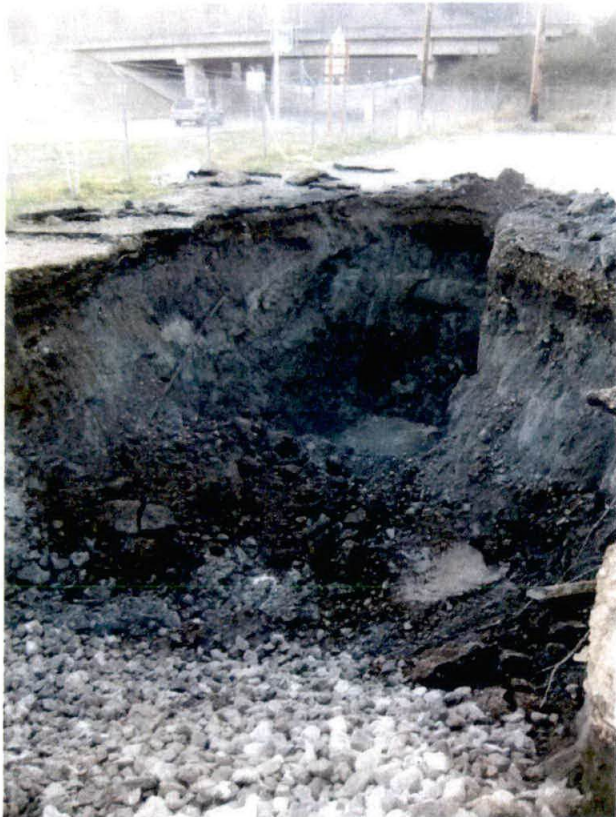
Photo 3: Western limits of excavation at end of day 1/19/09. Quarry spalls used to backfill excavation visible in foreground of photo.

Once the majority of the initially stockpiled soils were removed from the site on January 19, 2009, backfill of the UST excavation was begun. Within the remedial excavation, 2" to 4" "quarry spalls" were used to bring the base of excavation to within approximately 3-feet of the ground surface. The remainder of the excavation was backfilled with "pit-run" gravel. The four (4) test pits were backfilled to within 12" to 28" of the surface grade utilizing pea gravel. Soils excavated from test pits TP1 and TP2 were then used to bring these explorations to surface grade. In preparation for later paving, soils placed in all five excavations were compacted to some extent by Global.

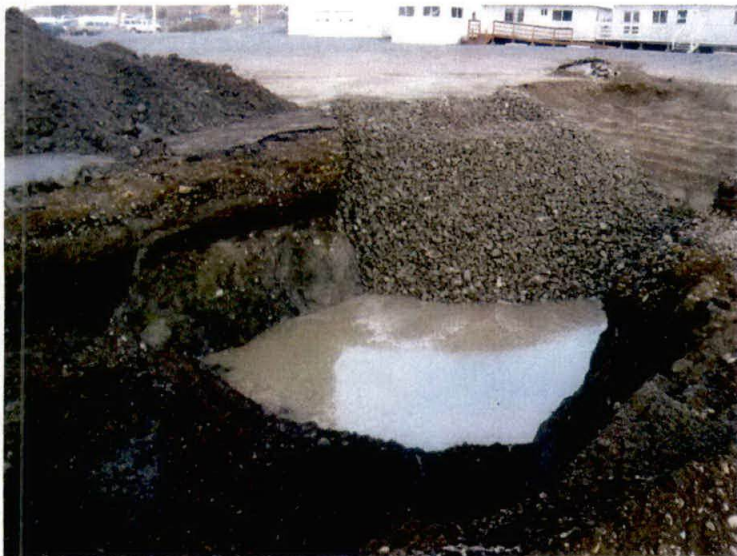
Photo 1: Water accumulated in excavation 1/20/09. Backfill material seen in background, with limits of 1/19/09 excavation in foreground.

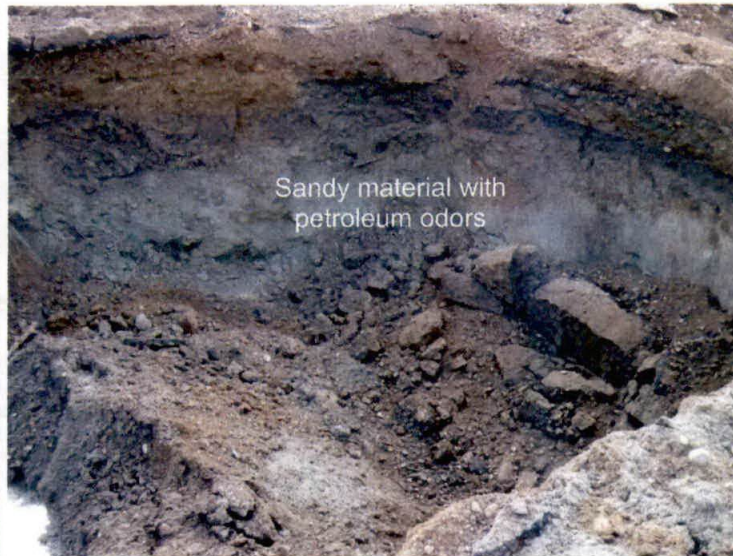
Photo 2: West/southwest limits of excavation (1/20/09). Grey soil on two visible sidewalls had strong petroleum odors and resulted in high PID readings.

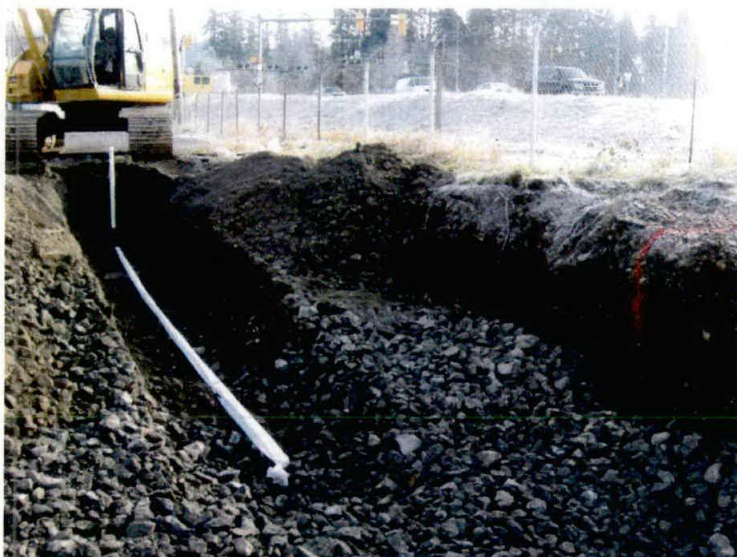
Photo 3: Eastern infiltration pipe. Installed atop quarry spalls, backfilled with visible pea gravel/pit run.

- Two (2) horizontal runs of two-inch diameter, perforated PVC drain pipe, wrapped with filter fabric. One (1) 30-foot and one (1) 40-foot PVC runs oriented in an east-west and northeast-southwest direction (respectively) were installed at the pit-run/quarry spall interface.
- A vertical length of 20-slot 2"-diameter PVC pipe was placed in all four (4) test pits prior to backfilling with pea gravel. These sections of slotted pipe extended from the base of exploration, and were discontinued at least 12" from the ground surface.

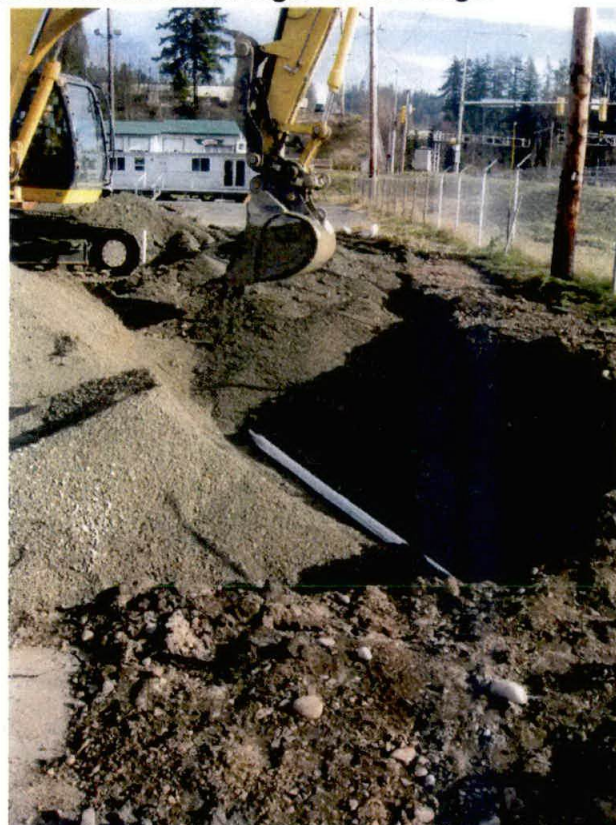
Photo 4: Western infiltration pipe. Eastern pipe is located behind excavator bucket.

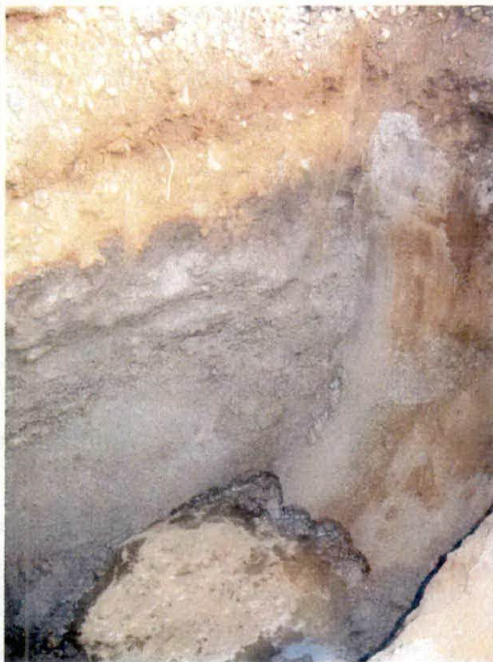
Grey medium grained sand with obvious petroleum odors encountered approximately 2-feet b.g. and extended to the bottom of the exploration. PID readings ranging from 20- to 250-ppm obtained in screening excavated soils. Soil sample (TP4) obtained from approximately 3-feet b.g. Test pit advanced approximately 2-feet north of southern property/fence-line, and 16-feet west of southwest corner of remedial excavation. Accumulated water was not sampled from this location, however a sheen was noted.

Photo 1: Grey sandy soil noted in TP4 displaying petroleum odors. Sample TP4 collected from this material.

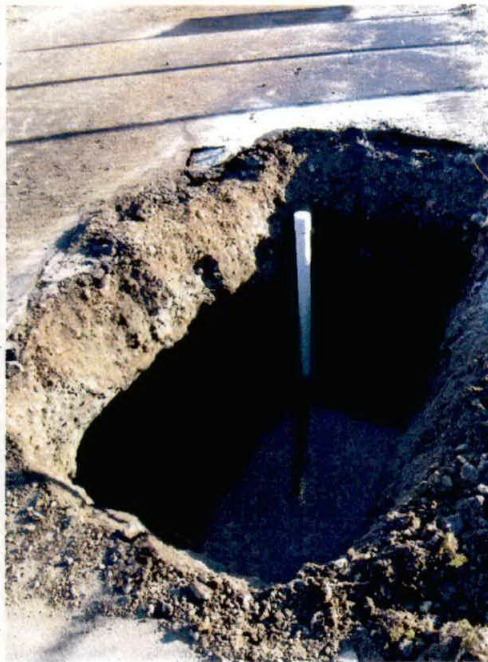
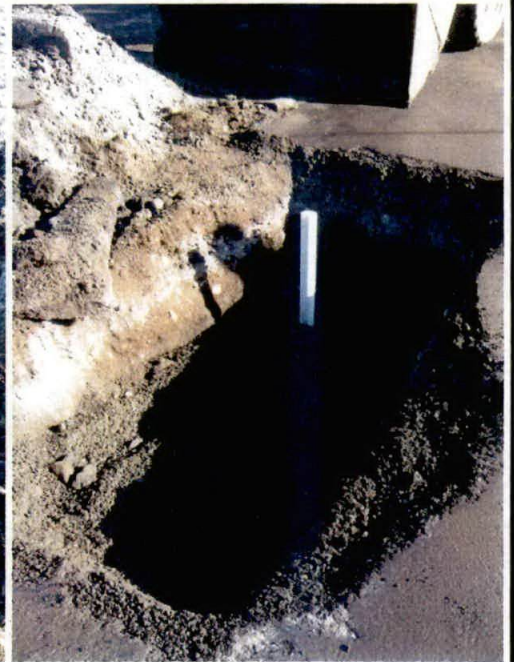
Photos 2-3: Example of typical installation of slotted pipe in test pit

To provide monitoring locations and facilitate injection/infiltration of nutrients, treatment compounds, etc. (if warranted), perforated and/or slotted 2"-PVC pipe was installed in all five (5) excavations (remedial excavation and four (4) test pits) during backfilling as follows:
