RE: Prospective Purchaser Consent Decree for CleanCare Property

Thank you again for meeting with representatives of Tacoma Taylor Property LLC (Tacoma Taylor) in December to discuss a Prospective Purchaser Agreement. As you know, Tacoma Taylor has been interested in acquiring property at 1510 and 1540 Taylor Way in Tacoma (the Property) for several years. The Property is the location of the former CleanCare facility, which was abandoned in 1999. It is part of the larger Taylor Way and Alexander Avenue Fill Area (TWAFA) Site being addressed under MTCA.

CleanCare Property
Port of Tacoma
Tacoma, Washington

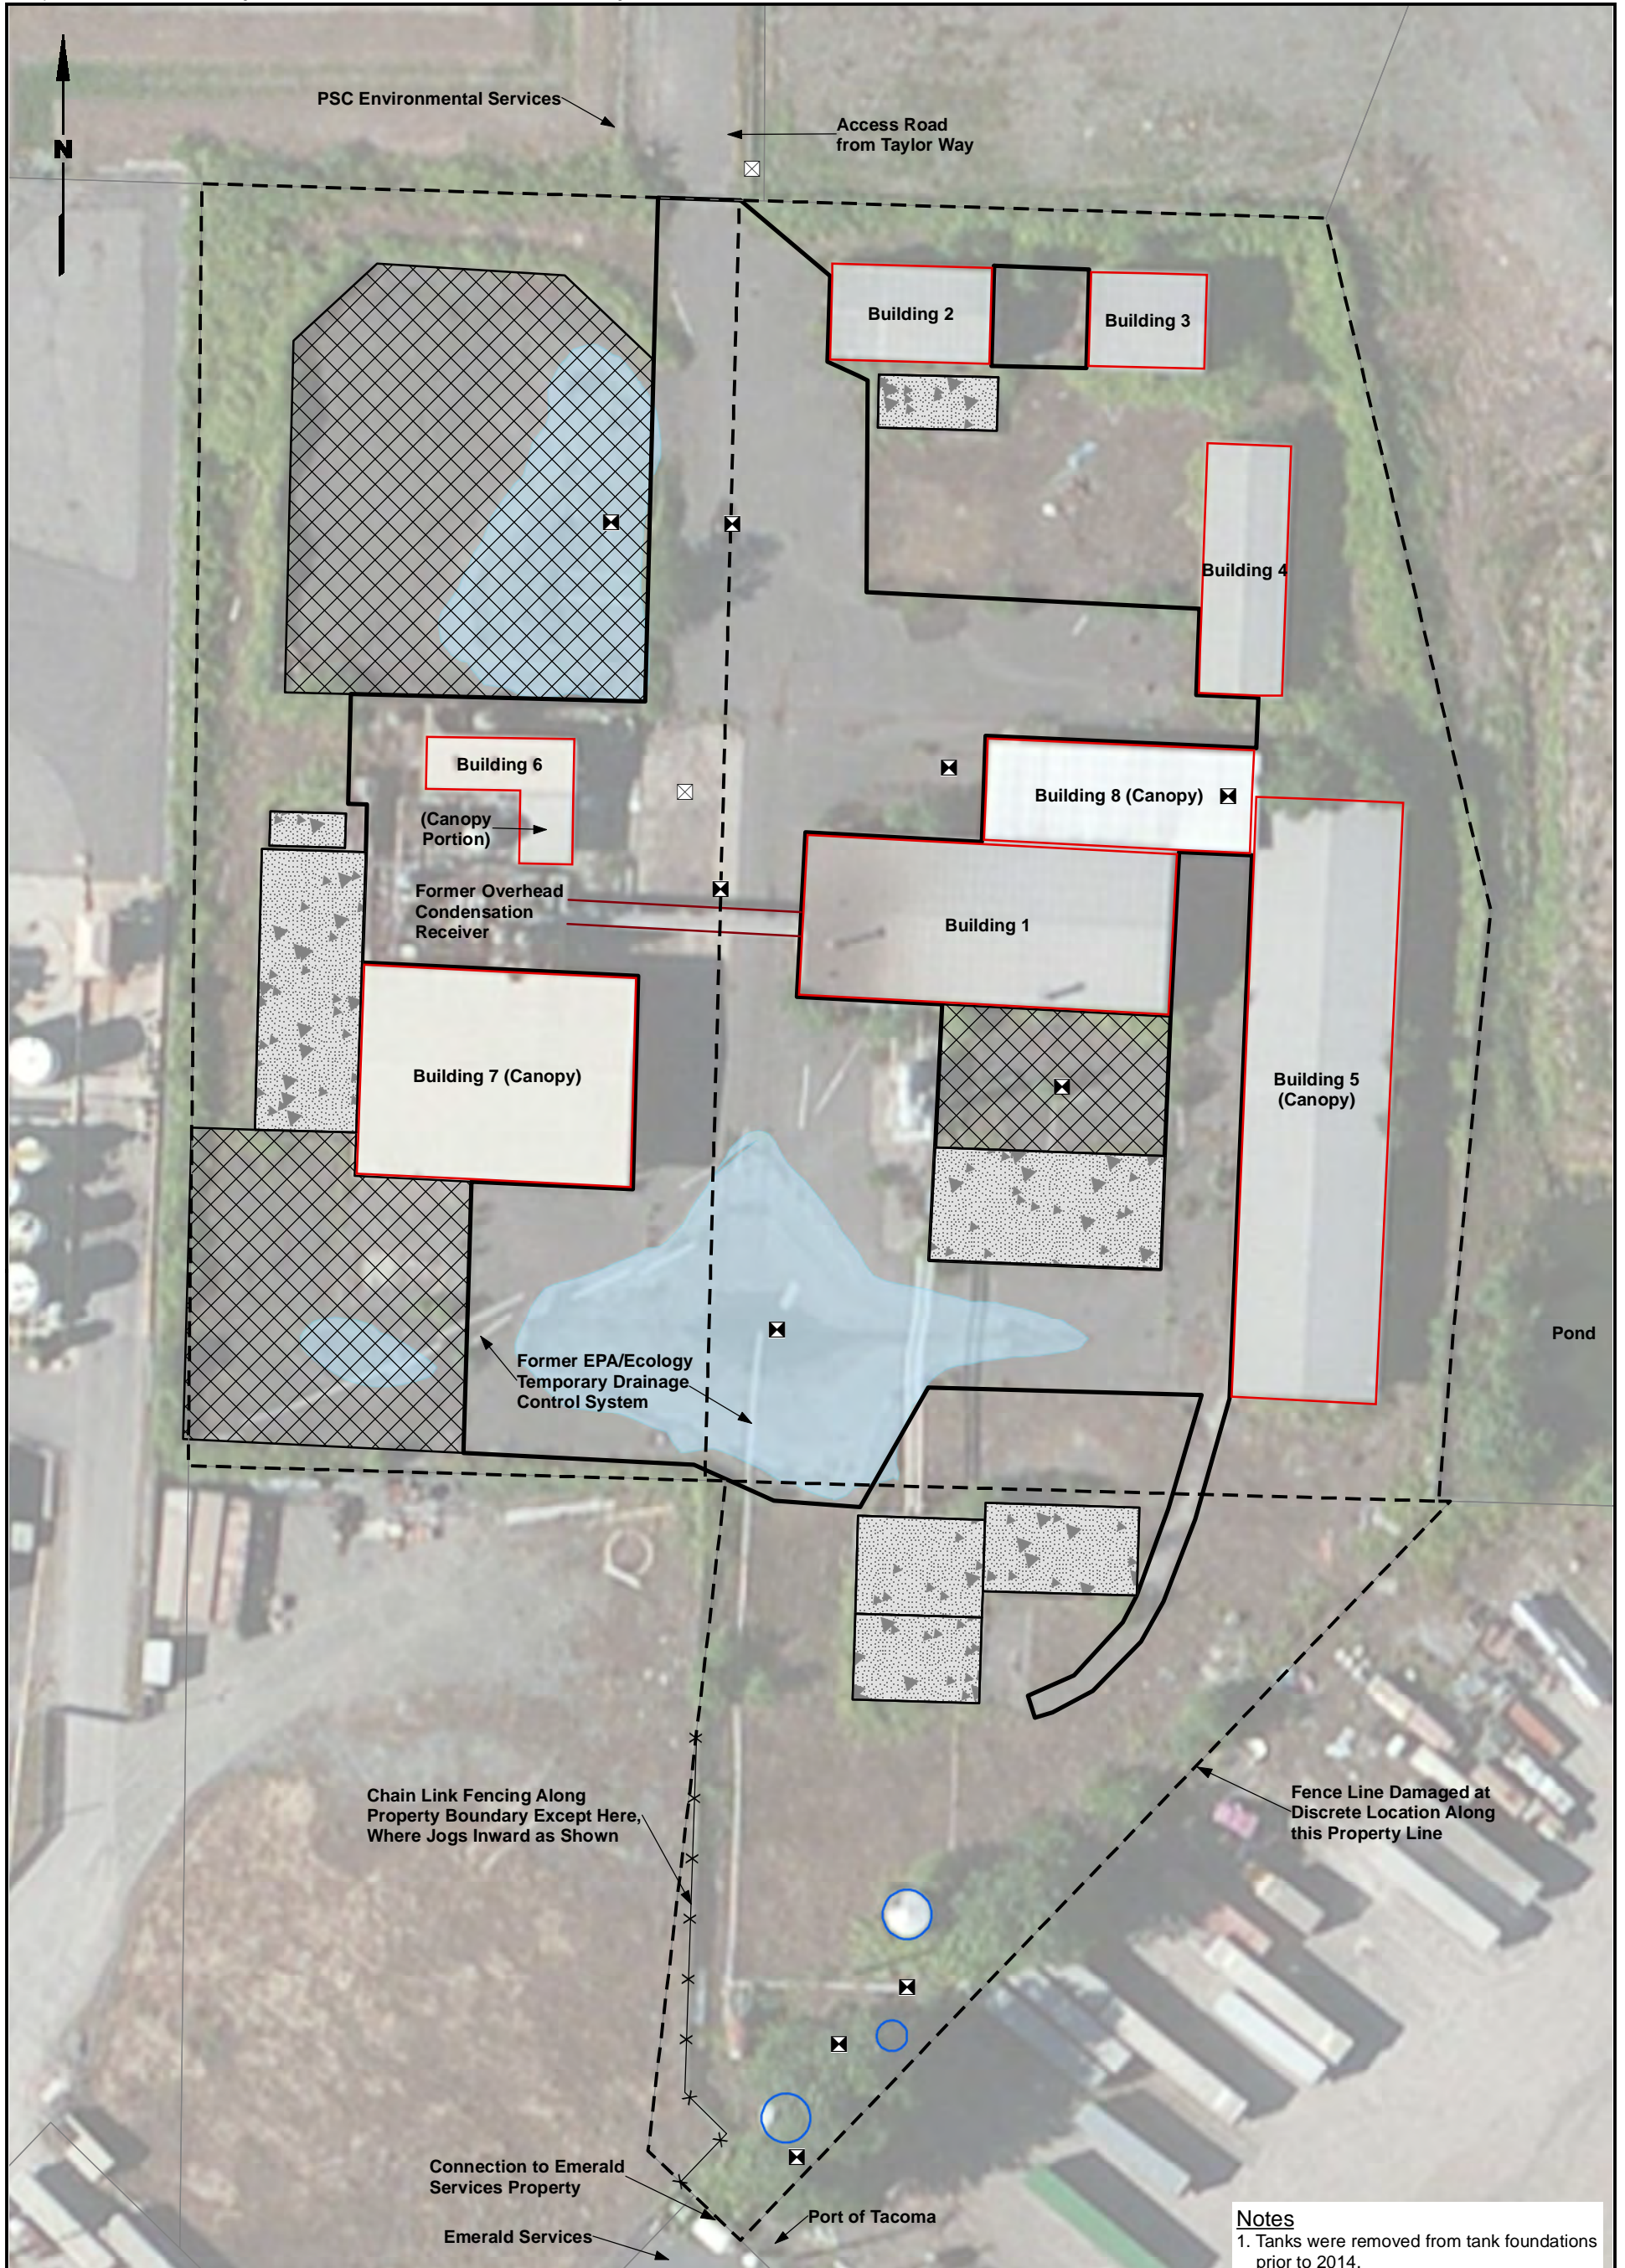
Figure
4

Using a number of historical site plans, the approximate historical utility drainage plan was compiled and is presented on Figure 4. As shown, Property storm drainage was historically conveyed offsite through the southernmost parcel from an onsite pump station to the public storm system along Lincoln Avenue. To reach Lincoln Avenue, the drainage ran through a joint-property private storm sewer line located on the Educator property.

**Historical CleanCare Utility
Drainage Plan**

As mentioned above, the temporary stormwater system is no longer functioning, and it is unclear when it stopped functioning. Due to uncontrolled security at the Property, it appears that all metal parts including pumps have been stolen from the system; remaining system components include some PVC piping, vaults, and aboveground storage tanks (ASTs). The low points where the temporary storm drainage system intercepted stormwater appear to be coincident with historical oily waste vaults. Field observations and historical records indicate that the oily waste line¹ was not fully capped, is damaged, and that oily waste residual contamination may be present in the standing water in the vicinity of the historical vaults. The location of the vaults and the ASTs previously used for stormwater management are shown on Figure 4.

26, 1999 release from the onsite storm sewer to the City storm sewer that prompted disconnecting the onsite system (EPA2000b). Other releases may have included chemical spills directly to bare soil, chemical leaks from any of the historical sewer infrastructure (such as the oily waste line; see Figure 4), and (more recently) leaks associated with the inoperable temporary storm system that EPA installed. Impacts from the tank farms were thoroughly investigated and remediated by the EPA. Soil borings have been conducted throughout the Property, in areas other than the tanks farms, and contamination has been found; sources could be from any of those discussed above. Impacts attributed to historical sewer lines or from the somewhat recently neglected temporary storm system constructed by the EPA appear to have been investigated.

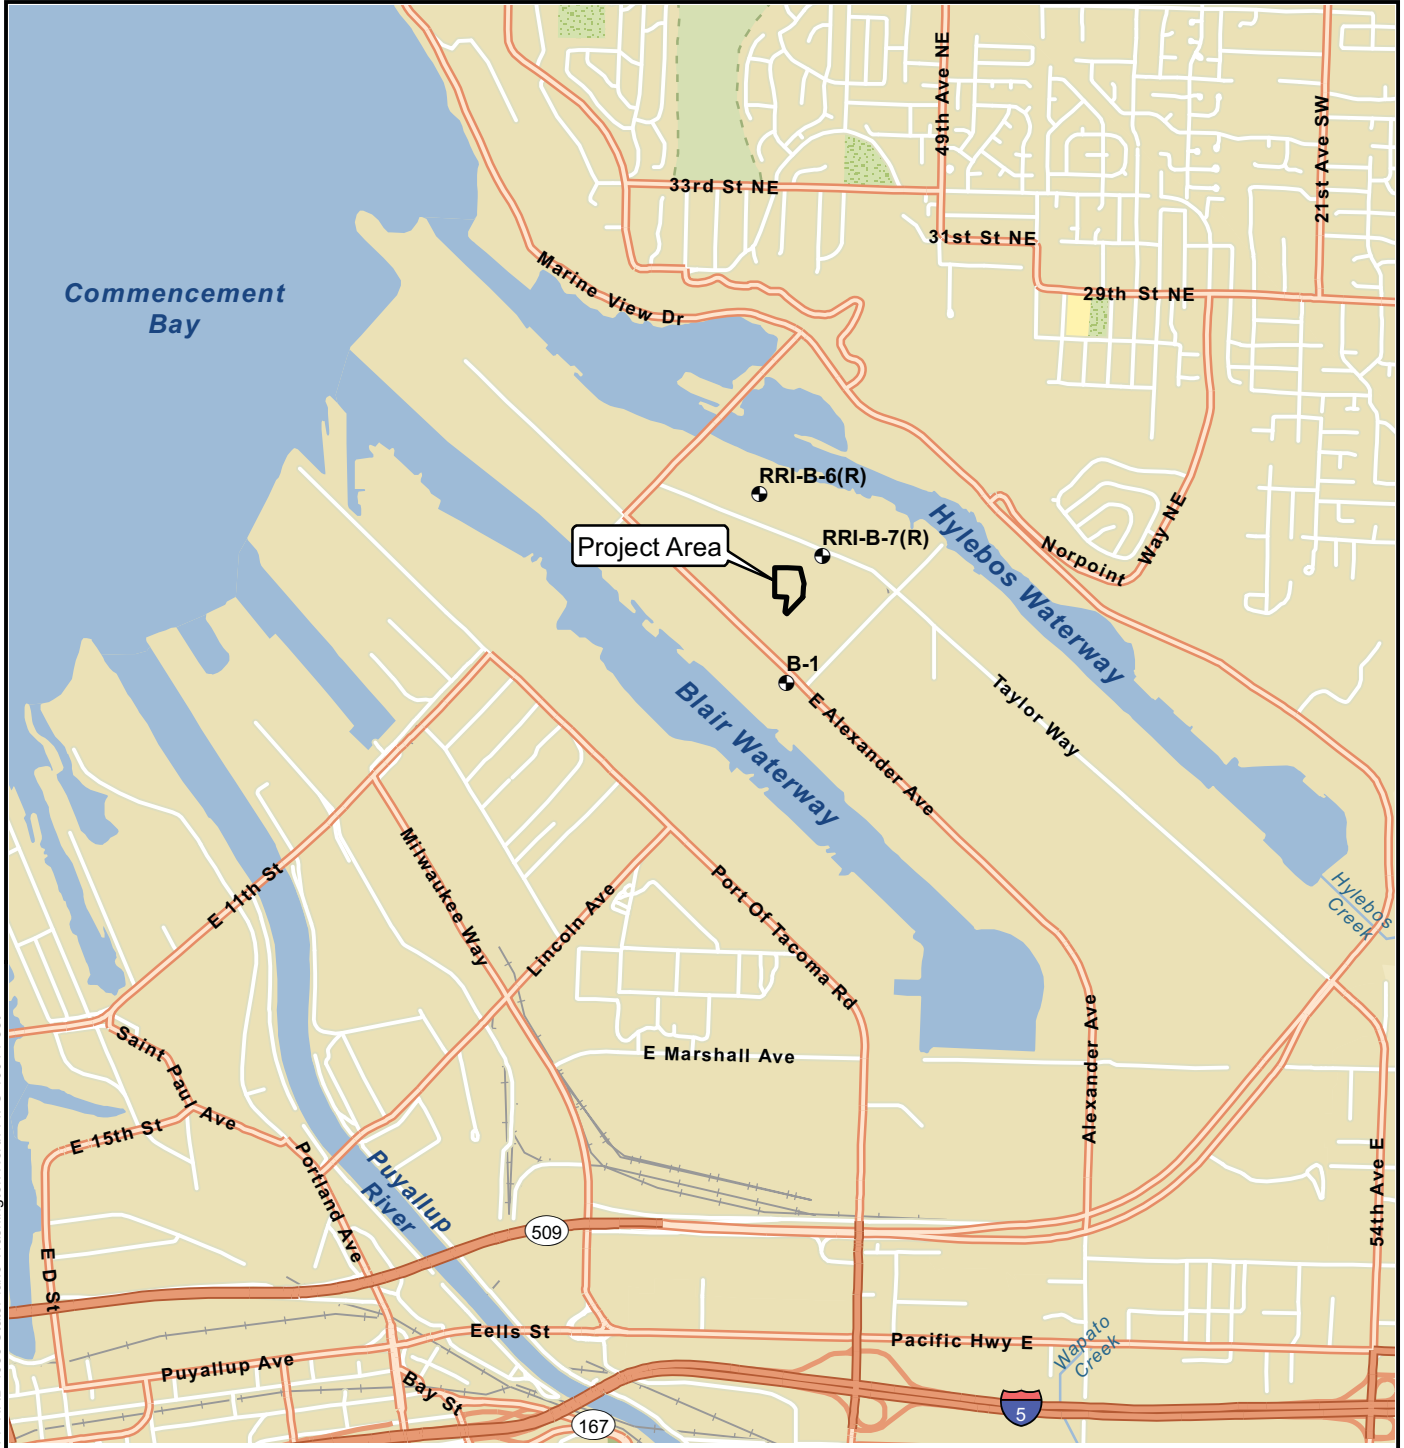
Figure
1

Landau Associates previously advanced borings at nearby properties for unrelated projects (approximate locations are shown on Figure 1). In one of these borings (B-1), about 1,300 ft south of the site, we observed similar conditions to those described in the historical borings in the upper 20 ft, with alluvial deposits generally becoming coarser with depth and grading to medium dense around 30 ft BGS, dense around 50 ft BGS, and very dense around 90 ft BGS. Two additional borings were advanced north of the project site: RRI-B-6(R) located about 1,100 ft northwest of the site, and RRI-B-7(R) located about 600 ft northeast of the site. Both of these borings were advanced to about 26.5 ft BGS and encountered similar conditions (fill over alluvium, with the upper several feet of alluvium containing organic material).

B-1 Approximate Location and Designation of Nearby Borings Advanced for Others

The project site is located in the Port, between Taylor Way and Alexander Avenue as shown on Figure 1. The total area of the site is about 4.25 acres, with the main body of the site forming a roughly 800 foot (ft) by 800 ft square. The site is approximately 1,200 ft southwest of the Hylebos Waterway and 1,300 ft northeast of the Blair Waterway. Property in the immediate vicinity of the site is generally characterized as industrial.

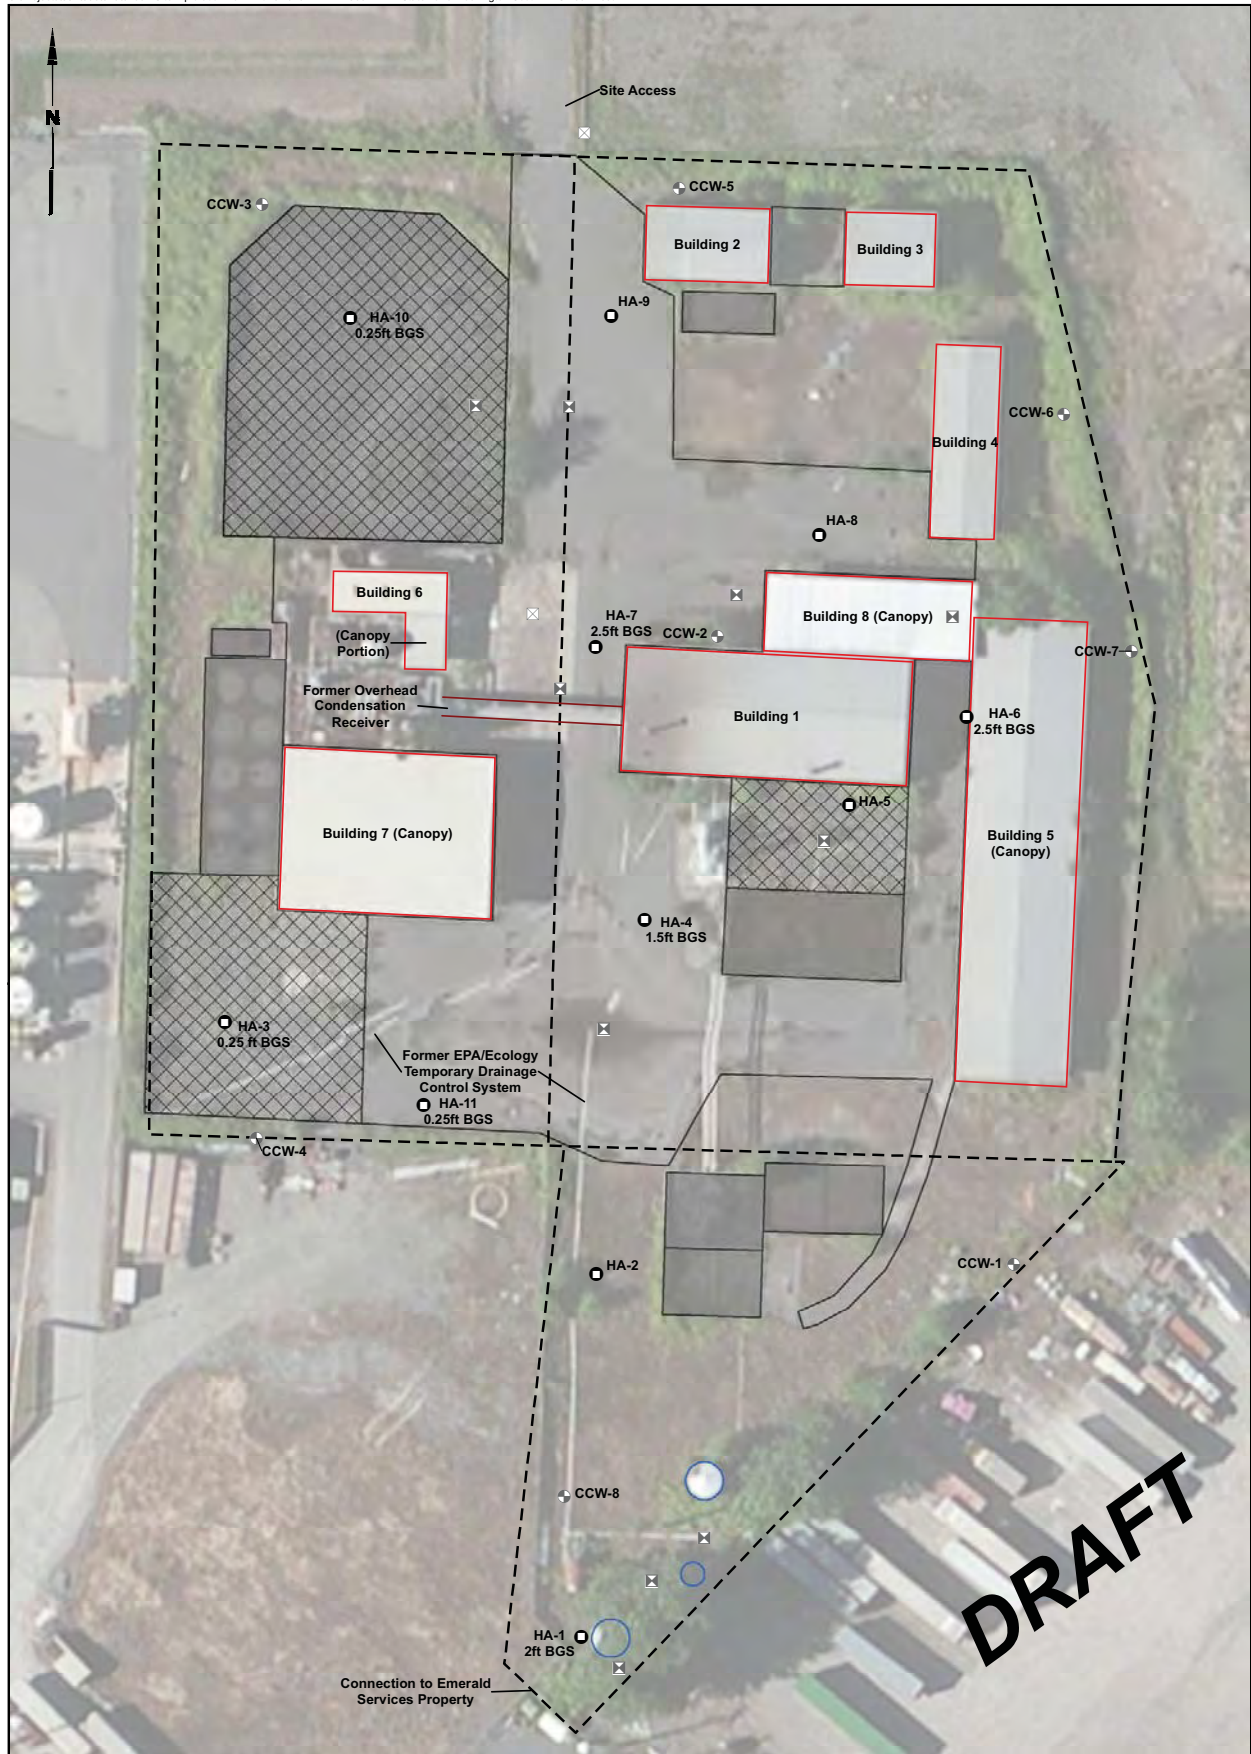
Subsurface conditions were explored on March 20, 2014 using a combination of asphalt coring and hand auger boring at 11 locations (HA-1 through HA-11) at the approximate locations shown on Figure 2. Asphalt coring was completed by All City Sawing and Drilling, LLC of Auburn, Washington under subcontract to Landau Associates. Hand auger borings were completed by a Landau Associates geologist and engineer, who also observed, logged, and sampled the subsurface soil conditions. Figure 3 provides a key to understanding the summary logs (Figures 4 through 9). Conditions encountered in the explorations are detailed in the summary logs and summarized below.

<p>Legend</p> <p>HA-1 2ft BGS</p> <p>CCW-1</p> <p>☒ Vault</p> <p>LANDAU ASSOCIATES</p>	<p>Approximate Location and Designation of Hand Augers and Depth to Water (if encountered)</p> <p>Approximate Location and Designation of Borings by Others</p> <p>Catch Basin</p> <p>Approximate Location and Designation of Hand Augers and Depth to Water (if encountered)</p> <p>Former EPA/Ecology Temporary Drainage Control System</p>	<p>☒ Subject Parcels</p> <p>☐ Asphalt (Non-Cap)</p> <p>☐ Former Tank Foundations</p> <p>☒ Pavement Capped Area</p> <p>0 50 100</p> <p>Scale in Feet</p>	<p>☐ Buildings</p> <p>☐ Stormwater Tanks</p> <p>CleanCare Property Port of Tacoma Tacoma, Washington</p>	<p>Notes</p> <p>1. Black and white reproduction of this color original may reduce its effectiveness and lead to incorrect interpretation.</p> <p>Data Sources: Pierce County GIS; Puget Sound Lidar Consortium; Esri World Imagery.</p> <p>Site and Exploration Plan</p>	<p>Figure 2</p>

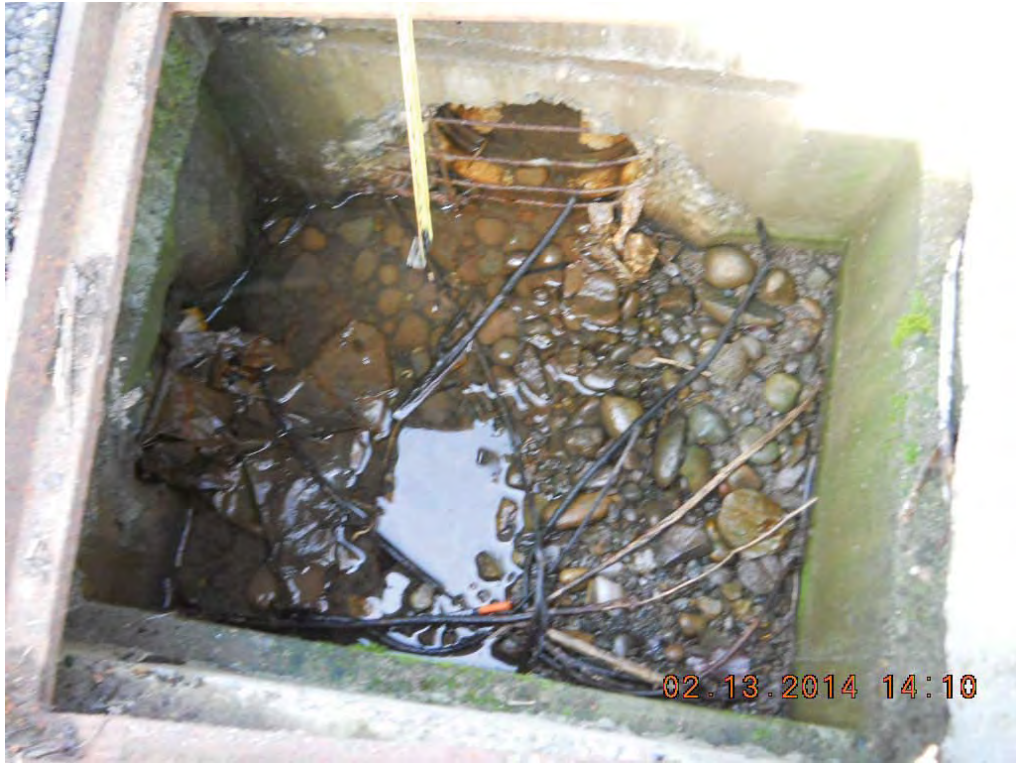
1. South catch basin

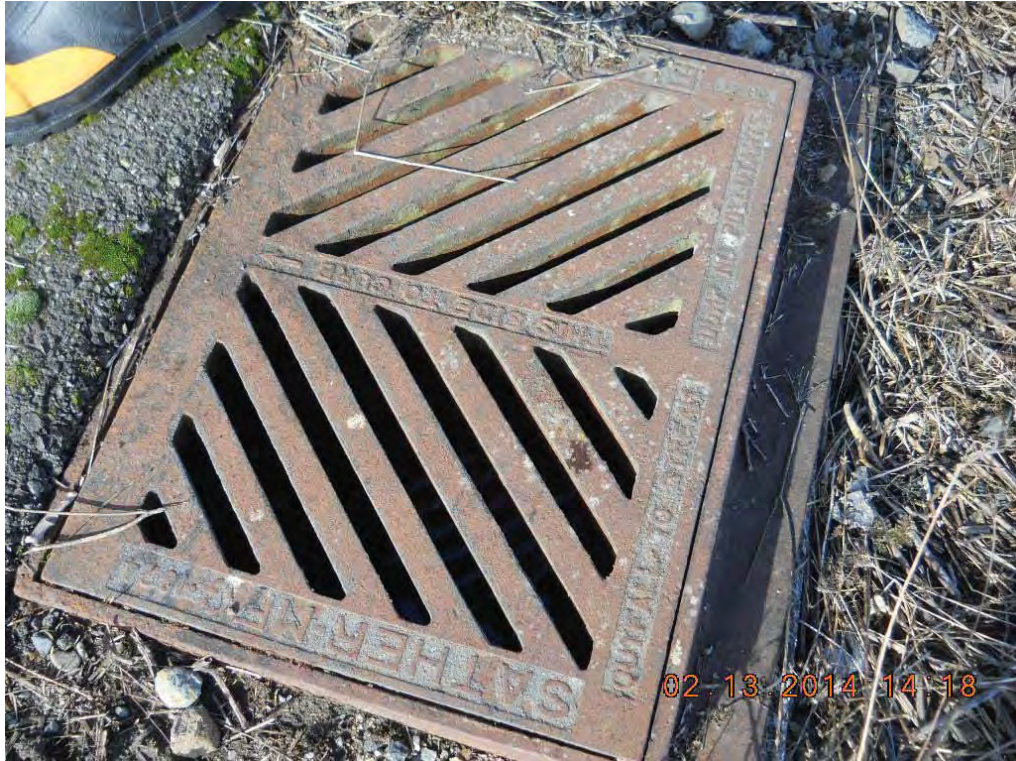
2. Middle catch basin; unable to open during site visit.

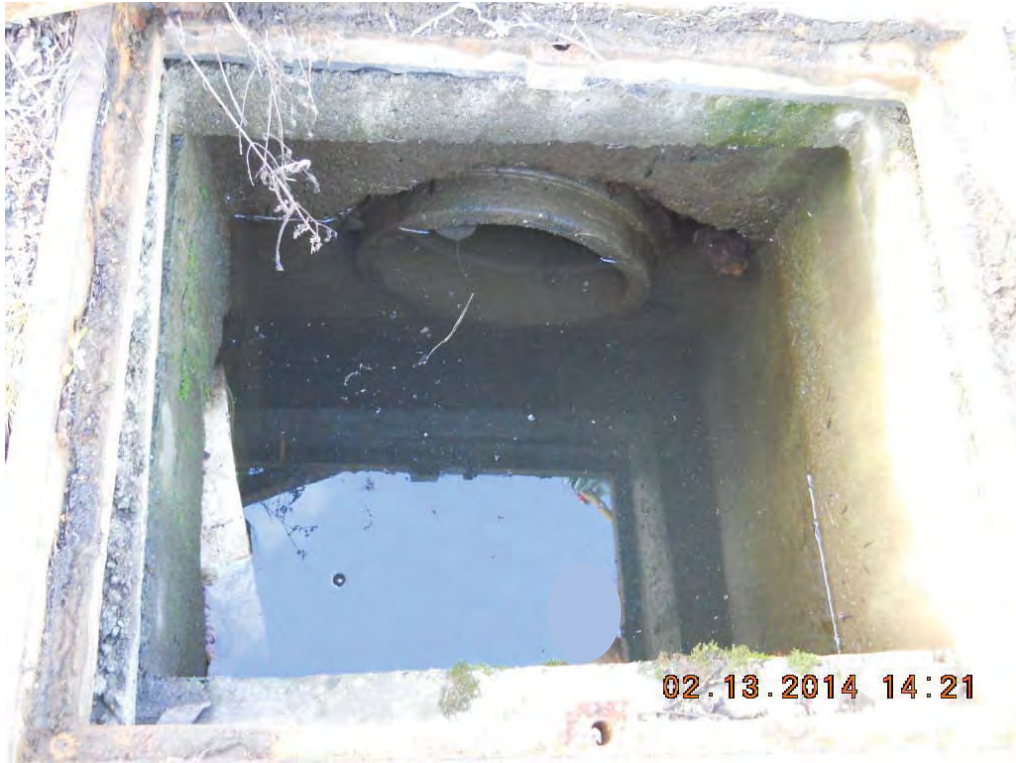
3. North catch basin.

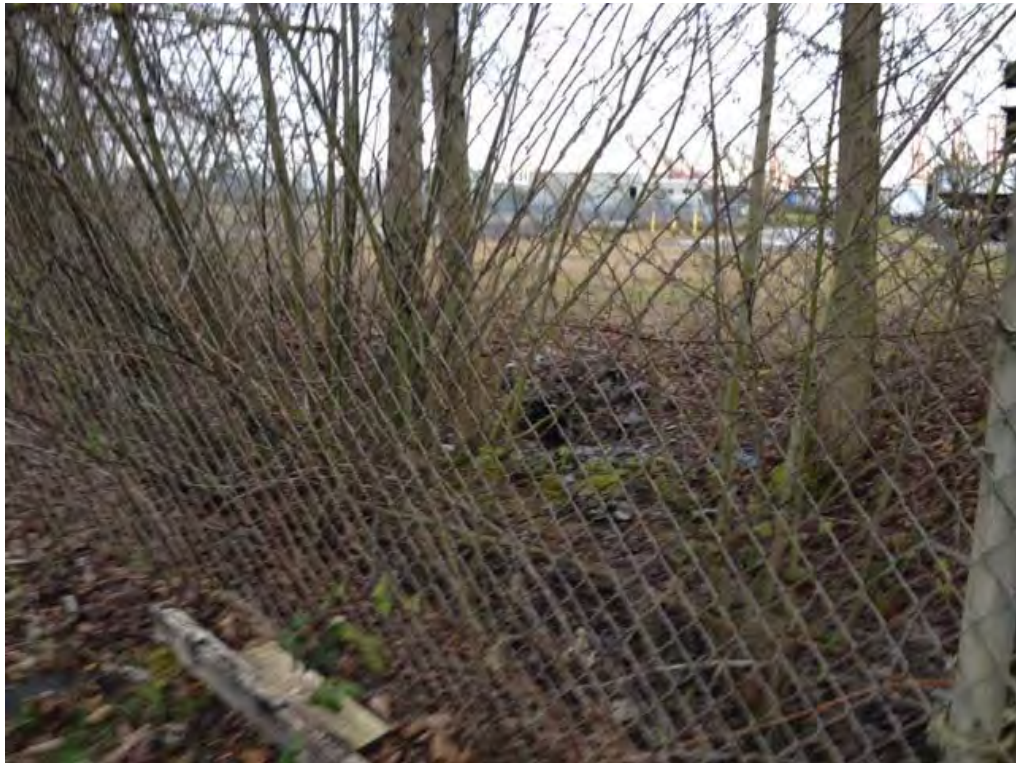
4. East ditch; shows inlet culvert from the north catch basin.

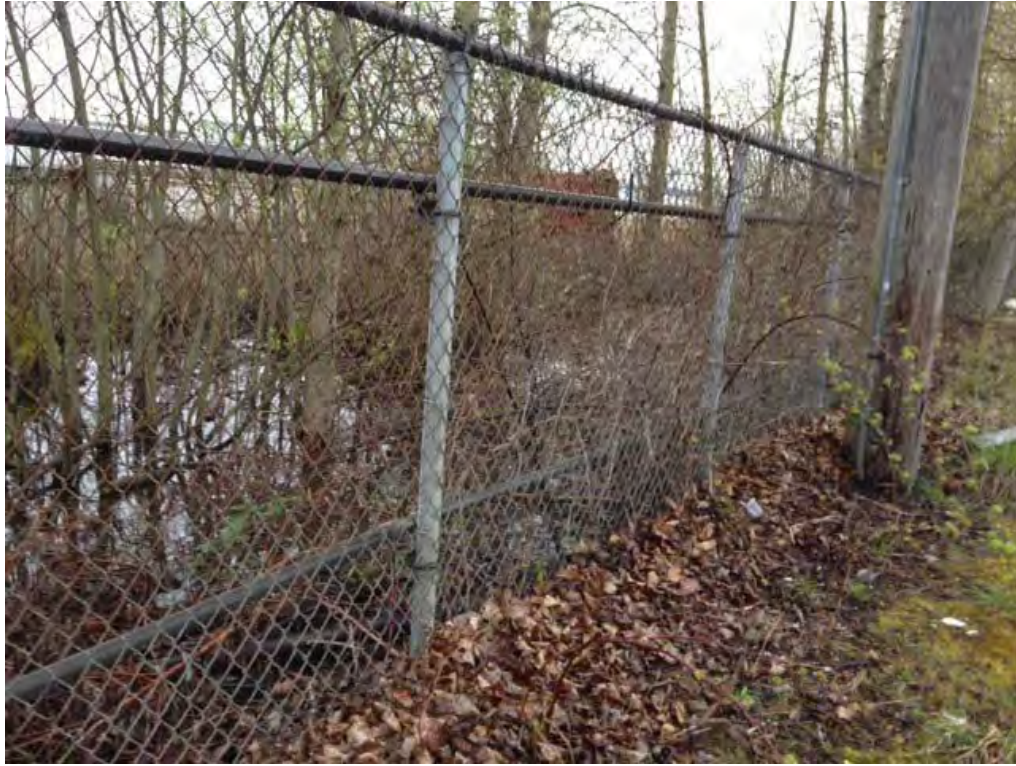
5. West ditch; standing water observed throughout ditch on March 25, 2014.

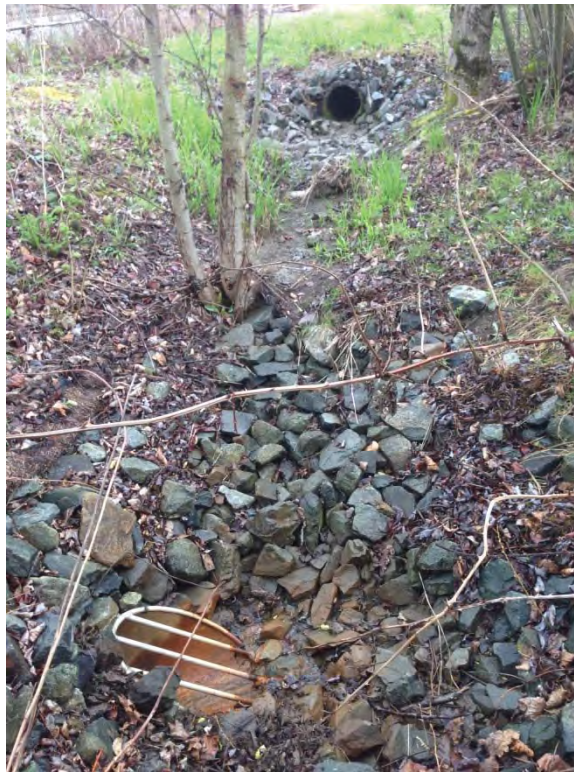
6. West ditch; relatively low water level observed on March 26, 2014.
