STATE OF WASHINGTON DEPARTMENT OF ECOLOGY

Re: No Further Action at the following Site:

• Site Name: Glenn's Diesel

• Site Address: 14885 State Route 9, Mount Vernon, Washington

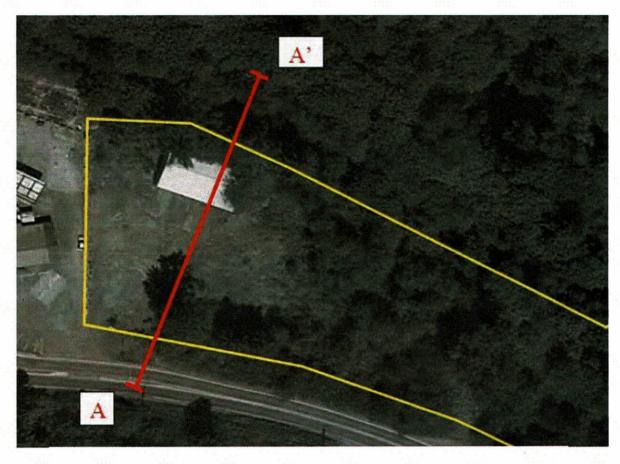
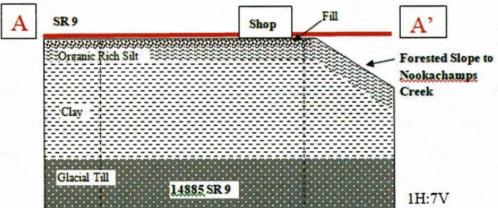
Figure 3. Conceptual cross section of site subsurface

No groundwater was encountered in a well drilled to four hundred feet in depth.

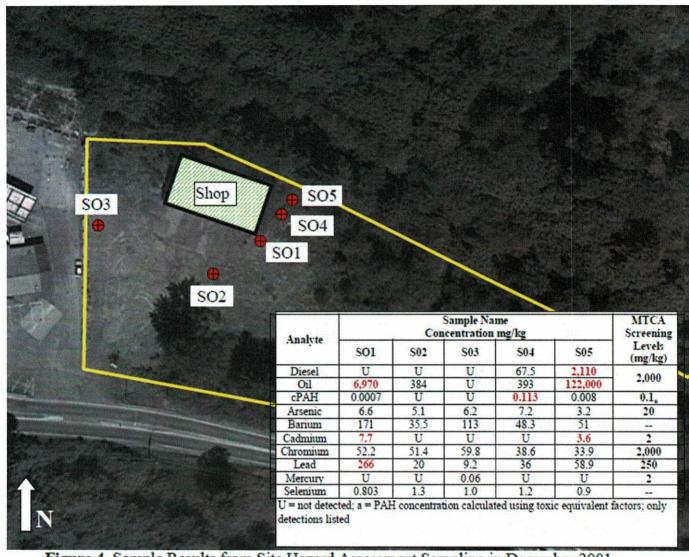
Figure 4. Sample Results from Site Hazard Assessment Sampling in December 2001

In December of 2001, five soil samples were collected and analyzed for diesel, oil, arsenic, barium, cadmium, chromium, lead, mercury, selenium, and carcinogenic polycyclic aromatic hydrocarbons. There were no exceedances of MTCA Method A standards for arsenic, barium, chromium, mercury, or selenium. For the other analytes, two soil samples had no exceedances of any analyte, one sample had an exceedance only for carcinogenic polycyclic aromatic hydrocarbons, one sample had exceedances only for oil and lead, and one sample had exceedances only for diesel, oil, and cadmium.

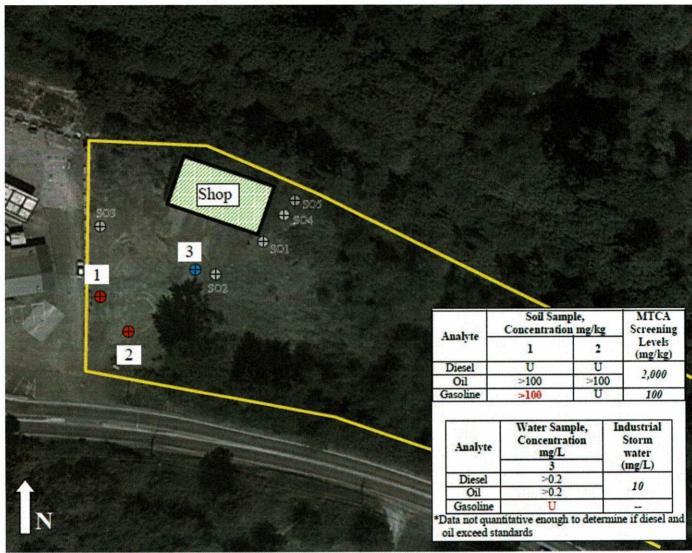
Figure 5. Sample results from spill response sampling in 2008

In November of 2008, responding to a report of a petroleum spill on an adjoining property, two soil samples and one water (puddle) sample were collected and analyzed for gasoline, diesel, and oil. Diesel was not detected in either of the soil samples. One soil sample had a detection of oil and the other had detections of gasoline and oil but it could not be determined if the concentration of oil exceeded the MTCA Method A standards. The concentration of gasoline exceeded the MTCA Method A standard. Gasoline was not detected in the water sample. Diesel and oil were detected in the water sample but it could not be determined whether the concentrations exceeded the MTCA Method A standards.

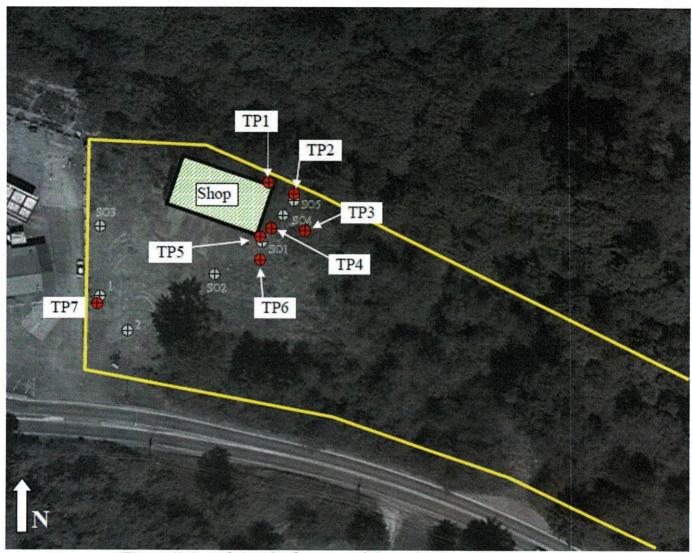
Figure 6. Sample results from test pit investigation, July 2008

In July of 2014, seven test pits were dug on site. One soil sample was collected from six of the test pits and three soil samples from the seventh test pit. The soil samples were analyzed for gasoline, diesel, oil, benzene, ethylbenzene, toluene, xylene, methyl tertiary butyl ether, cadmium, chromium, and lead. One soil sample was analyzed for arsenic, another soil sample was analyzed for mercury, and one soil sample was analyzed for volatile organic compounds. There were no volatile organic compounds detected in the soil sample. Although arsenic and mercury were detected in their respective samples, the concentrations did not exceed the respective MTCA Method A standards. Six of the nine soil sample shad no exceedances of the MTCA Method A standards for any analyte, one soil sample exceeded the MTCA Method A standard for cadmium, one soil sample exceeded the machine of the mach

Table 2. Soil sample results from test pit investigation, July 2014

Analyte	Soil Sample Name Concentration (mg/kg)										
	TP1	TP2	TP35	TP4	TP5- surface	TP5-2	TP5-3.5	TP6	TP7	Levels (mg/kg)	
Diesel	U	U	U	U	U	U	U	U	U		
Oil	U	620	580	490	24,000	U	U	1,800	2,800	2,000	
Gasoline	U	U	U	U	8.6	U	U	U	U	100	
Benzene	U	U	U	U	U	U	U	U	U	0.03	
Toluene	U	U	U	U	0.51	U	U	U	U	7	
Ethylbenzene	U	U	U	U	U	U	U	U	U	6	
Xylenes	U	U	U	U	U	U	U	U	U	9	
MTBE	U	U	U	U	U	U	U	U	U	0.1	
Arsenic				2112	7.4	(++)				20	
Cadmium	U	0.5	0.67	U	6.8	U	U	5.8	U	2	
Chromium	53	52	62	67	41	43	68	65	43		
Lead	11	85	67	63	130	4.8	11	120	26	250	
Mercury					0.026					2	
VOCs							U			varies

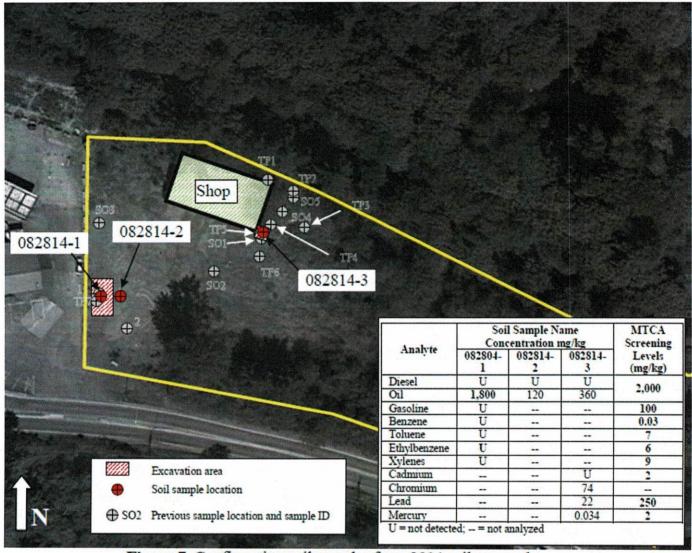
Figure 7. Confirmation soil samples from 2014 soil removal

In August of 2014, 3.3 tons of contaminated soil were excavated from the site and taken off-site to a permitted facility. Two soil samples were collected from one excavation site and one soil sample from the second excavation site. From the first excavation, one soil sample was analyzed for gasoline, diesel, oil, benzene, ethylbenzene, toluene, and xylene while the second soil sample was analyzed only for diesel and oil. There were no detections of any analyte except oil in either soil sample. Both oil detections were below the MTCA Method A standard for oil. The soil sample from the second excavation was analyzed for diesel, oil, cadmium, chromium, lead, and mercury. None of the detections exceeded the respective MTCA Method A standards.

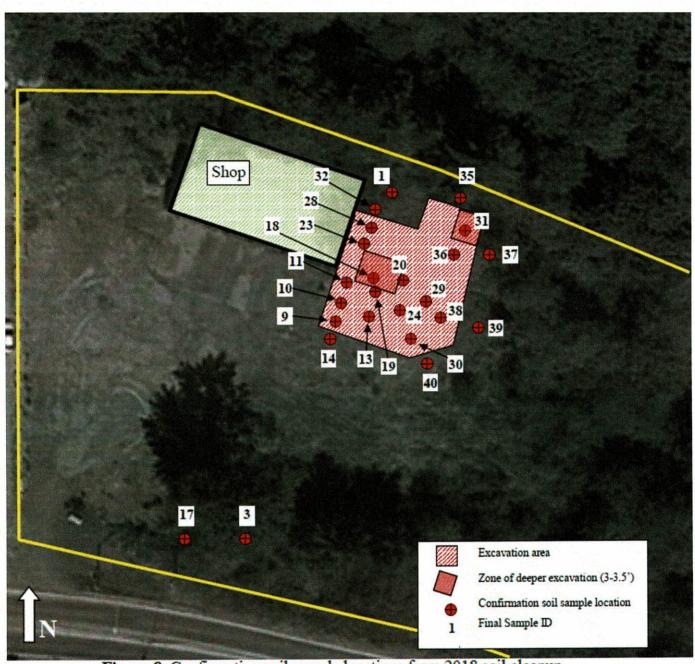
Figure 8. Confirmation soil sample locations from 2018 soil cleanup (scale is ~1" = 65')

Between September and December of 2018, 288 tons of contaminated soil were taken off-site to a permitted facility. Twenty-four confirmational soil samples were collected from the excavation. Twenty-three soil samples were analyzed for cadmium and lead. All lead concentrations and all but one cadmium concentration were below their respective MTCA Method A standards. One soil sample exceeded the cadmium standard by ten percent but satisfied the MTCA requirements that no soil sample exceed twice the standard and that the number of samples exceeding the standard be less than ten percent of the total number of samples. Four soil samples were analyzed for diesel and oil. Diesel was not detected in any of the four samples. Oil was detected in three of the four samples but all detections were below the MTCA Method A standard. One sample was analyzed for gasoline, arsenic, chromium, and mercury.

Gasoline was not detected in the sample and all three metals detections were below their respective MTCA Method A standards. One soil sample was analyzed for carcinogenic polycyclic aromatic hydrocarbons. There were no detections of carcinogenic polycyclic aromatic hydrocarbons in the sample.

Table 5. Confirmation soil sample results from 2018 cleanup

Map ID	Sample Number	Analyte Concentration (mg/kg)								-
			Cd	Pb	Cr	As	Hg	Gas	Diesel	Oil	cPAH
Confirmation samples; Soil remains in place	1	092818-1									U<0.02
	3	092818-3	0.76	110	76	9.1	0.079	U<20	U<50	330	
	9	101118-9	0.28	59							
	10	101118-10	0.32	75							
	11	101118-11	0.21	21	11,,						
	13	101118-13	0.29	65							
	14	101118-14	0.63	55							
	17	101118-17	1.6	72							
	18	102618-18	0.17	13					U<25	U<50	
	19	102618-19	0.28	19					U<29	81	
	20	102618-20	0.17	14					U<25	57	
	23	111618-23	0.25	70							
	24	111618-24	0.15	19							
	28	112818-28	0.21	46							
	29	112818-29	0.40	75							
	30	112818-30	0.26	64							
	31	112818-31	0.75	50	1				N		
	32	112818-32	1.1	70	715						
	35	120518-35	1.1	42							
	36	120518-36	0.30	23		-22	11134				
	37	120518-37	2.2	60		1					
	38	120518-38	0.44	29		3					
	39	120518-39	2.0	62	7 ·						
	40	120518-40	0.22	61							
Clea	Cleanup Levels (mg/kg)		2	118	2,000	20	2	100	2,0	00	0.1 TEF

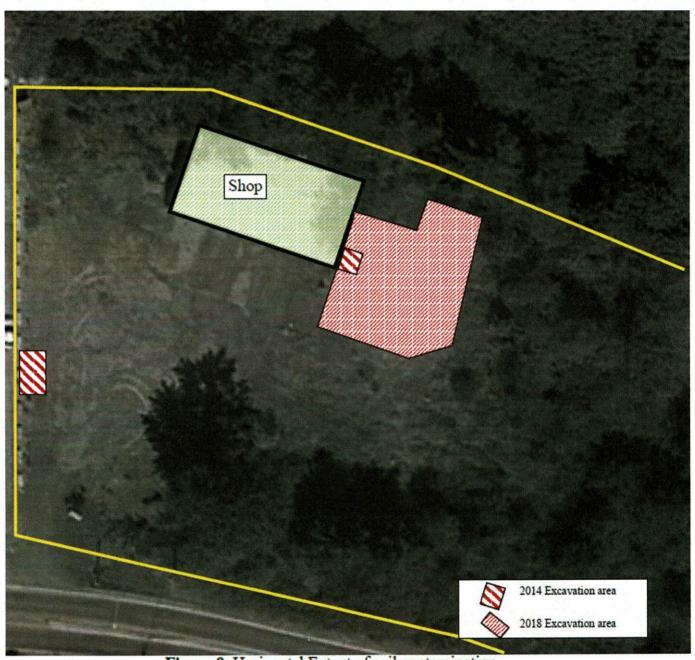
Figure 9. Horizontal Extent of soil contamination

Diesel, cadmium, and lead into the soil

The method selected for soil - excavation of the contaminated soil and transporting the soil off-site to a permitted facility – meets the minimum requirements for cleanup actions by providing a permanent solution, immediate restoration time frame, provides for confirmation monitoring, and protects human health and the environment.
