## SOIL MANAGEMENT PLAN

### **Maninder Singh - Expansion**

8701 Greenwood Ave North  
Seattle, Washington 98103

Partner Project Number: 20-293062.2

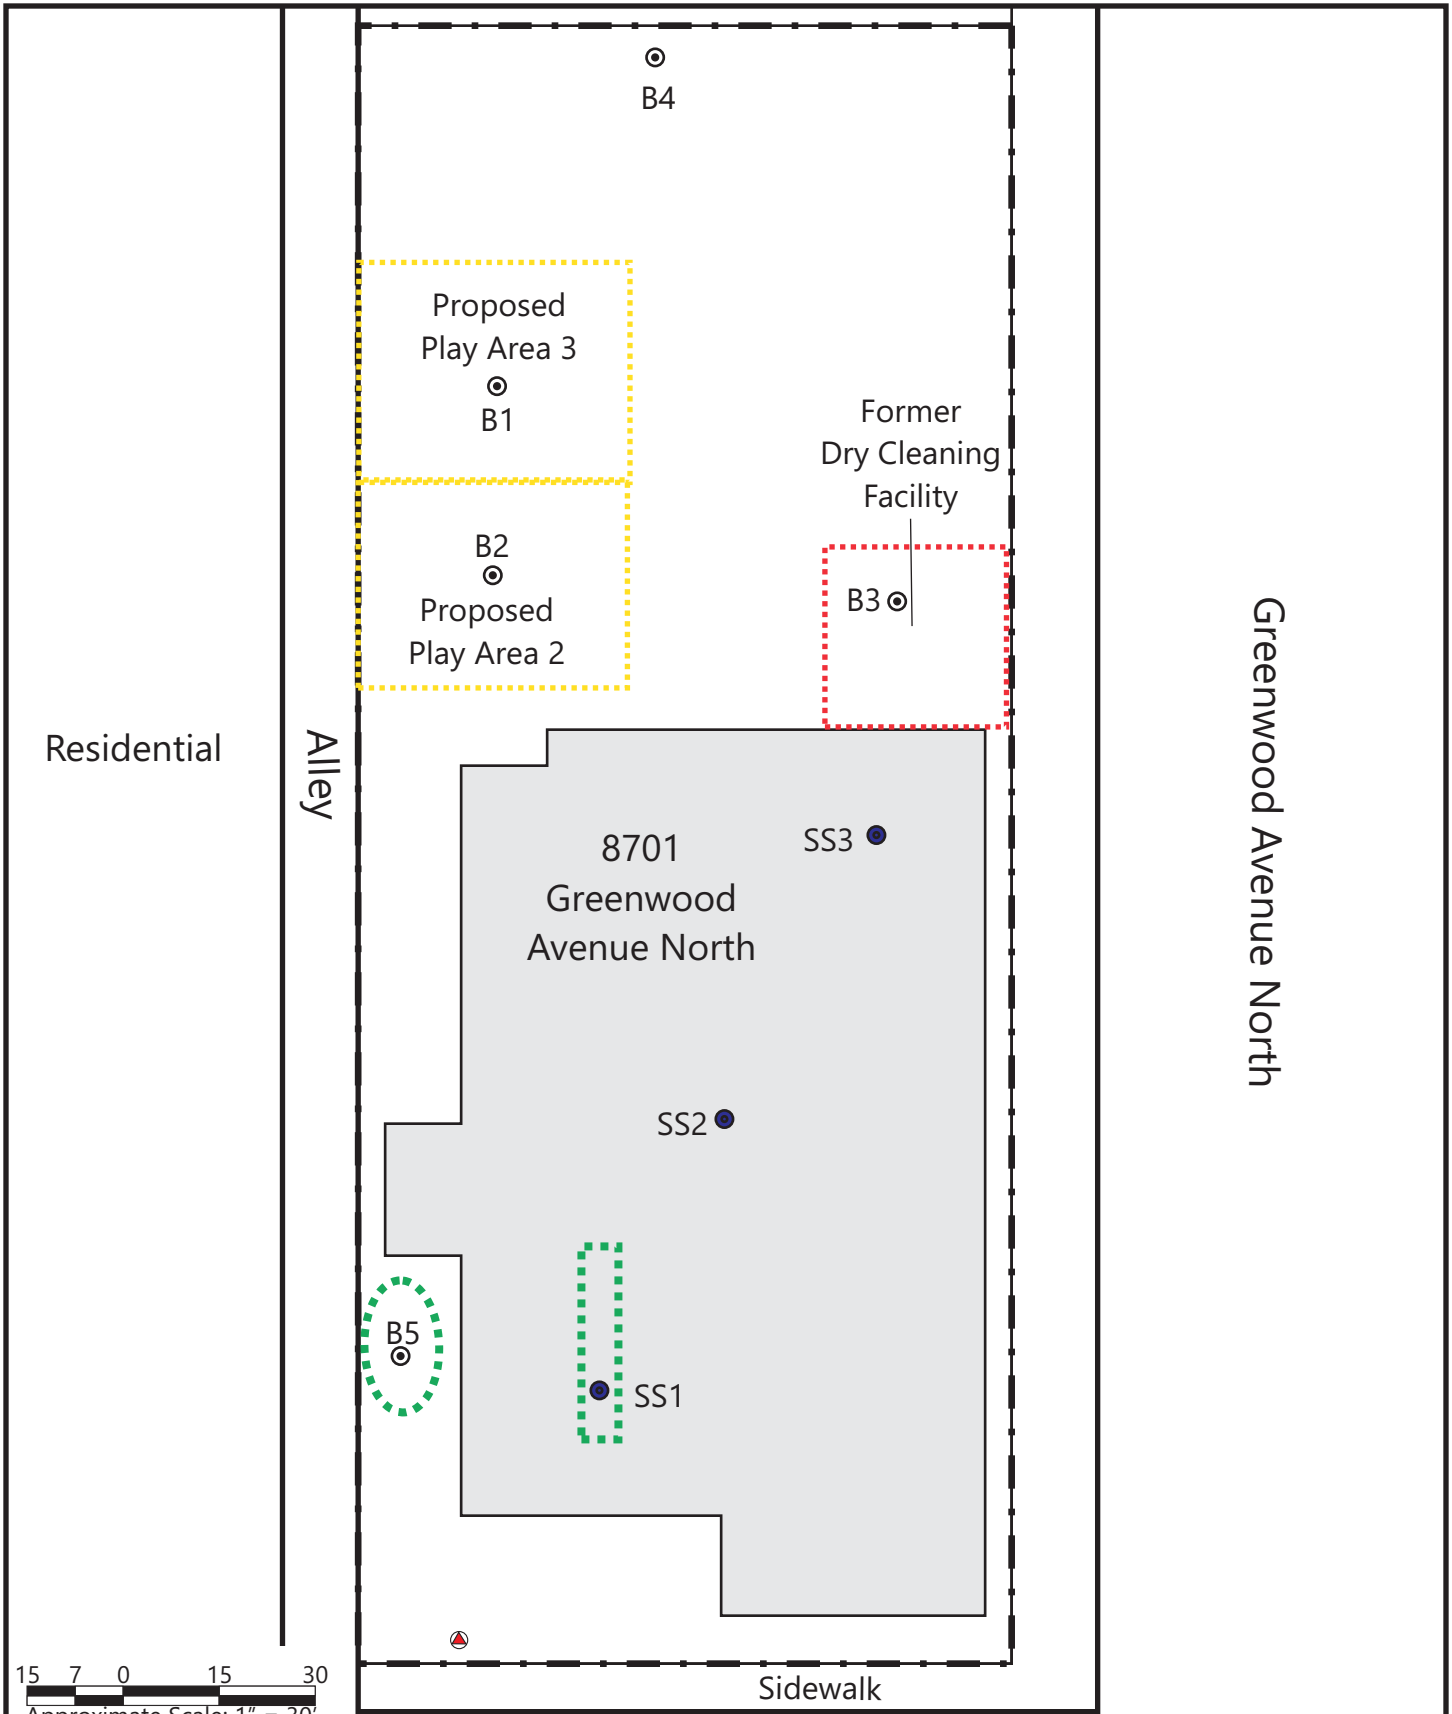
Figures:	<ol style="list-style-type: none"> <li>1 Site Vicinity Map</li> <li>2 Sample Location Map</li> </ol>
----------	--
