# REMEDIAL INVESTIGATION WORK PLAN

NORTHERN STATE MULTI SERVICE CENTER

SEDRO-WOOLLEY, WASHINGTON

AGREED ORDER NO. DE 16309  
CLEANUP SITE ID: 10048

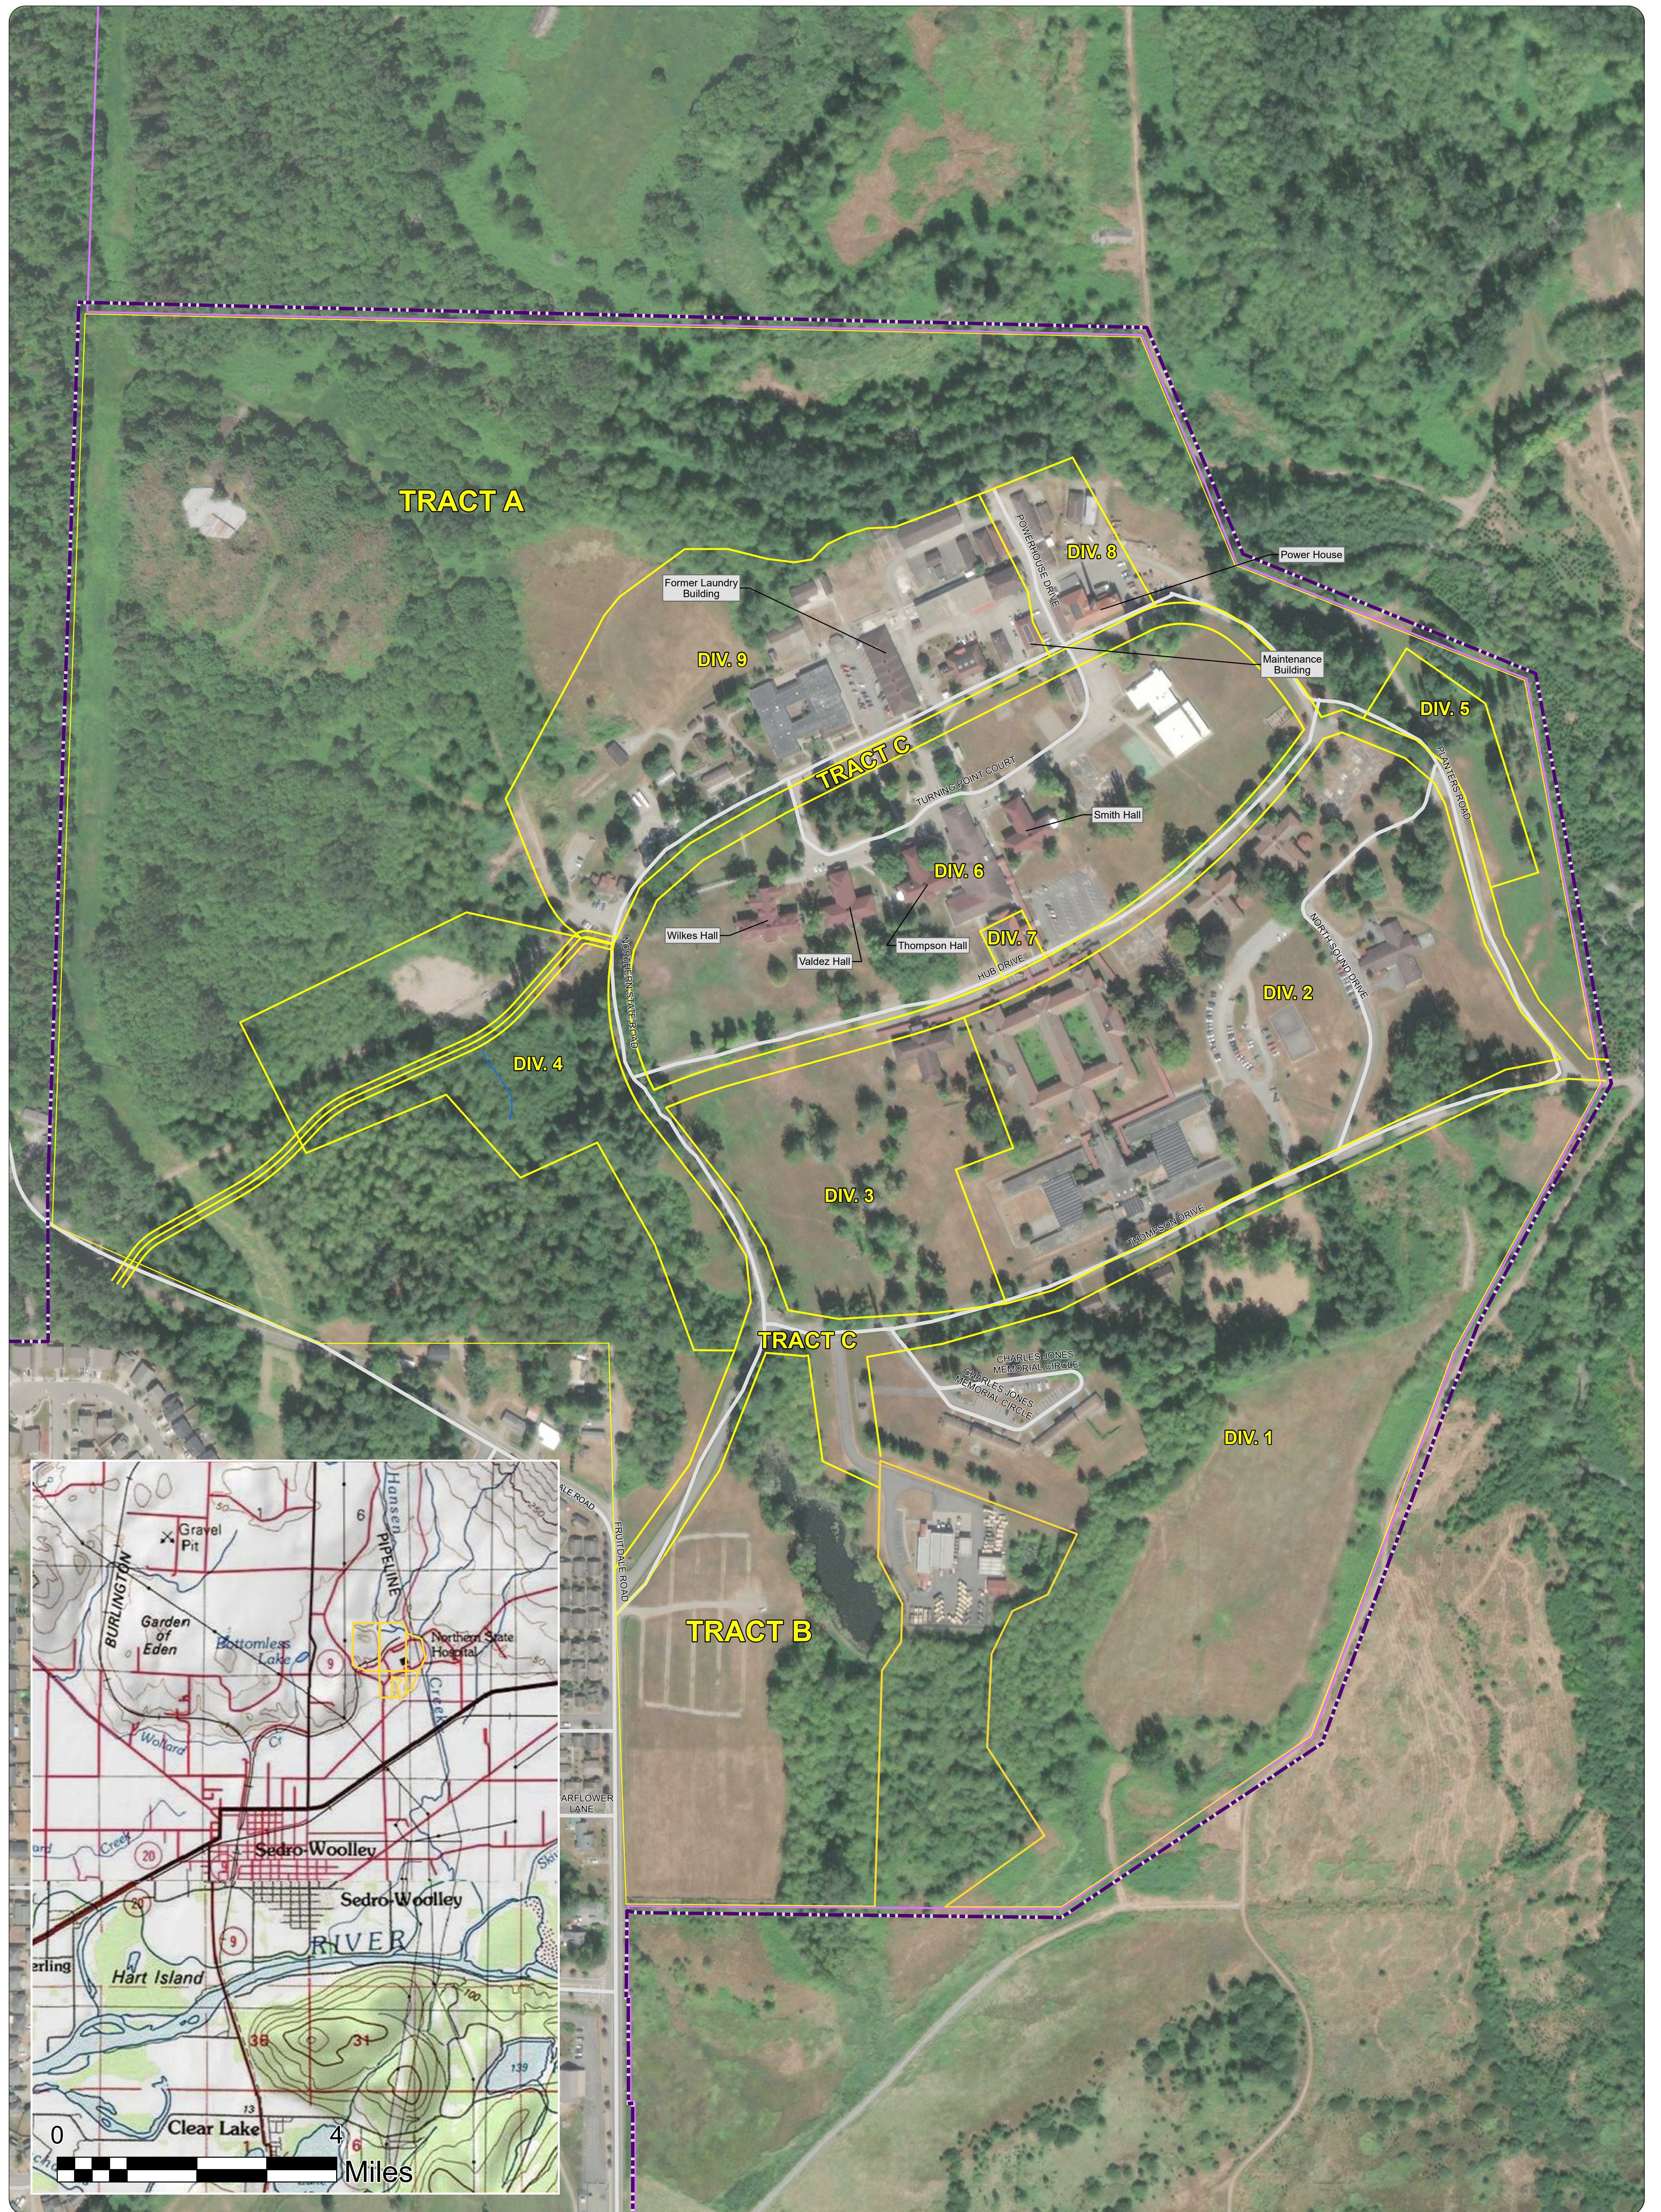
**Figure 1-1**  
**Property Vicinity**  
 Former Northern State Hospital  
 Port of Skagit  
 Sedro-Woolley, Washington

- Property Parcel and Parcel Name
- Northern State Recreational Area
- Sedro-Woolley City Limits (Post Annexation)
- Stream

The Property is in the northeast corner of Sedro-Woolley (see Figure 1-1). The approximately 220-acre Property includes twelve tax parcels based upon the boundary line adjustment completed on June 29, 2018 (see Figure 1-1). The Property was annexed by the City of Sedro-Woolley (City) on September 19, 2015. The Property is bordered on the north, east, and south by the Northern State Recreation Area, a public open space owned and managed by Skagit County and historically associated with the Northern State Hospital. The Property is bordered by Fruitdale Road and residential properties to the west.

Two creeks, Hansen and Brickyard, intersect the Property (see Figure 1-1). Hansen Creek bounds the north, east, and southeast portions of the Property. Brickyard Creek is located along the western perimeter of the Property. Both creeks discharge to the Skagit River, south of the Property.

Chlorinated solvents (chlorinated volatile organic compounds [cVOCs]), including tetrachloroethene (PCE), trichloroethene (TCE), and cis-1,2-dichloroethene (cis-1,2-DCE), were detected in soil, groundwater, and/or soil vapor in the northeast area of the former laundry building (see Figure 1-1) (MFA, 2018a). Historical use of chlorinated solvents in potential dry-cleaning operations was identified as a potential source of cVOC impacts in the former laundry building AOC.

Concentrations of heavy-oil-range organics (ORO) and carcinogenic polycyclic aromatic hydrocarbons (cPAHs) were detected above the MTCA Method A CULs (for unrestricted land use) in shallow soil (less than 3 feet bgs) north of the Power House (see Figure 1-1) (MFA, 2018a). Historical fill material containing coal/asphalt debris was determined to be a potential source of the ORO and cPAH impacts to shallow soil and appear localized to a small area underlying the existing asphalt immediately north of the Power House. Data collected for this area indicate that no data gaps remain and an evaluation to develop a protective remedy can be completed. Therefore, no additional characterization of this AOC is proposed in this work plan.

Benzene, toluene, ethylbenzene, total xylenes, and gasoline were identified in subsurface soil (between 7 and 12 feet bgs) and groundwater adjacent to the maintenance building (see Figure 1-1) at concentrations above MTCA Method A CULs (SES, 2017).

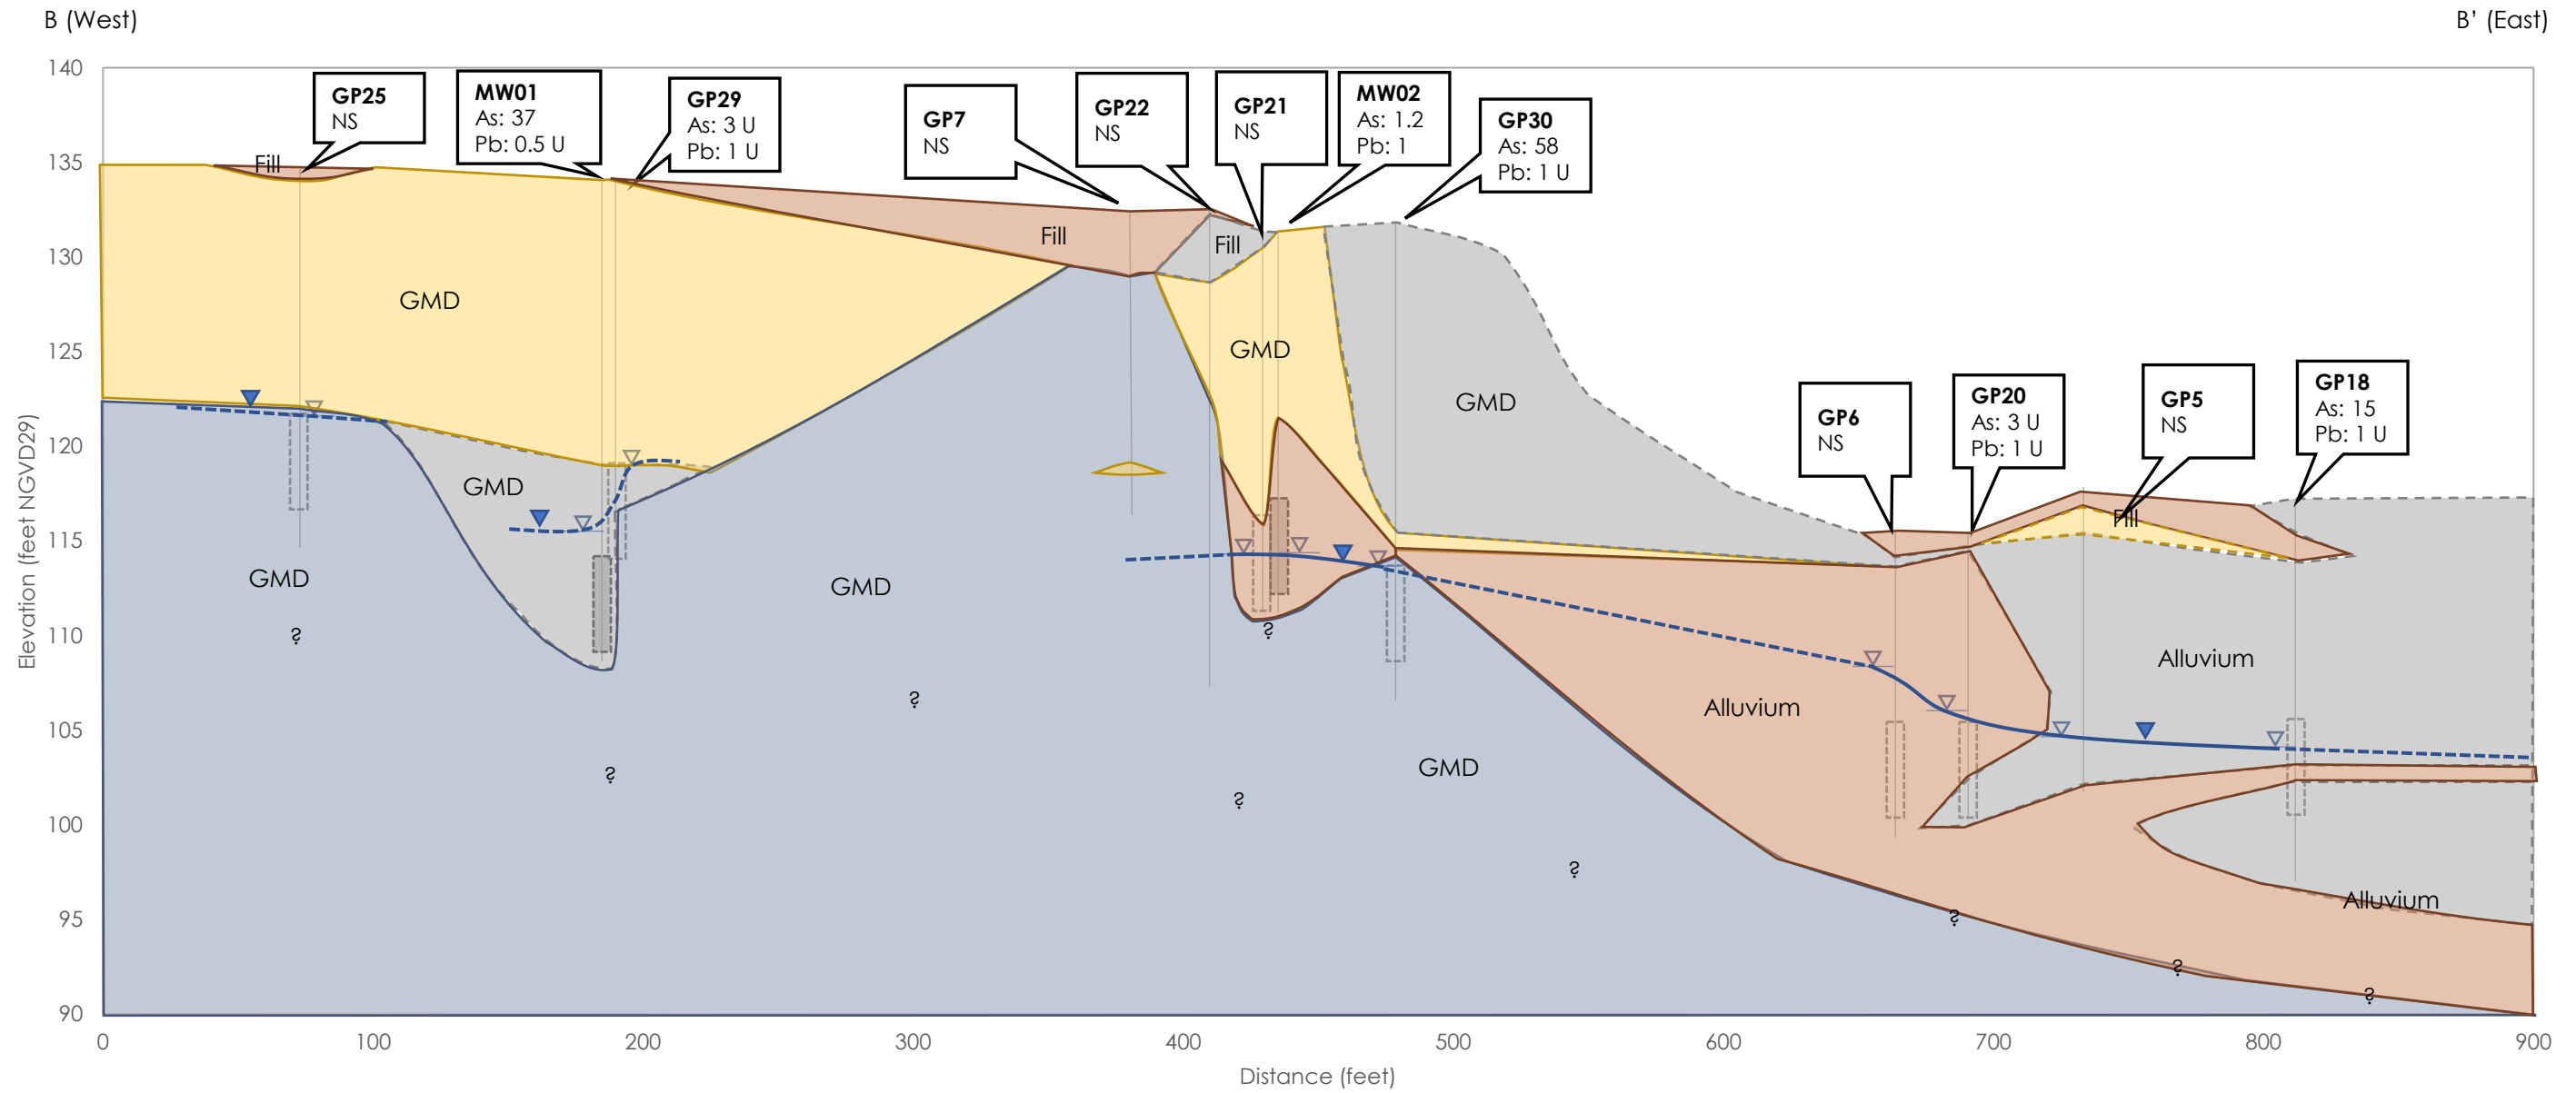
**Figure 4-5**  
**Geologic Cross Section**  
**Former Northern State Hospital**  
**Port of Skagit**  
**Sedro-Woolley, Washington**

<b>Legend</b>		Water table	<p><b>Location ID</b>          As = dissolved arsenic (ug/L)          Pb = dissolved lead (ug/L)</p>	<p><b>Notes:</b>          Dissolved lead and arsenic concentrations in groundwater samples. All feature locations are approximate. Units and water table are dashed where inferred. Water levels shown were observed during drilling. 2.5x vertical exaggeration. GMD = glaciomarine drift. NGVD 29 = National Geodetic Vertical Datum of 1929. U = not detected at or above the reporting limit. ug/L = micrograms per liter.</p>
	Gravelly sand to sandy gravel	Water level observed during drilling		
	Clay	Monitoring well screen interval		
	Silt	Temporary well screen interval		
	Silty sand to sandy silt

Soil observations recorded during previous investigation indicate relatively consistent geology throughout the Property, except at locations near Hansen Creek and north of the Power House (MFA, 2015, 2018a; SES, 2017). Thick units of soft to hard, nonplastic silt and clay with varying amounts of fine sand to depths of approximately 9 to 15 feet below ground surface (bgs) were encountered in most boring locations. Underlying the silt unit, thick deposits of bluish gray silty clay to clay were observed to approximately 25 feet bgs. Silty sand was observed underlying the silt unit to the maximum depth of 30 feet bgs. Minor lenses of silty sand and silty or sandy gravel were encountered intermittently in silt and clay units between 10 and 30 feet bgs. Soils near Hansen Creek, north of the Power House, consisted of sandy and gravelly soils below the silt at approximately 6 feet bgs. Fill containing brick pieces and woody debris was observed up to 15 feet bgs in the area to the north of the Power House (MFA, 2015; SES, 2017).

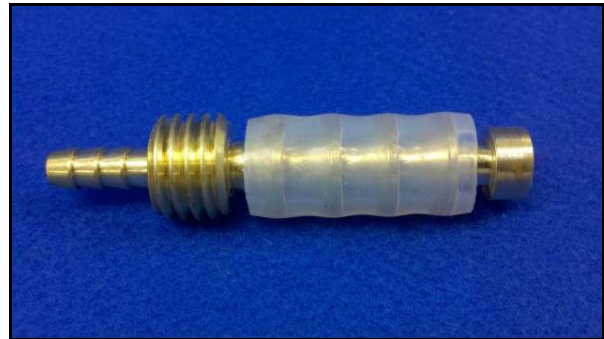
**Figure 1.** Assembled Vapor Pin™.

- Assembled Vapor Pin™ [Vapor Pin™ and silicone sleeve (Figure 1)];
- Hammer drill;
- 5/8-inch diameter hammer bit (Hilti™ TE-YX 5/8" x 22" #00206514 or equivalent);
- 1½-inch diameter hammer bit (Hilti™ TE-YX 1½" x 23" #00293032 or equivalent) for flush mount applications;
- ¾-inch diameter bottle brush;
- Wet/dry vacuum with HEPA filter (optional);
- Vapor Pin™ installation/extraction tool;
- Dead blow hammer;
- Vapor Pin™ flush mount cover, as necessary;
- Vapor Pin™ protective cap; and
- VOC-free hole patching material (hydraulic cement) and putty knife or trowel.

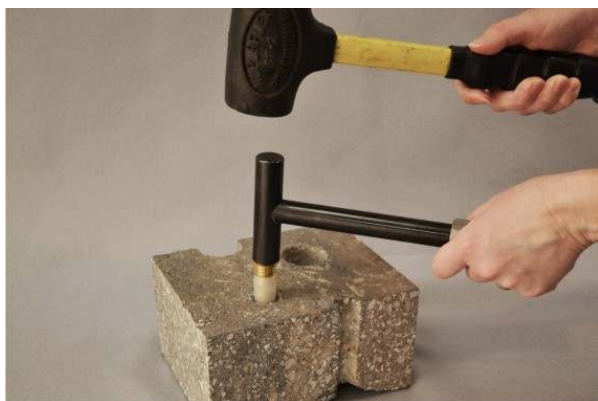
**Figure 2.** Installing the Vapor Pin™.

dead blow hammer (Figure 2). Make sure the extraction/installation tool is aligned parallel to the Vapor Pin™ to avoid damaging the barb fitting.

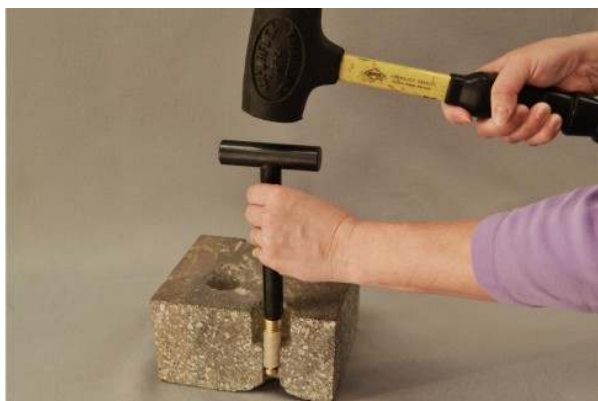
**Figure 3.** Flush-mount installation.

For flush mount installations, unscrew the threaded coupling from the installation/extraction handle and use the hole in the end of the tool to assist with the installation (Figure 3).

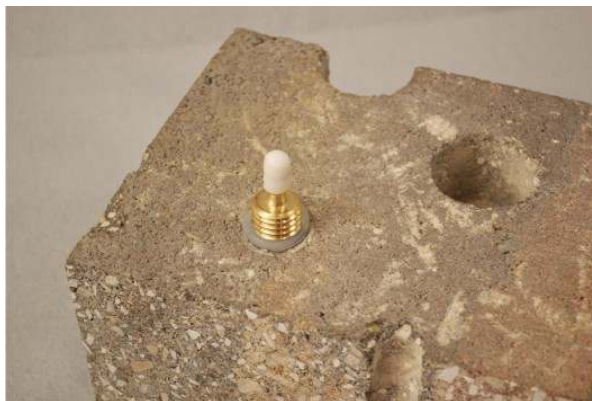
**Figure 4.** Installed Vapor Pin™.

During installation, the silicone sleeve will form a slight bulge between the slab and the Vapor Pin™ shoulder. Place the protective cap on Vapor Pin™ to prevent vapor loss prior to sampling (Figure 4).

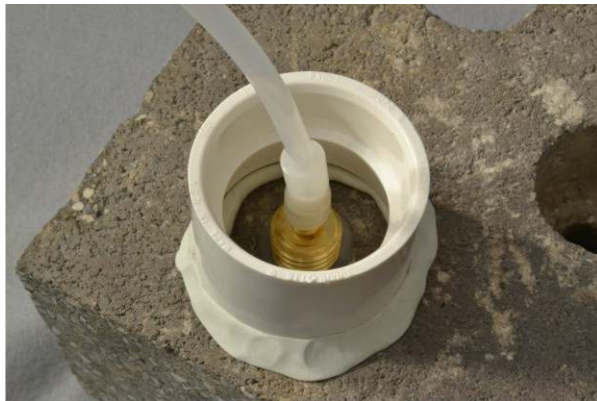
**Figure 6.** Water dam used for leak detection.

- 10) Conduct leak tests [(e.g., real-time monitoring of oxygen levels on extracted sub-slab soil gas, or placement of a water

dam around the Vapor Pin™) Figure 6]. Consult your local guidance for possible tests.

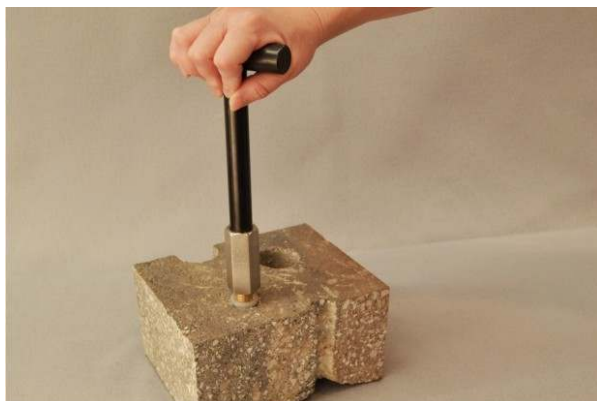
**Figure 7.** Removing the Vapor Pin™.

- 1) Remove the protective cap, and thread the installation/extraction tool onto the barrel of the Vapor Pin™ (Figure 7). Continue

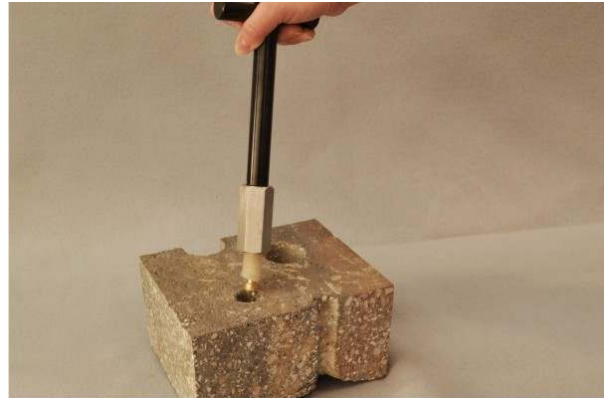
**Figure 8.** Extracted Vapor Pin™.

turning the tool to assist in extraction, then pull the Vapor Pin™ from the hole (Figure 8).

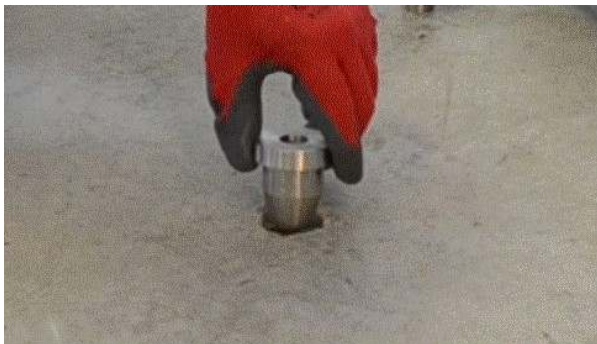
**Figure 3.** Installing the Drilling Guide.

- 4) Remove cuttings from the hole and place the Drilling Guide in the hole with the conical end down (Figure 3). The hole is sufficiently deep if the flange of the Drilling Guide lies flush with the surface of the slab. Deepen the hole as necessary, but avoid drilling more than 2 inches into the slab, as the threads on the Secure Cover may not engage properly with the threads on the Vapor Pin™.

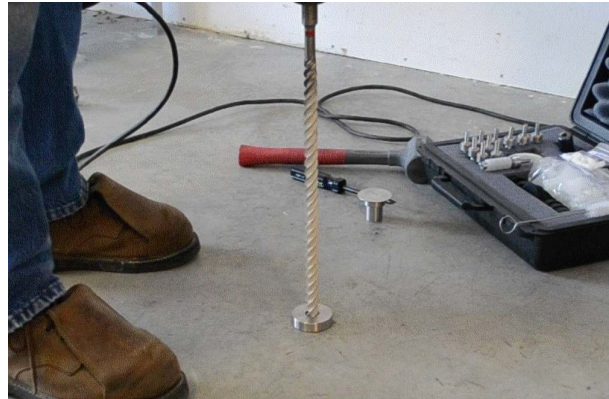
**Figure 4.** Using the Drilling Guide.

- 5) When the 1½-inch diameter hole is drilled to the proper depth, replace the drill bit with a 5/8-inch diameter bit, insert the bit through the Drilling Guide (Figure 4), and drill through the slab. The Drilling Guide will help to center the hole for the Vapor Pin™, and keep the hole perpendicular to the slab.
- 6) Remove the bit and drilling guide, clean the hole, and install the Vapor Pin™ in accordance with the SOP “Installation and Extraction of the Vapor Pin™.

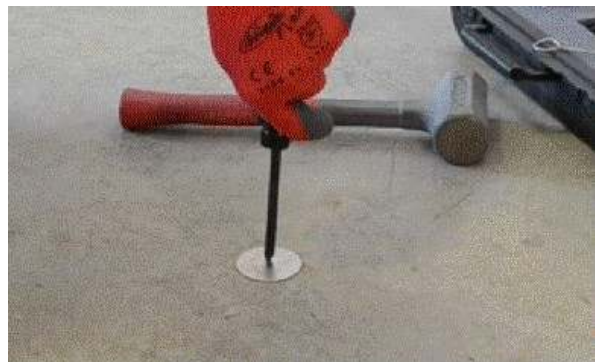
**Figure 5.** Tightening the Secured Cover.

- 7) Screw the Secure Cover onto the Vapor Pin™ and tighten using a #14 spanner wrench by rotating it clockwise (Figure 5). Rotate the cover counter clockwise to remove it for subsequent access.
