**FINAL REMEDIAL INVESTIGATION/FEASIBILITY STUDY WORK PLAN
ADDENDUM**
AMERICAN LINEN SUPPLY CO-DEXTER AVENUE SITE
700 DEXTER AVENUE NORTH
SEATTLE, WASHINGTON

Agreed Order No. DE 14302
Facility Site Identification Number: 3573
Cleanup Site Identification Number: 12004

JUNE 11, 2020

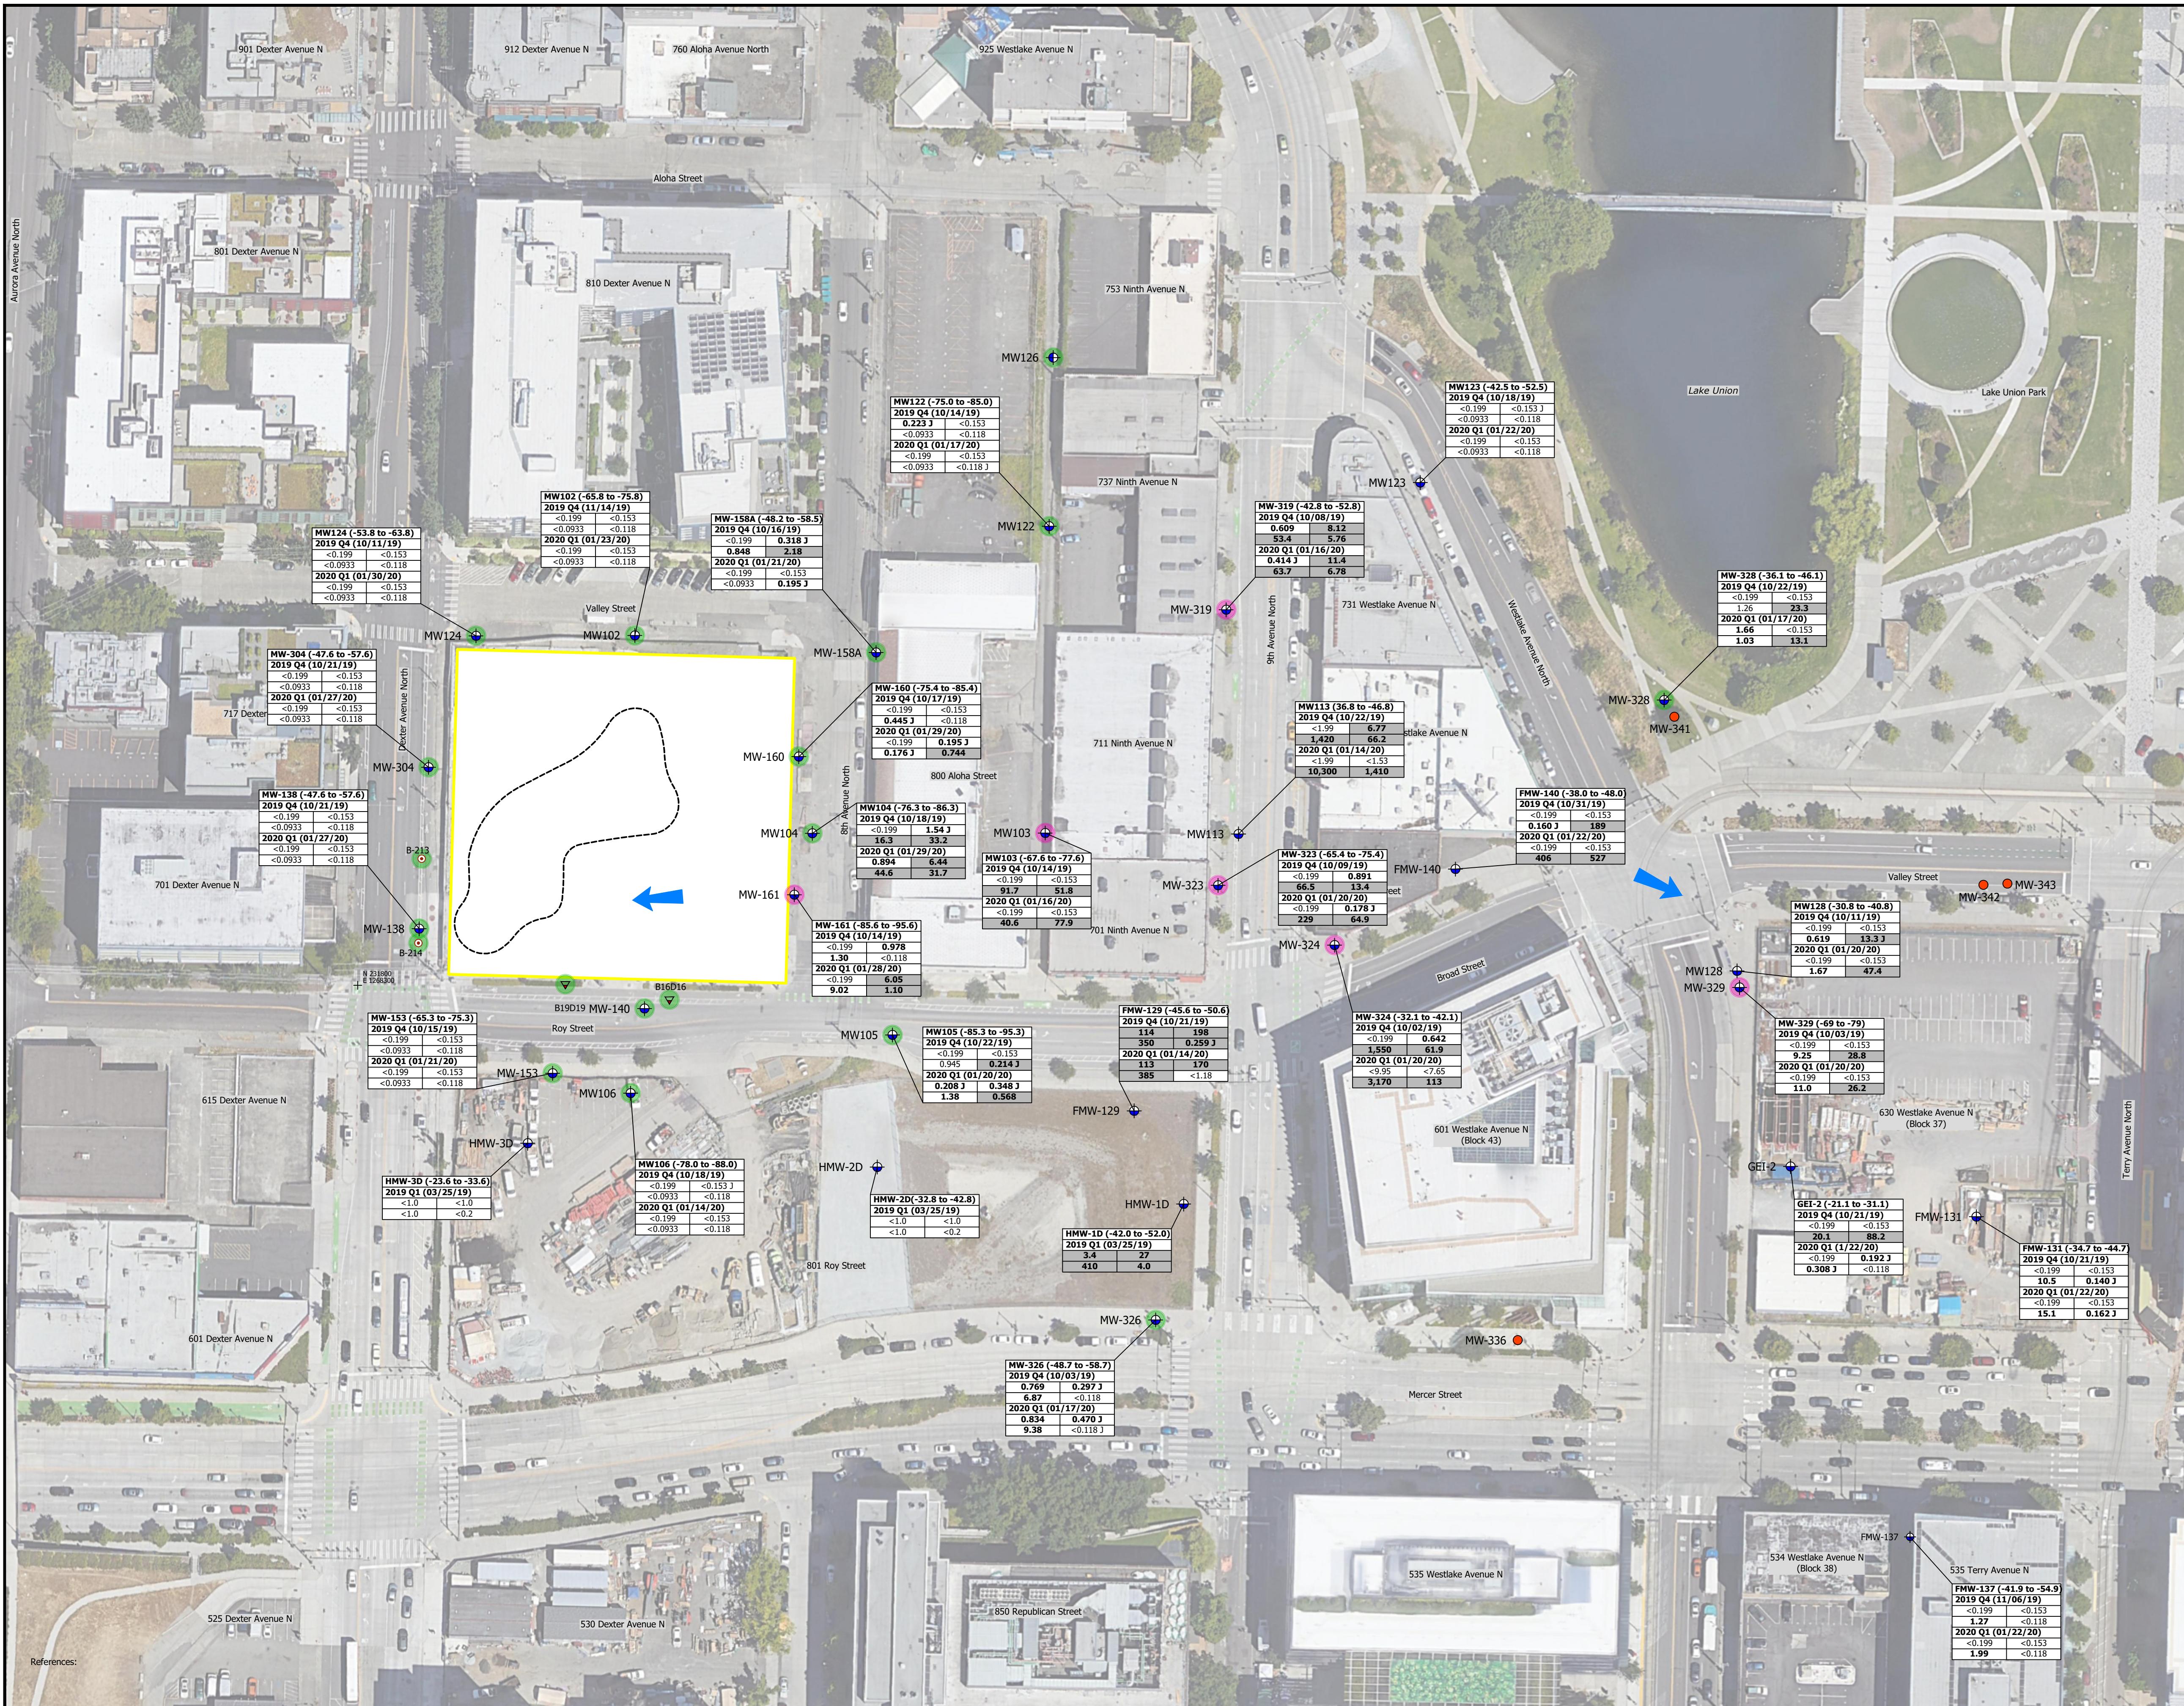
Groundwater Sampling Results Oct 2019-Jan 2020 Deep Zone

Well (screen elevation)	2019 Q4
PCE	2.4
TCE	1
cDCE	VC
2020 Q1	
PCE	2.4
TCE	1
cDCE	VC

Screening Levels	
2019 Q4	
PCE	TCE
1.6	0.2
2020 Q1	
PCE	TCE
2.4	1
cDCE	VC
16	0.2

Explanation Notes:
Concentrations reported in micrograms per liter ($\mu\text{g/L}$).
 $<$ = not detected at or above the method detection limit (MDL)
 J = the identification of the analyte is acceptable; the reported value is an estimate
 $+$ = the reported value may be biased high
Concentrations detected above the MDL are shown in **bold**
Concentrations above the screening level are highlighted and shown in **bold**
PCE = tetrachloroethene
TCE = trichloroethene
cDCE = cis-1,2-dichloroethene
VC = vinyl chloride
Well screen elevations shown in parentheses.
The PES 2019 Q4 GW sampling event occurred from October to December, 2019.
The PES 2020 Q1 GW sampling event occurred in January 2020.
