# REMEDIAL INVESTIGATION REPORT

Snopac Property

Prepared for: 5055 Properties LLC

Project No. 150054 • December 21, 2023 FINAL

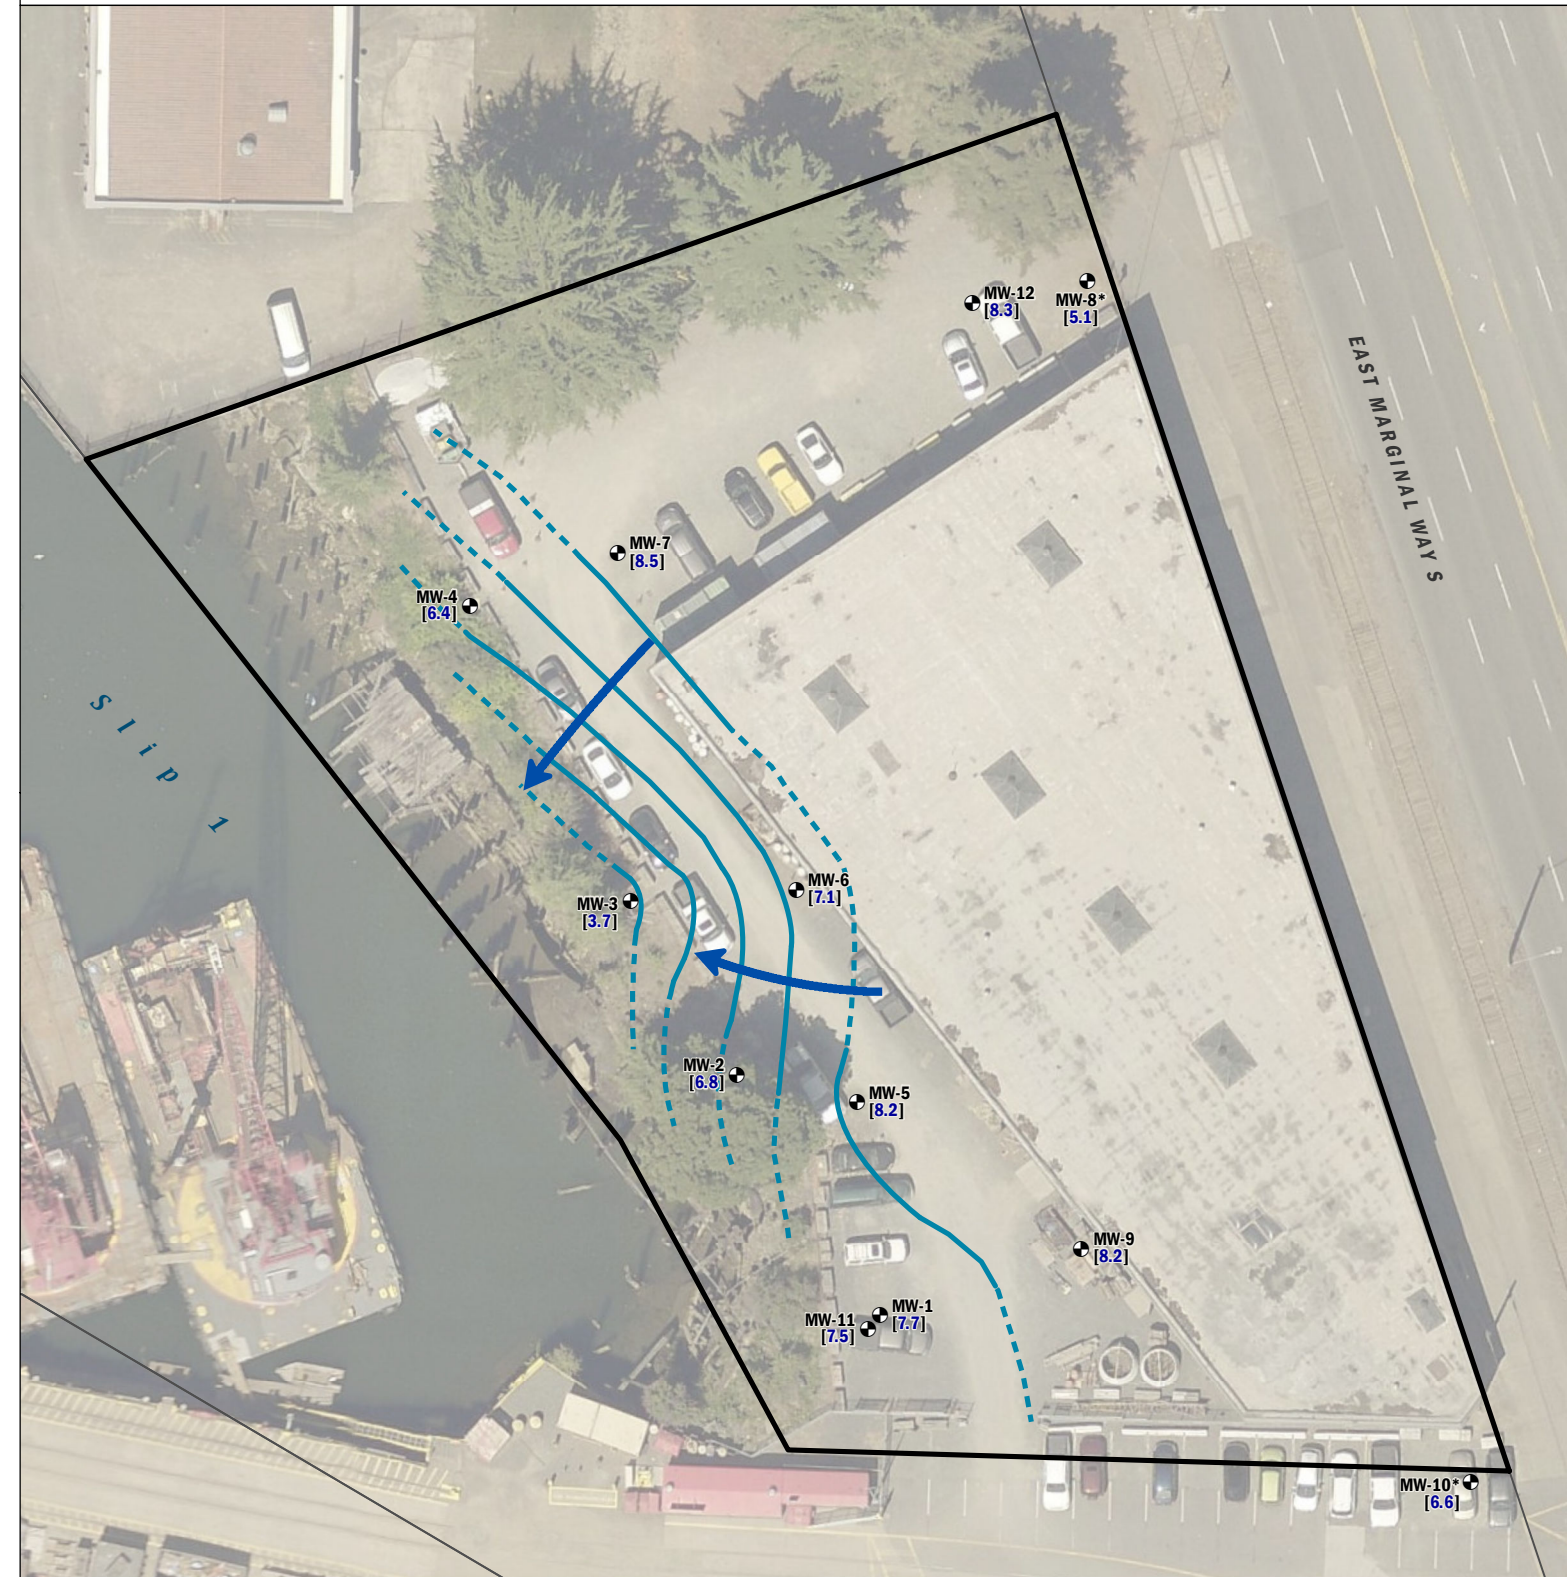
OCT-2019	BY: SJG / RAP	FIGURE NO. <b>7</b>
	PROJECT NO. 150054	REVISED BY: EAC

February 5<sup>th</sup>, 2017

January 28<sup>th</sup>, 2018

- Well Name **MW-4** [6.4]
