ASSOCIATED
ENVIRONMENTAL
GROUP, LLC

SUPPLEMENTAL SITE CHARACTERIZATION

ACME BULK FUEL PLANT & CARDLOCK
303 Thurston Ave. NE
Olympia, WA 98501

AEG Project #: 12-1144

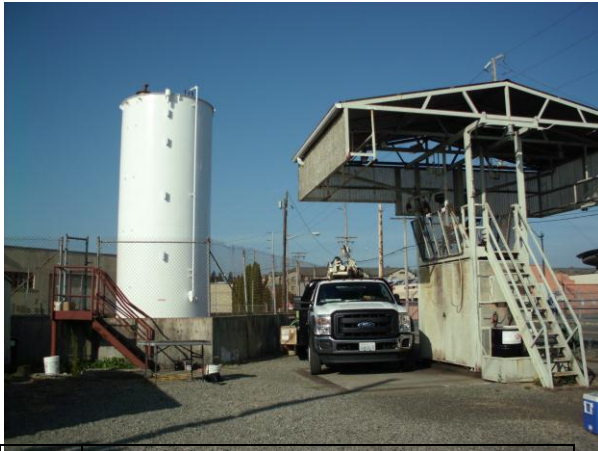
Photo #1: View of direct push probe drilling at boring B-1 adjacent north of bulk fuel area (looking northwest).

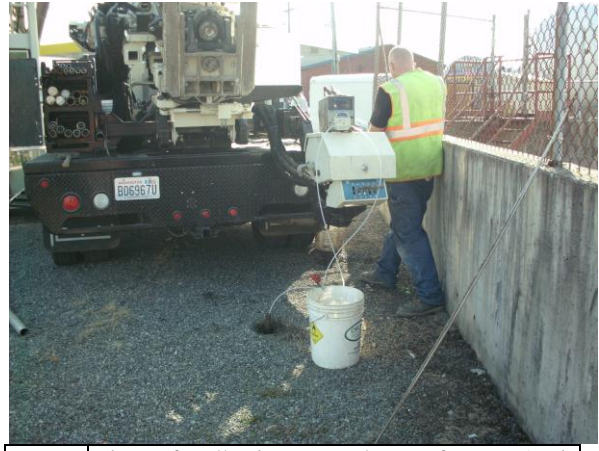
Photo #2: View of collecting groundwater from B-1 via peristaltic pump (looking east).

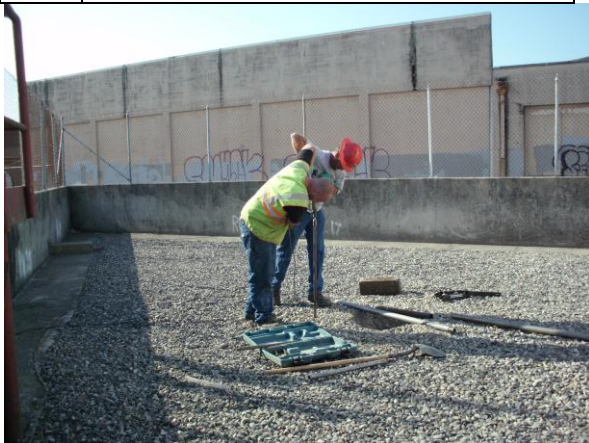
Photo #3: View of hand probe activities at boring B-2 (where the former 70k gal fuel tank was located) via a rotor hammer (looking west).

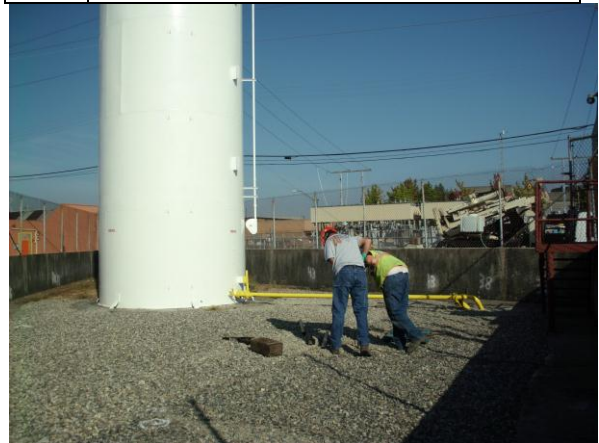
Photo #4: Secondary view of drilling at boring B-2, looking to the northwest. Note presence of the existing 30k gal fuel tank in background.

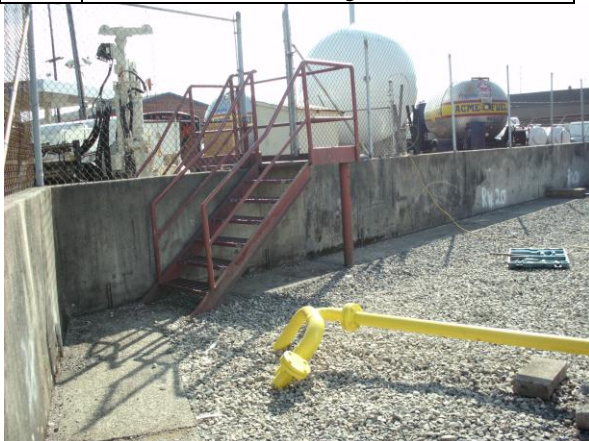
Photo #5: View of secondary containment area within the bulk fuel plant area at Acme (looking southeast).

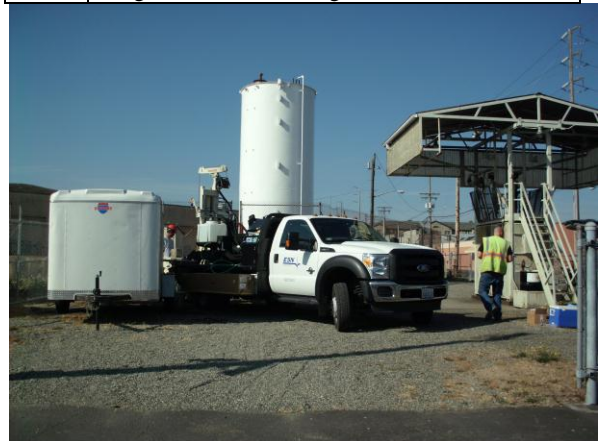
Photo #6: View of direct push probe drilling at boring B-3 (adjacent east of bulk fuel tank/spill area). View looking west.

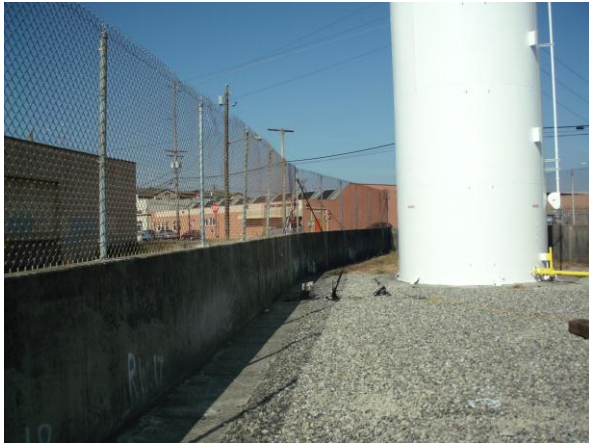
Photo #7: View of location of probe boring B-5, adjacent south of existing 30k gal fuel tank and west of former spill area (looking northwest).

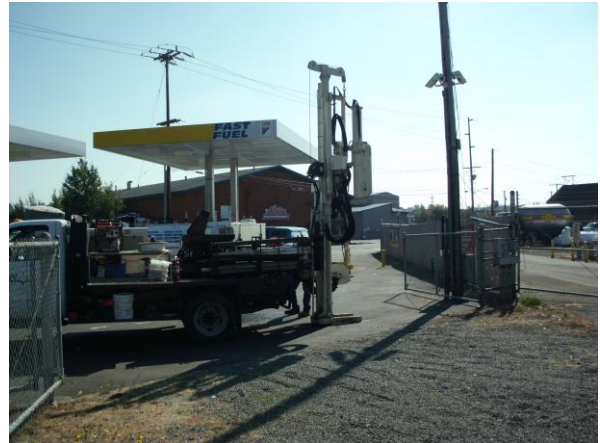
Photo #8: View of direct push probe drilling at boring B-6, east of bulk fuel tank/spill area on Cardlock facility area (refer to Figure 2).

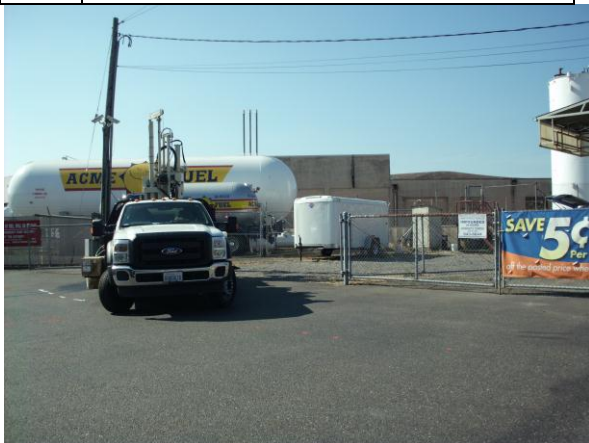
Photo #9: Secondary view of drilling at B-6, looking west-southwest towards bulk fuel plant area. Note location is outside of bulk fuel fenced area.

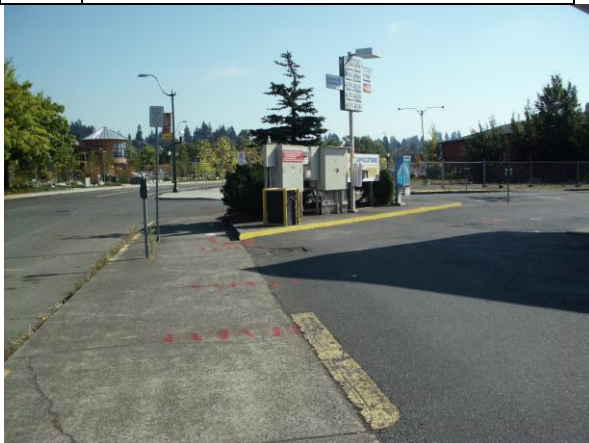
Photo #11: View of underground utilities markings adjacent north of Site on Thurston Ave NE sidewalk (looking to the northeast).

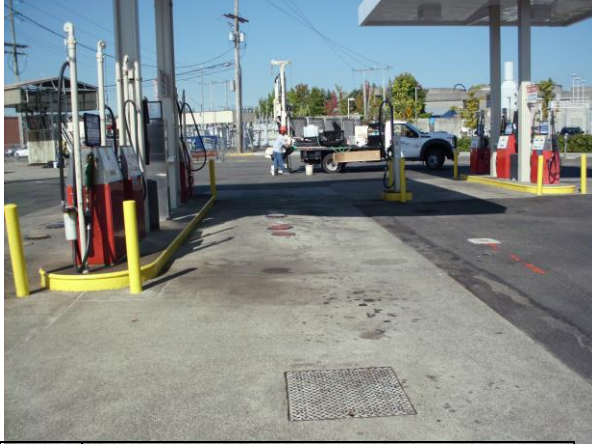
Photo #13: View of direct push probe drilling at boring B-8, north of dispenser islands and underground storage tanks at Cardlock facility (looking north)

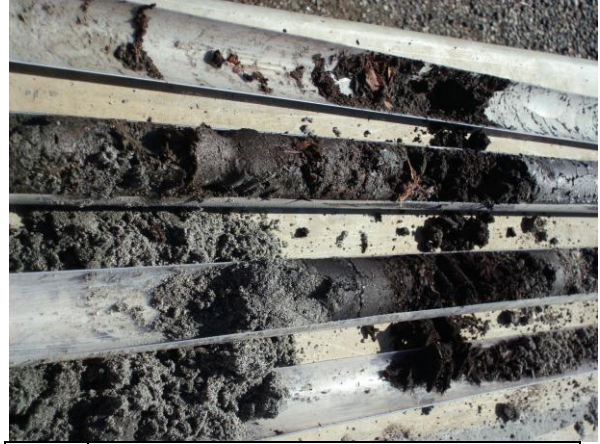
Photo #14: View of soil core samples collected from boring B-8. Upper cores denote soft wood debris materials from 8 to 10 feet bgs.

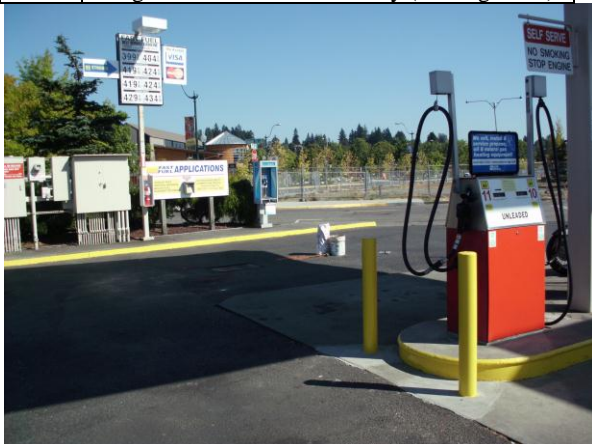
Photo #15: View of peristaltic pump (in background) set up to collect grab groundwater sample at boring B-9, adjacent east of eastern dispenser island.

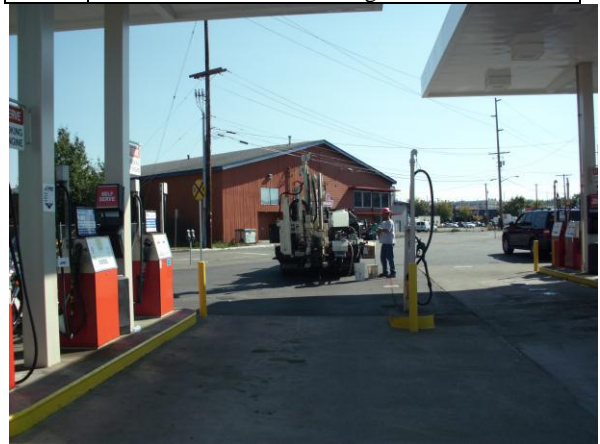
Photo #16: View of direct push probe drilling at boring B-10, adjacent south of 2 dispenser islands and associated underground storage tanks Looking southeast.

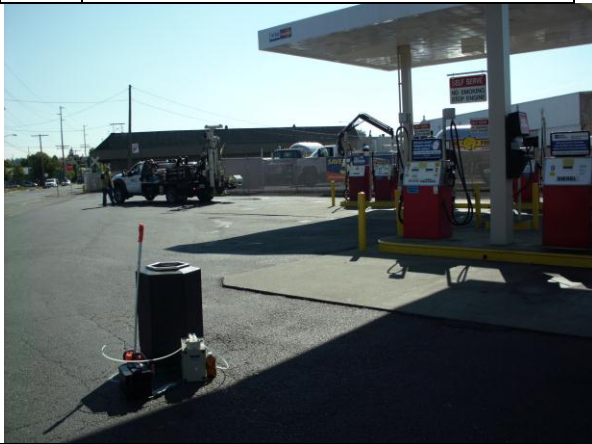
Photo #17: View of drilling at B-11, adjacent south of western dispenser island. Note groundwater sampling setup at B-9 in foreground.

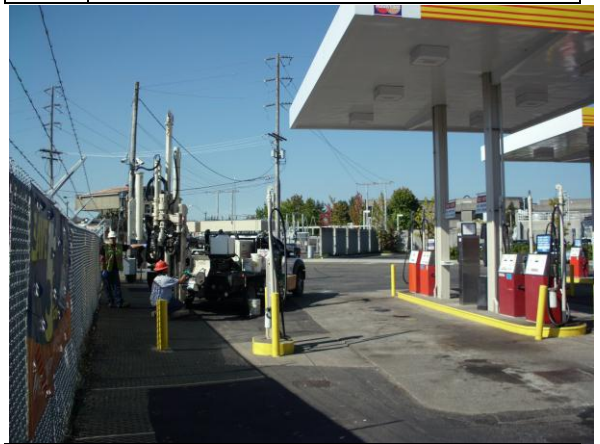
Photo #18: View of drilling at boring B-12, adjacent west of dispenser islands/associated underground storage tanks (looking north).
