**LIMITED PHASE II  
ENVIRONMENTAL SITE ASSESSMENT**

**SUNDANCE GOLF COURSE  
9725 NORTH NINE MILE ROAD  
NINE MILE FALLS, WASHINGTON 99206**

Project Number: 192860.00

Date: November 10, 2020

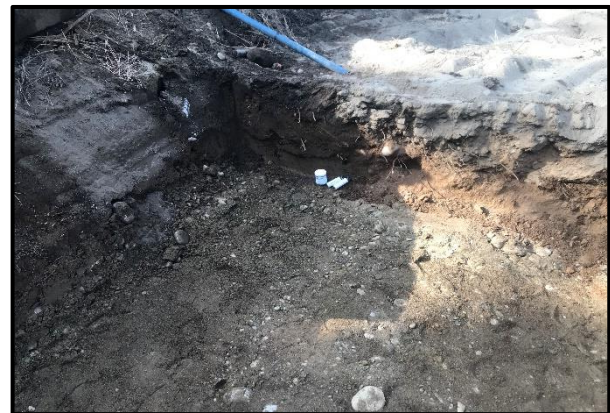
*View of excavation area showing near surface site soils.*

AVONVILLE soil horizons are described to consist of the following:

- From 0 to 16 inches bgs – fine gravelly – silt loam
- From 16 to 25 inches bgs – very gravelly – silt loam
- From 25 to 37 inches bgs – very gravelly – sandy loam
- From 37 to 60 inches bgs – very gravelly – sand

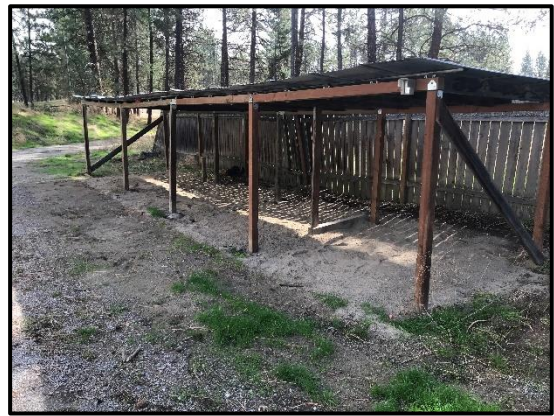
Fulcrum's inspection found the two ASTs and the drums to have been removed from the covered storage area. A fresh layer of soil had been placed throughout the covered storage area. Fulcrum randomly select five locations for sampling of soils within the covered storage area. In each location soil was hand excavated to an approximate depth of 1 foot (ft) below ground surface (bgs) and a soil sample was collected at the observed interface between the fresh soils and the former soils forming the floor of the covered storage area. See Figures 2 and 3 for soil sample location maps. All five samples (SGC-092619-01 through 05) were analyzed for gas, BTEX, and diesel/oil. Two of the sample locations (SGC-092619-01 and 04) were also analyzed for lead and one sample, was analyzed for PAHs.

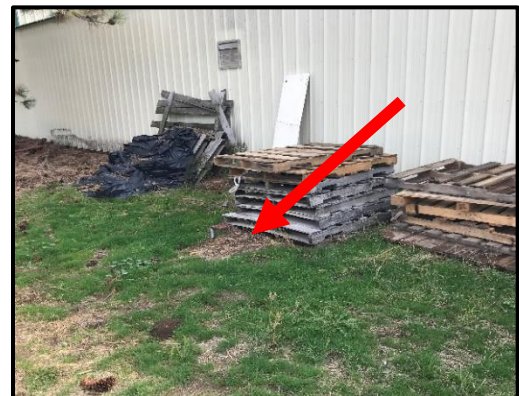
*View of AST storage area and localized stressed vegetation (see arrow) located proximal to the northwest corner of the warehouse shed*

A single sample (SGC-092610-07) was collected from the location of the distressed vegetation at a depth of approximately 1 ft bgs. The sample was analyzed for herbicides and pesticides.

A single sample collected from an area of distressed vegetation in the location of the removed AST was non-detect for all tested herbicides and pesticides. No further investigation of this location/condition was recommended.

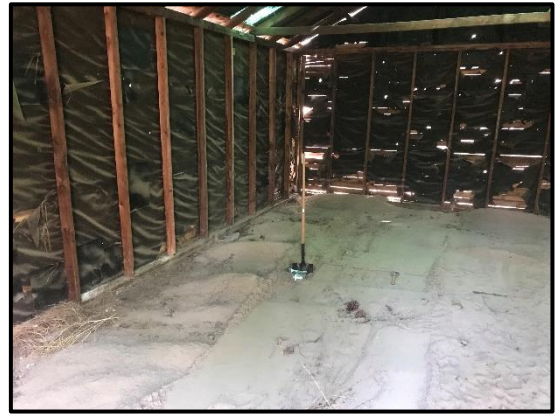
Fulcrum completed a visual inspection of shed that had been identified as a storage area for agricultural chemicals associated with golf course maintenance. All contents had been removed leaving the exposed sand floor. No suspect discoloration or any other indication of release or spills was observed. A single location was randomly selected for sampling. Fulcrum hand excavated the location to a depth of 6-inches bgs observing for any staining, discoloration, or other indication of impact. No indication of impact was identified and a sample (SGC-092610-08) was collected at approximately 6-inches bgs. The sample was analyzed for herbicides and pesticides.

*View of non-native sand overlain on bare soil within chemical storage shed. The shovel indicates where the soil was taken at approximately 6-inches bgs in native soil.*

One (1) sample was collected from the storage shed following removal of the stored agricultural chemicals. Analysis for pesticides and herbicides resulted in no detectable concentrations of any analytes except for Dicamba (a type of chlorinated herbicide) which was detected with a concentration of 0.0448 mg/kg. The MTCA regulatory threshold of for Dicamba is 2,400 mg/kg. No further investigation of this location/condition was recommended.

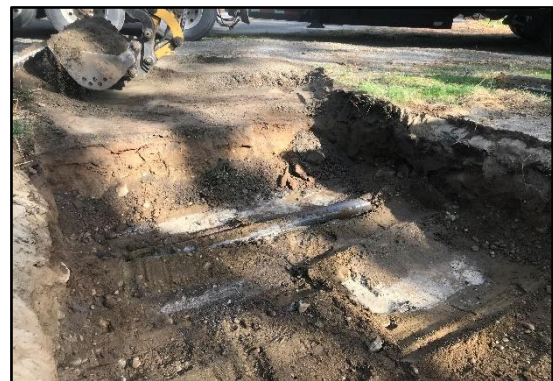
*View of northern AST and Drum Storage  
Remedial Excavation Area within the  
maintenance yard*

To facilitate access to the sample SGC-092619-02 area, the covered shed structure was knocked over and removed. An area centered on the sample SGC-092619-02 area measuring 20 feet long and 12 feet wide was excavated to a depth of approximately 2 ft bgs. No suspect staining, discoloration, odor or other field indicators of petroleum hydrocarbon impact were identified during the excavation or in remaining site soils at the bottom and sidewalls of the excavation area.

Fulcrum notified the owner of the sampling results and recommended that the Petroleum Contaminated Soil (PCS) associated with the SGC-092619-02 test location be excavated and transported to Graham Road Landfill for disposal as PCS.

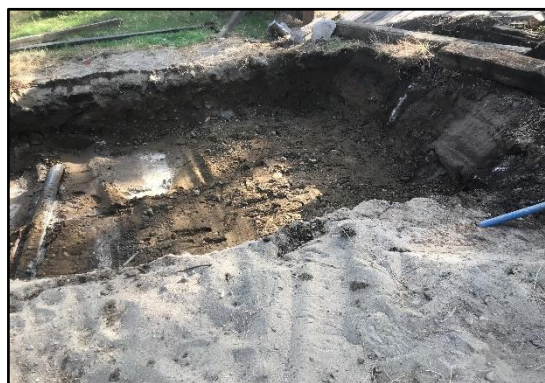
*View of southern AST and Drum Storage  
Remedial Excavation Area within the  
maintenance yard*

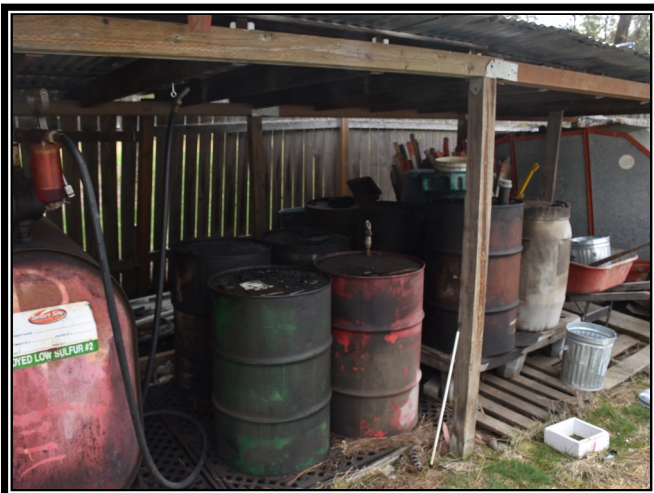
**Photograph #3: 4/04/2019**

View of the covered storage area prior to removal of the Above Ground Storage Tanks (ASTs) and drums.

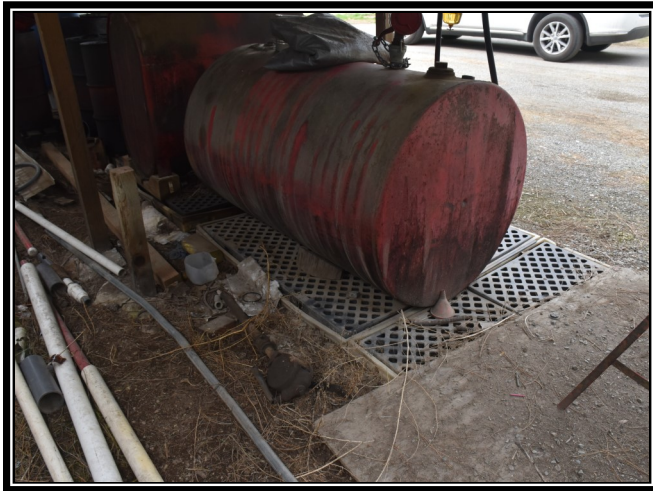
**Photograph #4: 4/04/2019**

View of an AST within the covered storage area prior to removal.

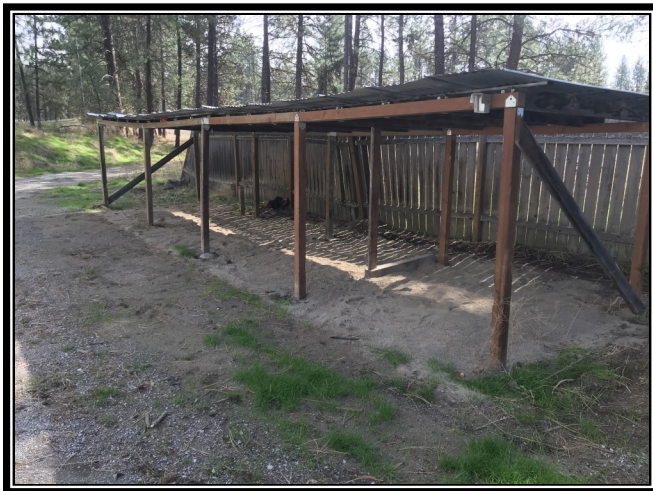
**Photograph #5: 9/26/2019**

View of covered storage area after all ASTs and drums were removed off-site. A non-native sand was observed to overlay native soil within the covered storage area.

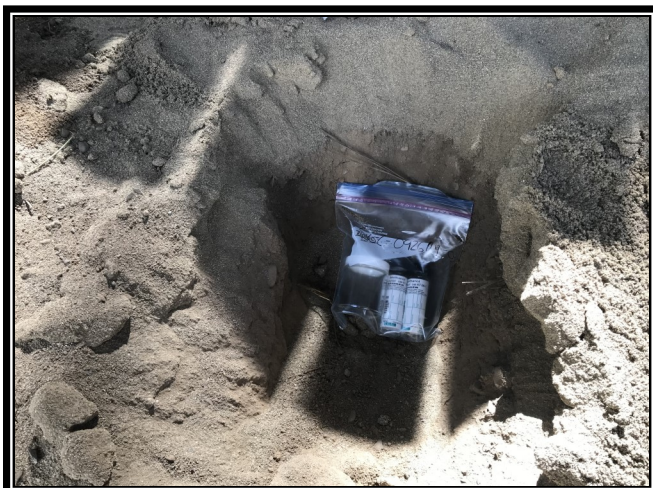
**Photograph #6: 9/26/2019**

View of typical near surface sample taken from approximately 1 ft below ground surface (bgs) within the native soil below the covered storage area. Laboratory analytical identified Petroleum Containment Soil (PCS) within the eastern portion of the covered storage area.

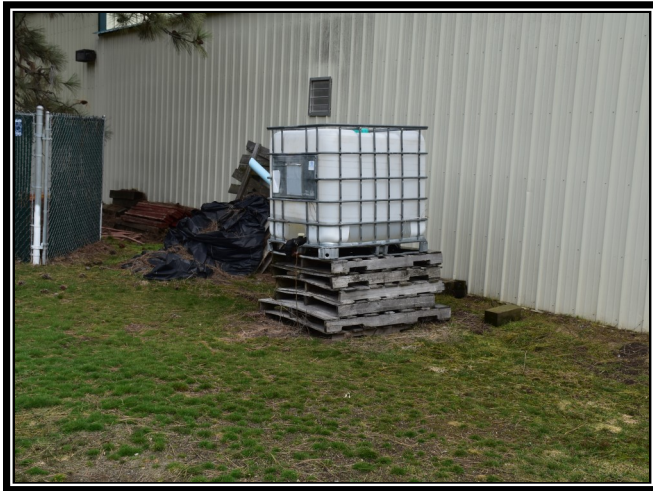
**Photograph #7: 4/04/2019**

View of the approximate 300-gallon suspect agricultural chemical AST prior to removal.

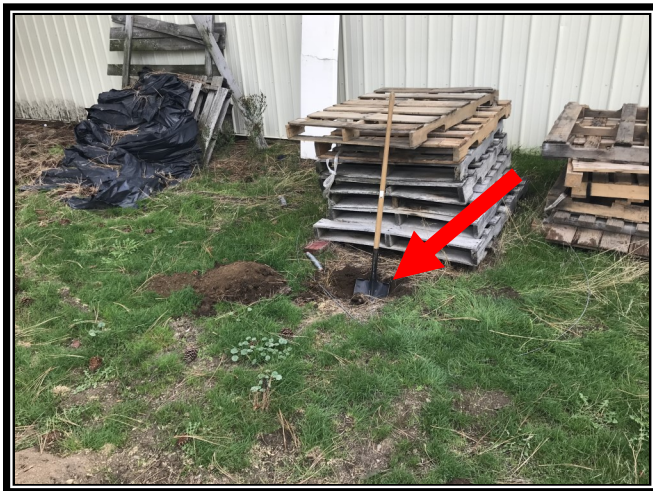
**Photograph #8: 9/26/2019**

View of the suspect agricultural chemical AST soil sampling location following removal of the AST.

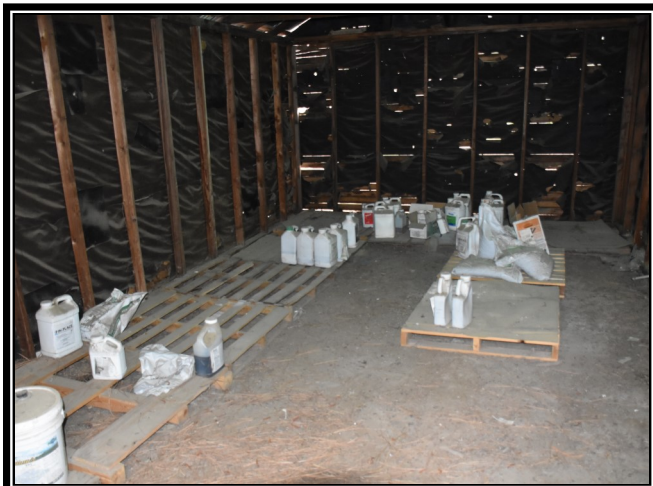
**Photograph #9: 4/04/2019**

View of storage shed prior to the removal of the agricultural chemicals.

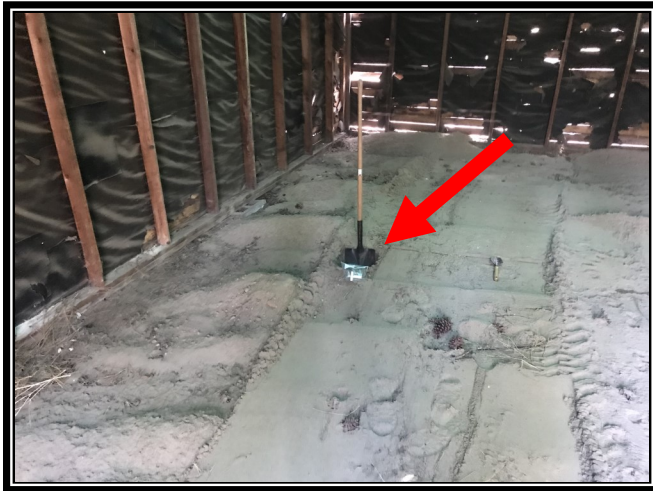
**Photograph #10: 4/04/2019**

View of the storage shed soil sample location following removal of the chemicals and pallets.

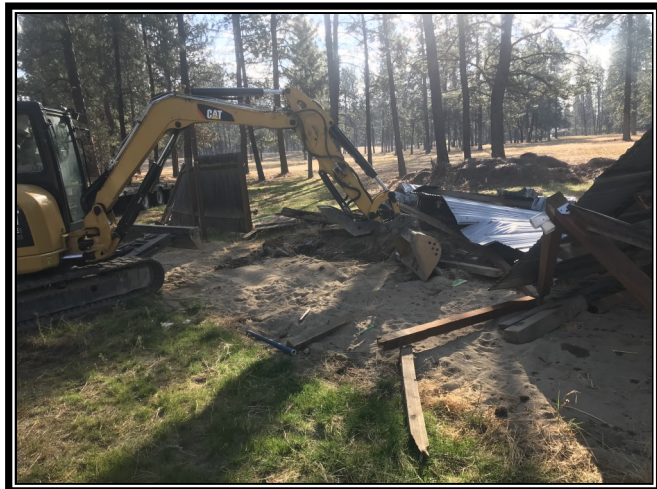
**Photograph #11: 9/26/2019**

View of covered storage area after lean-to and associated fencing was removed to conduct remedial excavation of the PCS located within the eastern portion of the covered storage area.

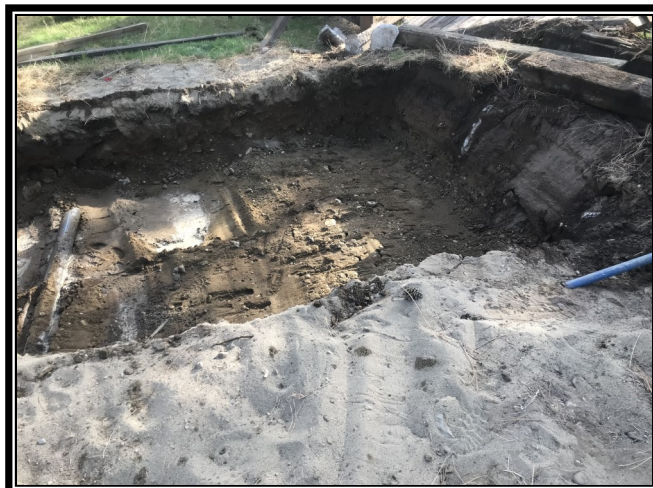
**Photograph #12: 10/22/2020**

View of remedial excavation conducted within the eastern portion of the covered storage area. Site soils were excavated down to approximately 2-ft bgs and the excavation was approximately 12 ft by 20 ft in area.

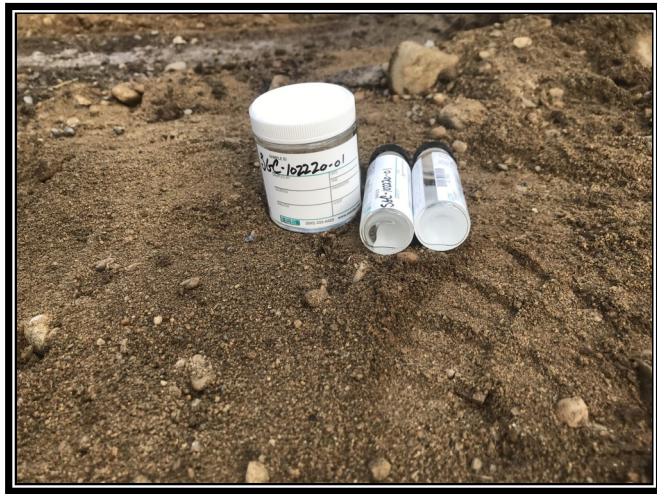
**Photograph #13: 10/22/20**

View of a typical soil sample taken from the pit bottom or sidewalls of the remedial excavation conducted within eastern portion of the covered storage area.

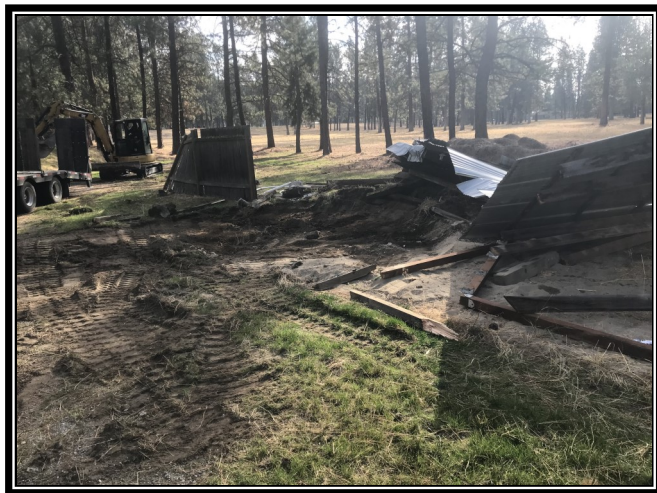
**Photograph #14: 10/22/20**

View of sloped excavation sidewalls and associated lean-to and fence debris after confirmatory soil sampling was completed.
