**REPORT:
VAPOR INTRUSION INVESTIGATION**

**FORMER CASCADE LAUNDRY
205 PROSPECT STREET
WHATCOM COUNTY PARCEL 380330111249
BELLINGHAM, WASHINGTON 98225
ECOLOGY FS ID: 21786898**

December 17, 2019

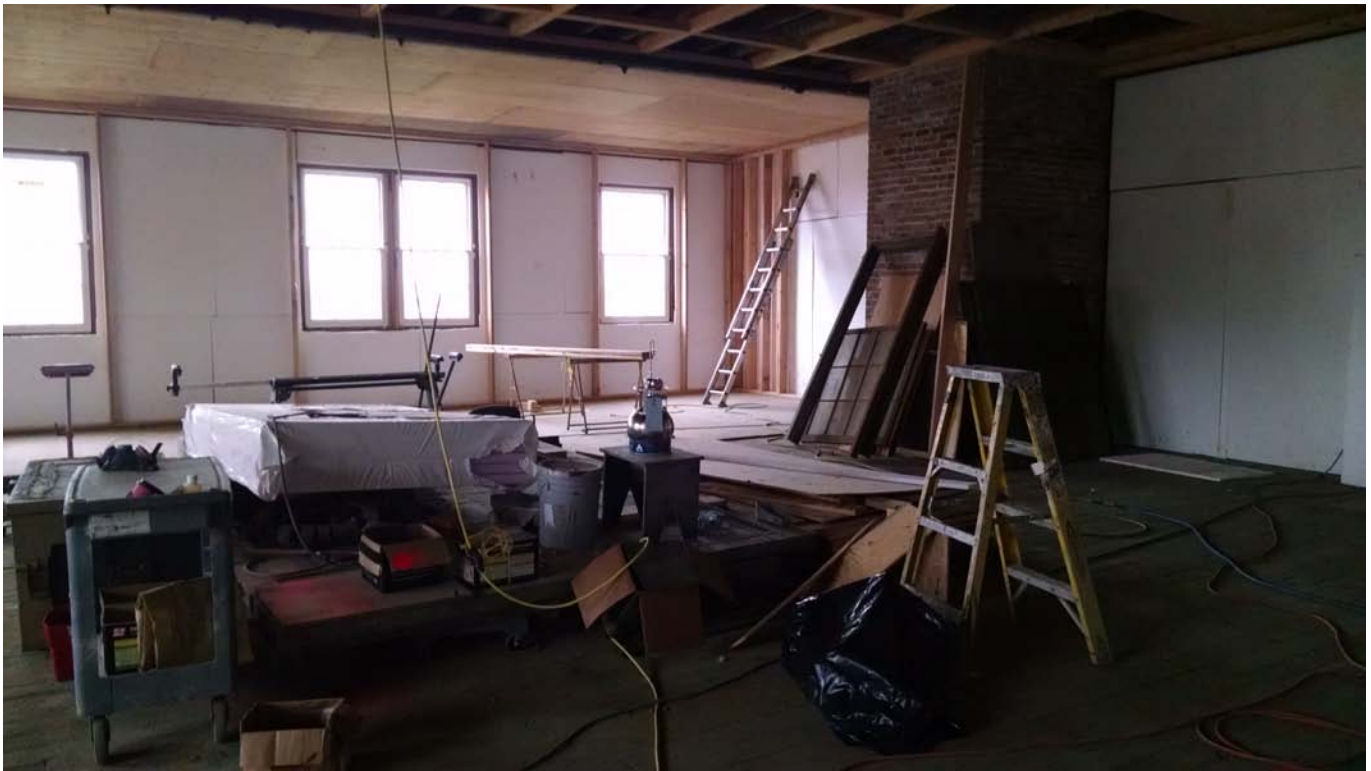
View of the indoor sampling location in the west end of the 2nd story of the building, Jan 2018 (map ID#1)

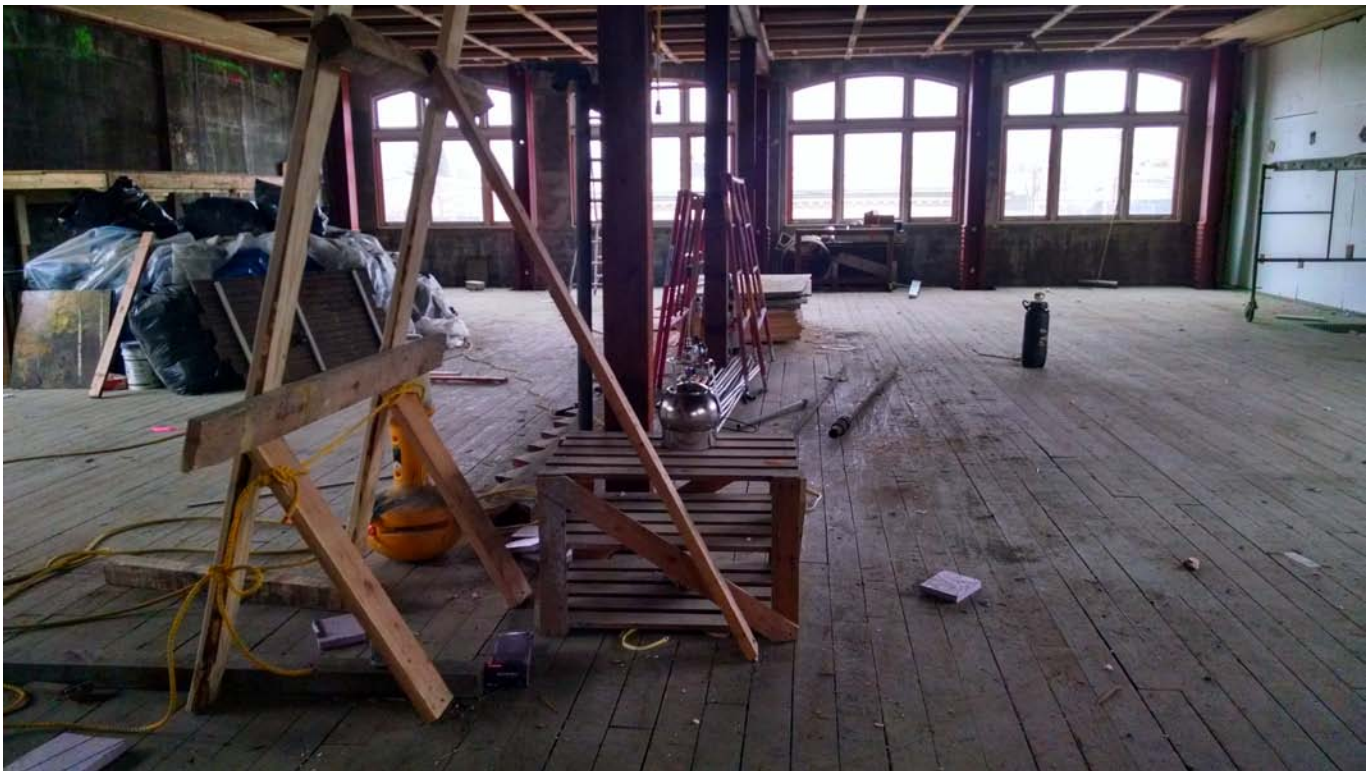
View of the indoor sampling location in the east end of the 2nd story of the building, Jan 2018 (map ID#2)

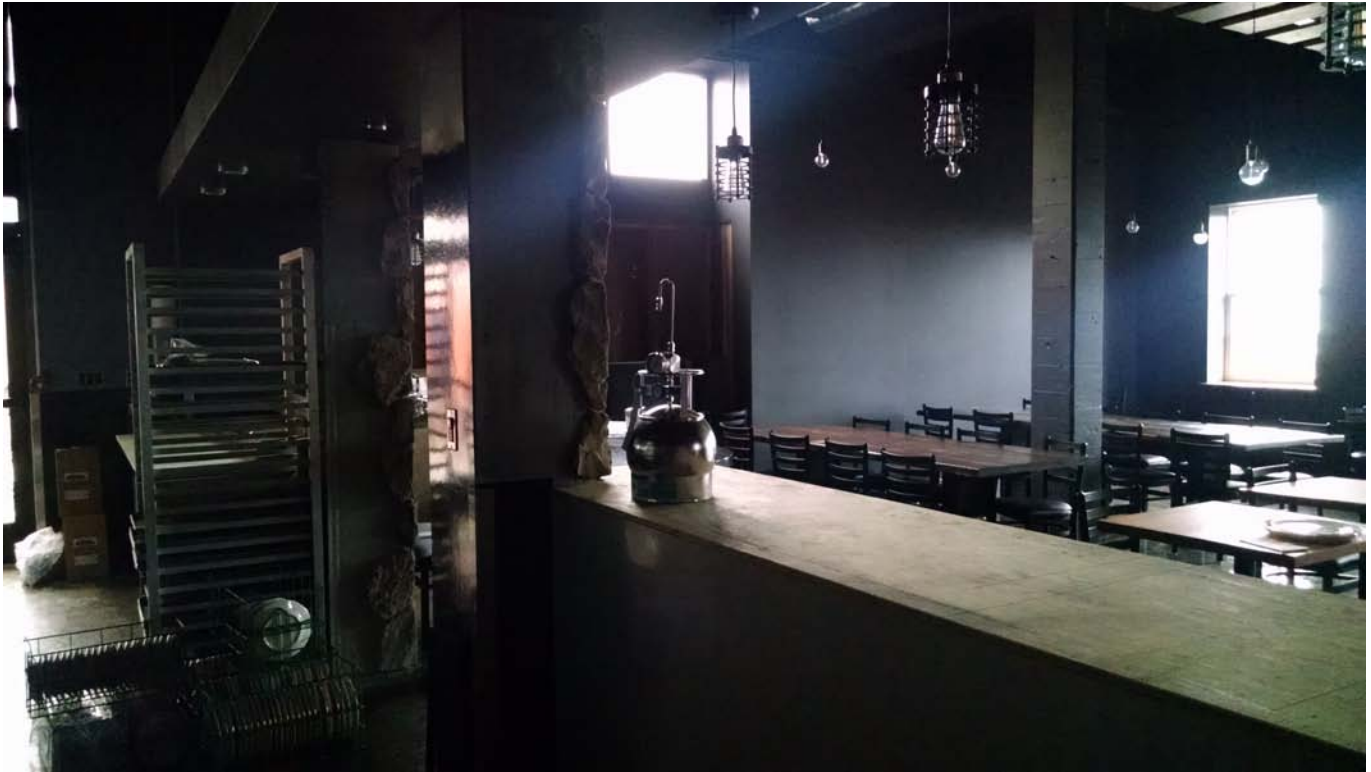
View of the indoor air sample location within the restaurant in the western portion of the main floor of the building (map ID#3). The restaurant is in process of remodel and has not currently in use, Jan 2018

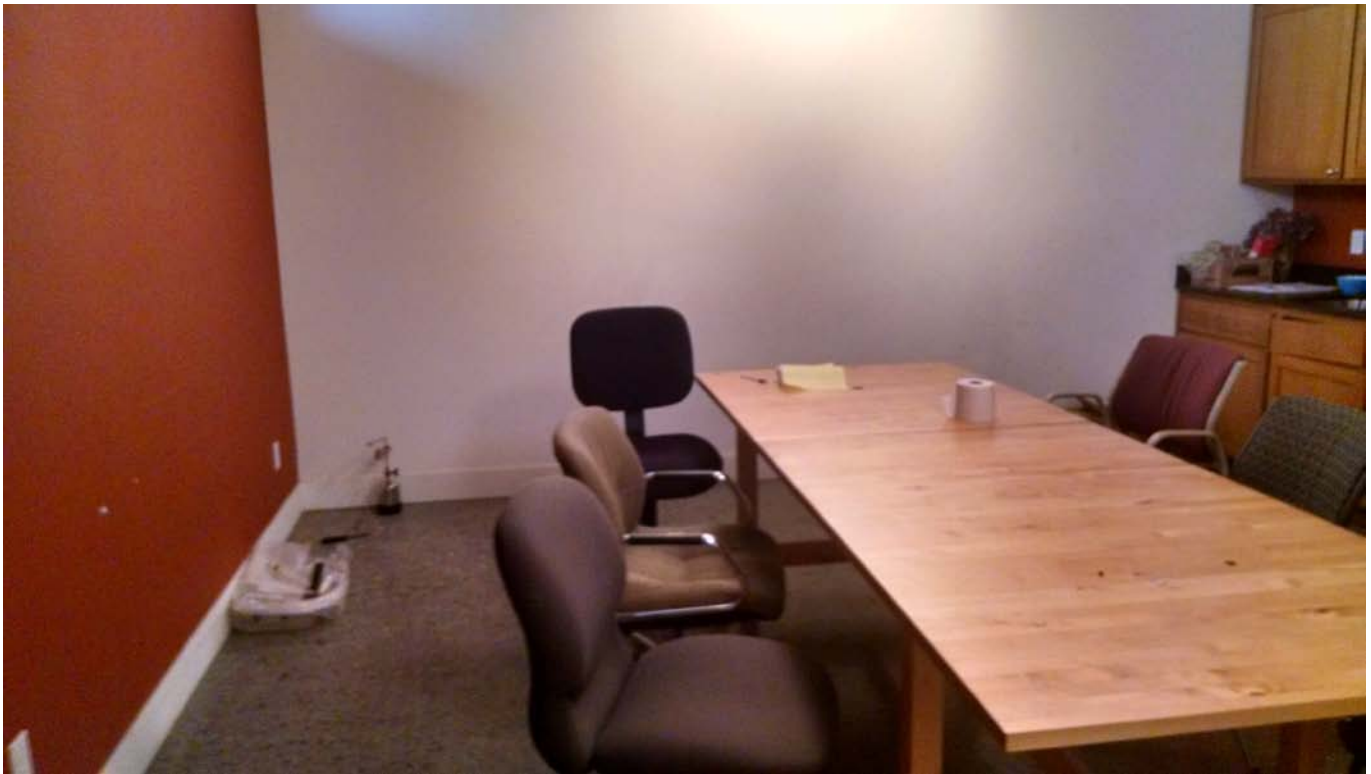
View of the sub-slab sample location within the conference room on the 1st floor (map ID#6), Jan 2018.
Indoor air and sub-slab sample collected from this location.

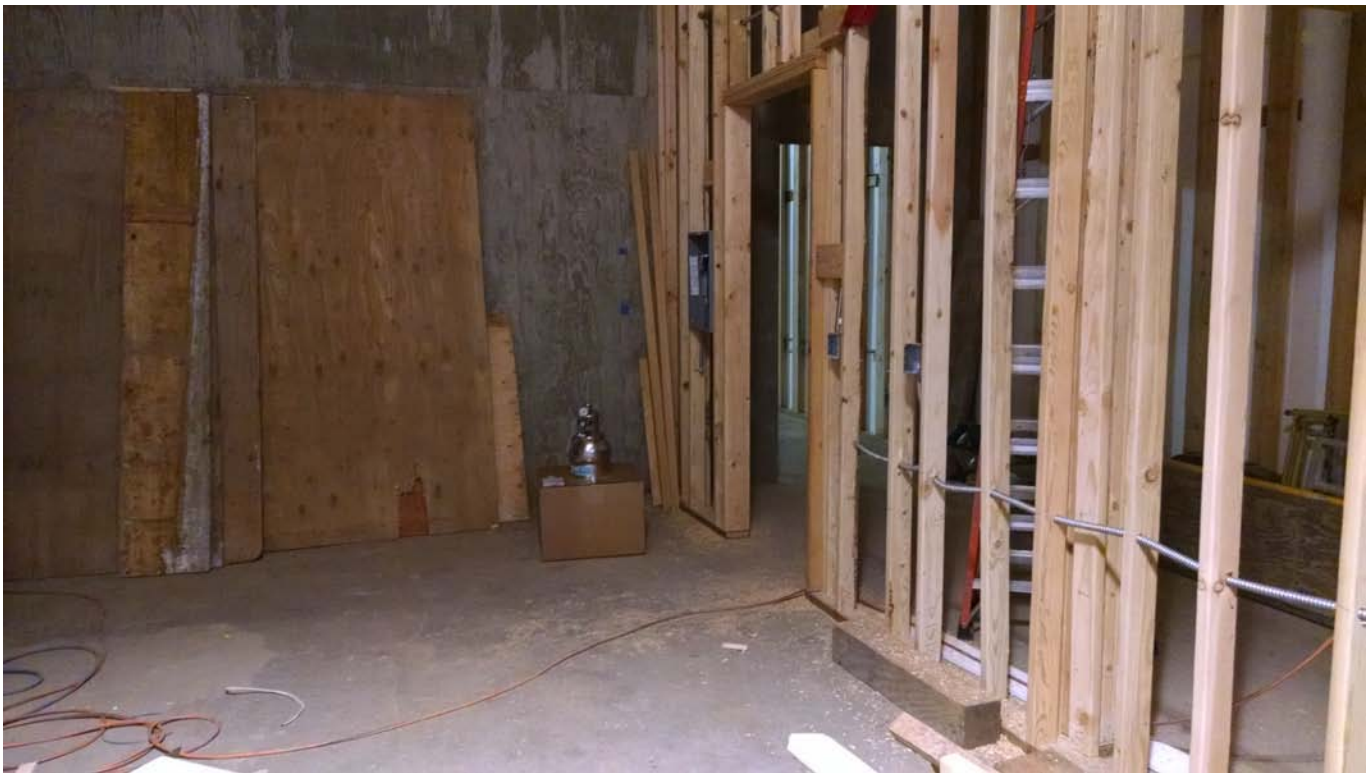
View of the indoor air sample location within the central portion of the main floor (map ID#7), Jan 2018.
Sub-slab sample also collected from this location.

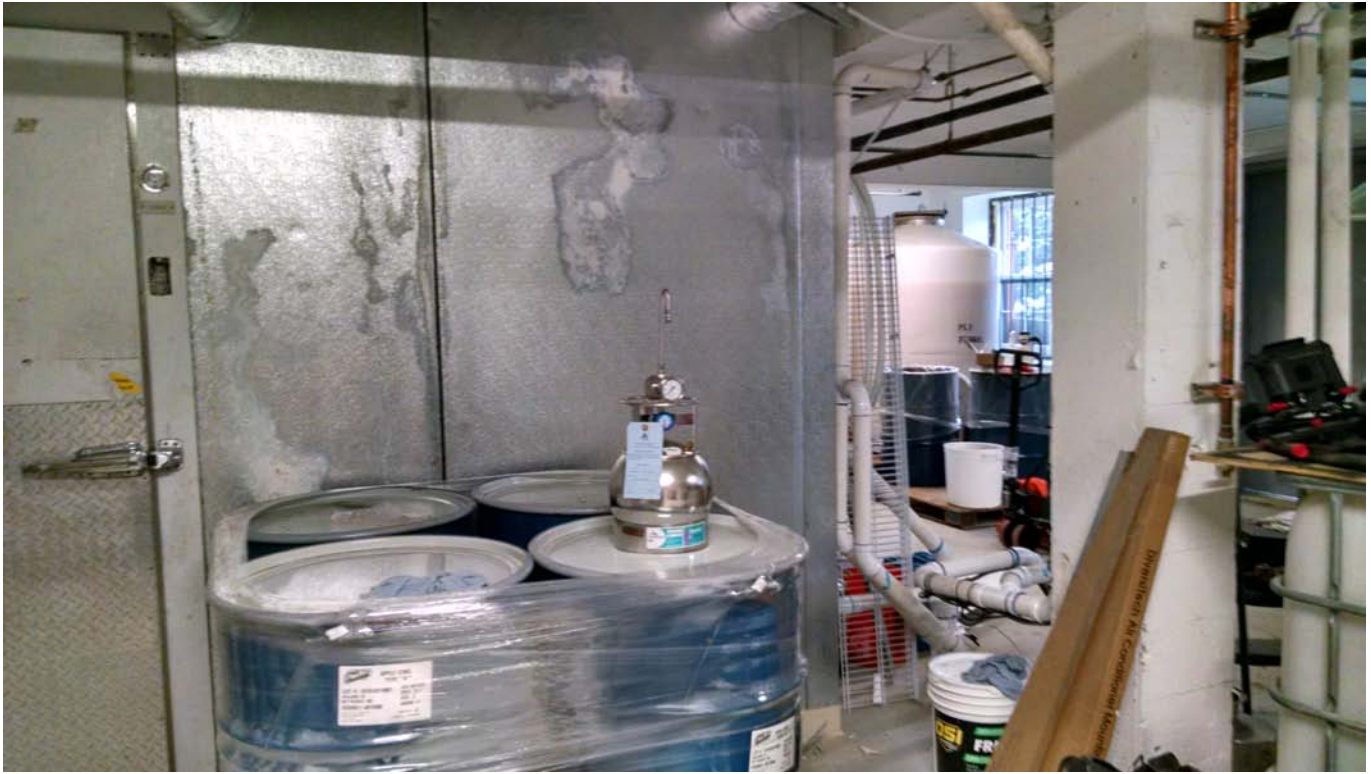
The concentrations of TCE and PCE in the basement sub-slab samples exceeded the screening levels. TCE was detected at $1,200 \mu\text{g}/\text{m}^3$, which is 100 times greater than the screening level of $12 \mu\text{g}/\text{m}^3$ for TCE. PCE was detected in the sub-slab sample from the basement at $11,000 \mu\text{g}/\text{m}^3$, which is 34 times greater than the screening level of $320 \mu\text{g}/\text{m}^3$ for PCE. Based upon the results, vapor intrusion is suspected as a contaminant pathway into the basement.

View of the indoor air sample location within the basement of the building, Jan 2018 (map ID#8).
Sub-slab sample also collected from this location

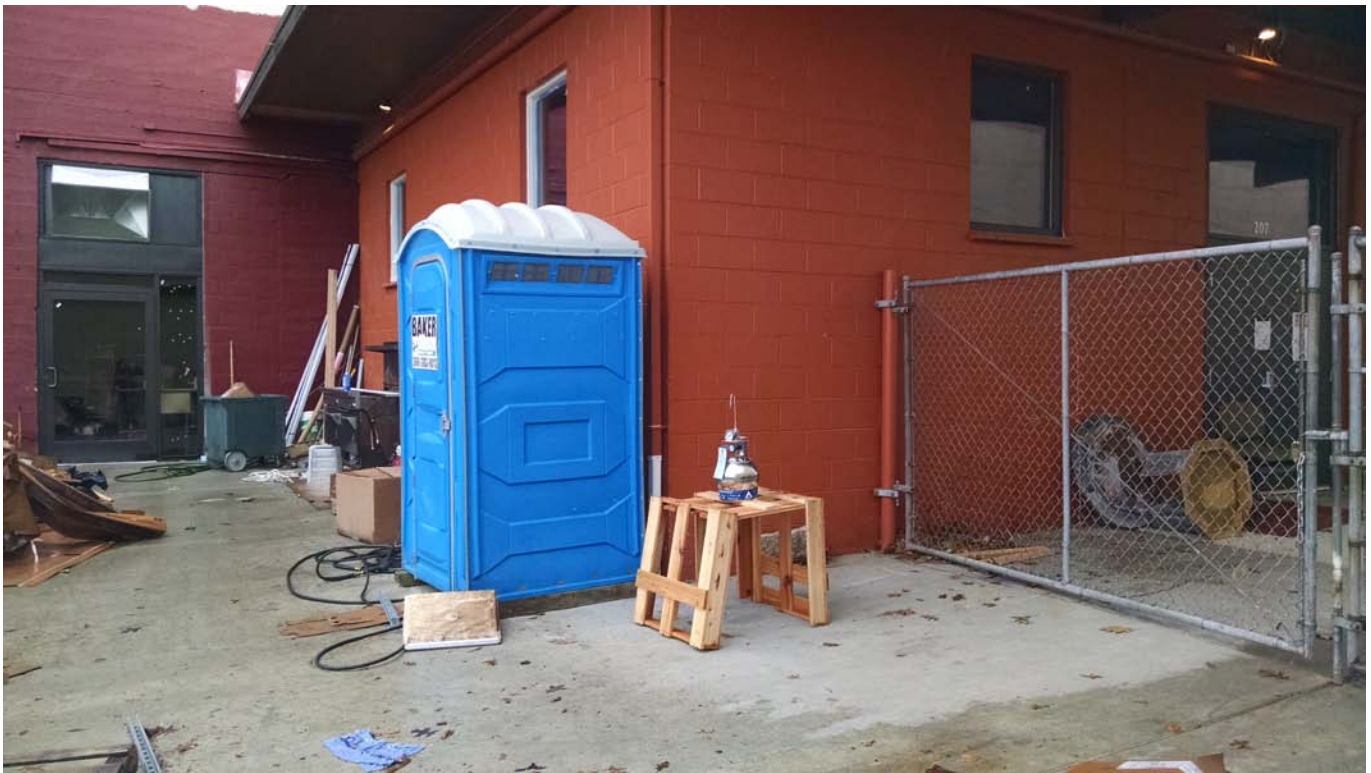
Benzene and carbon tetrachloride were detected in the ambient air sample, which was collected from the exterior of the site, near the southwest corner of the building during the January 2018 sampling event. The benzene concentration in the ambient air was measured as $0.57 \mu\text{g}/\text{m}^3$, which exceeds the indoor air cleanup value for residential use of $0.37 \mu\text{g}/\text{m}^3$. The carbon tetrachloride in the ambient air was detected at $0.39 \mu\text{g}/\text{m}^3$, which is just below the residential cleanup value of $0.42 \mu\text{g}/\text{m}^3$. Concentrations of TCE, PCE and chloroform were below the reporting limit in the ambient air sample.

View of the ambient air sample location near southwestern portion of building, Jan 2018 (map ID#9)
