**Preliminary Assessment for
Per- and Polyfluoroalkyl Substances**

Naval Station Everett and
Associated Special Areas
Everett, Washington

February 2021

Prepared for NAVFAC Northwest
by CH2M HILL, Inc.
Seattle, Washington
Contract N62470-16-D-9000
CTO N4425518F4117 (4117)

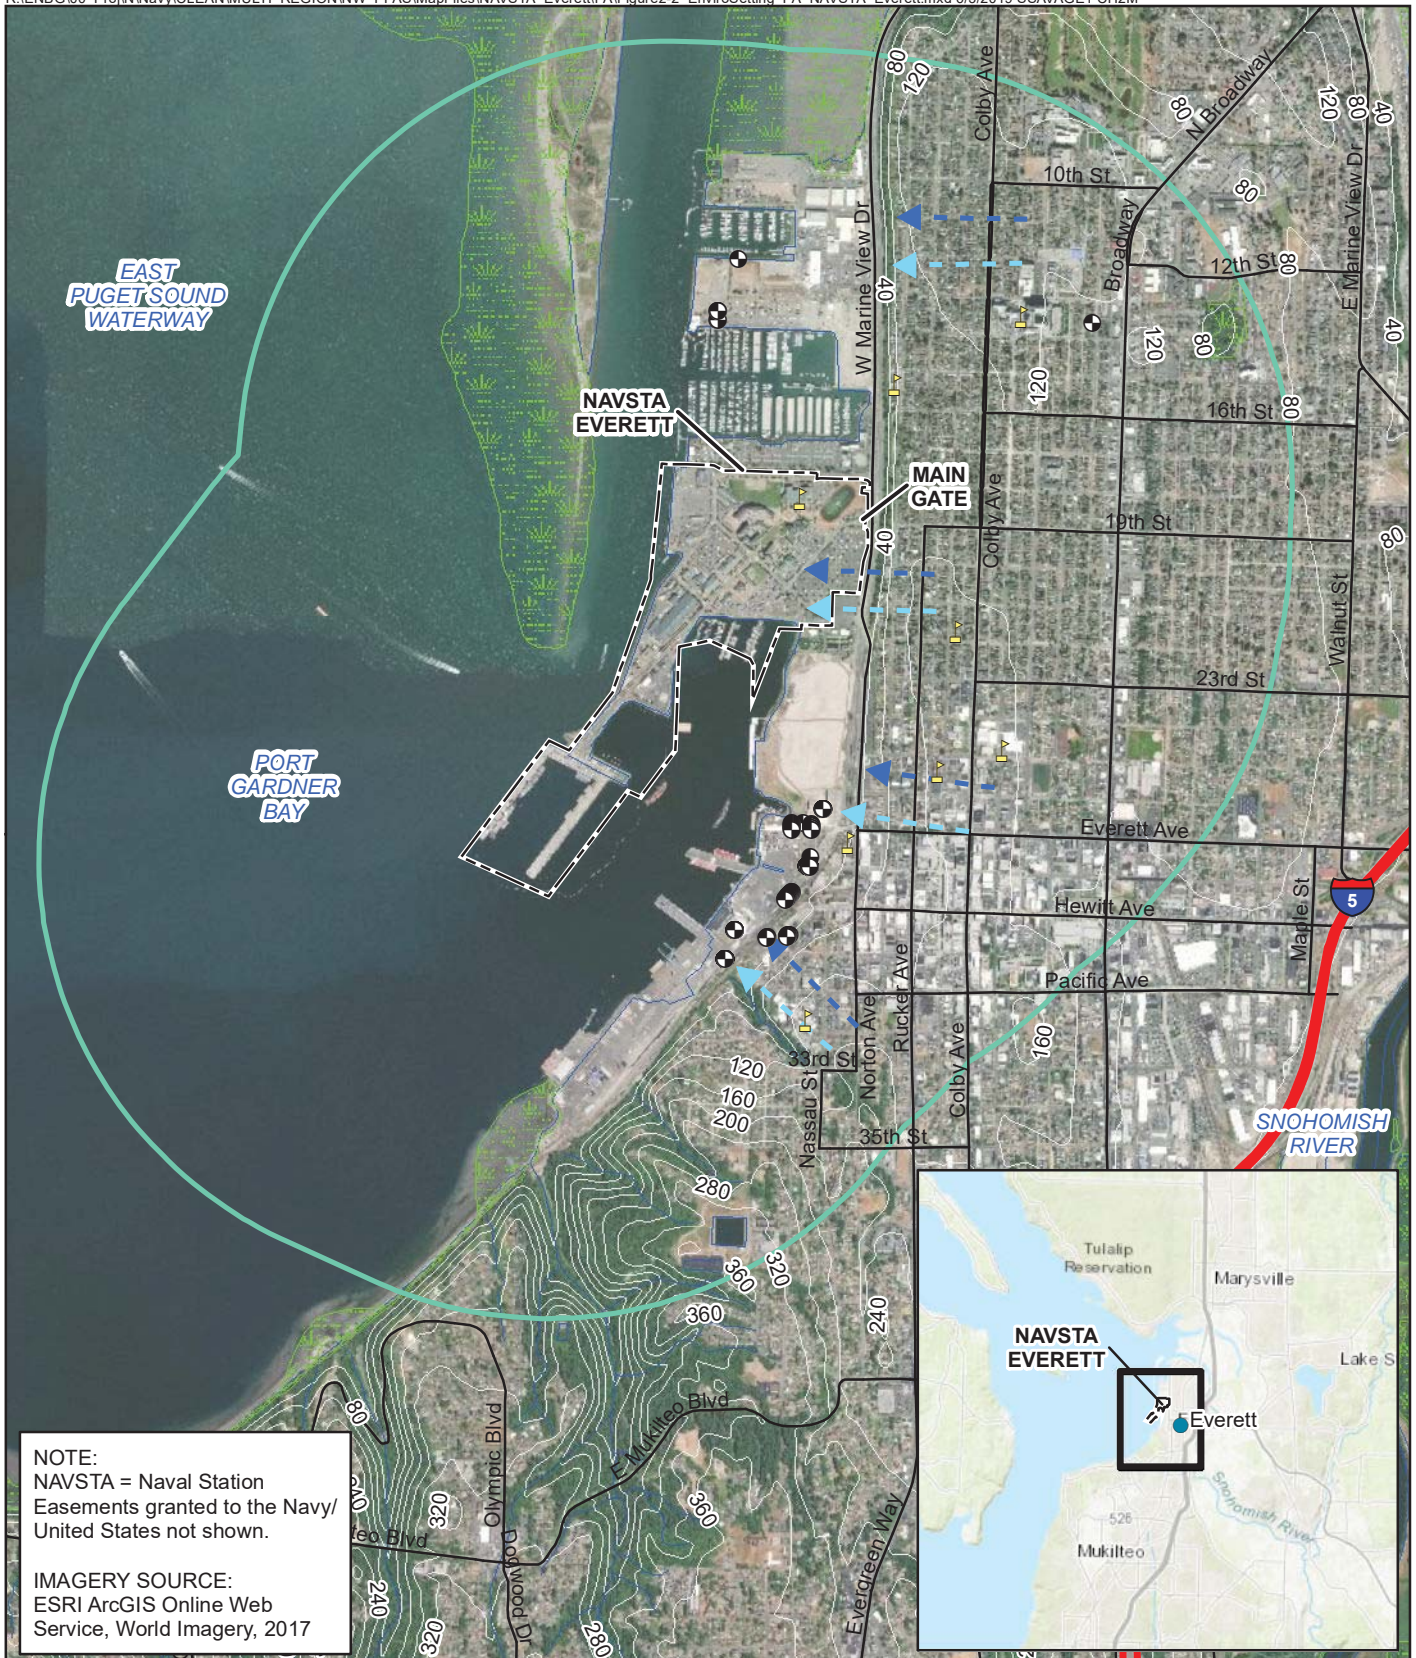
Figure 2-3
 Environmental Setting: NRS Jim Creek
 Preliminary Assessment for PFAS
 NAVSTA Everett, NRS Jim Creek,
 NRC Pacific Beach, Washington

- Active Drinking Water Well
- > Anticipated Groundwater Flow Direction
- > Anticipated Surface Water Flow Direction
- Surface Waterbodies
- 40' Topographic Contours
- Wetlands
- 1 Mile Installation Boundary Buffer
- Installation Boundary

NRS Jim Creek is located within a U-shaped valley that trends northwest-southeast (**Figure 2-3**). The valley is bordered by Ebey Hill to the northwest, Wheeler Mountain to the northeast, and Blue Mountain to the southwest (TEC, 2001). The geomorphology of the valley is the result of Pleistocene glacial activity. Bedrock is composed of metamorphic and igneous rocks including slate, phyllite, and graywacke (TEC, 2001). Cross sections of nearby areas to the north and south of NRS Jim Creek indicate that maximum depth to bedrock is 300 feet (Thomas et al., 1997). Valley fill sediments consist of talus, glacial moraine, landslide debris, and alluvial sand and gravel deposits with interbedded silt and clay. Landslides are common because of the low soil stability that is due in part to the presence of glacial sediments. However, there is no evidence of large-scale seismic activity (Malcolm Pirnie, 2006).

The primary water bodies at or near NRS Jim Creek are Jim Creek, Little Jim Creek, and Cub Creek (**Figure 2-3**). Jim Creek flows northwesterly through the installation. Little Jim Creek flows into Jim Creek near the eastern boundary of the installation. The on-Base reach of Cub Creek begins at the southwestern boundary of NRS Jim Creek in a wetland area south of Twin Lakes. From Twin Lakes, Cub Creek flows north to Cub Creek Reservoir and then into Jim Creek (Malcolm Pirnie, 2006). Both Jim Creek and Cub Creek are fed by numerous small spring and snow-fed streams (NEESA, 1990). Other minor water resources on the installation are LaBarge Lake and the Chain Lakes, all of which are within the Cub Creek watershed (Malcolm Pirnie, 2006).

Access to NRS Jim Creek is restricted to active military personnel, government employees, and government contractors. Jim Creek is surrounded by forest land in northwest Washington in Snohomish county, approximately 12 miles east of Arlington (**Figure 2-3**). The surrounding forest acts as a natural boundary separating the installation from surrounding civilian populations. A perimeter fence surrounds Jim Creek with access through the main gate located in the northwestern portion of the installation. The area surrounding Jim Creek is rural and is zoned either residential or commercial and agro-forestry. Because of the rural proximity of the installation, no high-use human receptor sites were identified within 1 mile of the Base boundary.

There are nine private drinking water wells within 1 mile of NRS Jim Creek (**Figure 2-3**), none of which are downgradient of any potential PFAS source areas. No complete exposure pathway has been identified for off-Base drinking water, and no emergency response action is warranted at this time.

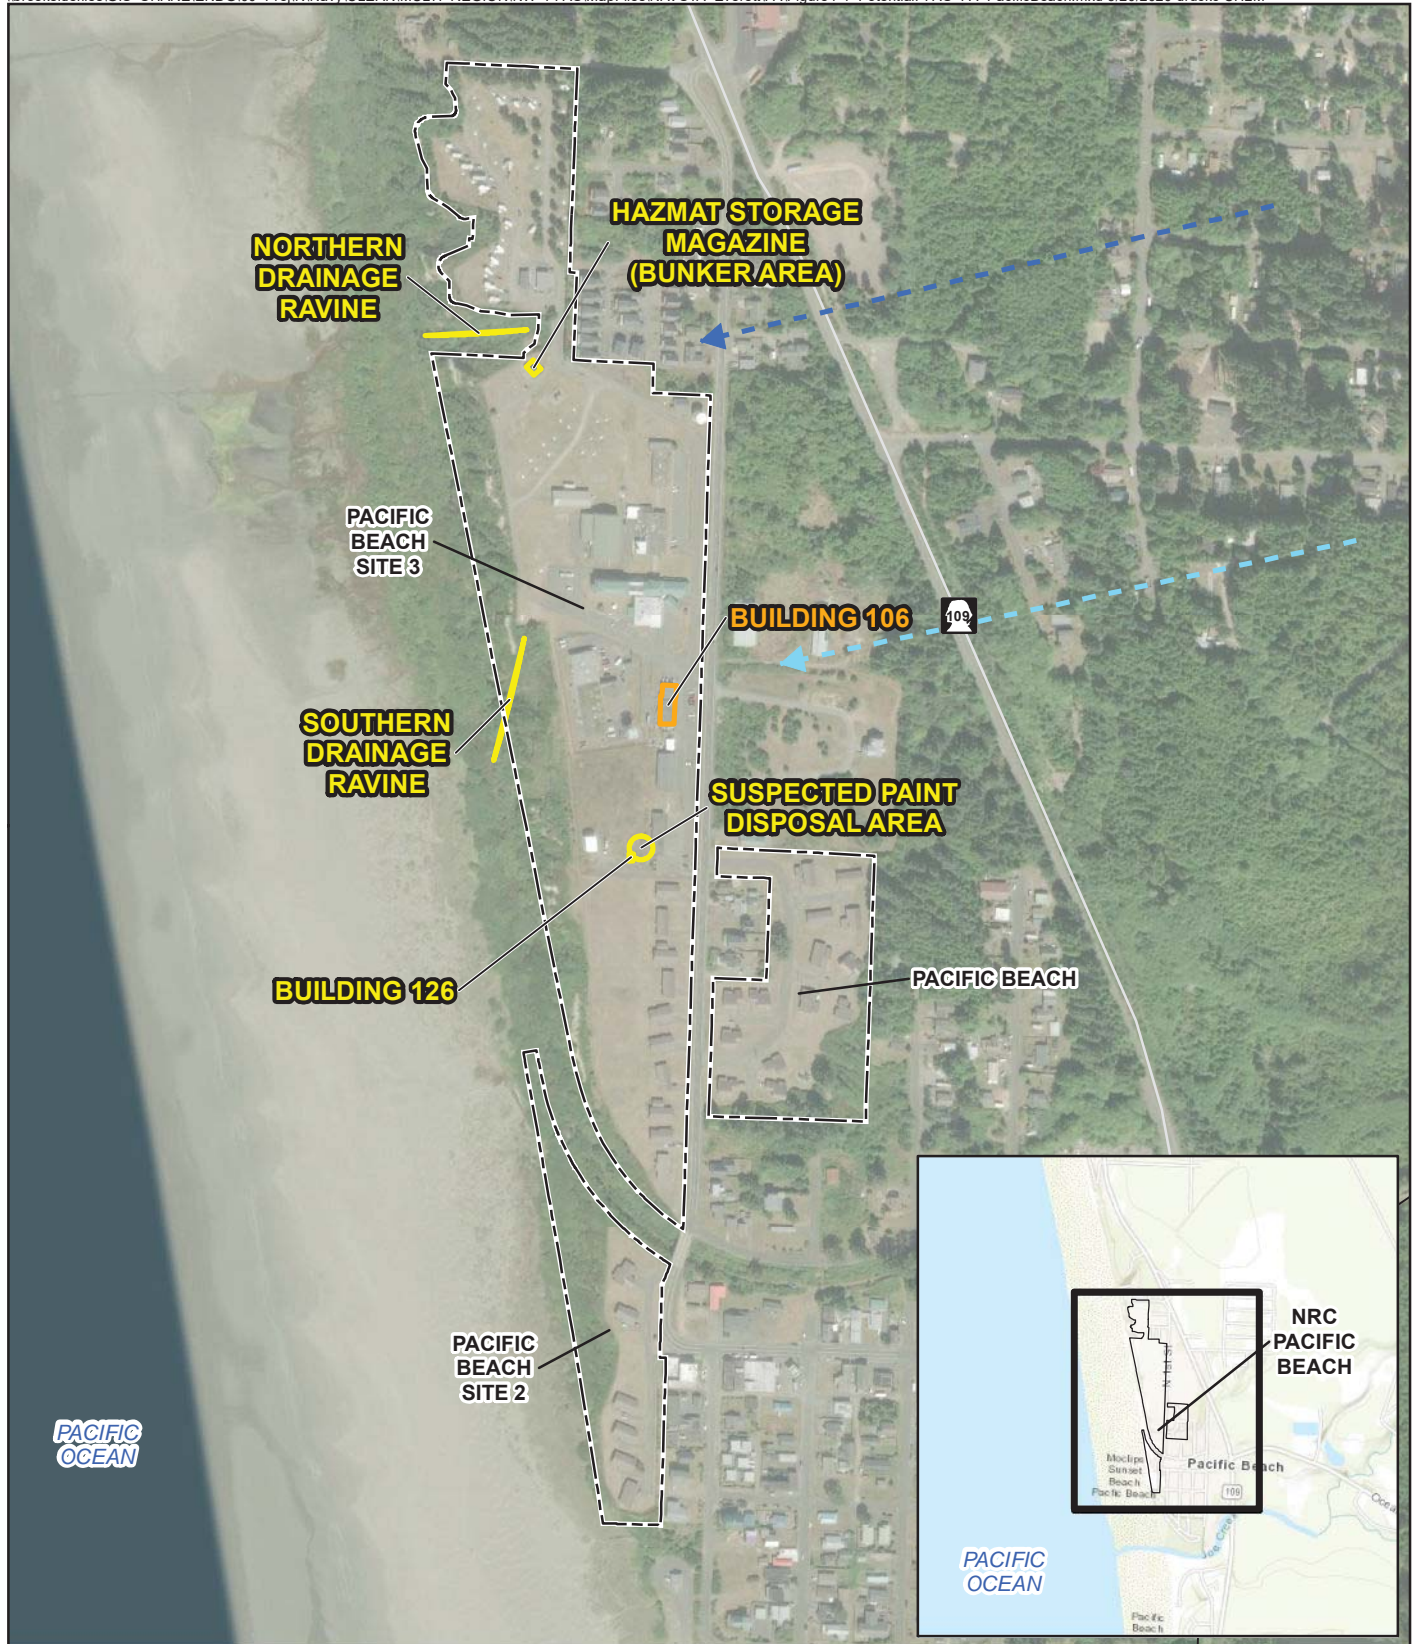
Figure 4-4
Potential PFAS Source Areas: NRC Pacific Beach
*Preliminary Assessment for PFAS
NAVSTA Everett, NRS Jim Creek,
NRC Pacific Beach, Washington*

There are no perennial streams, lakes or other surface water bodies at NRC Pacific Beach (**Figure 2-4**). The nearest major freshwater body is Joe Creek, which empties to the Pacific Ocean approximately half a mile to the south. Surface runoff is drained west toward the Pacific Ocean along two ravines referred to as the Northern and Southern Drainage Ravines. The poor drainage of the soil has contributed to the slope destabilization as subsurface flow is concentrated in the porous soil layers and finer material is gradually washed away. As a result, slope failure has been and continues to be a problem at Pacific Beach (NAVFAC, 2017).
