## **Second Periodic Review Spokane River Upriver Dam and Donkey Island PCB Sediment Site**

**Facility Site ID 65178472, Cleanup Site ID 4213**

**Toxics Cleanup Program, Eastern Region**

Revised September 2022

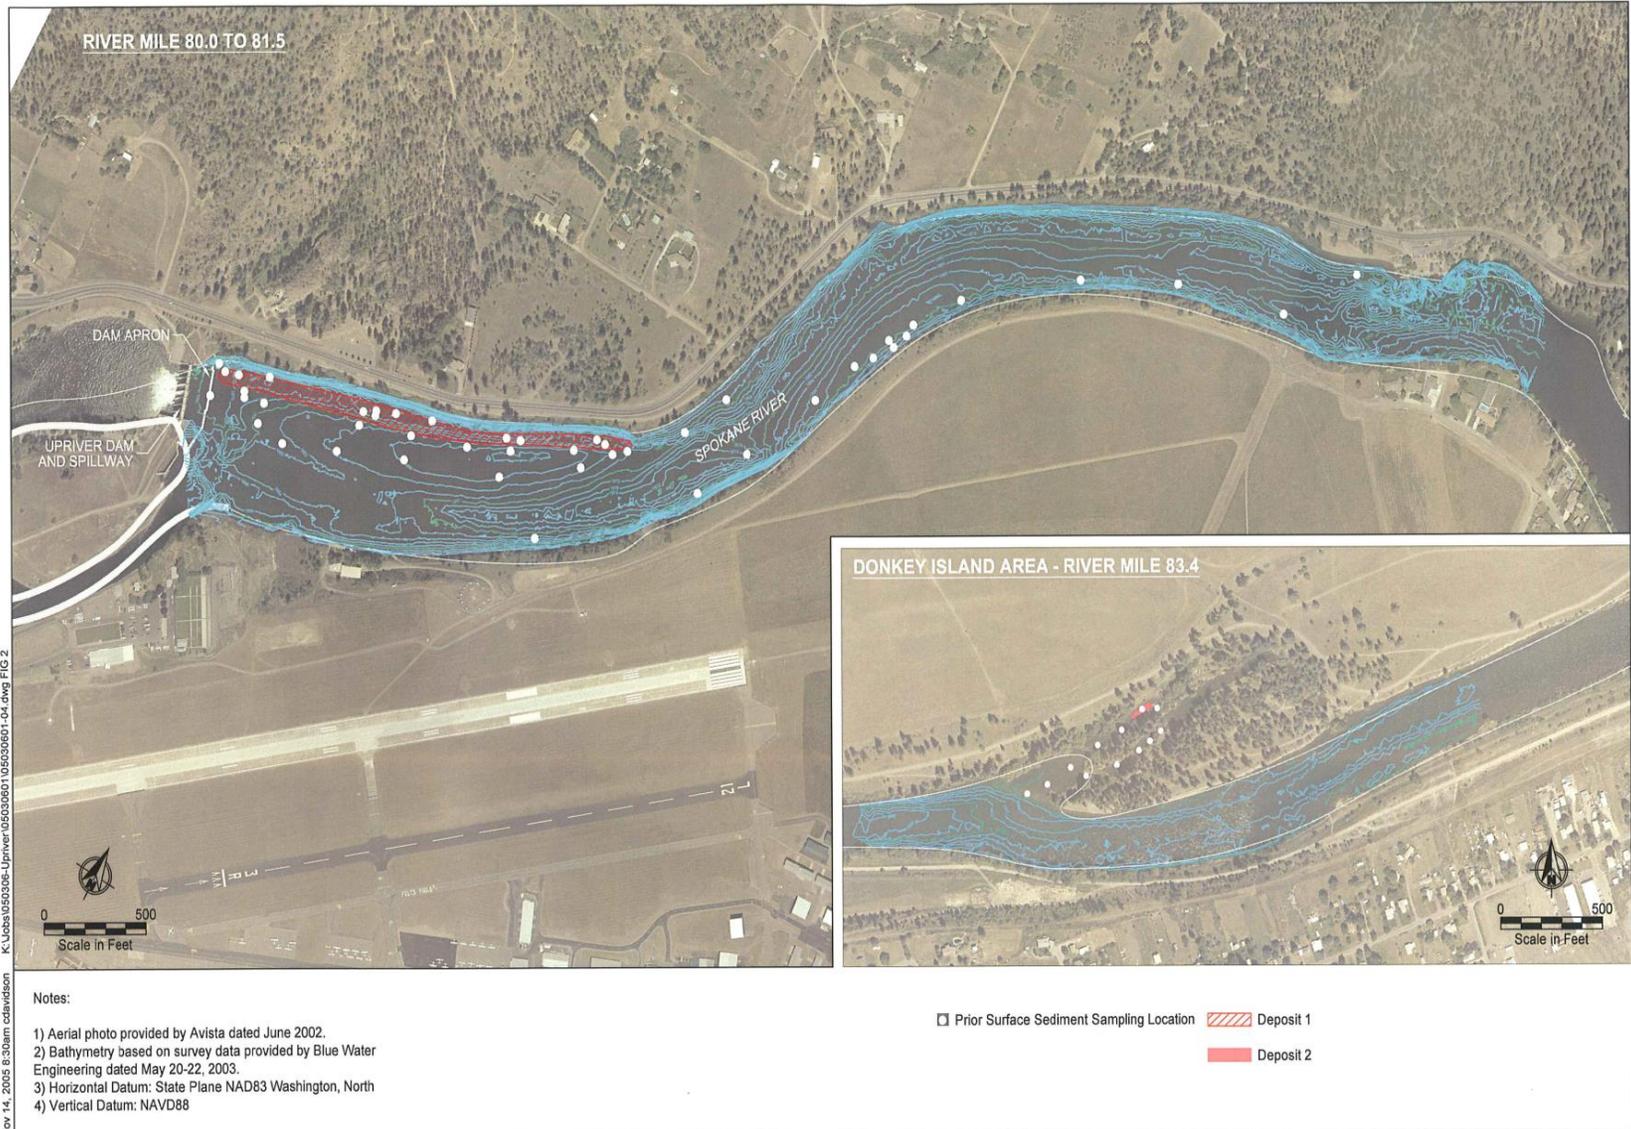
Figure 2. Overview of Site deposits 1 and 2, courtesy of Anchor Environmental, L.L.C.

*Deposit 1* – approximately 3.7 acres in deep water zones (20 to 25 feet below normal pool level) near the dam (approximately RM 80.1 to 80.6), containing dry-weight (dw) surface sediment PCB concentrations up to 1,430 micrograms per kilogram ( $\mu\text{g}/\text{Kg}$ ). Sub-surface sediments within the deposit contain PCBs at concentrations reaching 20 milligrams per kilogram ( $\text{mg}/\text{Kg}$ ). The contaminated sediments had accumulated in a channel depression formed by the river prior to dam construction. Preliminary ownership determinations at Deposit 1 indicate that portions of the deposit or land adjacent to the deposit along the bank are owned by the City of Spokane, while the principal underwater sediments of concern are believed to be located within the bed and banks of the river owned by the State of Washington, under the control of the DNR.

*Deposit 2* – a smaller (0.2-acre) shallow water area on the north bank side channels near Donkey Island (RM 83.4), containing surface sediment PCB concentrations up to 330 µg/Kg. The upland area is owned by the Washington Department of Parks and Recreation. Some submerged portions, as bed and bank of the river, may be owned by the State of Washington, under the control of DNR. Donkey Island is valuable riparian habitat that provides shelter for juvenile salmonids. Donkey Island is a highly heterogeneous environment consisting of areas that are only seasonally inundated as well as channels that have standing water throughout the year. The proximity of the two backwater channels to known spawning areas for trout and other species enhances the ecological importance of this area.

Two distinct fine-grain sediment deposits, containing co-located PCBs, are within the Site in areas owned by the City of Spokane, the Washington Department of Natural Resources (DNR), and the Washington Department of Parks & Recreation. See Appendix B: Figure 2.

The objective of the focused sediment sampling activities was to investigate other depositional areas immediately upstream of the dam apron to determine if surface sediments in such depositional areas contained hazardous PCB concentrations. Based on the bathymetric survey and video transect of the four suspect deposits, sediment samples from three areas were analyzed for PCBs. To characterize the extent of PCB contamination, sediment cores were used to profile the PCBs in the largest deposit (Figure 2).

Sediment samples from the three remaining areas suspected to contain PCB contaminants were collected in June and July 2003. Additional sampling efforts were conducted in July 2004 to further delineate the contaminated sediment deposits identified by earlier sampling events. Specifically, sediment samples were collected from the large deposit immediately upstream of the dam, the two backwater channels of Donkey Island, and a small deposit on the south side of the riverbed. These three deposits suspected of containing elevated PCBs were evaluated in the Remedial Investigation and Feasibility Study (RI/FS). Sampling efforts enabled Ecology to select the deposits with elevated PCB levels. Two of the three deposits sampled contained PCB concentrations exceeding Ecology's selected cleanup levels and are discussed below and depicted in Figure 2.
