Lower Duwamish Waterway RM 4.2 to 5.8 West (Restoration Areas)

Summary of Existing Information and Identification of Data Gaps

July 2013

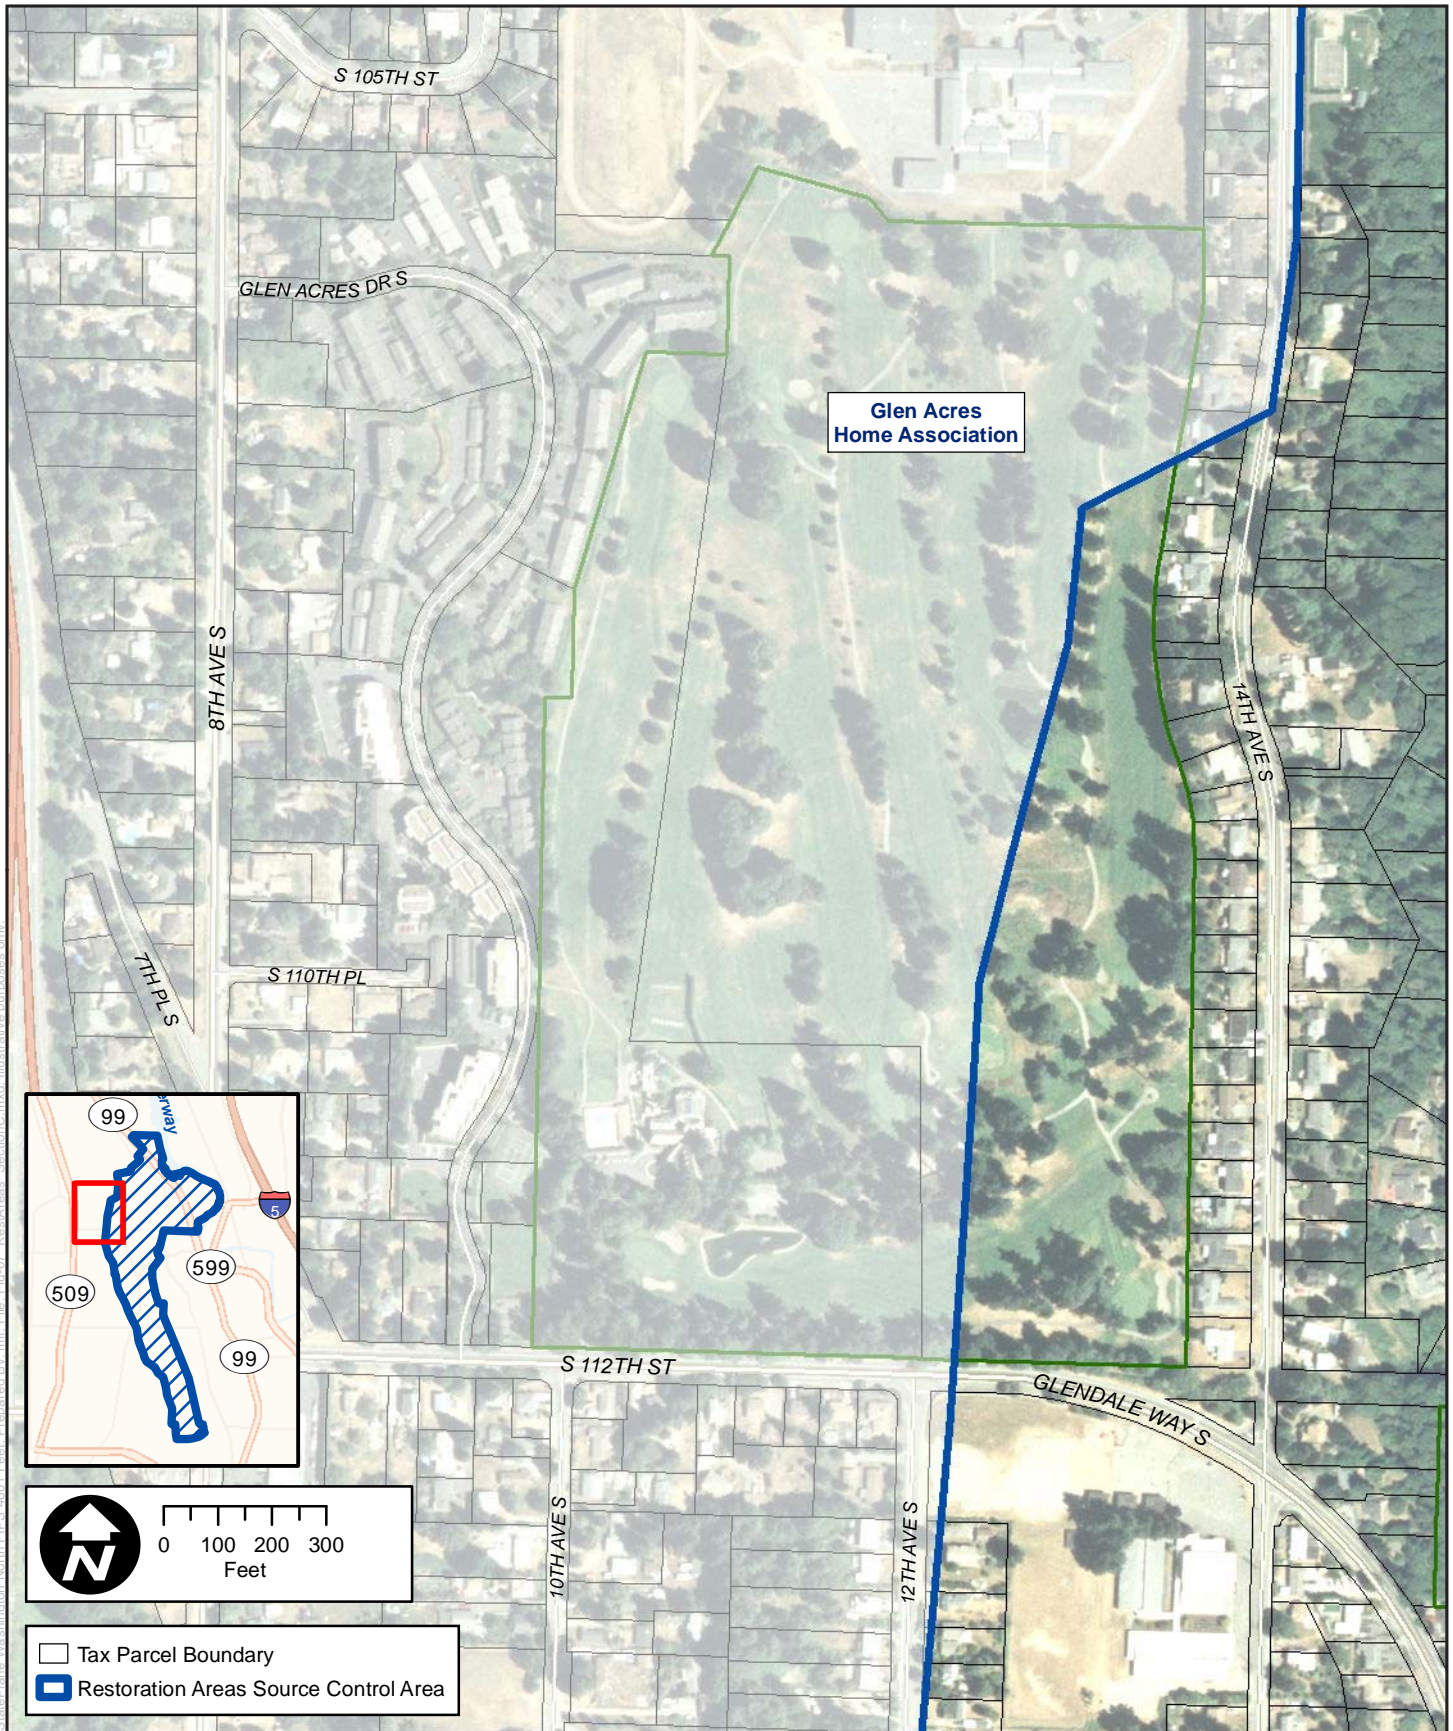
Coordinate System: NAD_1983_StatePlane_Washington_North_FIPS_4601 Feet; Prepared By: mlf; File: Fig_06_RestAreas_SectionB.mxd; Illustrative purposes only.

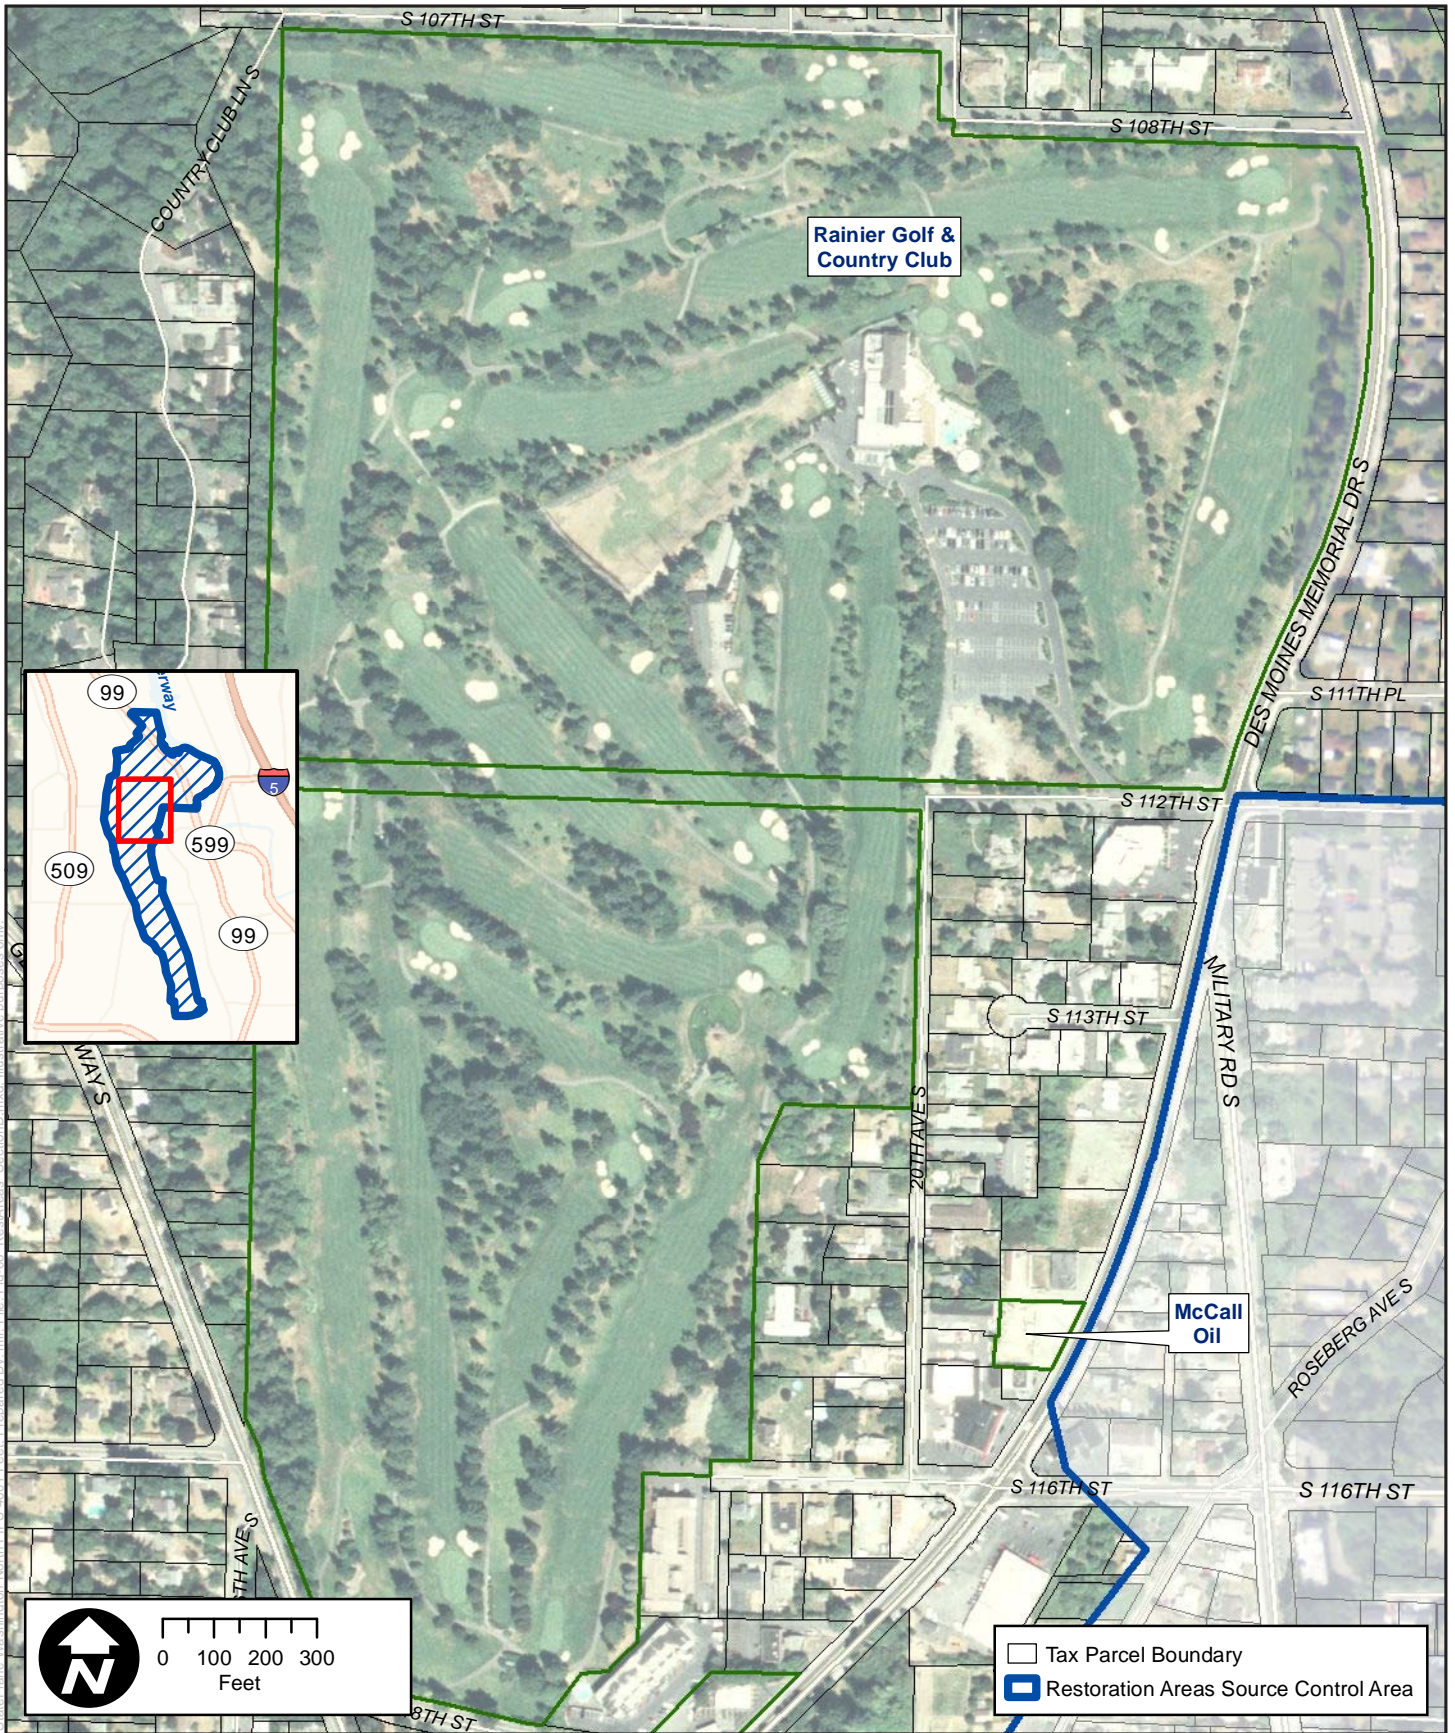
Figure 7. Restoration Areas Source Control Area (Section C)

Coordinate System: NAD_1983_StatePlane_Washington_North_FIPS_4601 Feet; Prepared By: mlr; File: Fig_07_RestAreas_SectionC.mxd; Illustrative purposes only.

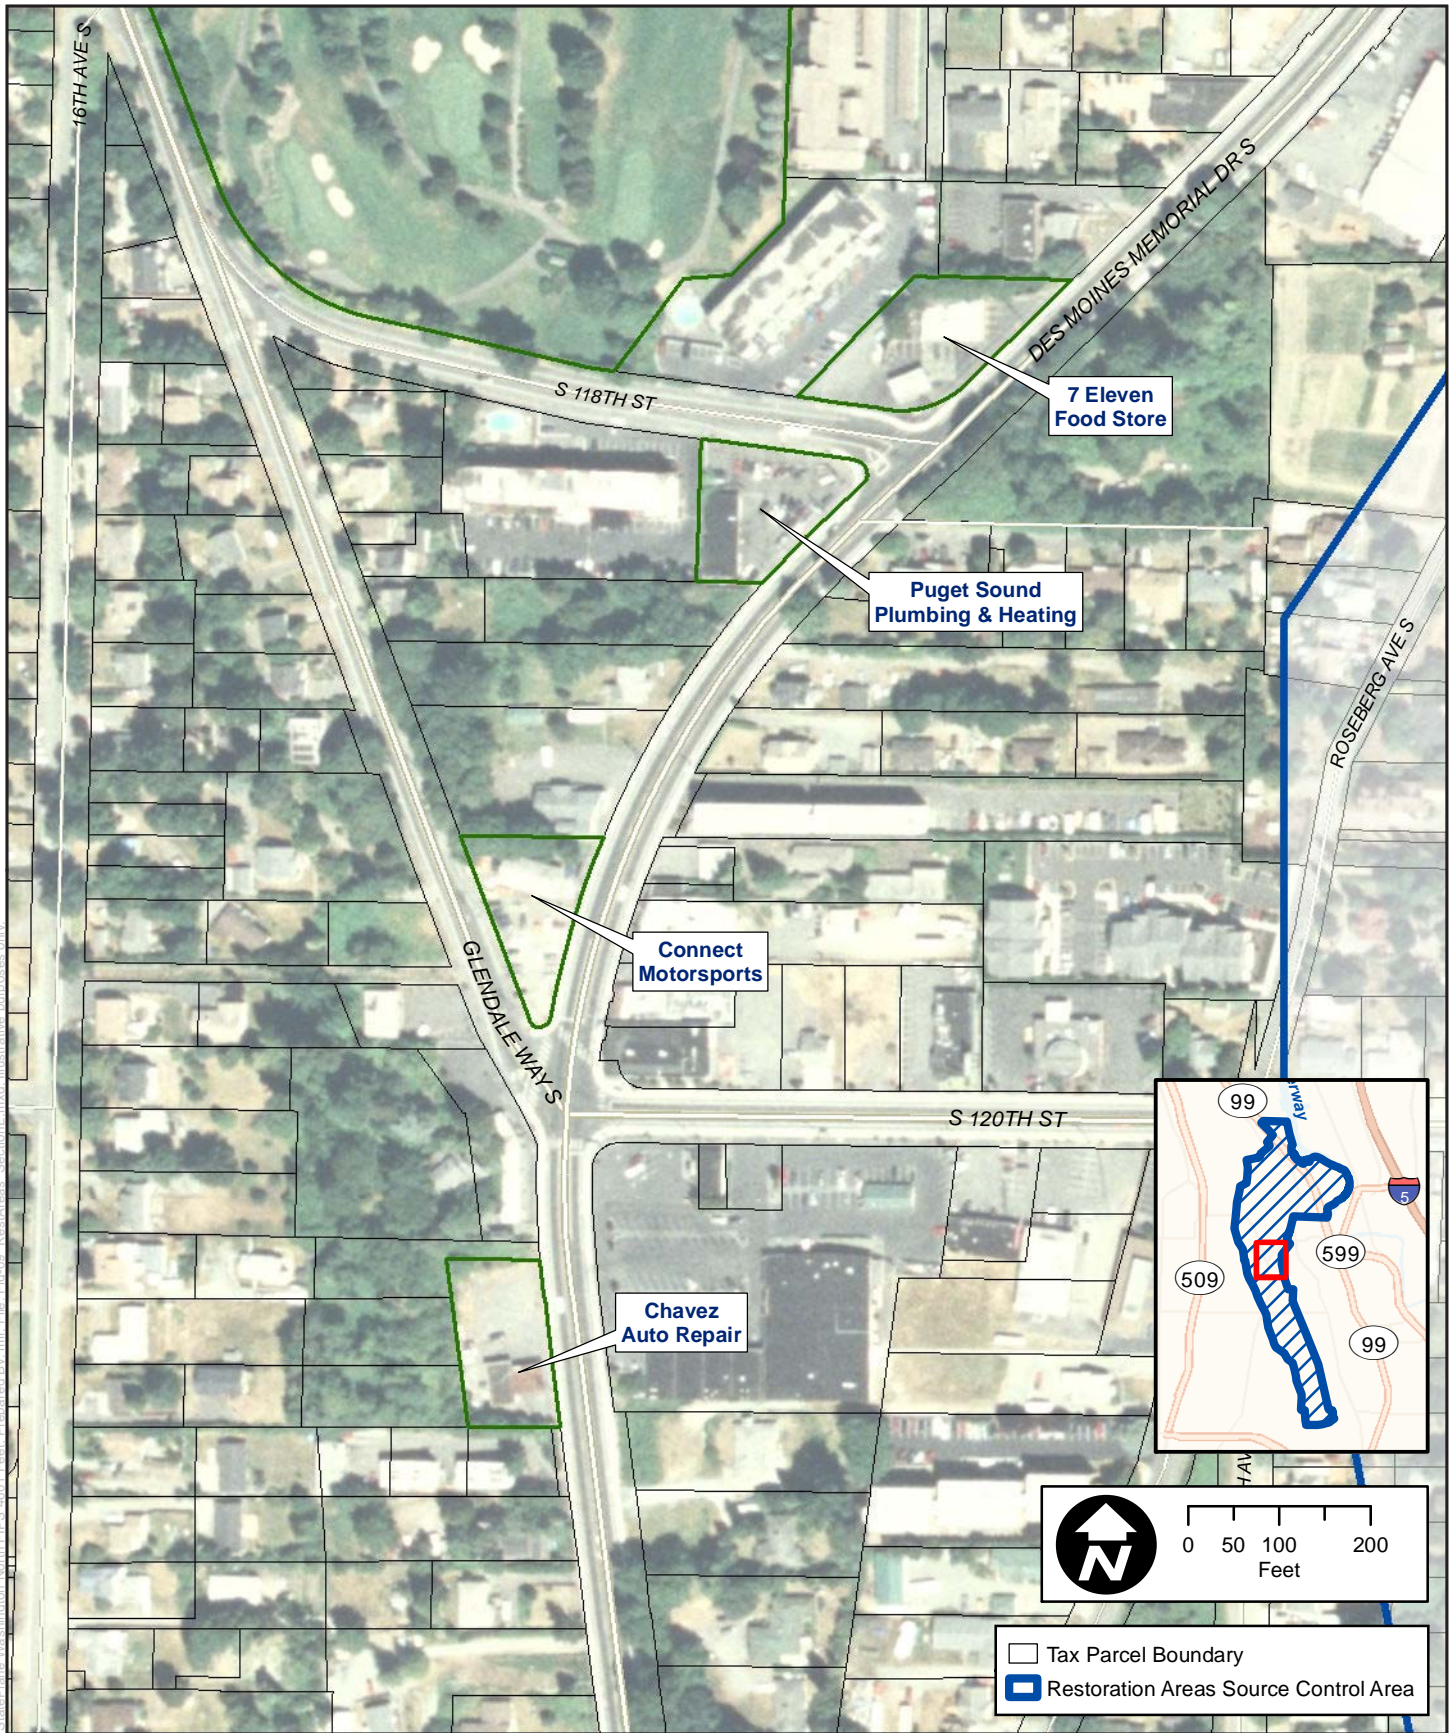
Figure 8. Restoration Areas Source Control Area (Section D)

Coordinate System: NAD_1983_StatePlane_Washington_North_FIPS_4601; Feet; Prepared By: mlf; File: Fic_08_RestAreas_SectionD.mxd; Illustrative purposes only.

Rainier Golf & Country Club is located approximately 1,500 feet southwest of the LDW. The property is bordered by S 107th Street to the north, Des Moines Memorial Drive and 20th Avenue S to the east, Glendale Way S to the south, and 14th Avenue S to the west. Residential properties surround the golf course (Figure 8).

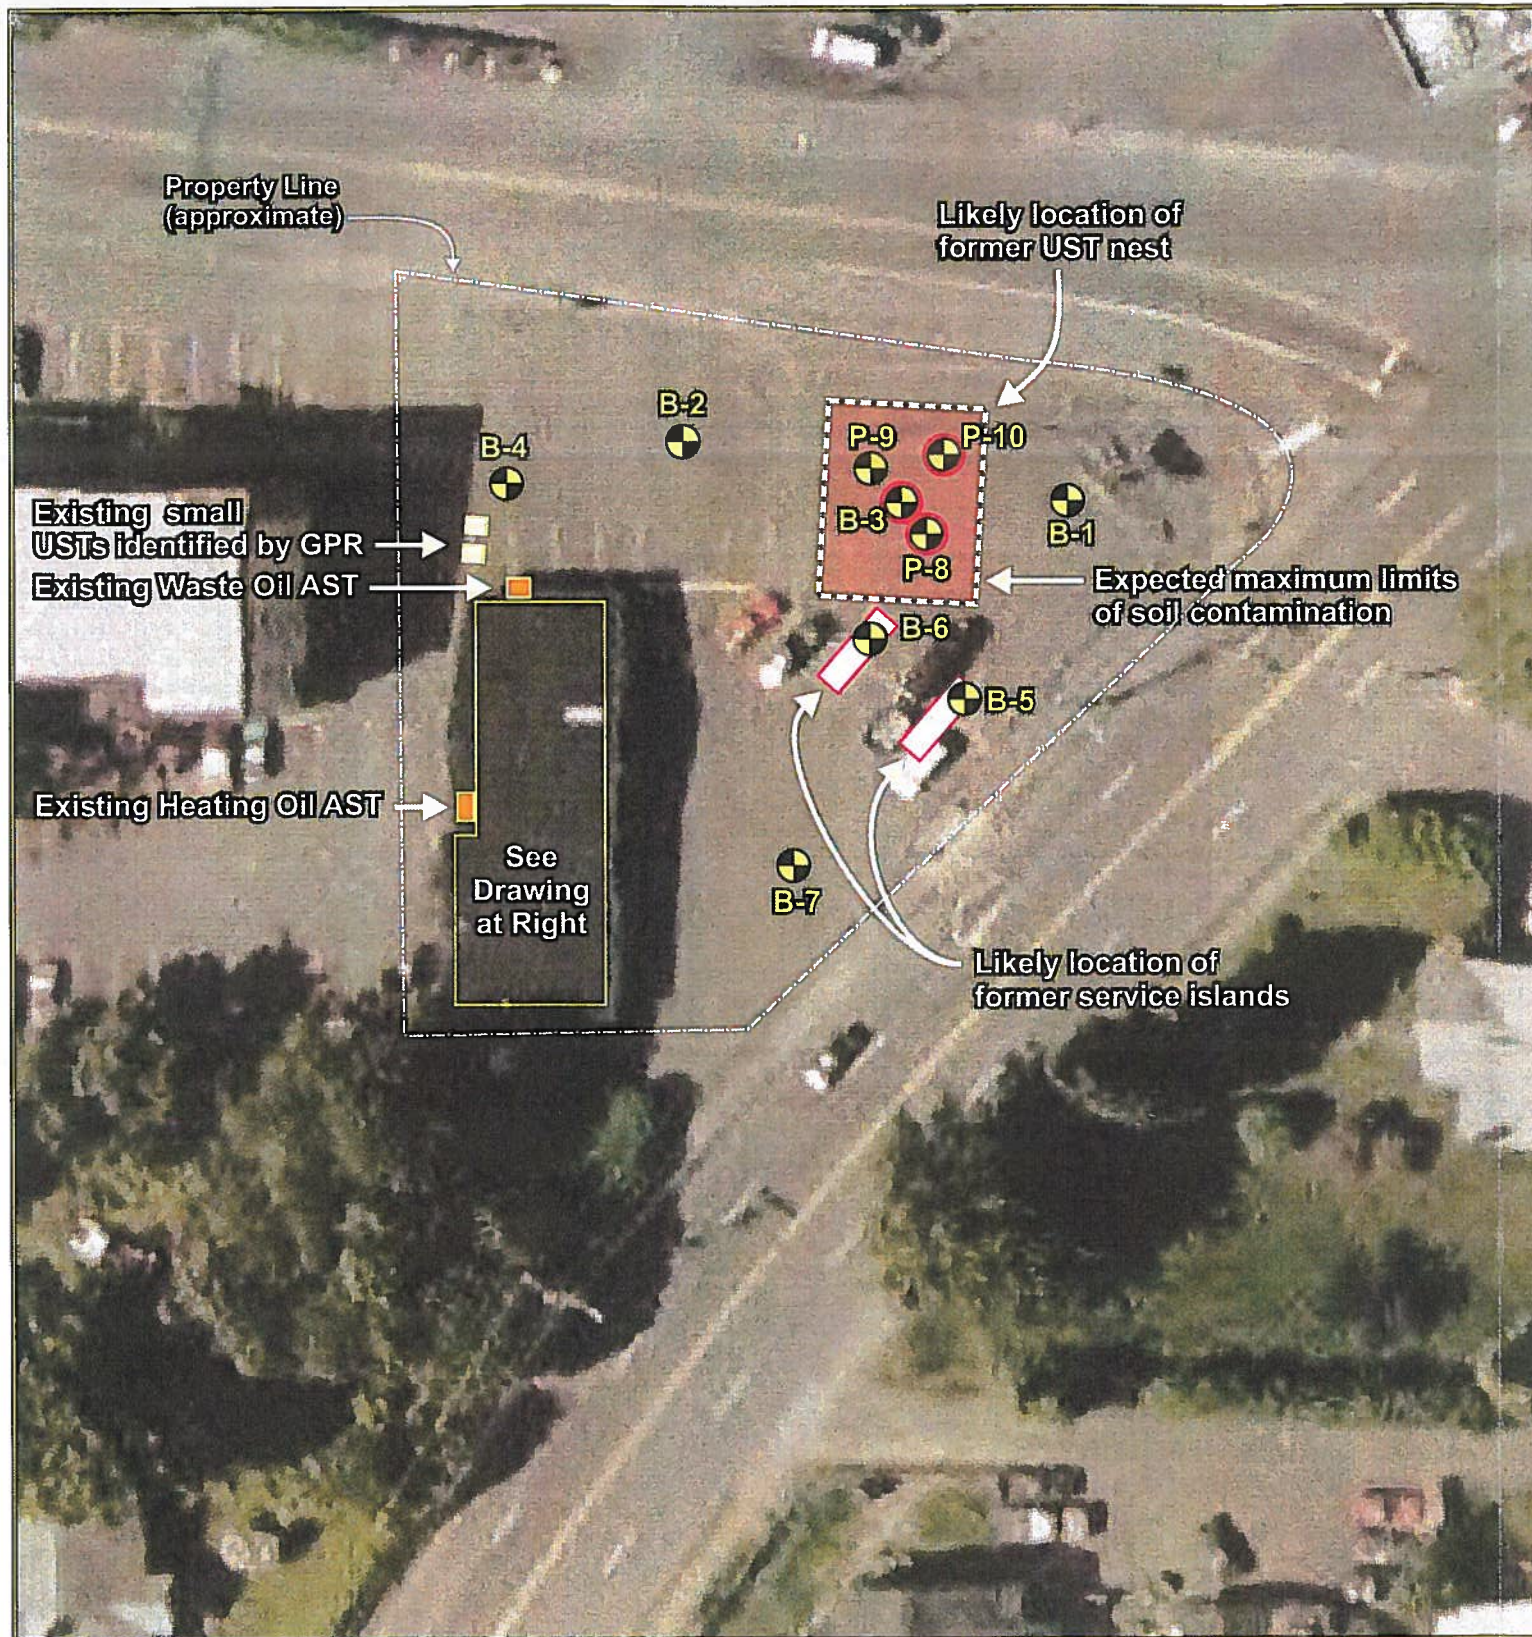
Explorations In and Near the Building

- Likely location for former UST nest
- Former Service Island Locations
- UST locations confirmed by Ground Penetrating Radar
- AST Locations
- Boring Location
- B-1 P-3
- HA-1 Hand Auger Exploration Location
- Exploration location symbols are circled in red where MTCA Method A Cleanup Levels are exceeded

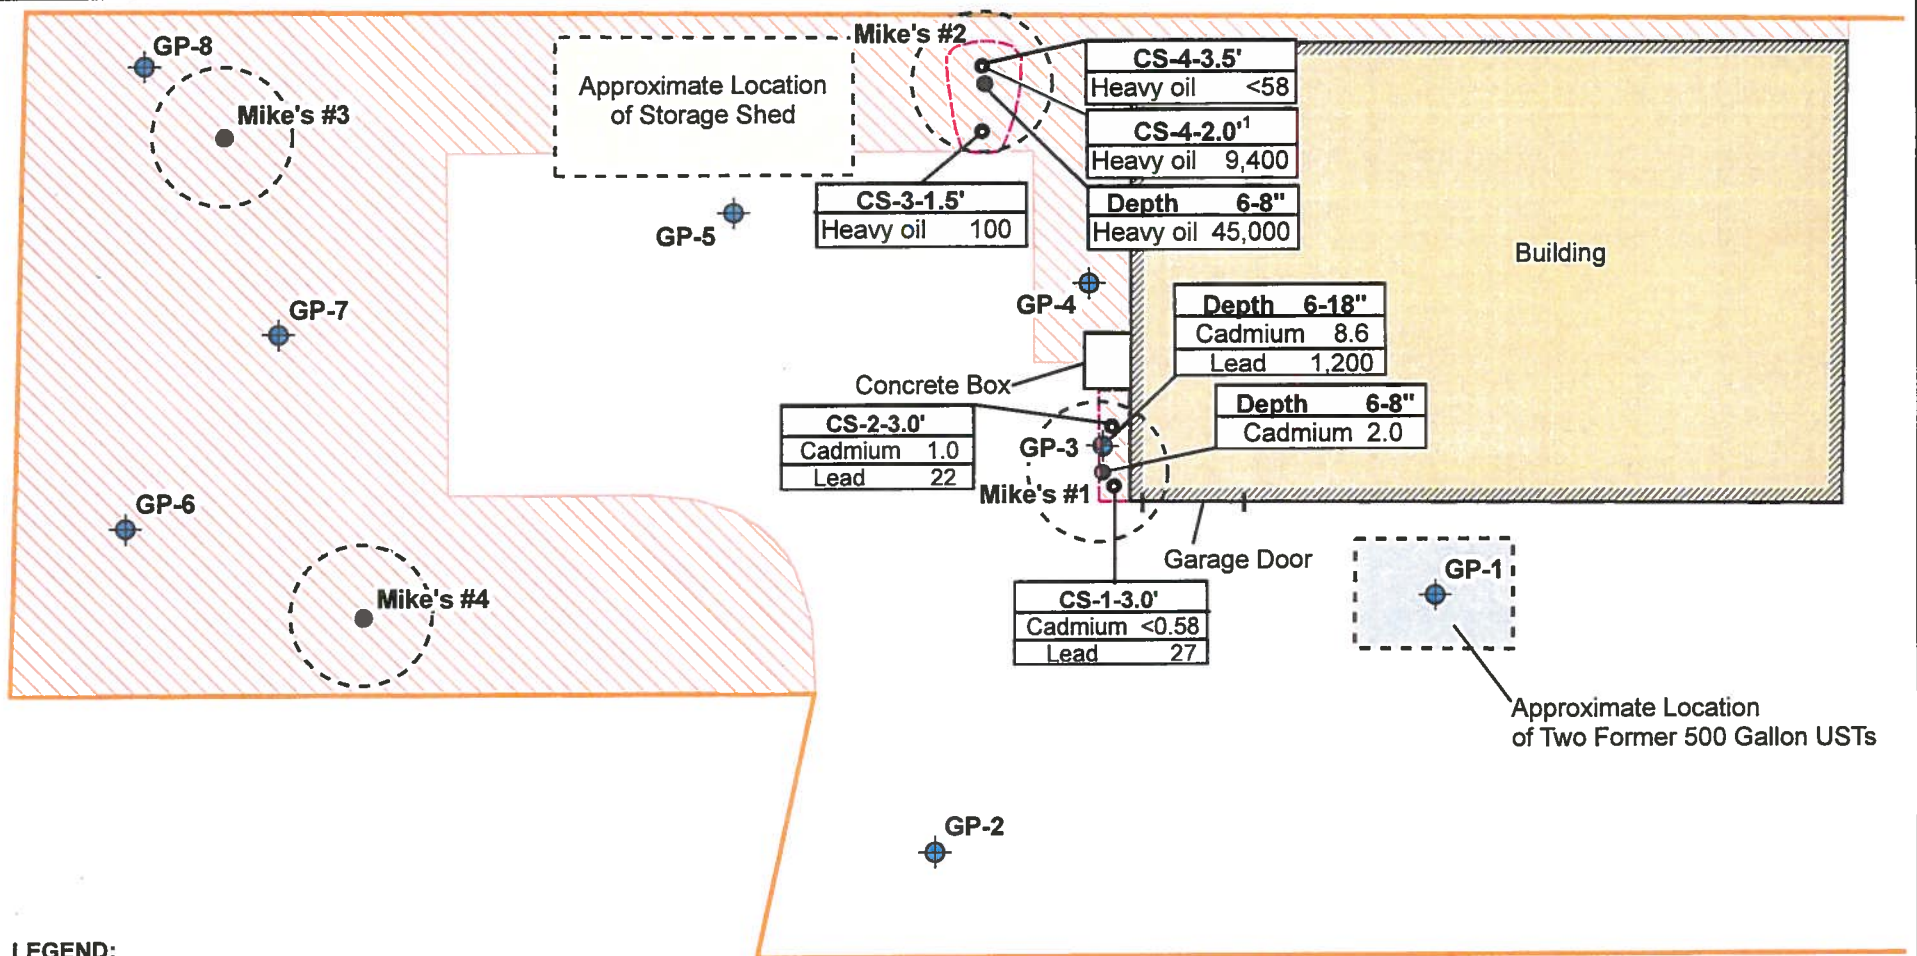
- Confirmation Sample Location, Geomatrix Consultants, June 9 and 20, 2005
- GP-1 ● Direct Push Location, Geomatrix Consultants, April 2005
- Mike's #1 ● Approximate Surface Sample Location, King County Health Department, November 2000 (Dashed Circle Indicates Estimated Location)
