VCP SITE CLOSURE REPORT
Former Ballard Auto Wrecking
Seattle, Washington

Prepared for: Washington State Dept. of Ecology
Prepared by: RK Environmental

May 2, 2011

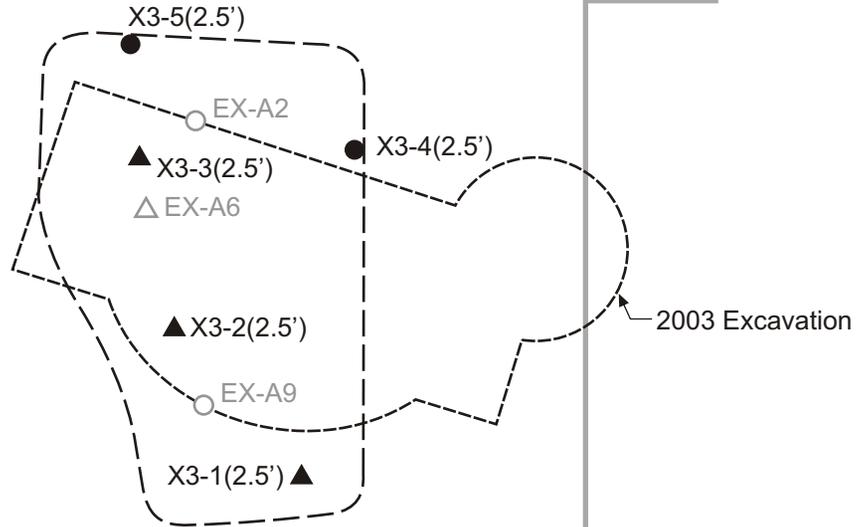
Former Wrecking Facility & Cleanup Construction Results

- Confirmation Sidewall Sample Location—Closed
 - ▲ Confirmation Bottom Sample Location—Closed
 - Sidewall Sample Location—Overexcavated
 - △ Bottom Sample Location—Overexcavated
- X3-2(2.5') Sample ID (and Depth in Feet)
- Limits of 2011 Excavation
 - - - - Limits of 2003 Excavation
