**George R. Webster, P.E.
Consulting Professional Engineer
16355 Densmore Ave. North
Shoreline, Washington 98133
(206) 542-2218**

June 13, 2016

Re: Further Action at the following Site:

- **Site Name:** Main Street Grocery
- **Site Address:** 901 Martin Luther King Jr. Way, Tacoma, WA
- **Facility/Site No.:** 53355321
- **Cleanup No.:** 12291
- **VCP Project No.:** SW1481

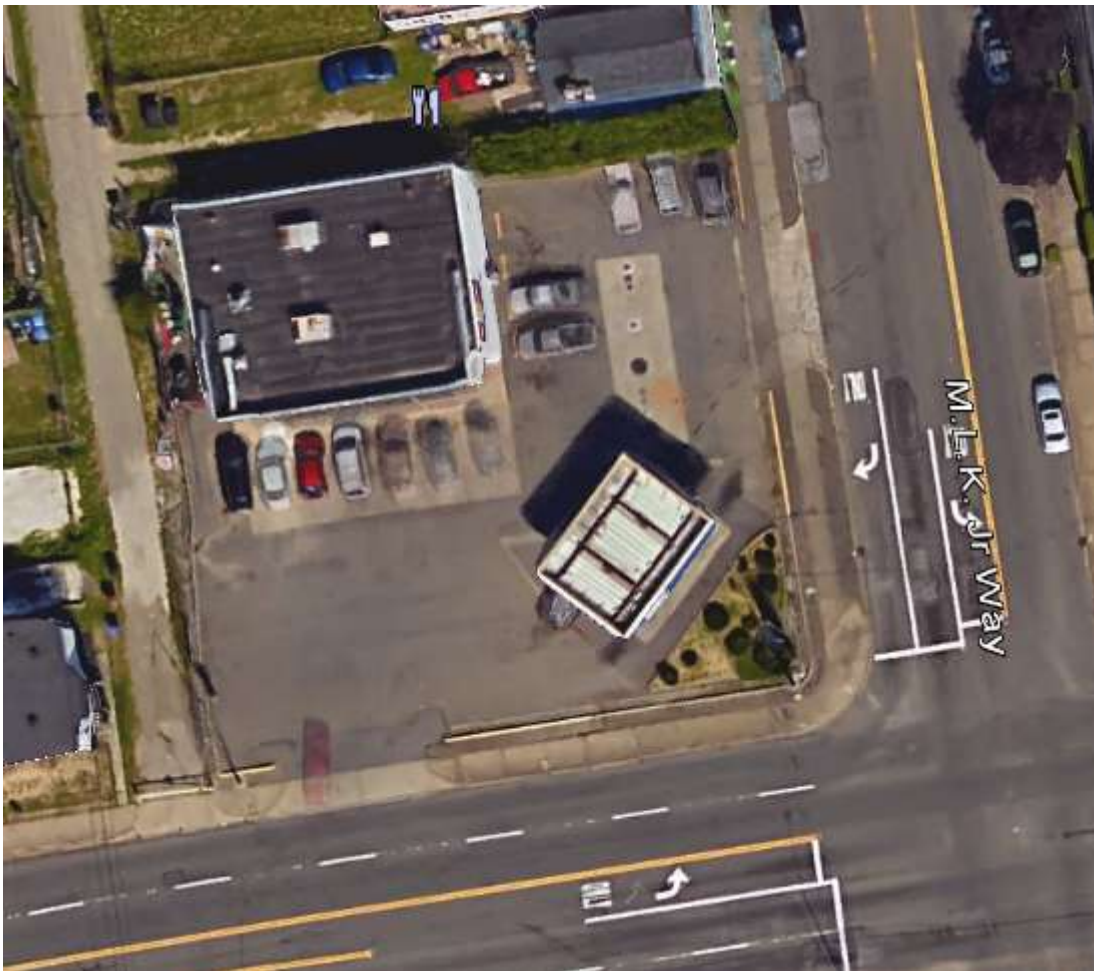
Two Gasoline Stations are located at the intersection of So. 19th and MLK Jr. Way, ten blocks to the South. A "smaller" station is located on the NW corner of the intersection. A photo of this station is shown below.

The elevation of both of these two Stations is at 366 feet, and the distance of separation to the subject site is estimated to be about one mile.

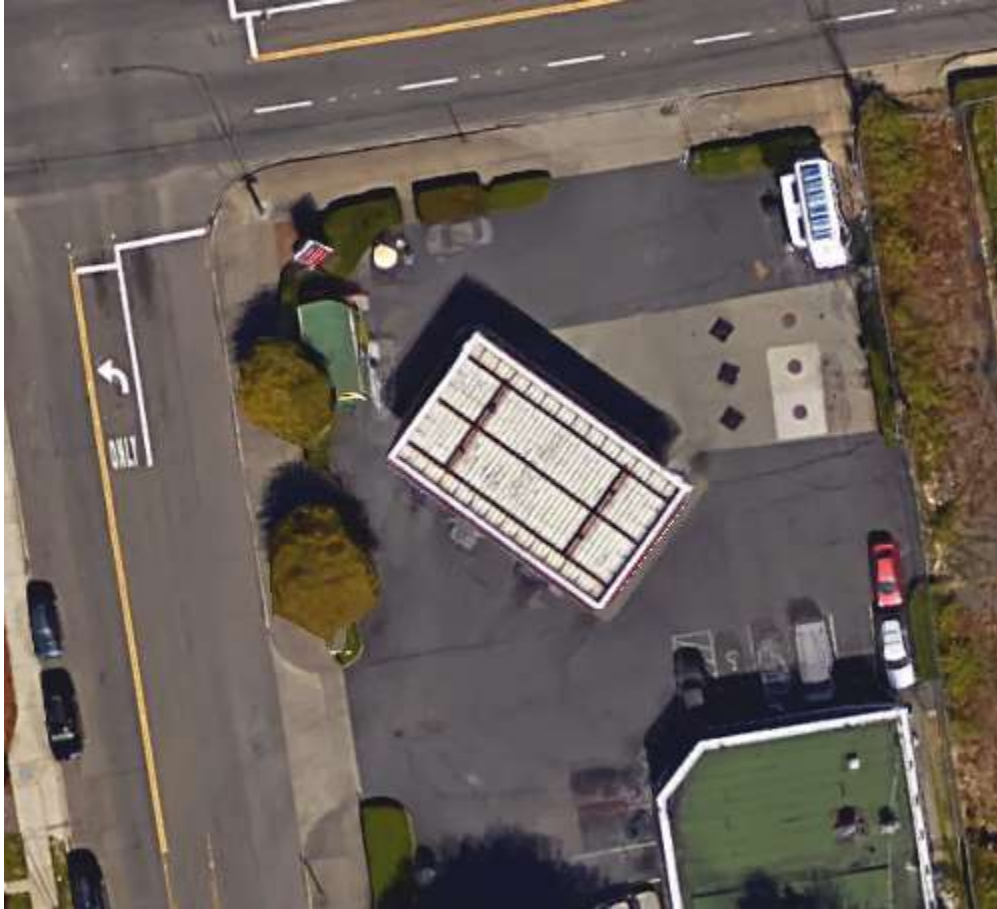
This "larger" Gasoline Station is located on the Southeast corner of the So. 19th and MLK Jr. Way (diagonally across the intersection for the above Station). A photo of this Station is shown below.

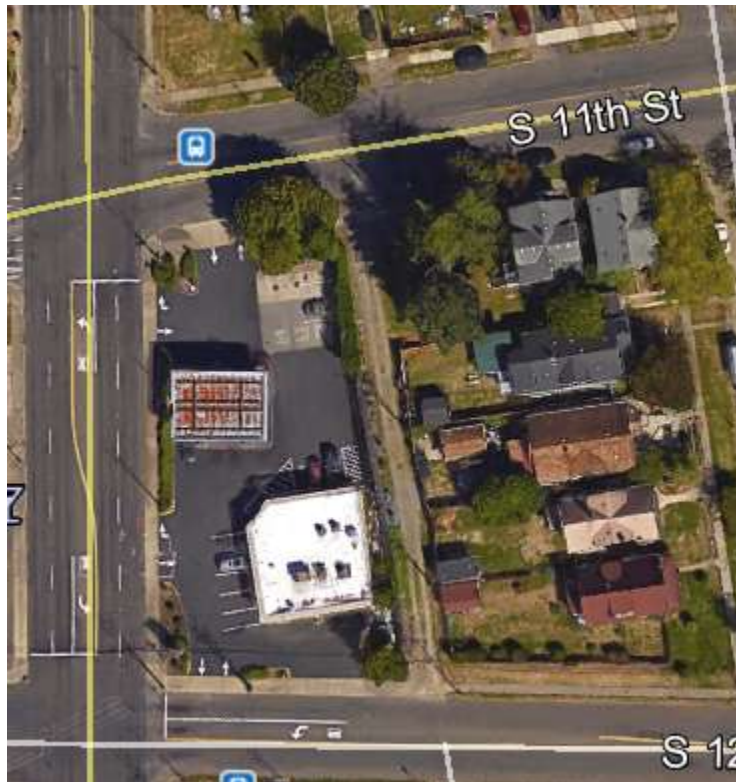
A third Gasoline Station is located to the West of the "Main Street Grocery" site at So. 11th Street and So. Sprague Ave. The elevation at that Station is 371 feet. A photo of this Station is shown below. This Station is also approximately one mile from the subject site.

Based on the distance of separation and relatively small elevation differences between these Stations and the "Main Street Grocery" site, it is "safe to say" that any contamination releases from these three Gasoline Stations have not had an impact upon the subject site.

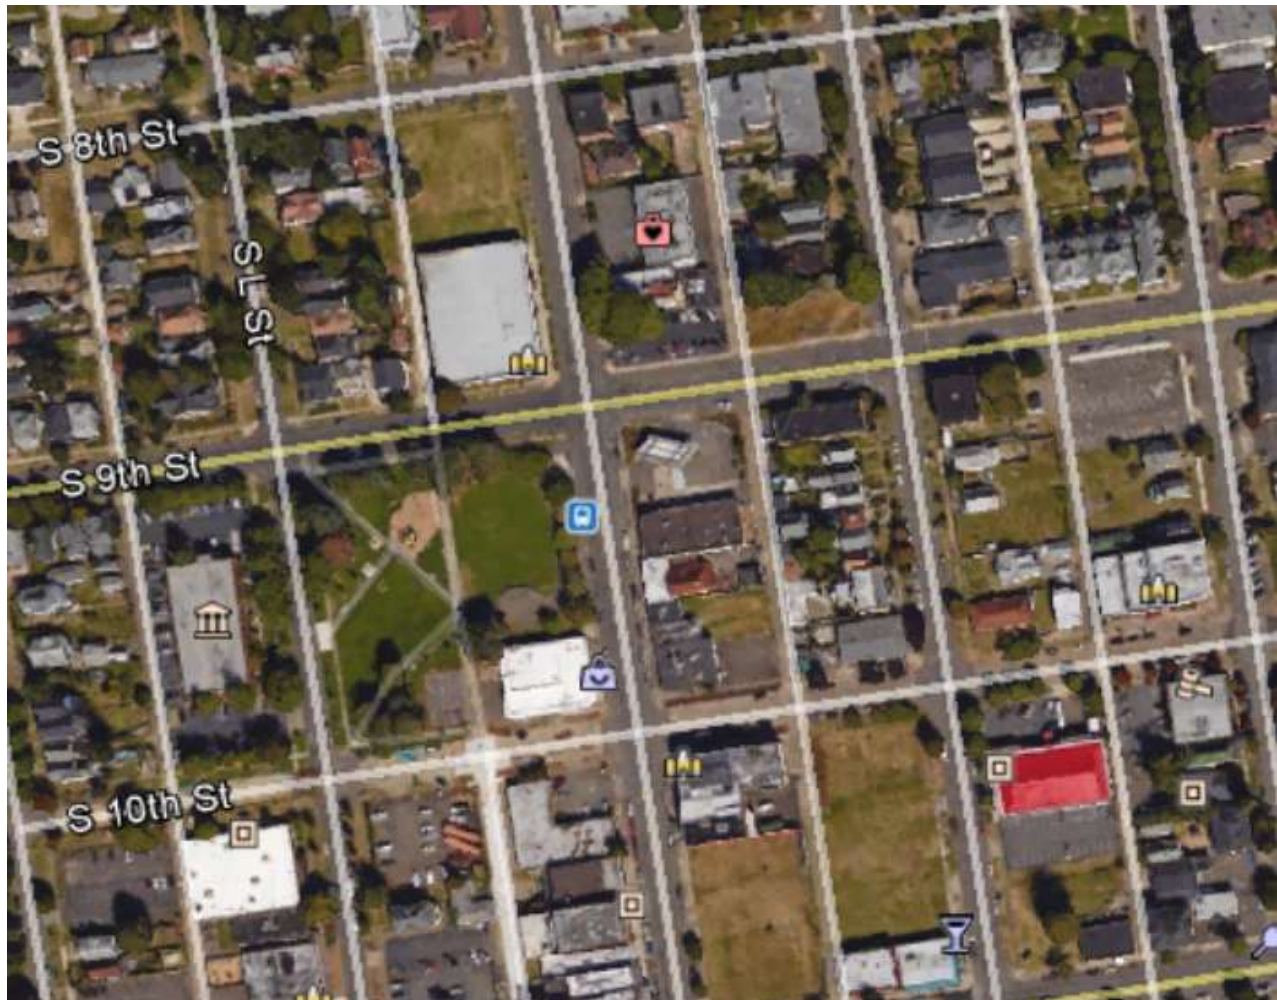
The ECY "Figure 1", shown at the end of your ECY letter Report is a large scale drawing showing much of the City of Tacoma. Below is shown a smaller scale aerial photo of the subject Site, and the nearby surrounding area. The "Main Street Grocery" is shown in the center of the photo, in the southeast corner of the intersection, of So. 9th St. and MLK Jr. Way, just east of the People's Park. It may be seen that this neighborhood area, known as "Hilltop", is a mixed residential and commercial area. Also, photos in a number of additional Reports in the ECY Files show the location of this Site in relationship to the nearby surrounding area.

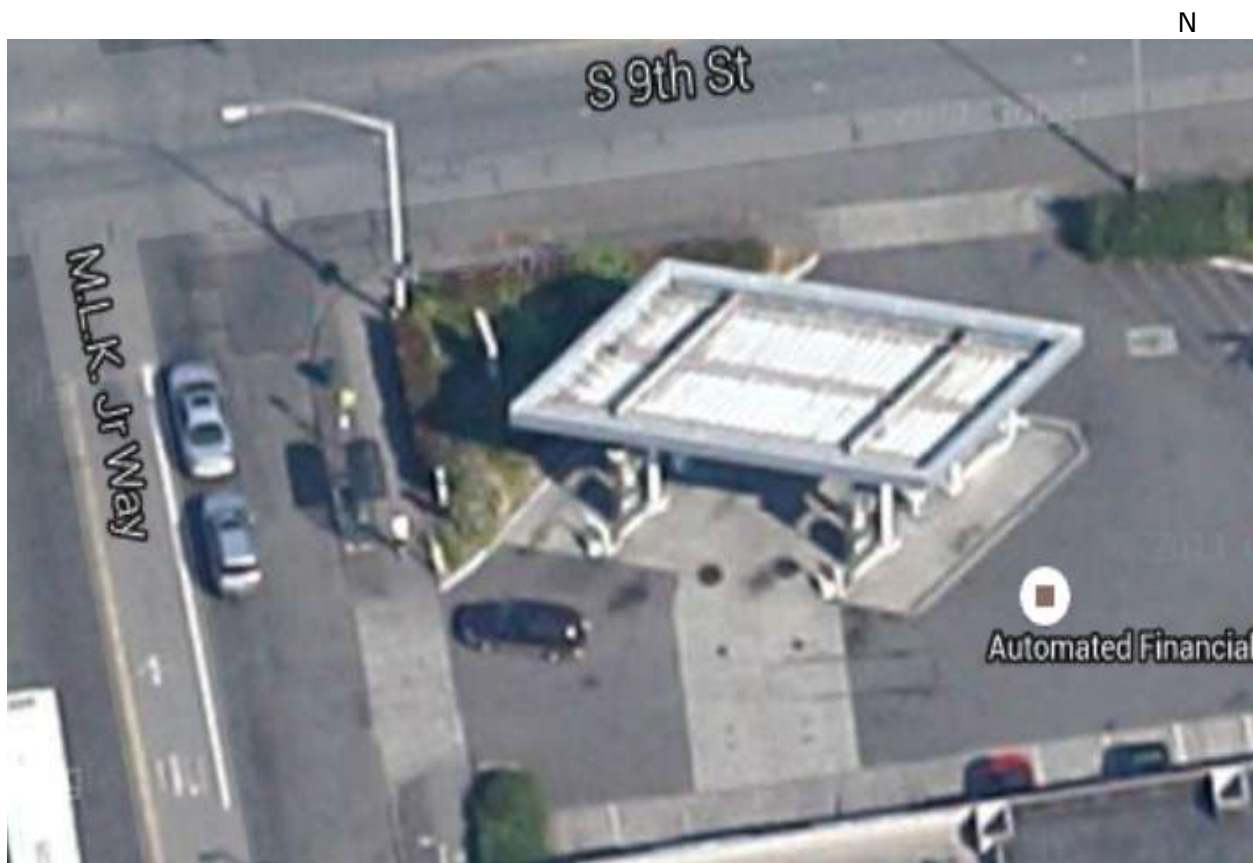
Old view showing the 901 Martin Luther King Jr. Way "Main Street Grocery" Gasoline Station.

The first photo is of an unknown date, BUT it is a view of the Gasoline Station taken sometime before ANY of the "NES and Webster" work efforts at the 901 MLK Jr. Way Gasoline Station. Please note the "NORTH" symbol N, atop the photo.

This first undated photo shows a view of the Main Street Grocery Gasoline Station at some time AFTER the Decommissioning of the third UST, which was done in 1999. Please note the concrete slab, between the car parking spaces (in front of the Building), and the Pump Island (with a white-top Canopy). That concrete slab is atop the two side-by-side remaining USTs at the Site (see the round-shaped, dark colored metal covers of the UST openings on the slab). Observe the difference between the concrete areas and the "gray" asphalt surfacing of

the remaining surface of the Site and the street pavements. Also, please observe a "dark line", on the right-hand side of the pump island slab. That "dark line" is a covered drainage trench along the eastern edge, and northern side, (top edge), of the Island slab. As the Island slab is sloped downward in the northeast direction, the Island drainage flows into that drainage ditch to the underground outlet in the Northeast corner of the Island. The Island drainage then flows underground to the Oil/Water separator, which may be seen further down-slope to the northeast, identified by the whitish-colored square-shaped cover, atop the Oil/Water separator within the asphalted area. (Please disregard the pop-up advertising for "Automated Financial".)

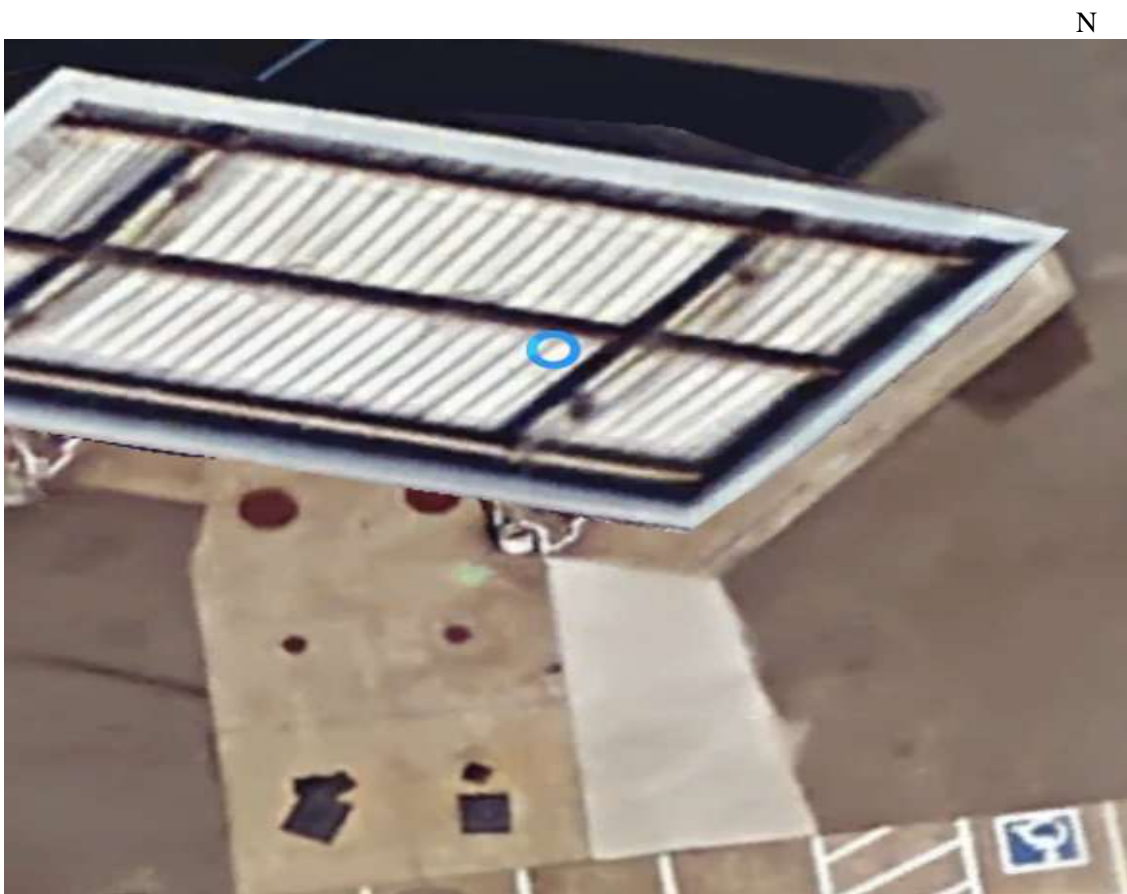
This second aerial photo shows a "present-day" close-up photo segment of the Gasoline Station, AFTER the exploration and cleanup action work-efforts were performed by both the NES and Webster. Please compare these two photos.

The white top cover of the Canopy is covering the concrete pump island pad, and the four fuel dispensers. The changes from the first Station photo and this present-day photo are shown as two "modified surface areas" are now found within the former asphalt paved area that surrounds the pump island. (The asphalt area was shown as gray colored in the first photo, but now is shown as brownish colored on this photo). Remaining is the now lighter brownish colored slab, south of the pump island that covers the two remaining 10,000 gallon double-walled fiberglass fuel USTs, and can be identified by the round-shaped, dark colored, metal covers of the openings of the two UST's.

The "first" new surfacing area addition is just to the right of that USTs covering slab, and is seen as a whitish colored concrete slab with no openings. That concrete slab was poured by NES in late 2015, (instead of replacing the asphalt surfacing that had been removed) to "properly" cover the "Decommissioned-in-Place" UST. That new slab was poured after Webster's June 2014, *Environmental Actions Report* detailing the completion of the NES & Webster "clean-up actions". As explained within that Webster Report, the asphalt covering of the "Decommissioned third UST", was directly involved in actions directly impacting, and causing the Benzene "release".

Now look at the aerial photos on above two pages (pages 13 and 14), and you can clearly see the exact NES Geoprobe sampling location where Sample "2AE" was taken in relationship to the remaining two USTs, and the Gasoline Station as a whole.

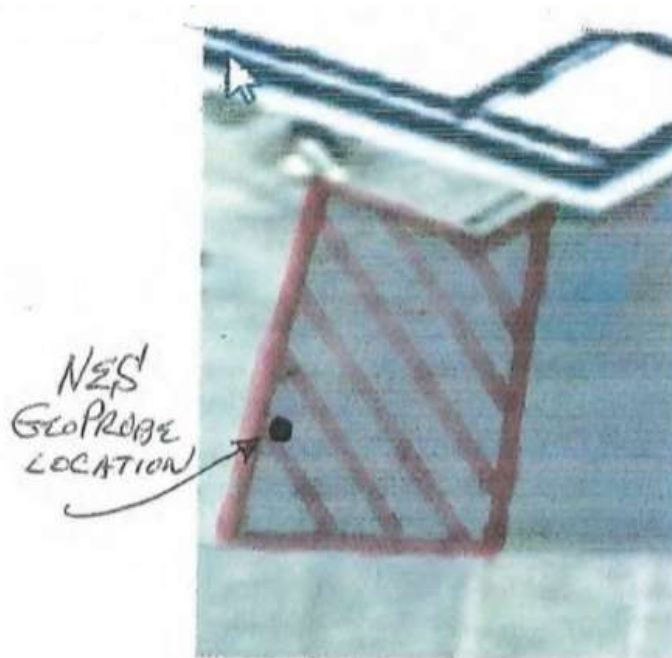
This marked up photo was included in the Webster June 2014 Report and was intended to show the location of the NES Geoprobe effort adjacent to the Decommissioned third UST. The sample location drawing contained in the NES January 2014 report (which was contained as the last page of your ECY January 2016 letter Report) did not adequately designate the exact sampling locations at the Site. The red colored cross-hatched marked area in the following small photo was attempting to identifying the gray-colored asphalt surfaced area covering the location of the Decommissioned-in-Place third UST, as shown in the first Station area photo,. This "drawing" was used to define the exact location of the second NES Geoprobe sampling effort performed on January 3, 2014, adjacent to the Decommissioned UST, where Sample "2AE" was taken.

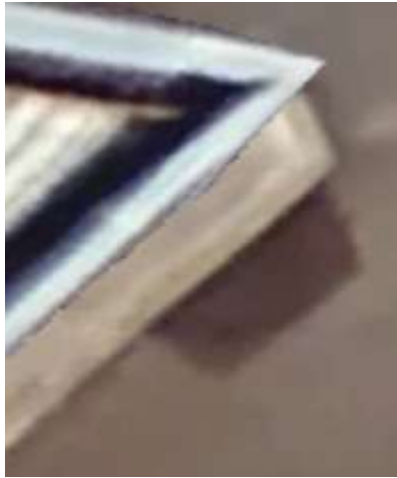
A "second" new surfacing area is shown near the top-right corner of the Pump Island Slab on the page 14 Station photo, that is not found in the page 13 Station photo. That "new" area shows a new darker brownish colored asphalt surfacing addition, adjacent to the concrete pad at the northeast corner of the pump island (see below).

That area is the location of the NES Backhoe excavation and "Sample 3E" location, and also where the follow-up additional NES-Webster April 2014, work-effort was done to define the Oil contamination level of the drainage which had been released from the damaged pump island concrete pad drainage ditch.

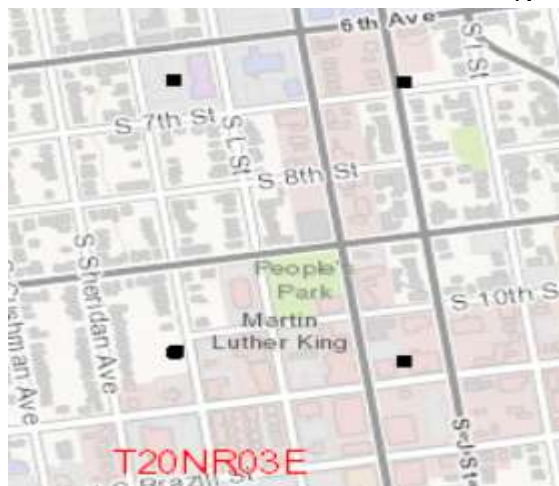
An investigation of the on-line ECY well log files within the nearby area shown within the photo below was performed. 190 Well Logs were investigated.

The subject site is located on the SE corner of the intersection of So. 9th Street and MLK Jr. Way, across the street from the People's Park (which is shown in green in the center of the map). There were 190 ECY well-logs contained within the shown map area which surrounds the subject Site. All 190 well-logs were viewed. Most all of these well-logs were of borings related to construction foundation explorations, and were between six and 15 feet in depth. A number of borings were performed at a nearby site located at 1023 MLK Jr. Way by Parametrix in 2006, and Krazan and Associates in 2007, and are shown on the following pages. Of the 190 well-logs in the area, these two Company's well-logs were the closest borings to the site. The deepest borings in these two efforts were to the depths of 20 feet (Parametrix), and 40 feet (Krazan). No evidence of a water table was found to the 40 foot depth.

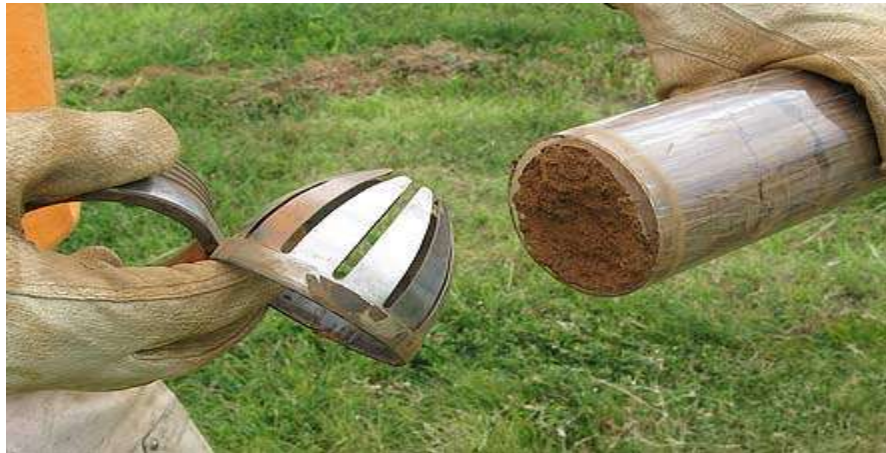
A more detailed sampling procedure description is defined at the Geoprobe website, <http://geoprobe.com> See the photo below, of a larger diameter core-catcher and plastic tube soil sample. This photo was taken from the Geoprobe Systems company website.

The hole was advanced to the desired depth with 3'-5' sections of threaded 1 ½" diameter drive rods to the sample location. At that depth, the drive rods are pulled from the sample hole, and a 2' long stainless steel split-spoon tube sampler, equipped with a 2' long x 1 ½" diameter polycarbonate insert, and a bottom-end "core-catcher" (that "opens" for receipt of the sample) was fitted to the end of the drive rod, and the rods lowered to the bottom of the hole. The sample collection split-spoon tube is then driven two feet deeper into the soil for the collection of the soil sample. The drive rods are removed from the hole, and the split-spoon sample tube was removed from the bottom of the drive rods. The sample tube is laid on a clean table, and the top-half of split-spoon sample tube is removed to display the plastic tube inside. The soil sample is resting in the plastic tube within the lower-half of the split-spoon tube. The plastic tube is removed, laid on the table, the length of the tube "cut-open" with a knife, so that the sample can be inspected and "swept" with a PID to determine if petroleum hydrocarbons exist within the sample, and to be able to recover a soil sample. Soil samples are collected and placed in laboratory-certified four-ounce glass jars, leaving no headspace, labeled and placed into a zip-lock bag, and then placed into a cooler with ice-substitute to maintain required temperature. The sample cooler was delivered to Spectra Laboratories in Tacoma, WA for analysis using the proper "chain-of-custody" protocols. After

the sample collection, the split-spoon was cleaned; triple rinsed with deionized water and alconox soap solution, and is then ready for reuse.

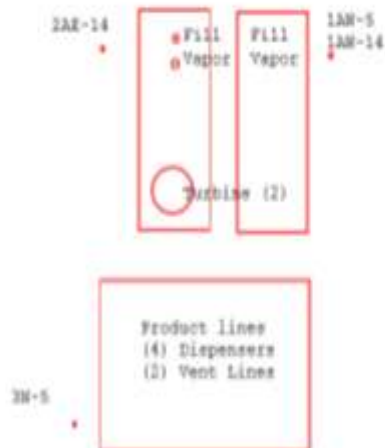
NES – Sample location drawing - Main Street Grocery 901 MLKJrWy

Below is an edited copy of the NES sample location drawing which was the last page of your ECY Review letter Report. Please also see the WEBSTER drawing on Page 15, of this Report.

SOUTH is UP !
