RE: REMEDIAL ACTION FINAL REPORT: REMEDIATION PROJECT • DORN 1803
PROJECT SITE: 1803 13TH AVE, SEATTLE, WASHINGTON 98102

In accordance with your request, Diane's Tank Removal Services, LLC, a licensed, bonded, and insured environmental construction firm, is pleased to present the results of our Remedial Action Final Report.

This Remedial Action Final Report (RAFR) presents the key findings, objectives, methods, and conclusions of Diane's Tank Removal Services, LLC during the soil remediation activities at the above referenced property shown in the vicinity map below.

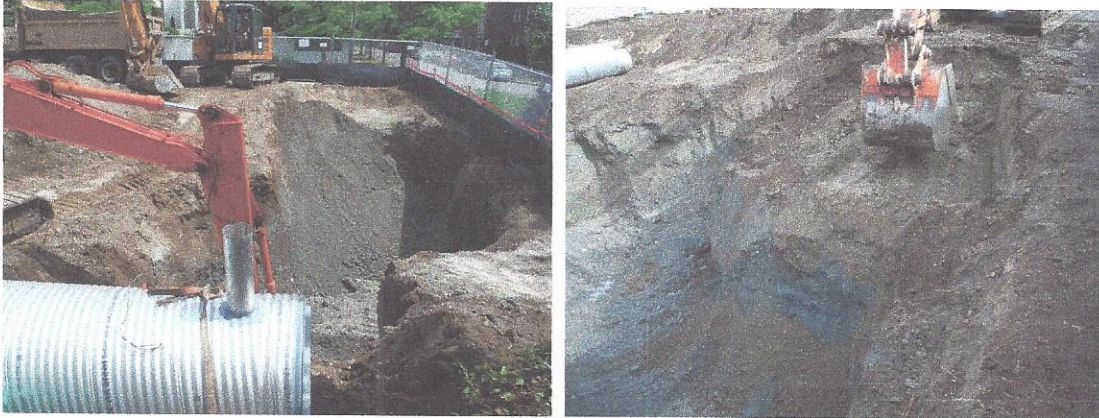
Figure No. 2 & 3.

The geology of the soils underlying the former UST location appears to be consistent with USGS data. This soil stratum is located from the surface to approximately 10.5 feet beneath ground surface (bgs) at the location of the previously decommissioned LUST (Leaking Underground Storage Tank). This glacial till is again speculated to be underlain with a very dense layer of sand with sand lenses, pebbles and some cobbles classified as an advance outwash soil matrix that is again characterized as having very rapid permeability and very good seismic stability. There was an area of this stratum off of the northeast corner of the house that was overlain with a layer of cobbles similar to the consistency of river rock.

Photograph's above depict the ongoing excavation of petroleum contaminated soils at the site where clean overburden was removed from the upper layer and the grey/blue stained contaminated soils were removed and hauled away to a certified disposal facility as Petroleum Contaminated Soil (PCS),

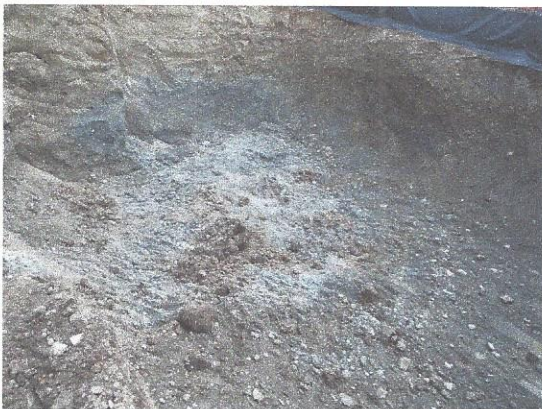
East wall of excavation pit

**photograph's above (4-10) depict the excavation pit after the removal of 617.32 tons of PCS*

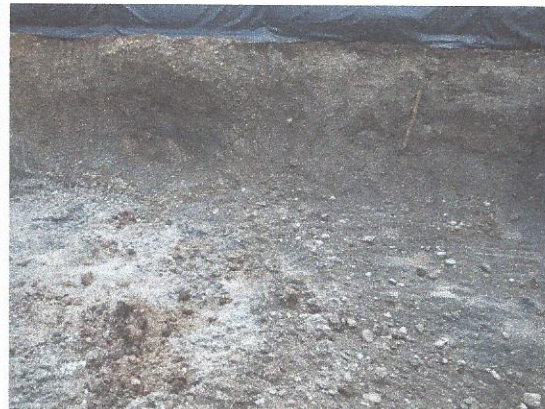
South wall of excavation pit

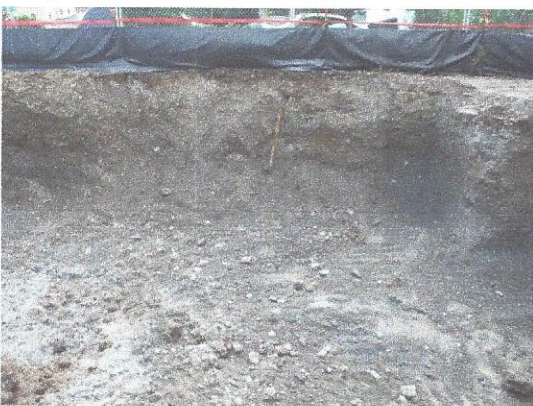
South wall of excavation pit

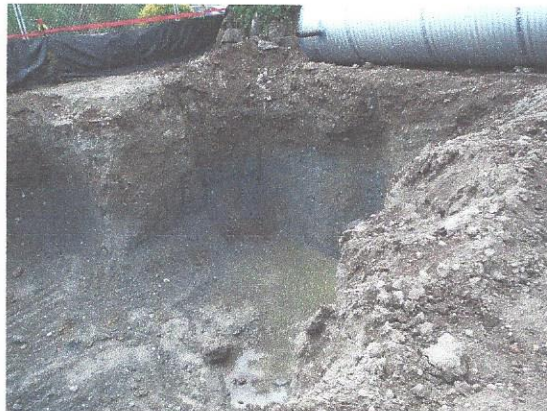
West wall of excavation pit

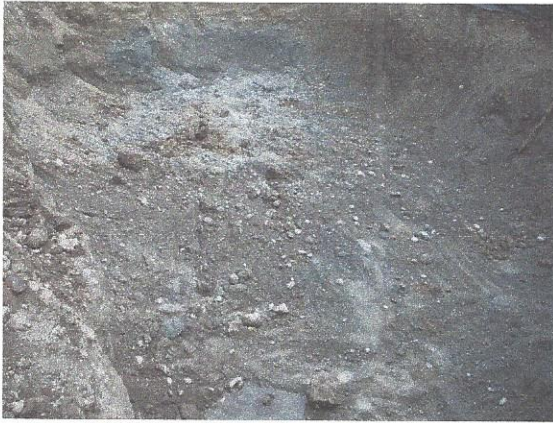
Bottom of excavation pit

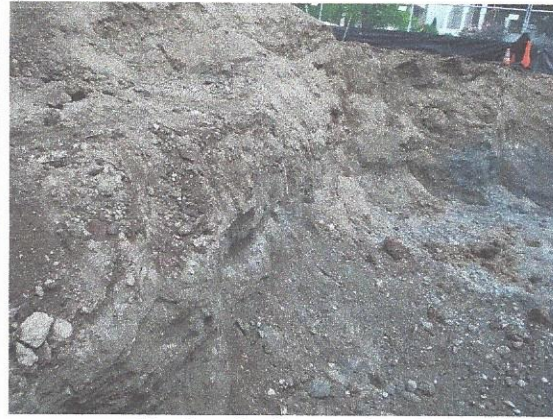
North wall of excavation pit

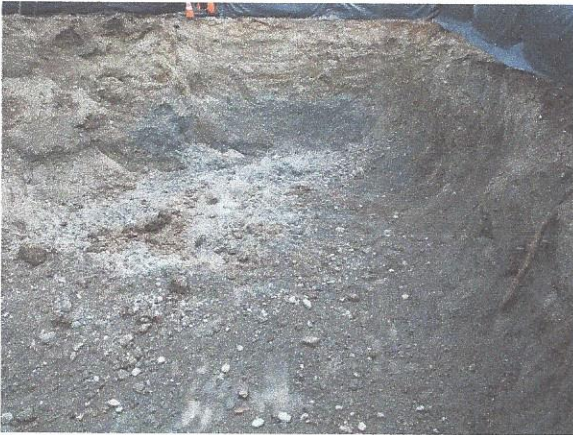
East wall of excavation pit

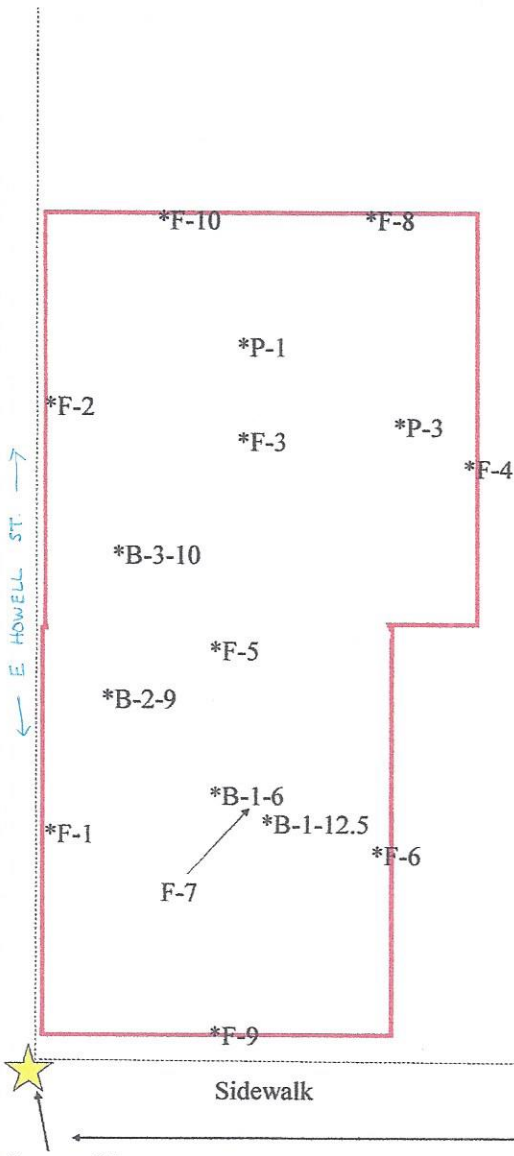
SOIL SAMPLE LOCATIONS AND RESULTS

<u>Sample Location</u>	<u>Depth (ft)</u>	<u>Distance from new POR Point of Reference</u>	<u>Results</u>
B-1-6-032415	6'	12' North, 18' West	20,000 ppm
B-1-12.5'	12.5'	14' North, 17' West	320 ppm
B-2-9'	9'	3' North, 20' West	13,000 ppm
B-3-10'	10'	4' North, 28' West	780 ppm
P-1-9-051616	9'	12' North, 38' West	7,300 ppm
P-3-7-051816	7'	19' North, 34' West	3,100 ppm
F-1-9.5-051816	9.5'	1' North, 12' West	96 ppm
F-2-9.5-051916	9.5'	1' North, 36' West	330 ppm
F-3-10.5-051916	10.5'	12' North, 30' West	<50 ppm
F-4-9.5-051916	9.5'	23' North, 30' West	<50 ppm
F-5-10.5-051916	10.5'	12' North, 24' West	<50 ppm
F-6-9.5-051916	9.5'	18' North, 12' West	<50 ppm
F-7-10.5-051916	10.5'	14' North, 17' West	<50 ppm
F-8-9.5-051916	9.5'	18' North, 48' West	<50 ppm
F-9-9.5-051916	9.5'	12' North, 5' West	<50 ppm
F-10-9.5-051816	9.5'	8' North, 48' West	<50 ppm

Point of Reference—SE Corner of Property Line
