REMEDIAL ACTION REPORT
STEVENS PASS SKI AREA
SKYKOMISH, WASHINGTON

Prepared for
Stevens Pass Ski Area
December 8, 2011

Prepared by
SLR International Corp
22118 20th Avenue SE, Suite G-202
Bothell, Washington 98021

Project 101.00418.00005

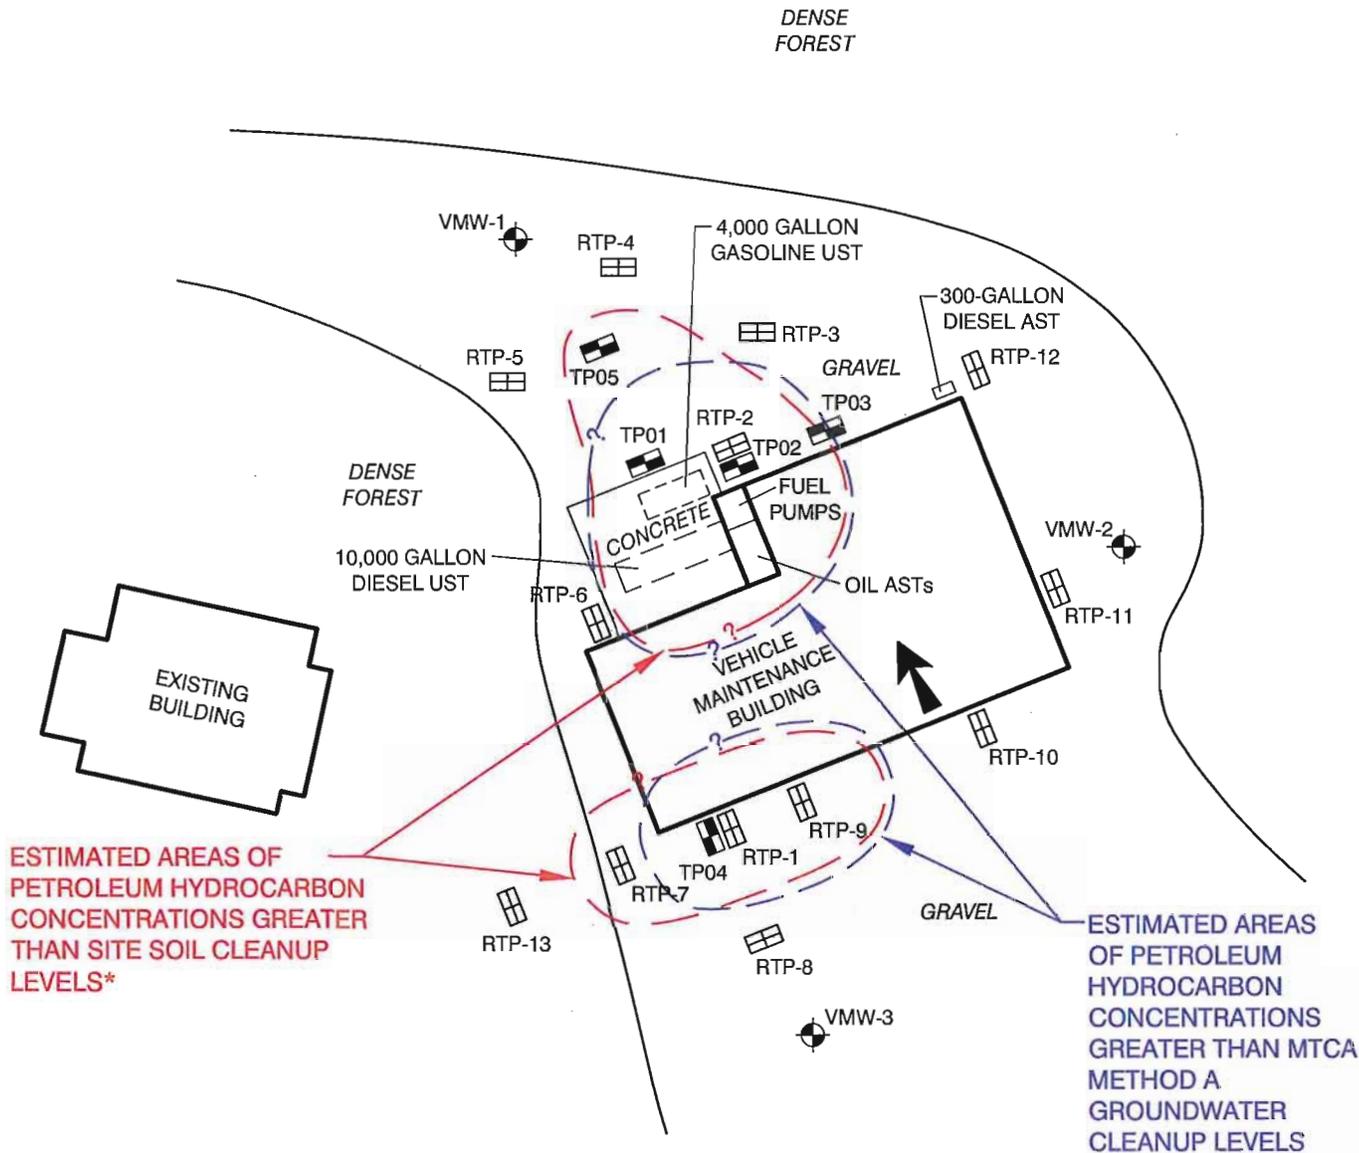
FIGURE 2
STEVENS PASS SKI RESORT
SKYKOMISH, WASHINGTON
ESTIMATED AREAS OF HYDROCARBON
IMPACTED SOIL AND GROUNDWATER -
CURRENT VEHICLE MAINTENANCE FACILITY

ESTIMATED AREAS OF PETROLEUM HYDROCARBON CONCENTRATIONS GREATER THAN SITE SOIL CLEANUP LEVELS*

ESTIMATED AREAS OF PETROLEUM HYDROCARBON CONCENTRATIONS GREATER THAN MTCA METHOD A GROUNDWATER CLEANUP LEVELS

Based on the investigation results, petroleum hydrocarbon concentrations greater than the site soil cleanup levels were present beneath two areas of the current vehicle maintenance facility. Based on shallow soil contamination and surface staining, it appears that maintenance activities to the south of the building (outside of a maintenance bay) and fuel spills to the north of the building (at the vehicle fueling area) were the sources of the impacted soil and groundwater. To the south of the building, the estimated area of impacted soil was approximately 85 feet long by 40 feet wide (see Figure 2). To the north of the building, the estimated area of impacted soil was approximately 90 feet long by an average width of approximately 55 feet. The petroleum hydrocarbon concentrations greater than the site groundwater cleanup levels were present in slightly smaller areas than the impacted soil areas (see Figure 2).

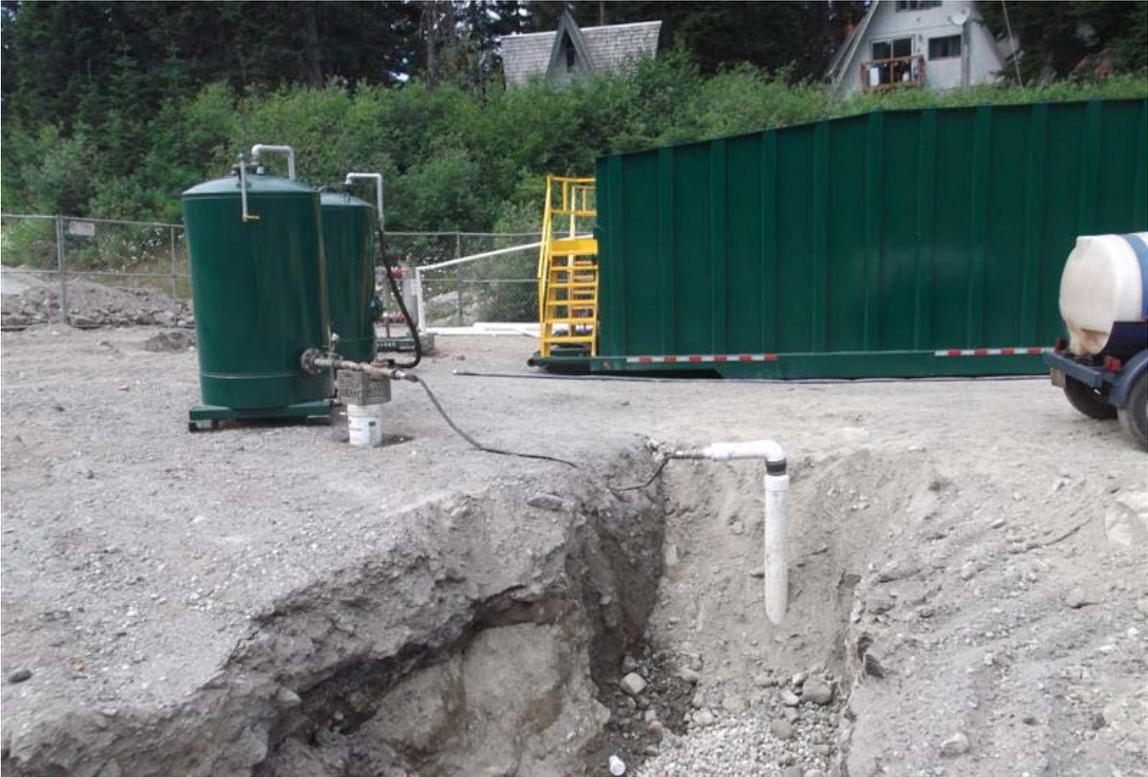
Groundwater treatment system and reinfiltration trench.

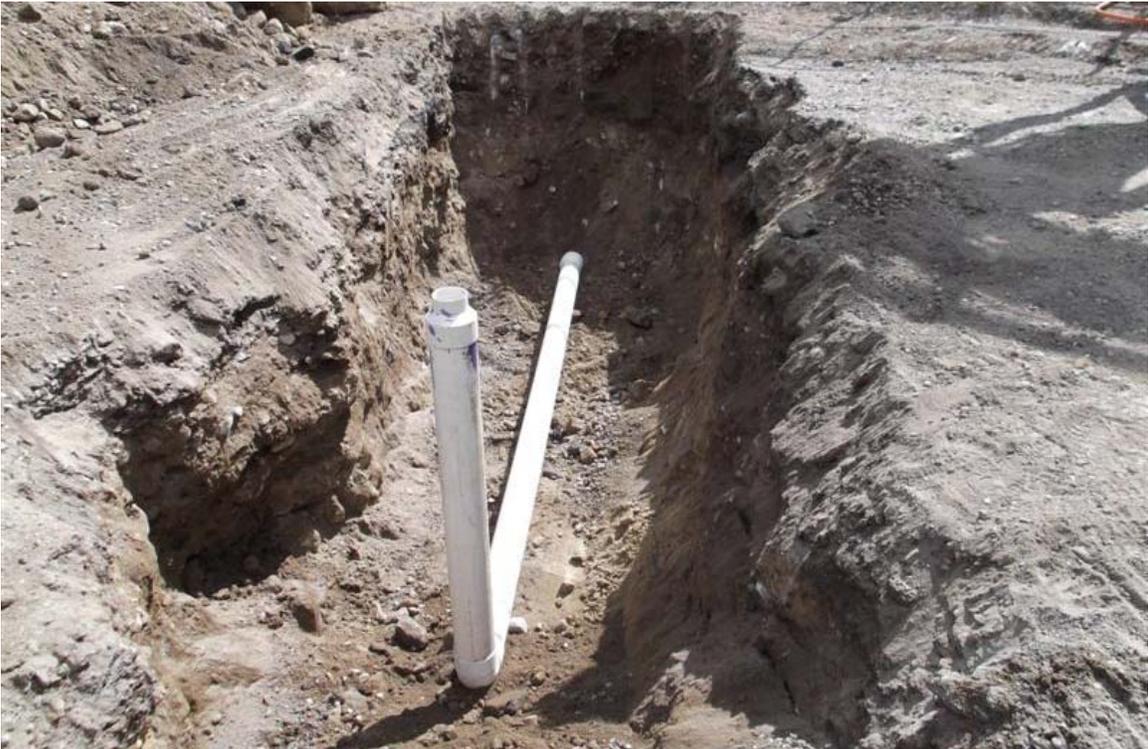
Construction of reinfiltration trench.

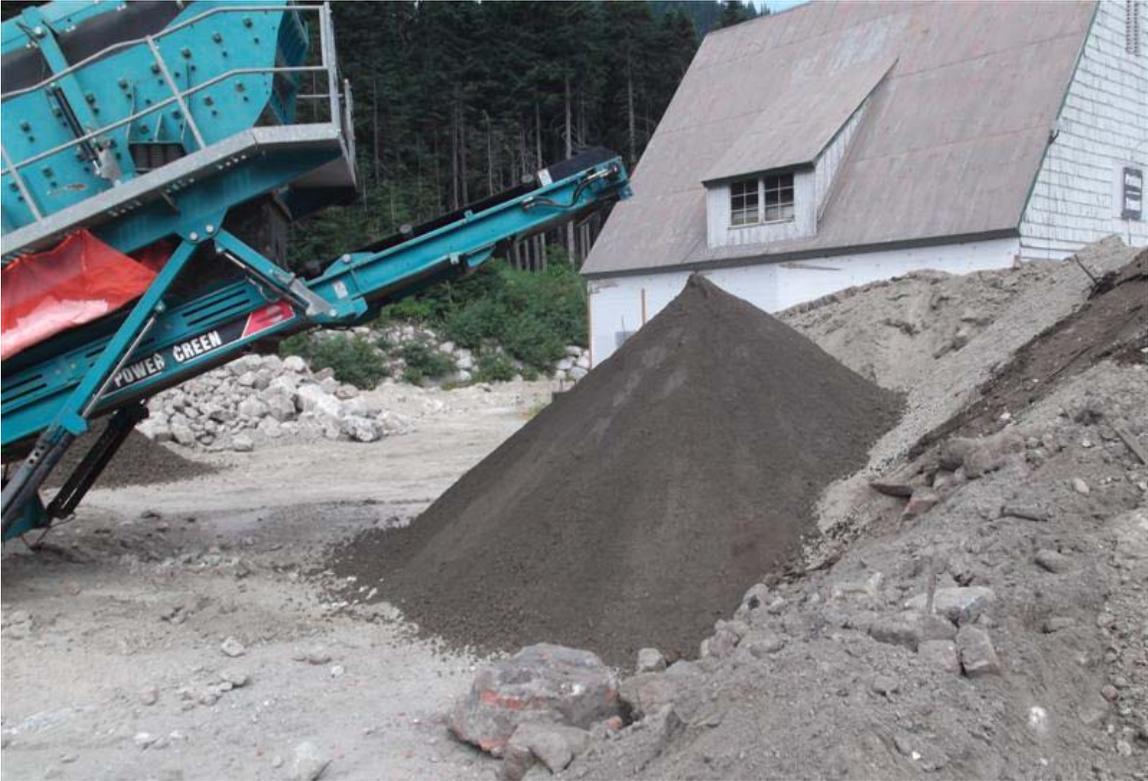
Fine-grained soil that passed through screener.

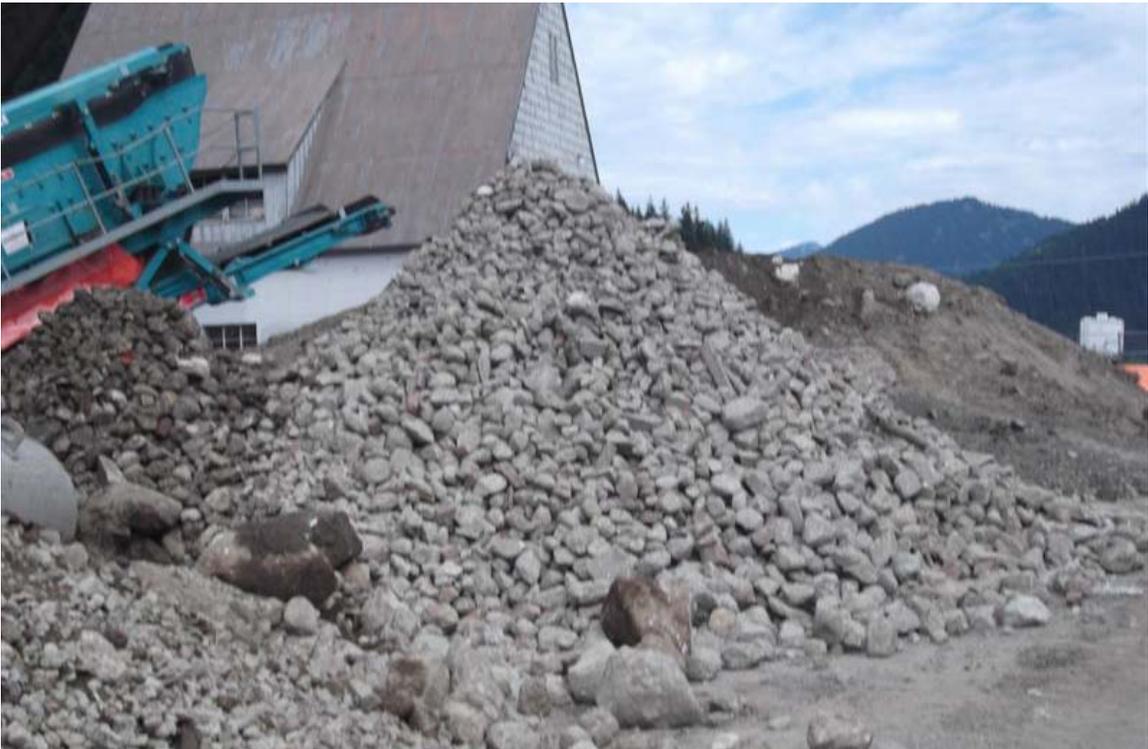
Stockpile of coarse material after passing through screener.

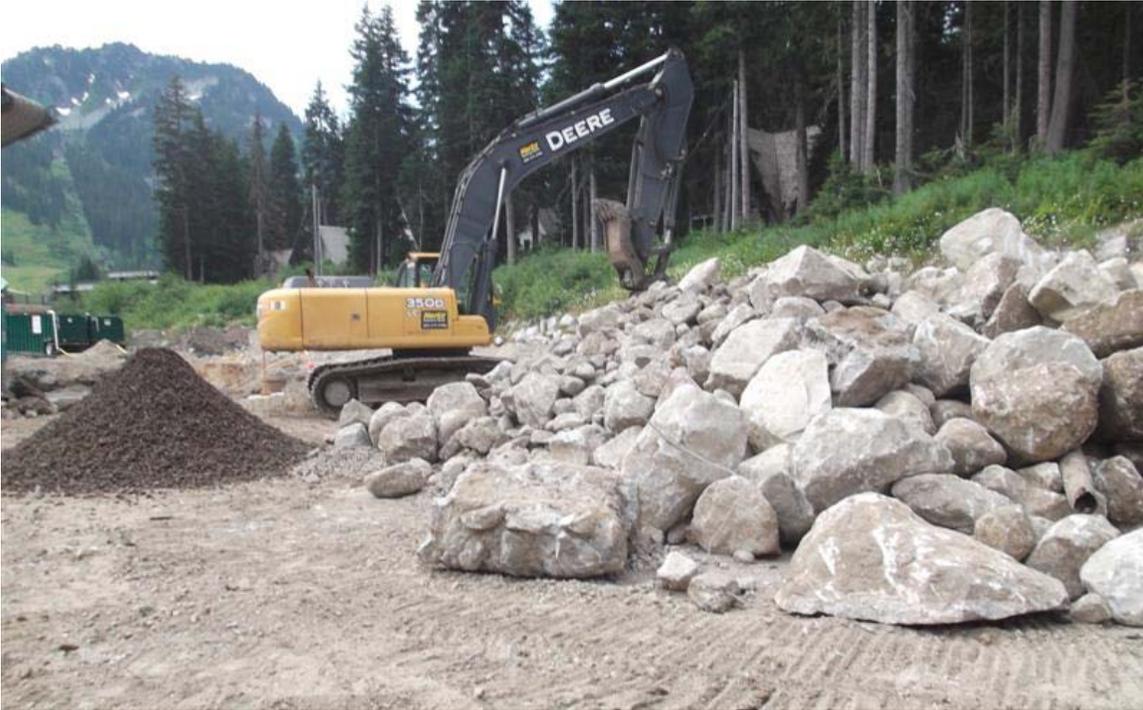
Stockpile of boulders from excavations.

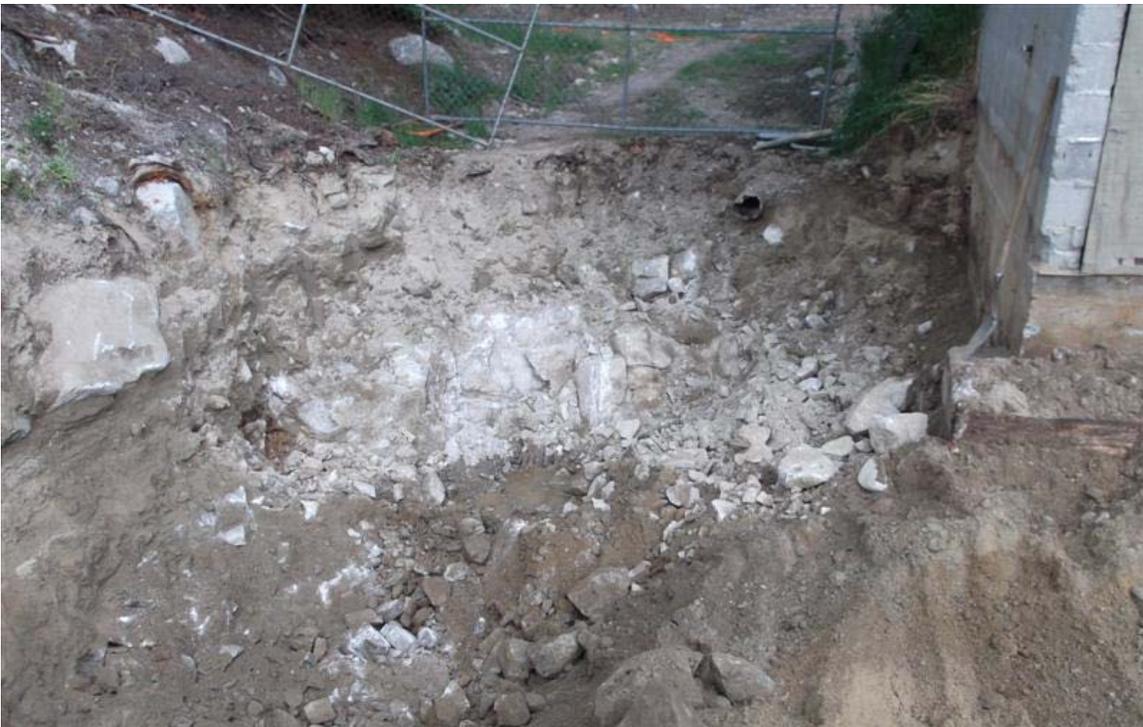
South to north view of northern corner of southern vehicle maintenance facility excavation.

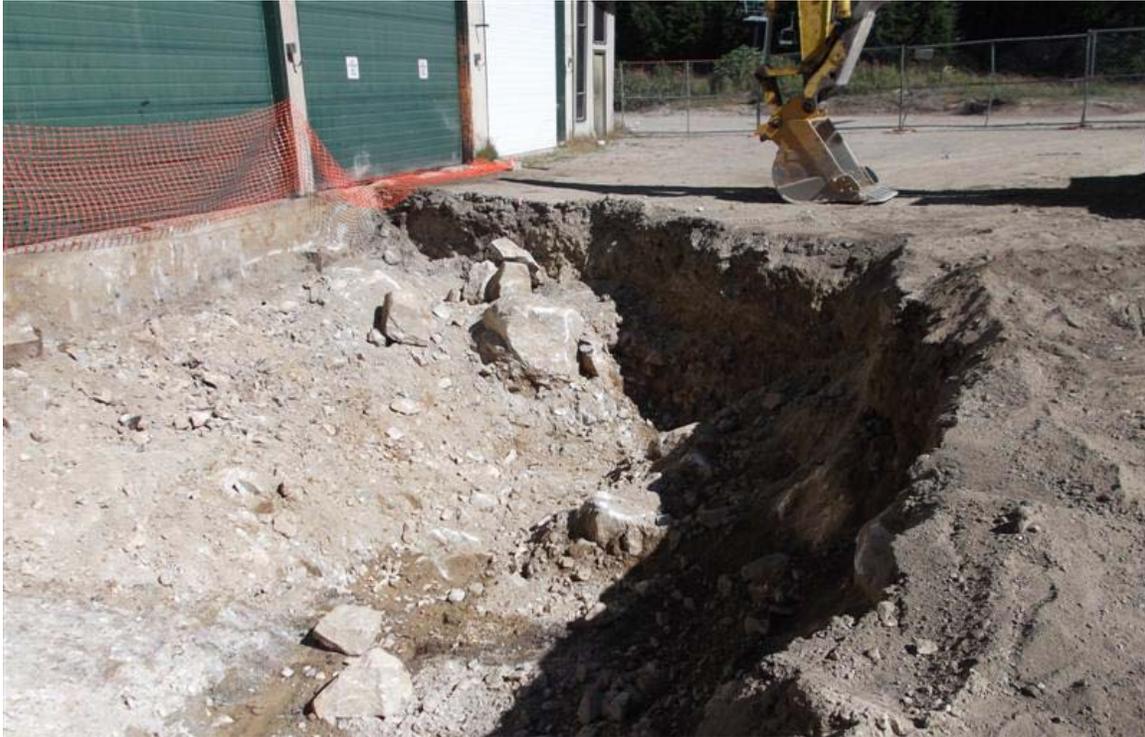
West to east view of eastern portion of southern vehicle maintenance facility excavation.

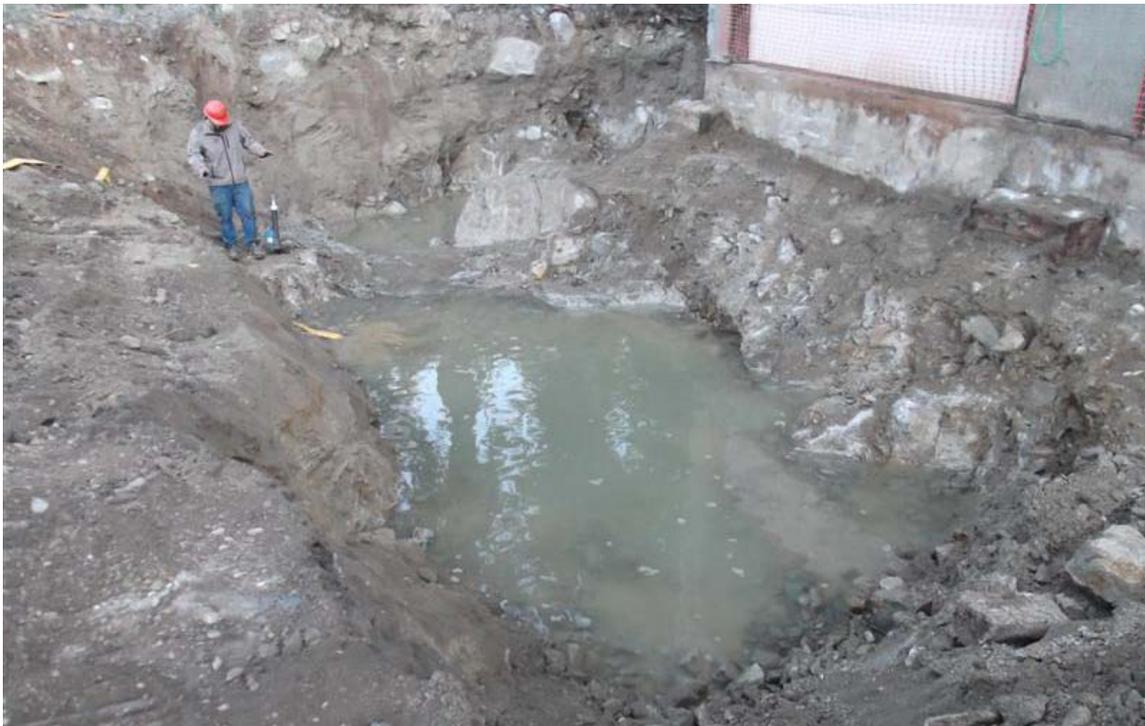
Extraction of groundwater from western and central parts of southern vehicle maintenance facility excavation.

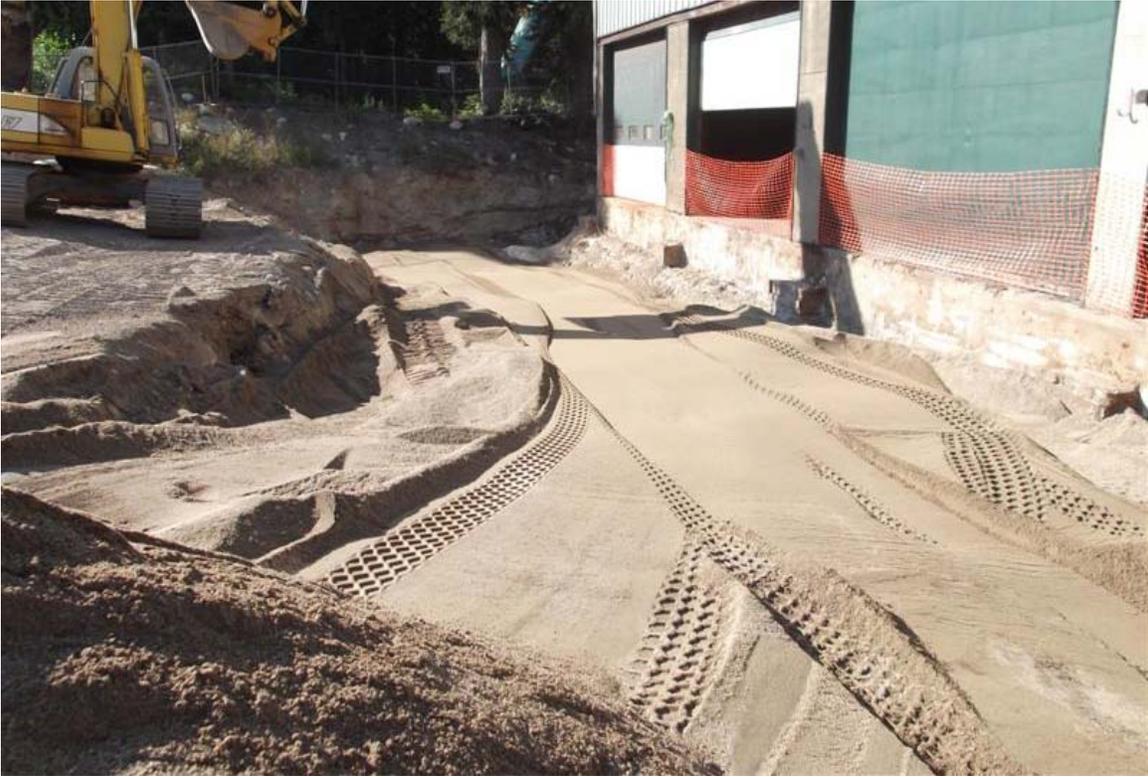
East to west view of backfilling of southern vehicle maintenance facility excavation.

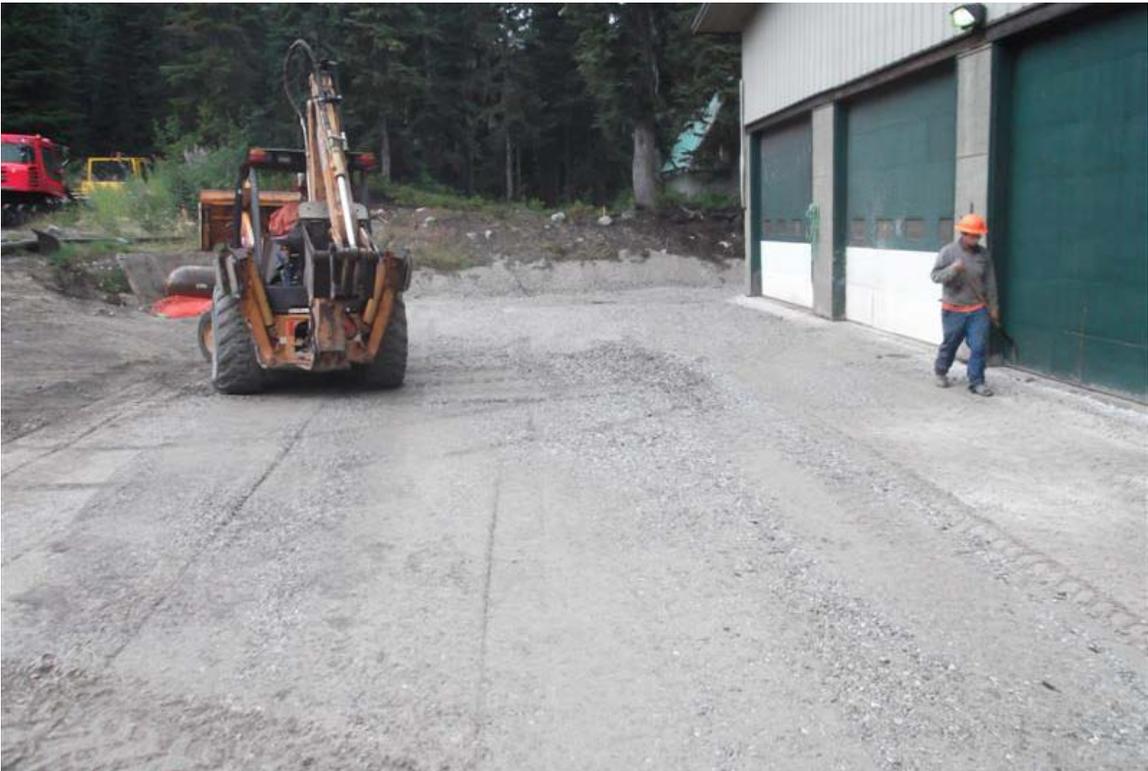
East to west view of southern vehicle maintenance excavation area after backfilling.

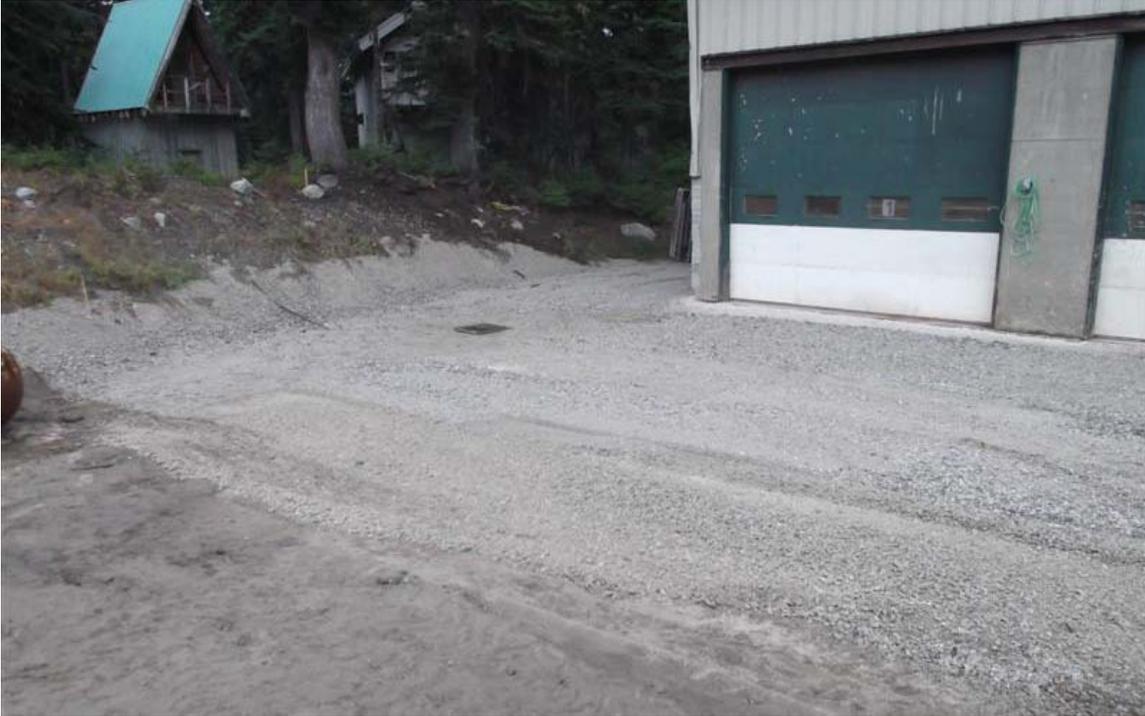
Southeast to northwest view of southern vehicle maintenance facility excavation area after backfilling.

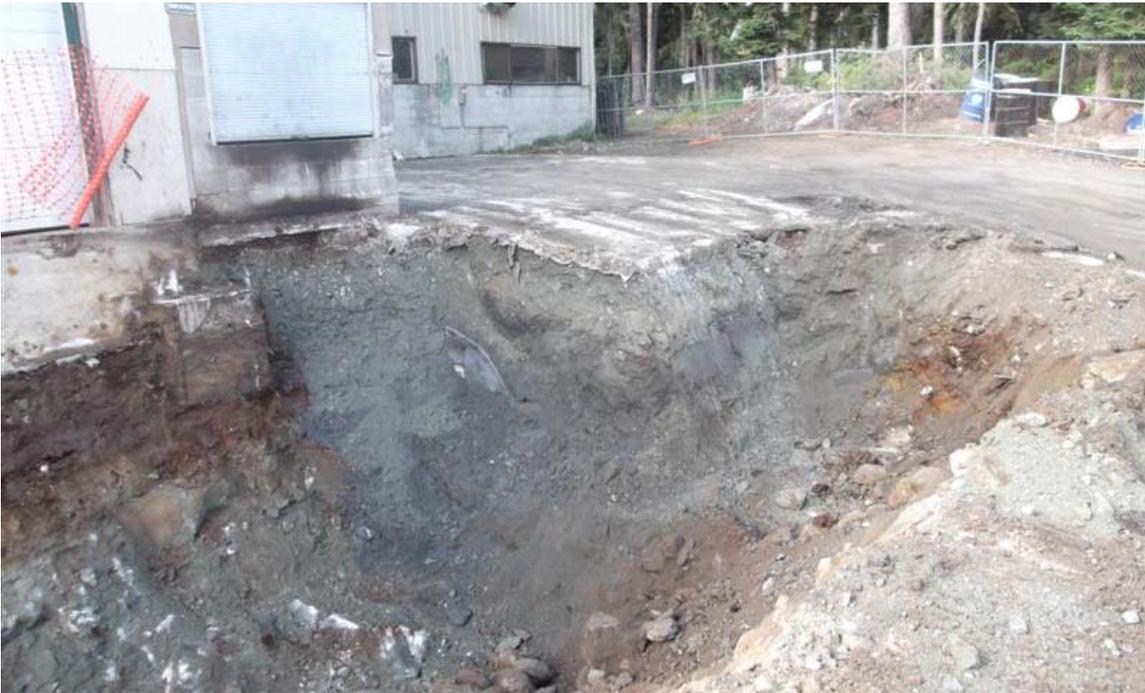
East to west view of gray-stained soil beneath fuel dispensing area and along the northeast corner of UST area at northern vehicle maintenance facility excavation. East end of gasoline UST is partially exposed.

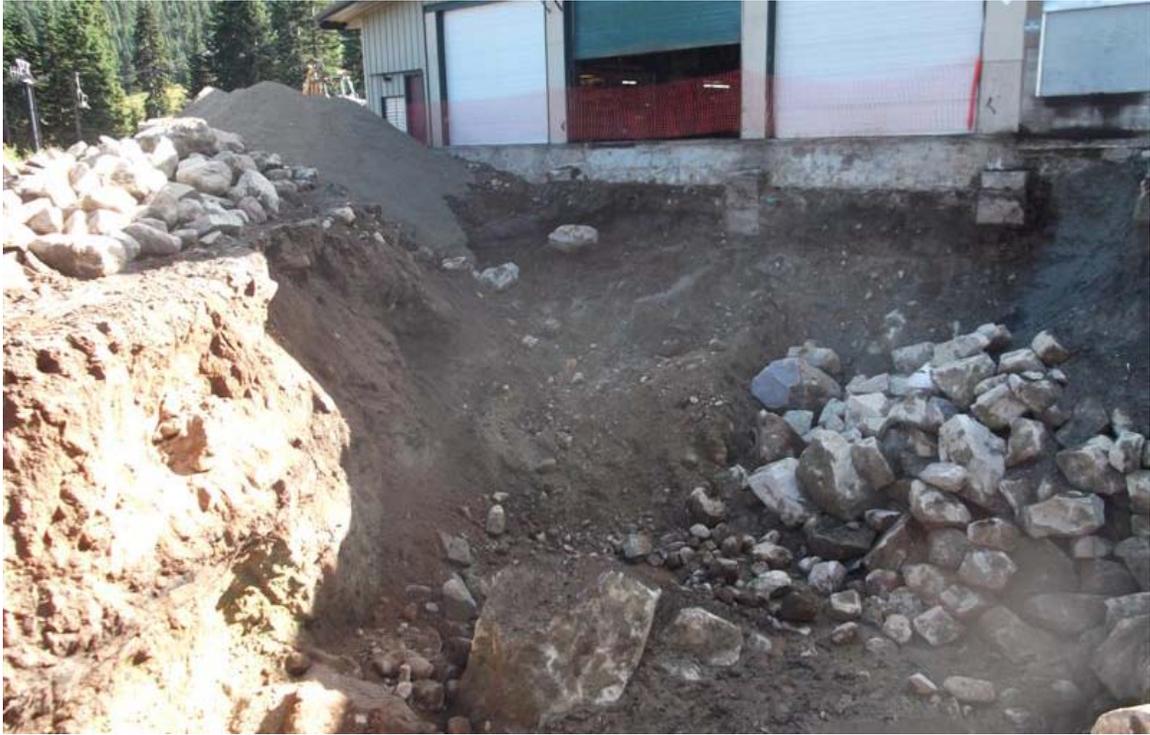
North to south view of eastern part of northern vehicle maintenance facility excavation.

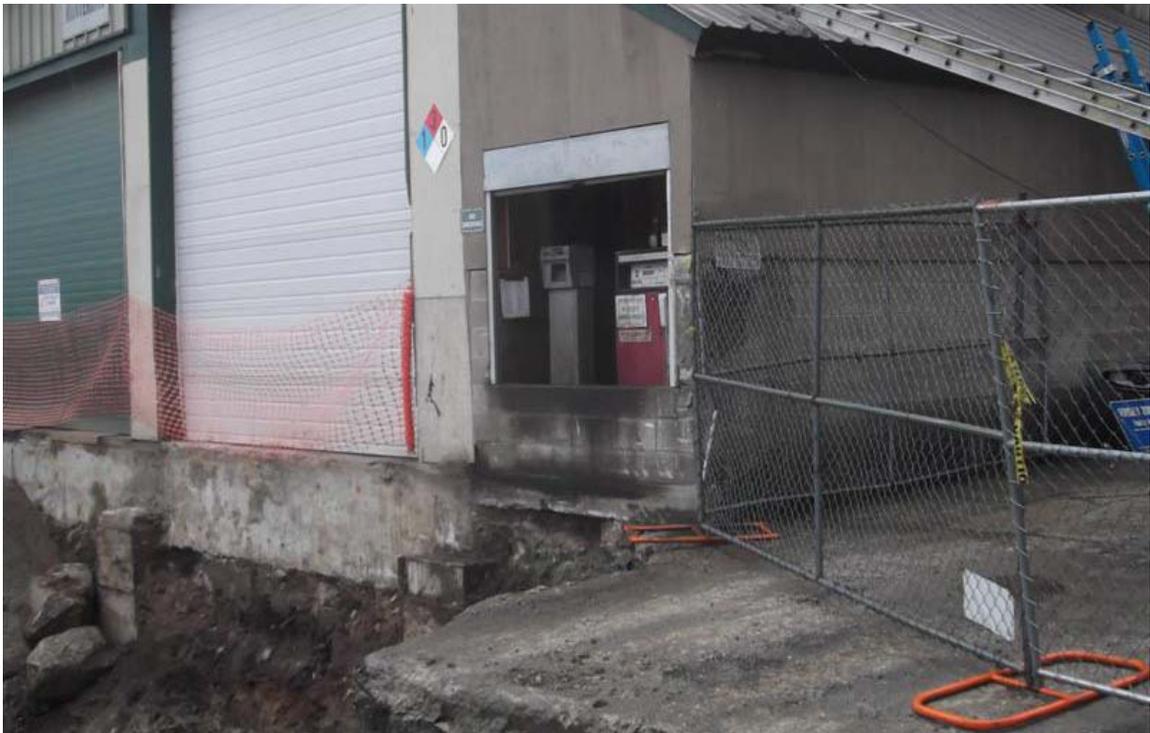
North to south view of fuel dispensing shed that was demolished in order to remove the USTs and the associated impacted soil.

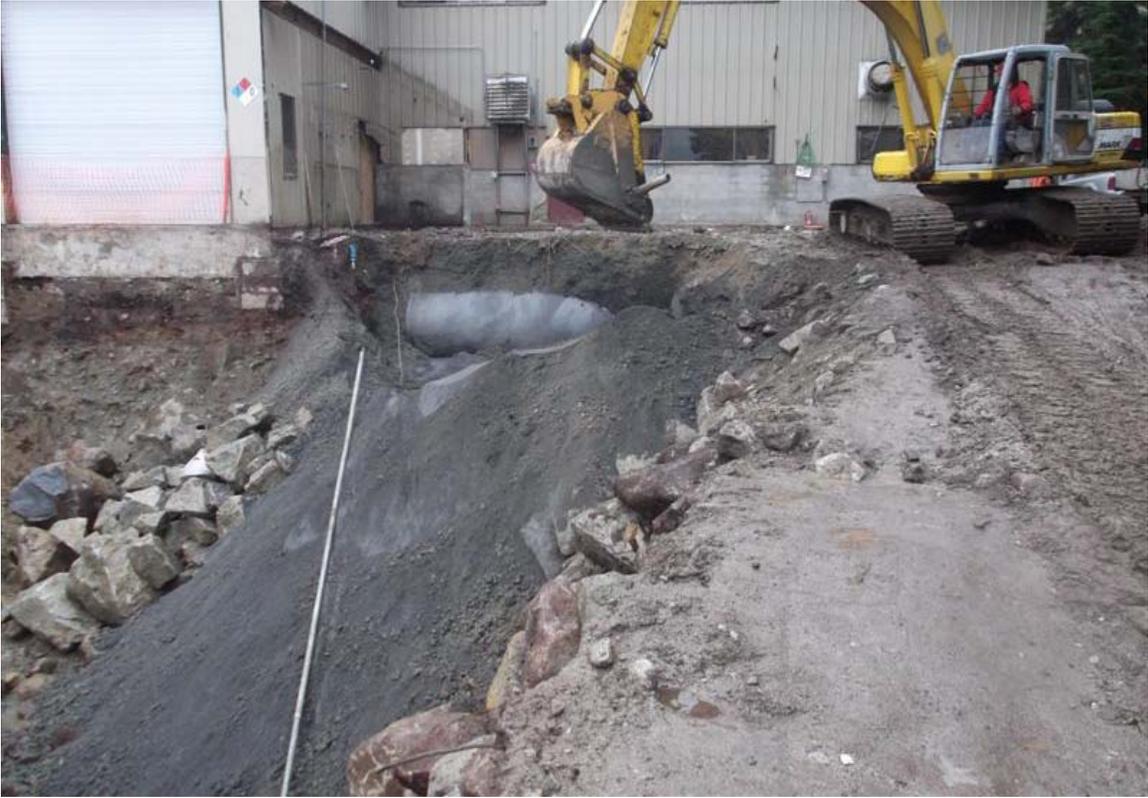
North to south view of 4,000-gallon gasoline UST prior to removal.

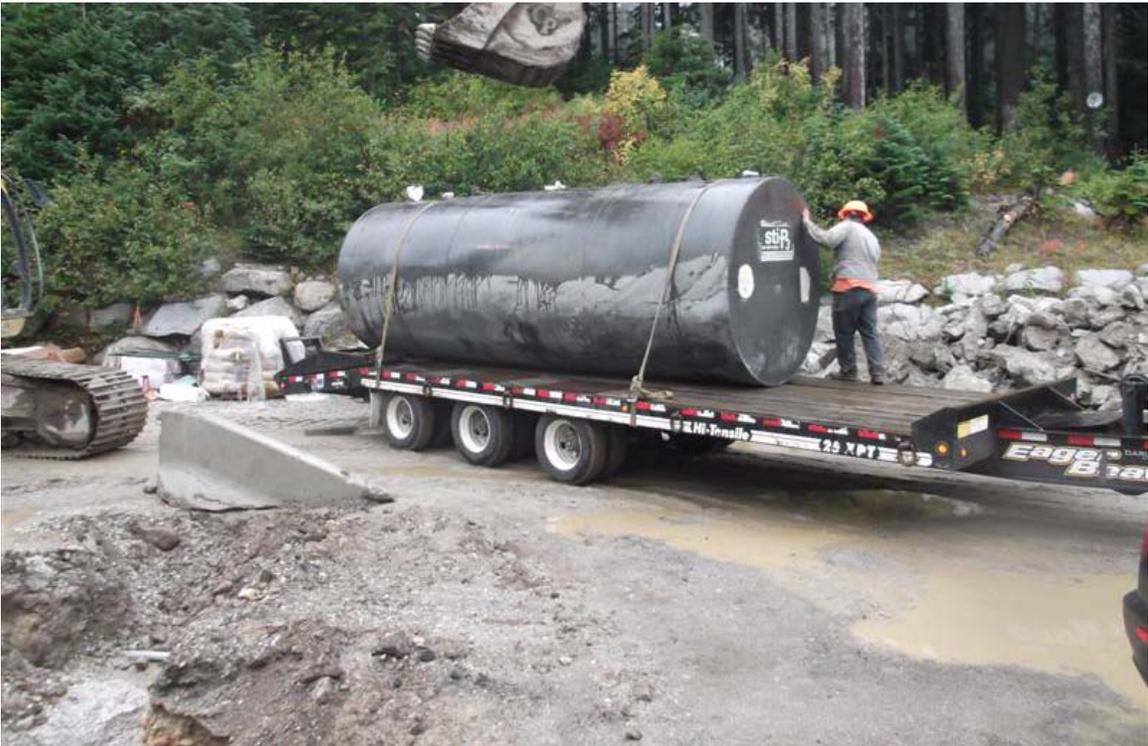
4,000-gallon gasoline UST after removal.

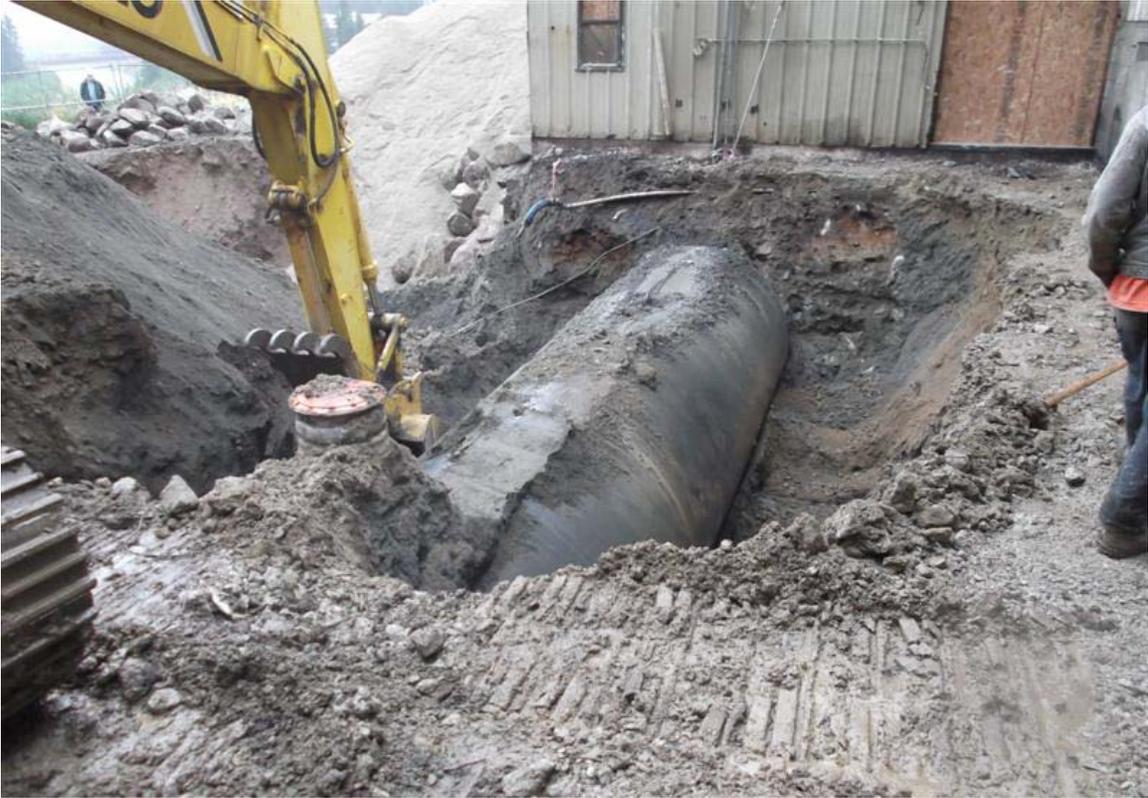
West to east view of 10,000-gallon diesel UST prior to removal.

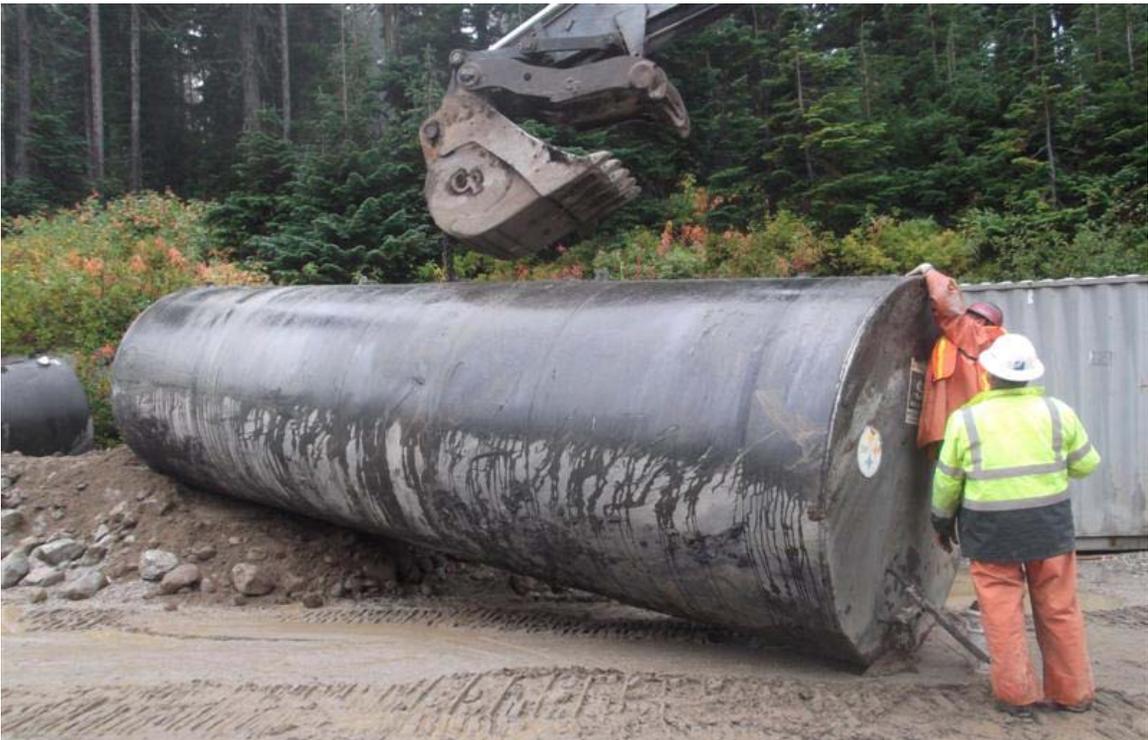
10,000-gallon diesel UST after removal.

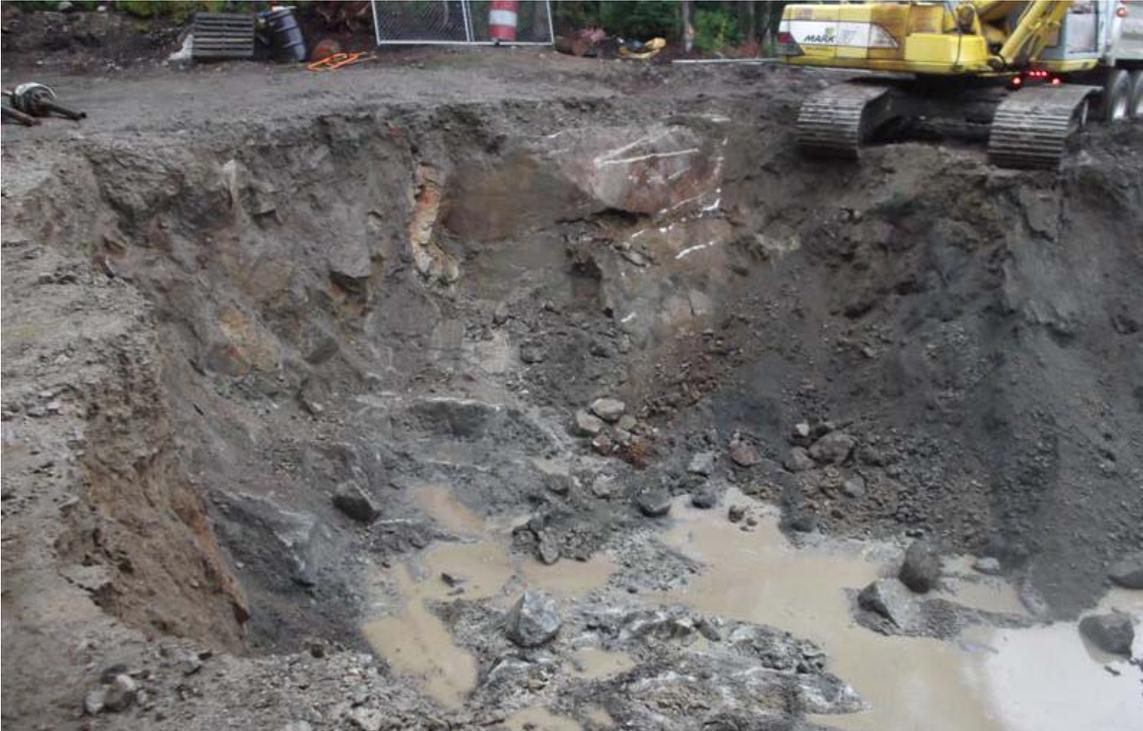
Southeast to northwest view of bedrock along western sidewall of northern vehicle maintenance facility excavation.

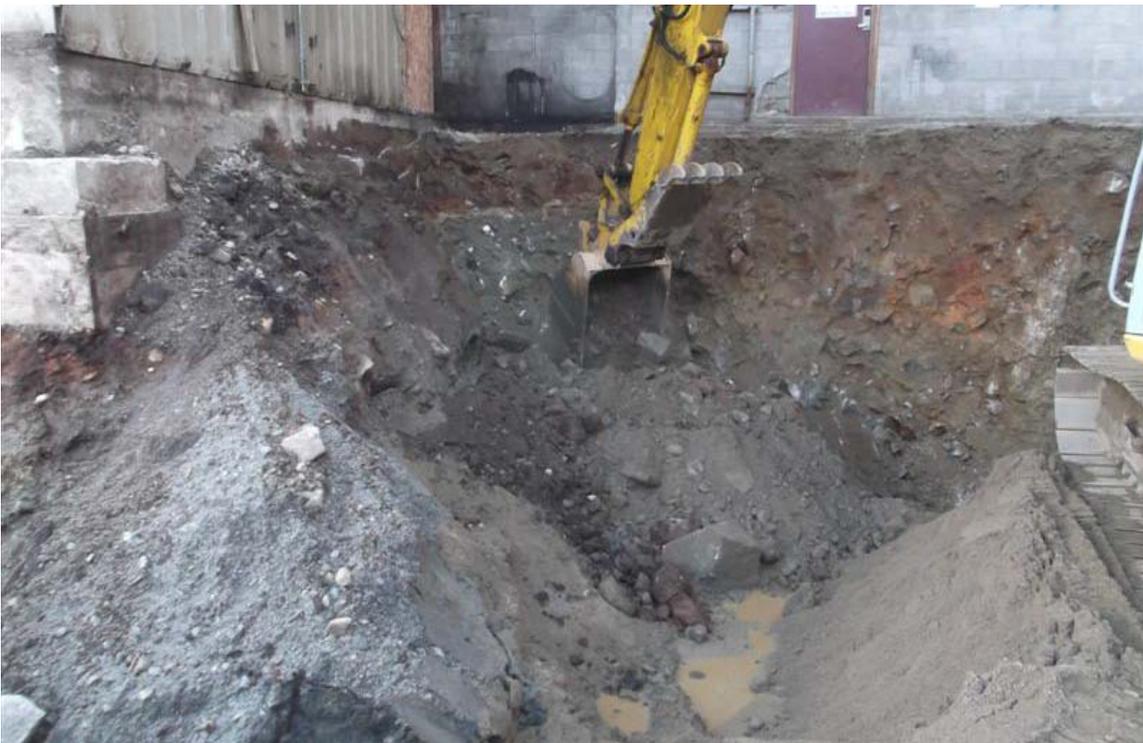
North to south view of excavation beneath former fuel dispensing shed adjacent to vehicle maintenance building.

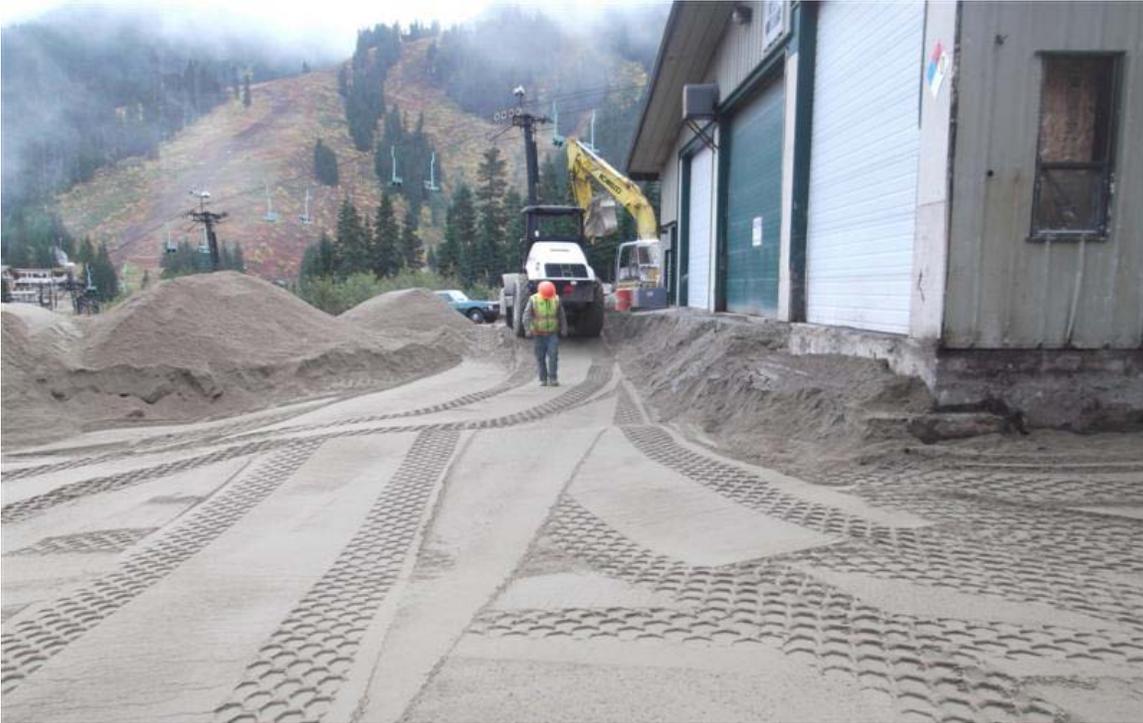
West to east view of backfilling of eastern part of northern vehicle maintenance facility excavation.

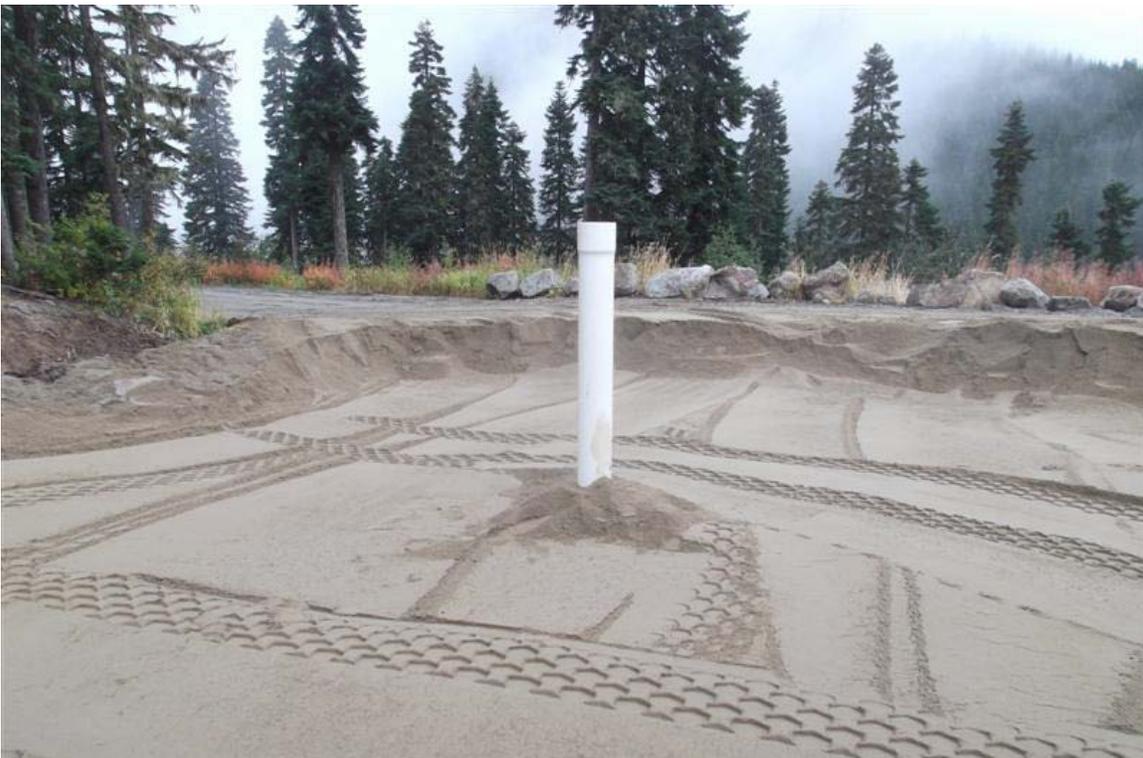
South to north view of backfilling of northern part of northern vehicle maintenance facility excavation. PVC pipe was used for the installation of monitoring well VMW-4.

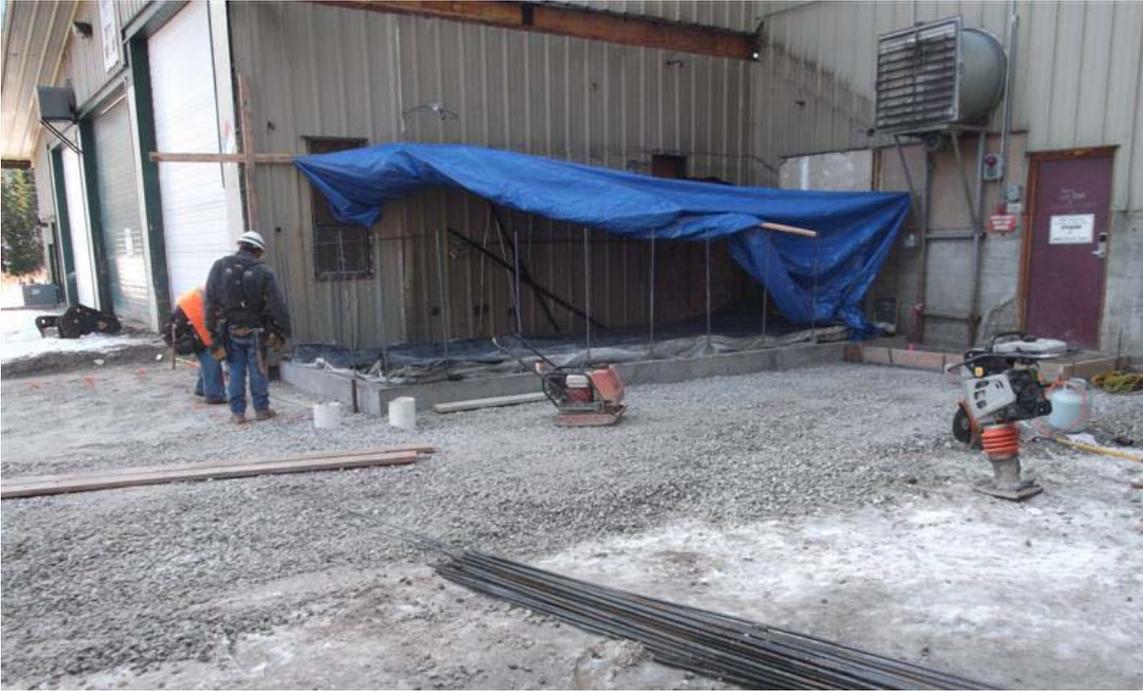
Construction of forms for concrete surface cap along north side of vehicle maintenance building, prior to rebuilding of shed.

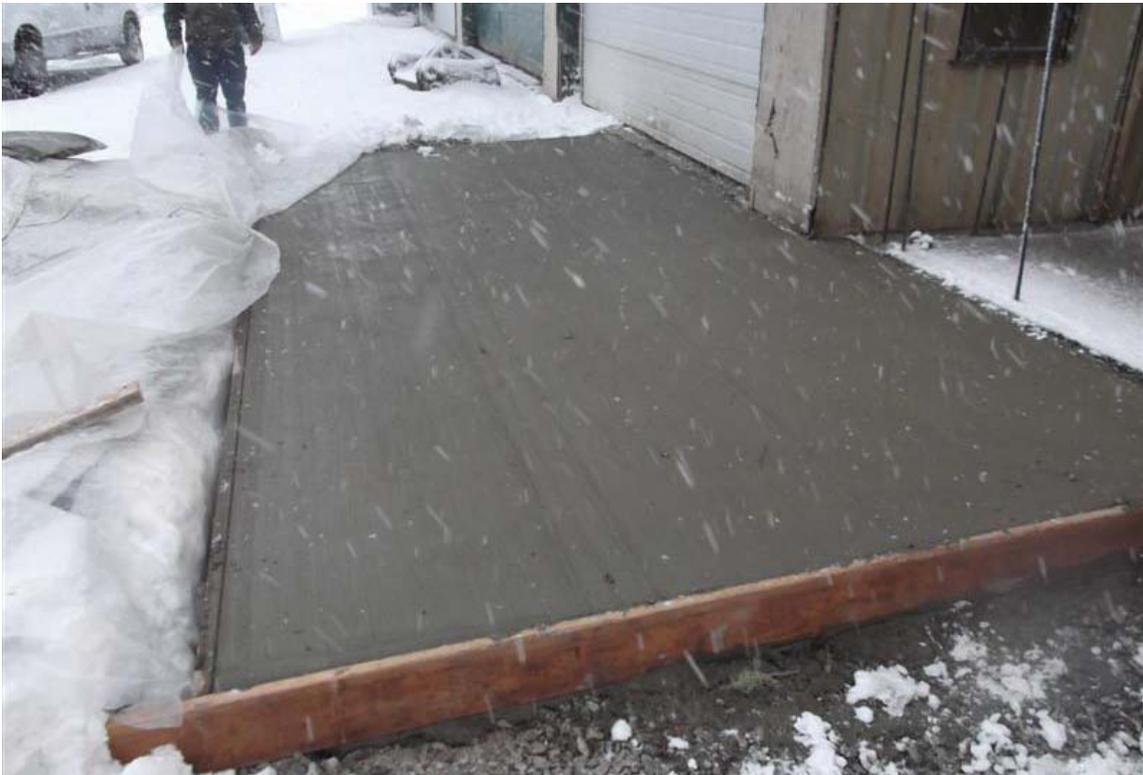
West to east view of northern portion of concrete surface cap along north side of vehicle maintenance building.
